WOOD DESTROYING PESTS AND ORGANISMS INSPECTION REPORT #: 20267613

BUILDING NO. 401	STREET YARMOUTH RD.	CITY PALOS VERDES ESTATES	ZIP 90274	Date of Inspection 05/12/2026	NUMBER OF PAGES 1 of 7
----------------------------	-------------------------------	-------------------------------------	---------------------	---	----------------------------------

Escocia Termite Inc www.escociatermite.com

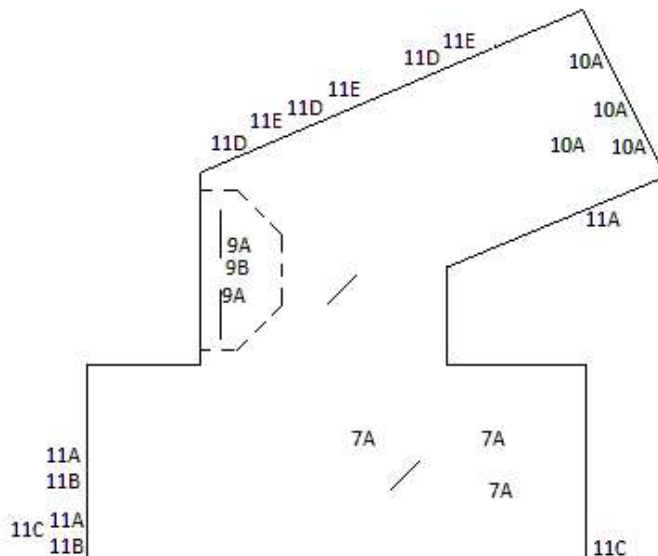
FINDING: Evidence of DRYWOOD TERMITES as indicated by 7A on the diagram. Evidence noted in or near: ATTIC FRAMING.

FINDING: EXCESSIVE MOISTURE indicated by 9A on diagram. The EXCESSIVE MOISTURE was noted in or near: STUCCO, BEAM.

FINDING: At the time of the inspection support beam and stucco were noted to be cracked.

FINDING: Evidence of DRYWOOD TERMITES as indicated by 10A on the diagram. Evidence noted in or near: EAVES, SIDING.

ITEM NO. 11A (Section 1)
FINDING: Evidence of DRYWOOD TERMITES as indicated by 11A on the diagram. Evidence noted in or near: TRIM.

ITEM NO. 11B (Section 1)
FINDING: DRYWOOD TERMITE DAMAGE as indicated by 11B on diagram. The damage was noted in or near: TRIM.

ITEM NO. 11C (Section 1)
FINDING: FUNGUS DAMAGE indicated by 11C on diagram. The FUNGUS DAMAGE was noted in or near: SIDING.

ITEM NO. 11D (Section 1)
FINDING: Evidence of DRYWOOD TERMITES as indicated by 11D on the diagram. Evidence noted in or near: STORAGE FRAMING.

ITEM NO. 11E (Section 1)
FINDING: DRYWOOD TERMITE DAMAGE as indicated by 11E on diagram. The damage was noted in or near: STORAGE FRAMING.

RECOMMENDATION: 7A Fumigate the structure with a fumigant lethal to DRYWOOD TERMITES (Sulfuryl Fluoride). See the occupants fumigation notice for further details. This company is not responsible for delays or schedule changes due to inclement weather or other agencies, nor is it responsible for damage to roof or plants as a result of the fumigation. Refer to the occupant's fumigation notice/preparation sheet (sent separately) for additional information.

RECOMMENDATION: 9A It is recommended that owner contact a state licensed contractor to correct.

RECOMMENDATION: 9B This firm recommends getting a state licensed contractor to assess the condition and recommend any necessary corrections.

RECOMMENDATION: 10A Fumigate the structure with a fumigant lethal to DRYWOOD TERMITES (Sulfuryl Fluoride). See the occupants fumigation notice for further details. This company is not responsible for delays or schedule changes due to inclement weather or other agencies, nor is it responsible for damage to roof or plants as a result of the fumigation. Refer to the occupant's fumigation notice/preparation sheet (sent separately) for additional information.

RECOMMENDATION: 11A Fumigate the structure with a fumigant lethal to DRYWOOD TERMITES (Sulfuryl Fluoride). See the occupants fumigation notice for further details. This company is not responsible for delays or schedule changes due to inclement weather or other agencies, nor is it responsible for damage to roof or plants as a result of the fumigation. Refer to the occupant's fumigation notice/preparation sheet (sent separately) for additional information.

RECOMMENDATION: 11B Scrape out termite damage and repair with appropriate wood filler.

RECOMMENDATION: 11C Remove and replace damaged wood as necessary with today's available widths and grades.

RECOMMENDATION: 11D Fumigate the structure with a fumigant lethal to DRYWOOD TERMITES (Sulfuryl Fluoride). See the occupants fumigation notice for further details. This company is not responsible for delays or schedule changes due to inclement weather or other agencies, nor is it responsible for damage to roof or plants as a result of the fumigation. Refer to the occupant's fumigation notice/preparation sheet (sent separately) for additional information.

RECOMMENDATION: 11E Remove and replace damaged wood as necessary with today's available widths and grades.
