# Inspection Report

**Property Address:**  
9191 San Diego Way #47  
Atascadero CA 93422

9/17/2025

**Harper Homes: Home Inspection Services**

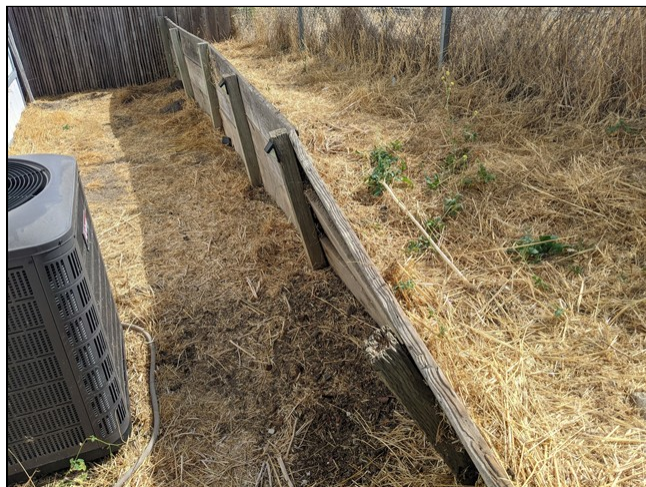
1.4 Item 1(Picture)

Foliage needs trimmed back from contacting the siding. This will decrease the probability of moisture and pest intrusion.

Landscape retaining wall at the rear exterior is leaning slightly and can be altered or re-installed, as needed.

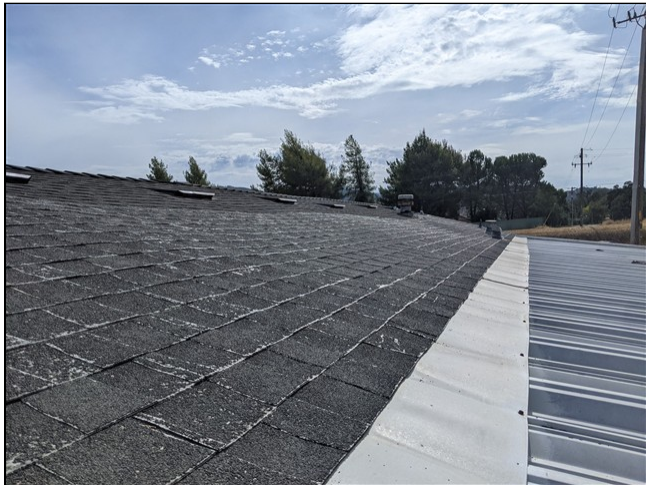
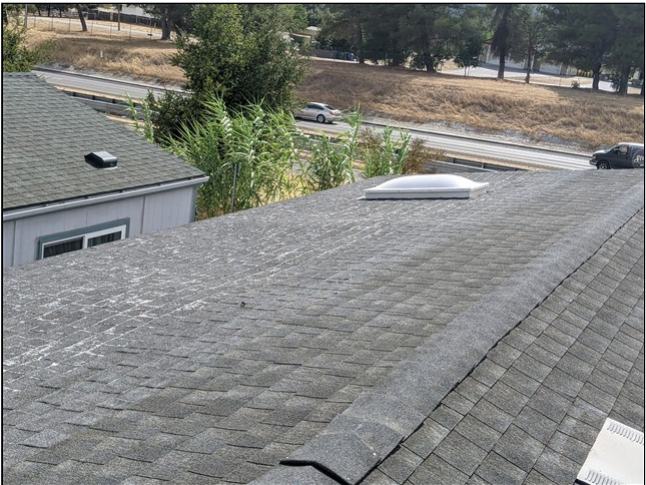
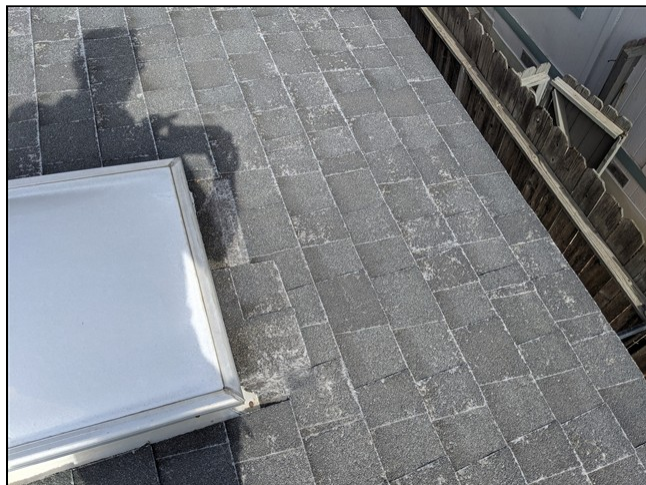
2.0 Item 1(Picture)

FURTHER EVALUATION  
Areas of the roofing material are weathered and in need of replacement. Recommend further evaluation with cost to replace and remaining life determined by a licensed roofing contractor.

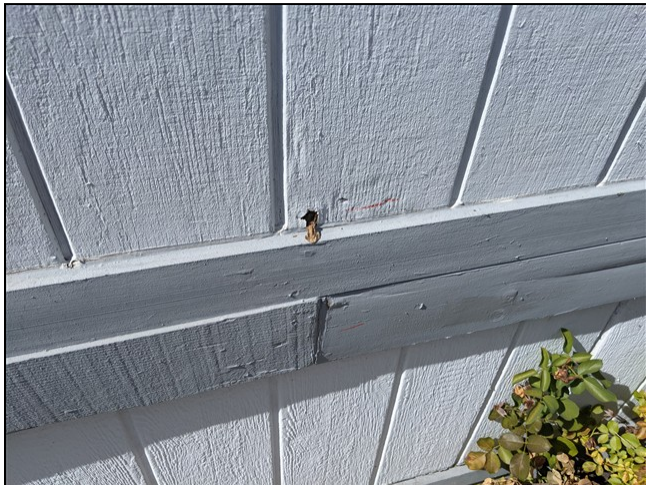
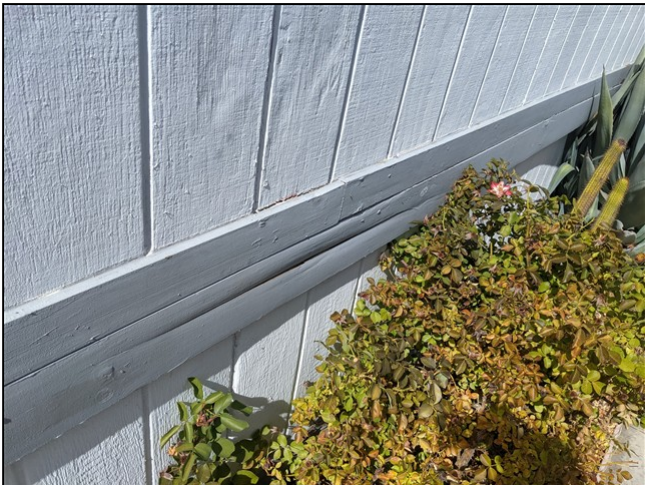
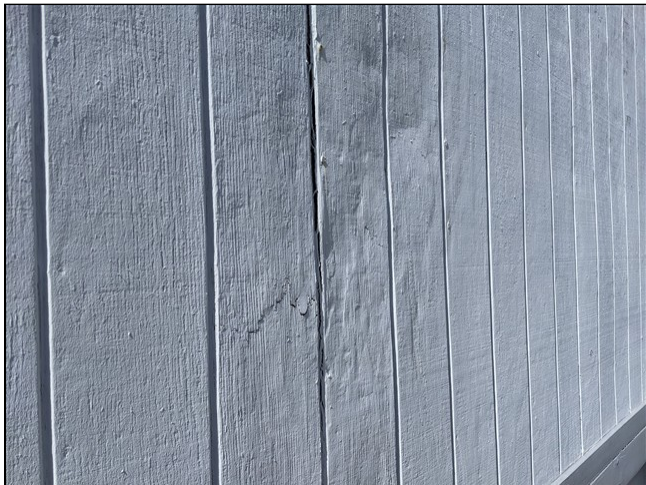
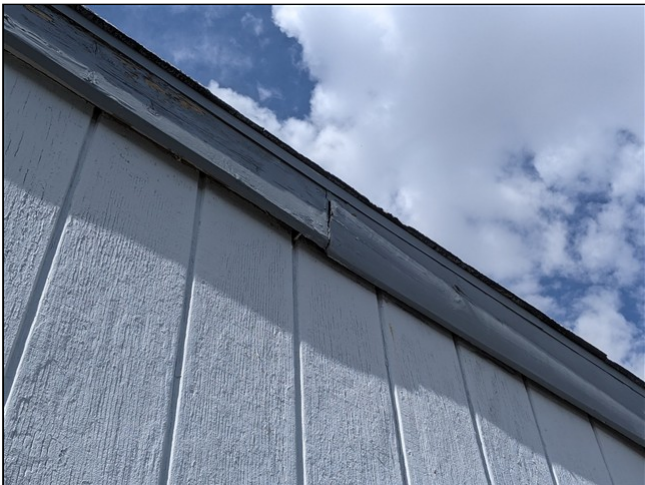
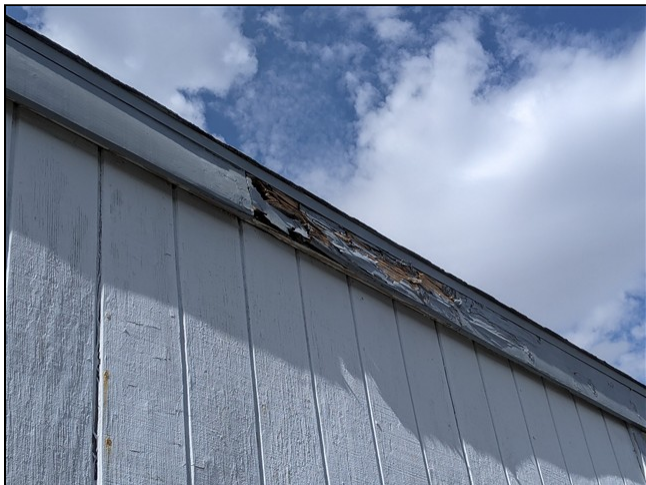
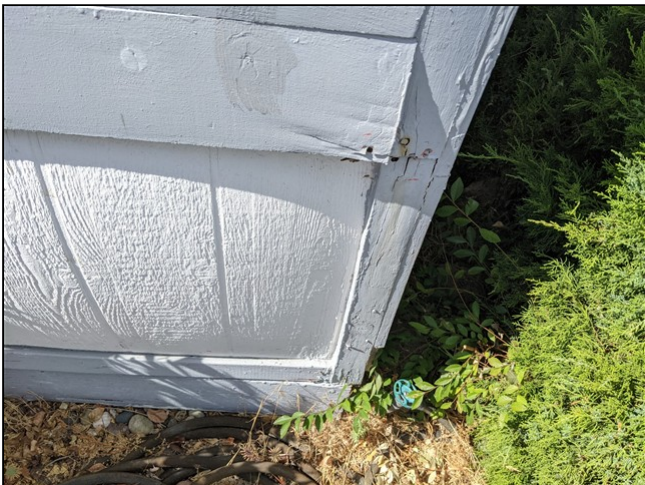
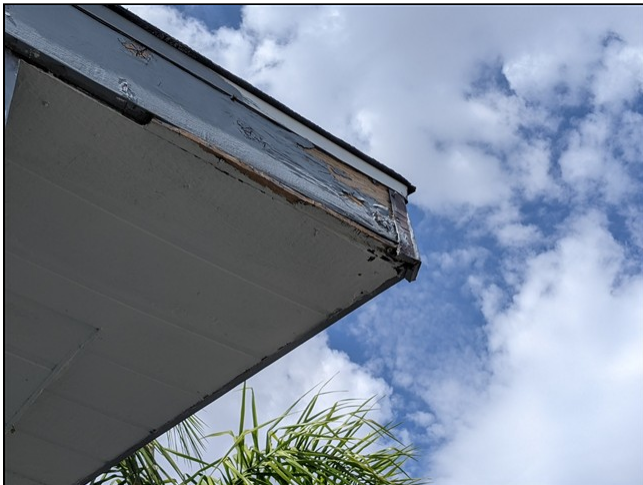
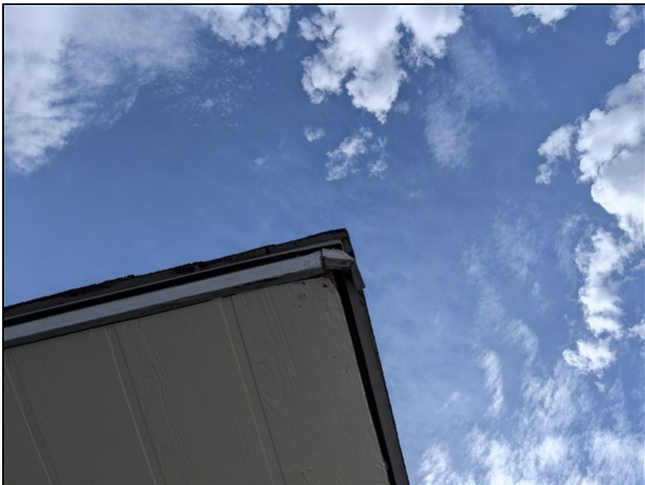
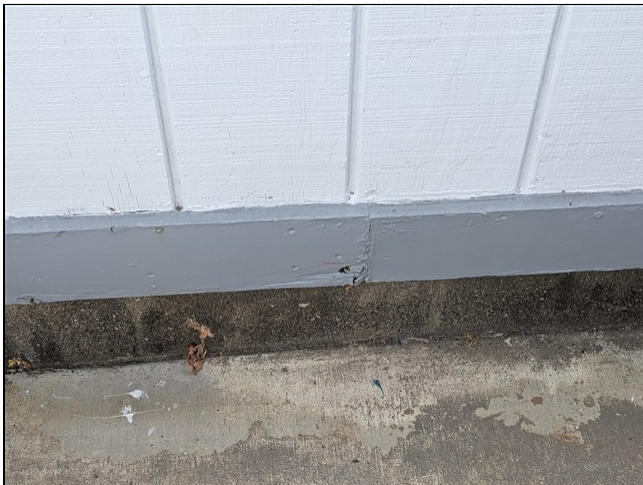
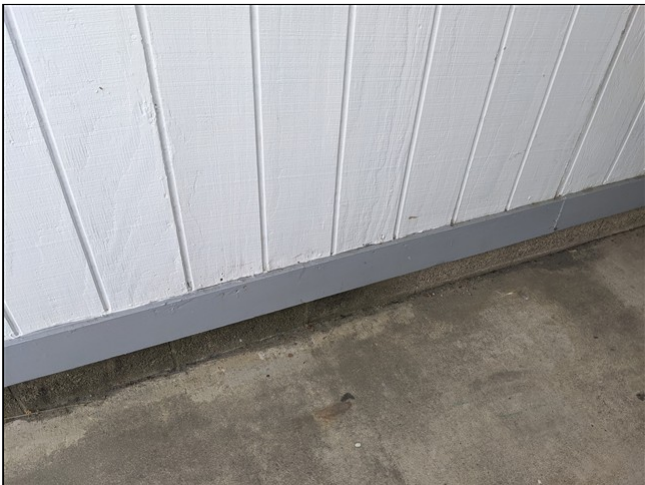
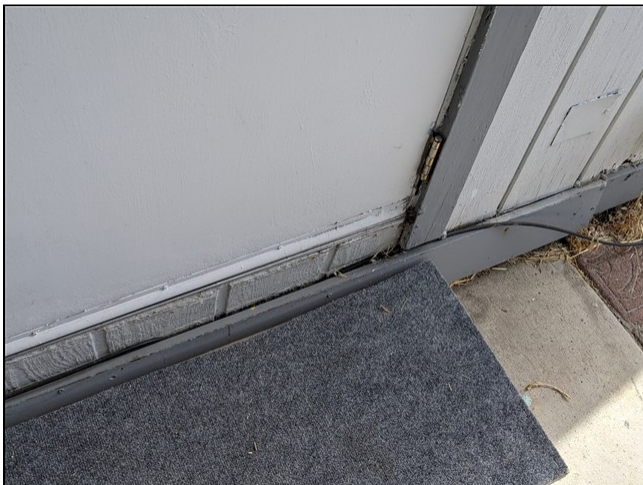
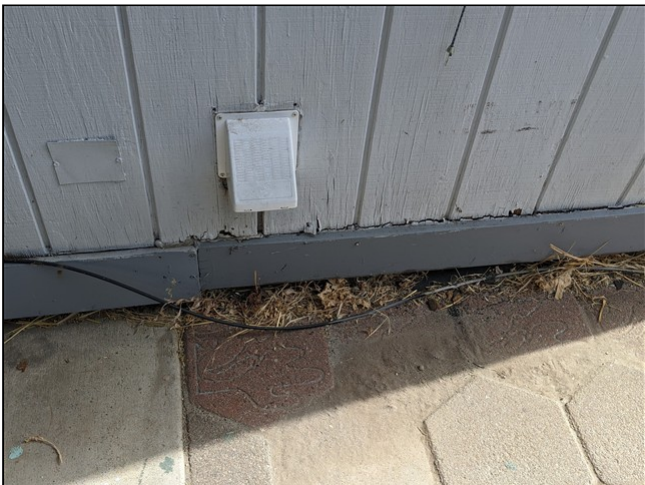
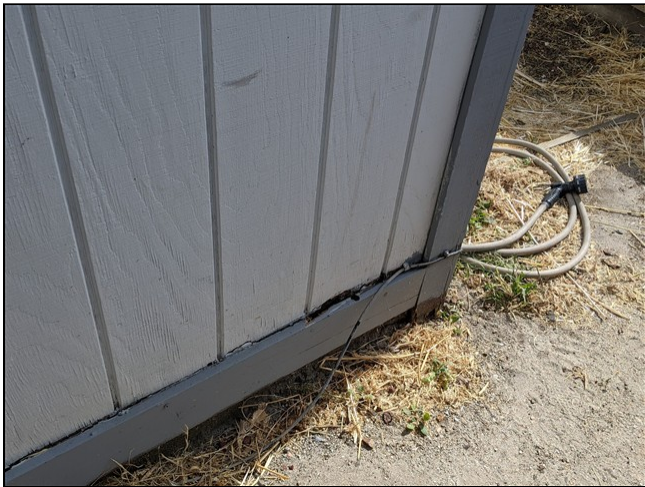
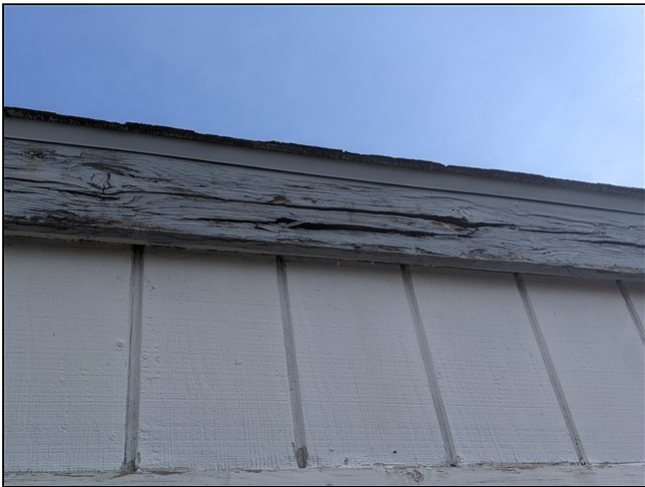
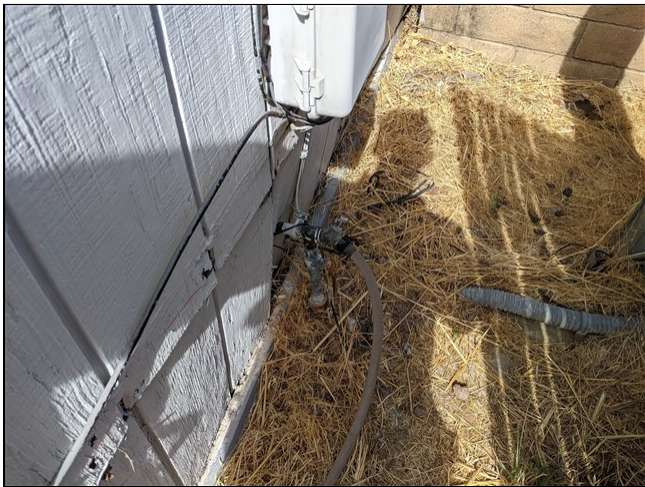
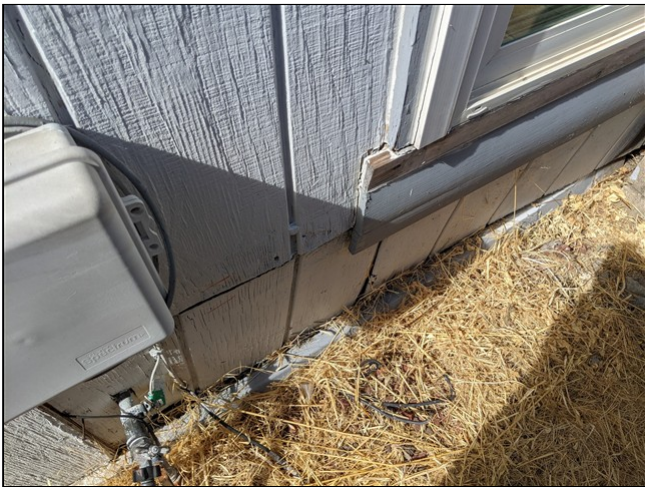
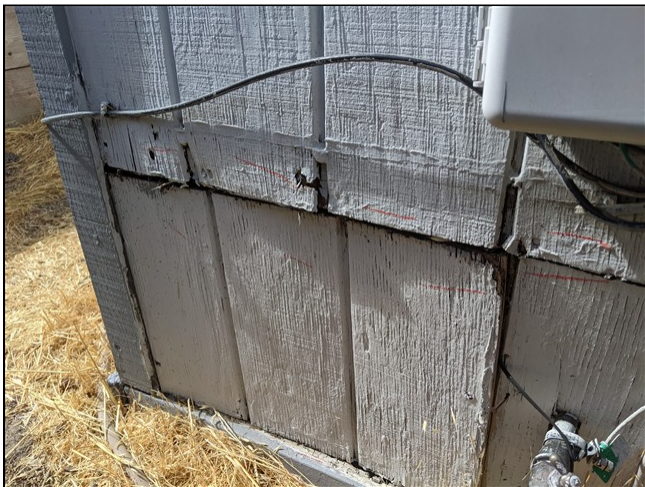
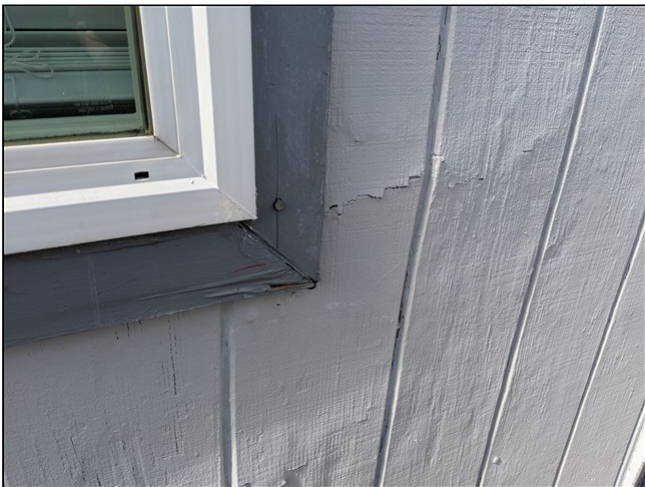
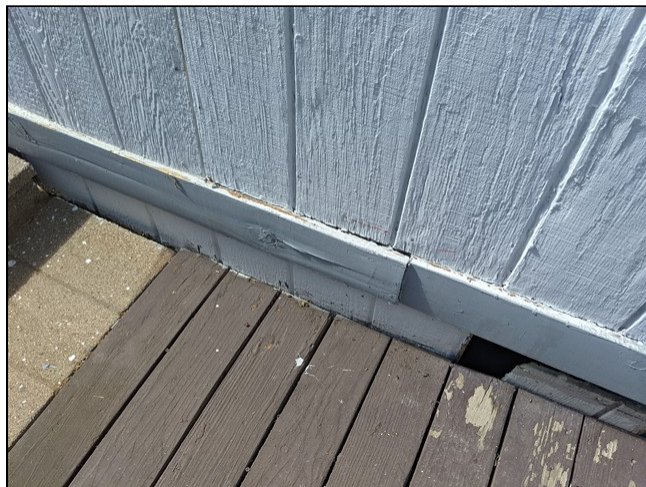
Areas of the fascia, trim and siding contain moisture damage. Refer to the pest report for further information on this condition and make repairs as prescribed.

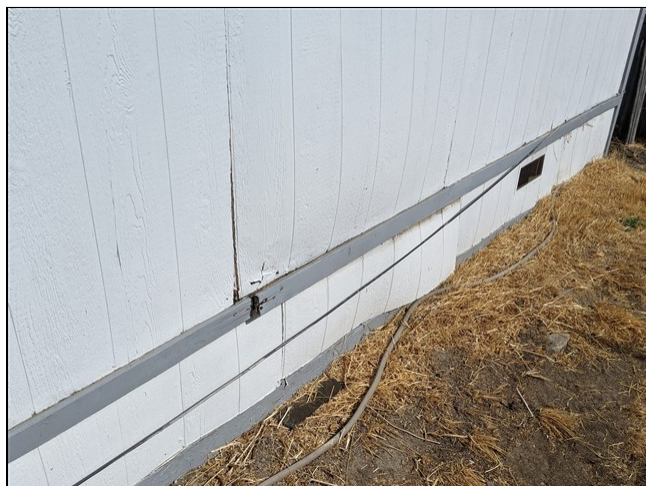
2.4 Item 20(Picture)

Wood siding is buckling in areas. Probable moisture absorption at the siding due to moisture damage has caused the siding to expand and push outward between connection points. Not of structural concern. Recommend replacement of the siding as needed.

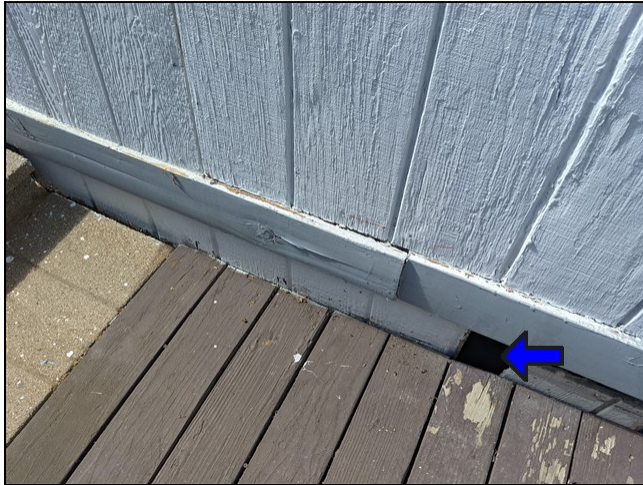
2.4 Item 21(Picture)

Perforations in the siding at the left side of the home should be patched or repaired to prevent pest or moisture intrusion.

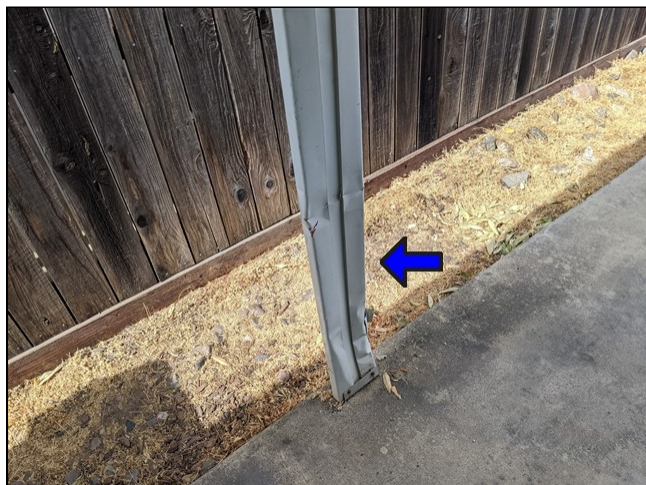
2.7 Item 1(Picture)

The carport post is damaged and repairs are needed to ensure proper support at this location.

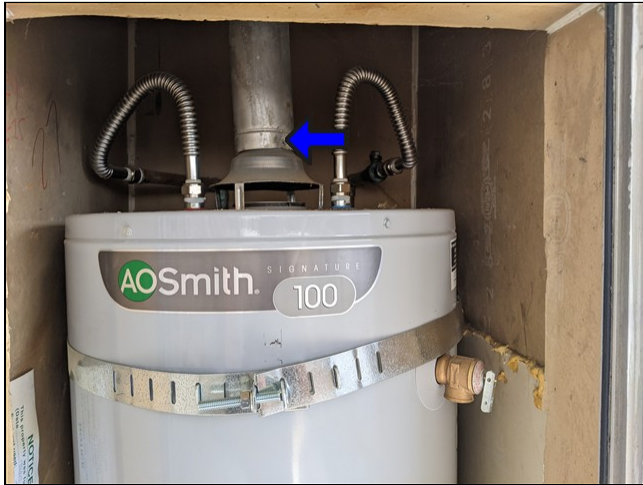
4.0 Item 1(Picture)

Water heater vent pipe connections need proper fasteners installed to help prevent the chance of displacement in the event of seismic activity.

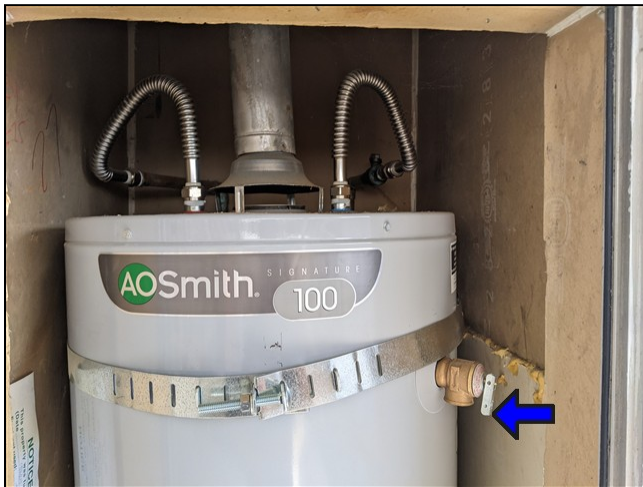
4.0 Item 2(Picture)

Water heater safety valve piping missing and needs properly installed to prevent an unsafe condition if the TPR is activated.

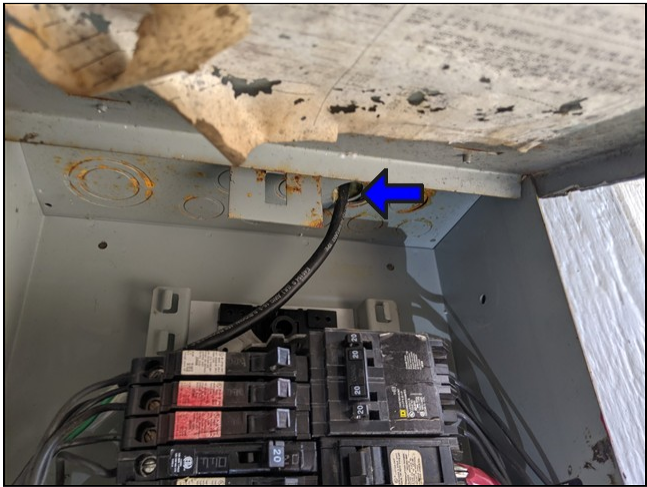
5.1 Item 1(Picture)

(1) INSTALLATION NEEDED  
Box clamp/wire bushing not installed at sub panel. Recommend installation of proper box clamp by a qualified professional to prevent the chance of wire damage from contact with the box edge.

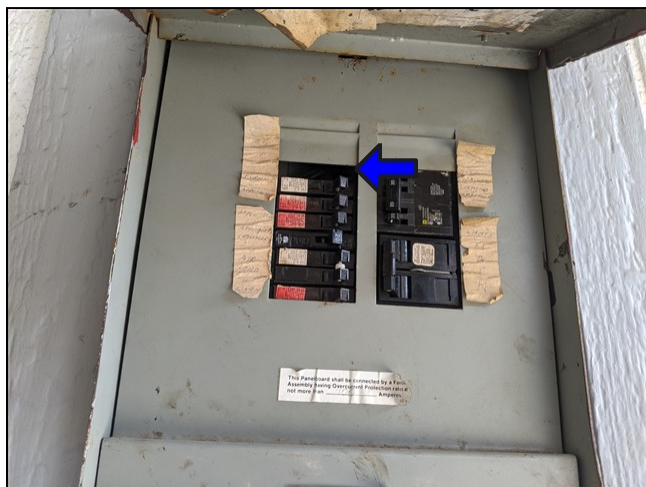
5.1 Item 2(Picture)

Unused breaker slot remains exposed at the sub panel and needs the appropriate breaker slot cover installed.

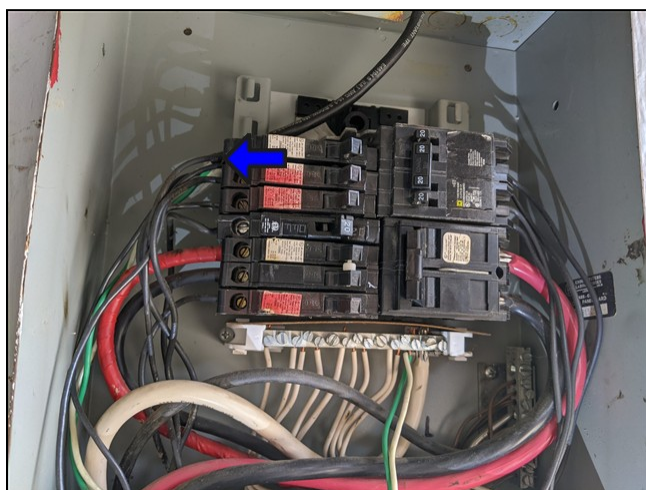
5.2 Item 1(Picture)

Double wires improperly installed on a breaker in the sub panel. Alteration or repairs should be made to prevent an unsafe condition.

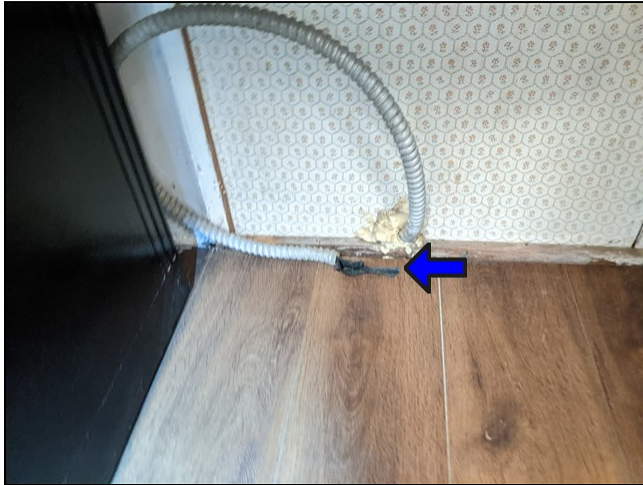
5.3 Item 1(Picture)

Wire terminates improperly in the kitchen. Exposed wire needs installed in a junction box or removed back to the previous connection point.

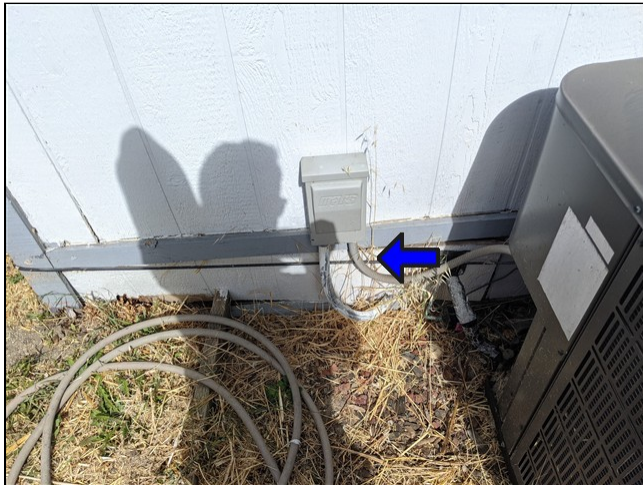
5.4 Item 1(Picture)

Conduit needs properly secured at the air conditioner power supply.

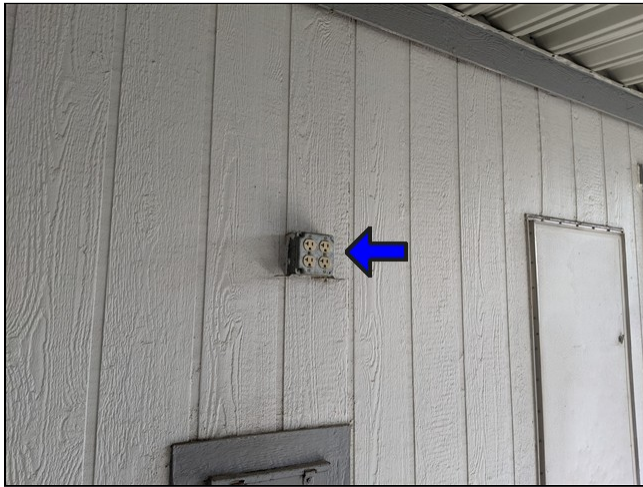
5.6 Item 1(Picture)

Exterior receptacle without a weather cover noted at the right exterior. Installation is needed to insure full safety of this system.

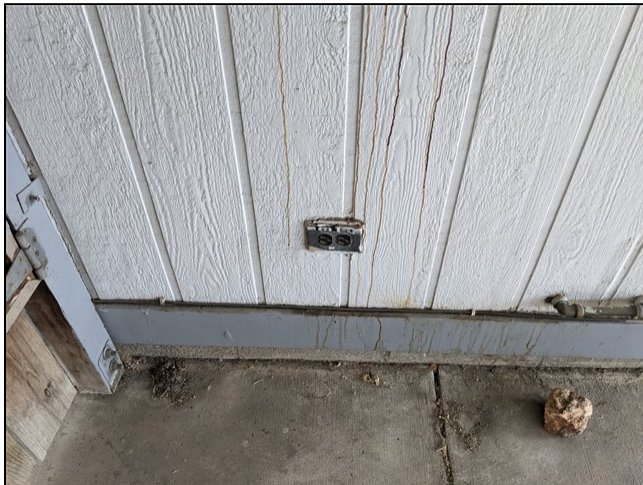
5.6 Item 2(Picture)

Weather cover for the exterior receptacle at the right exterior is damaged and needs replaced to insure intended safety.

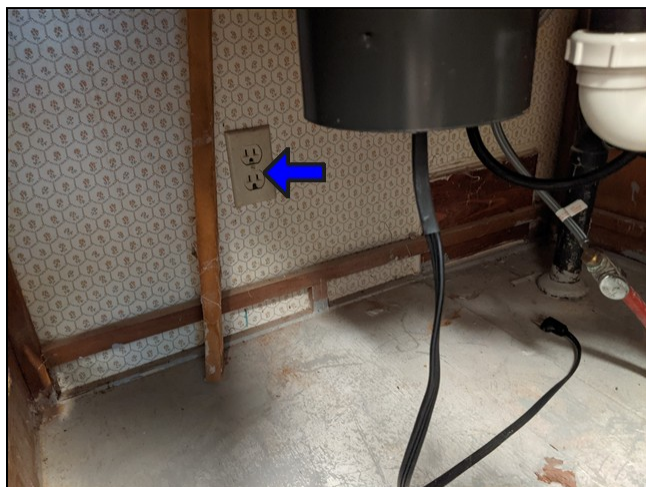
5.6 Item 3(Picture)

The receptacle at the switched receptacle under the sink was inoperative at the time of inspection and repairs are needed.

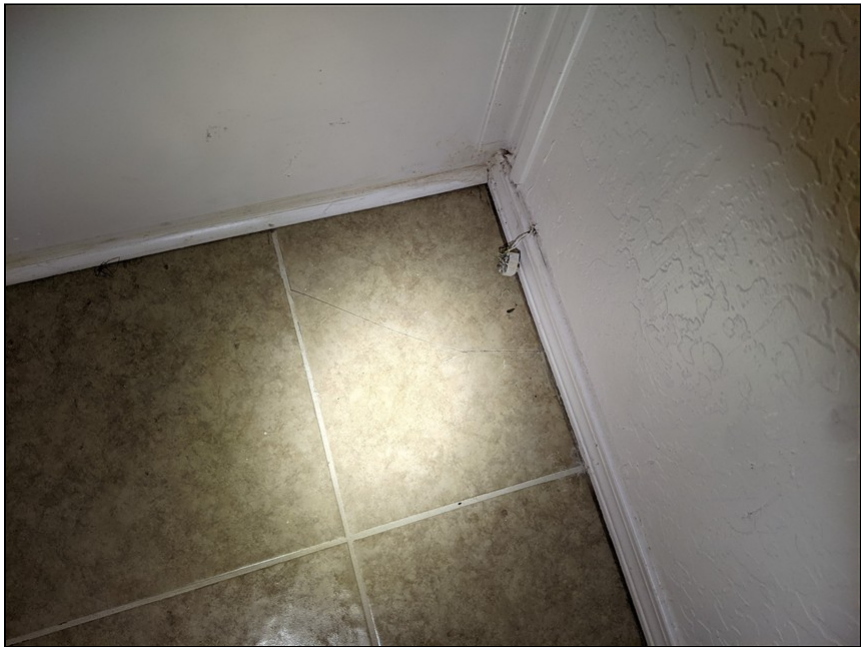
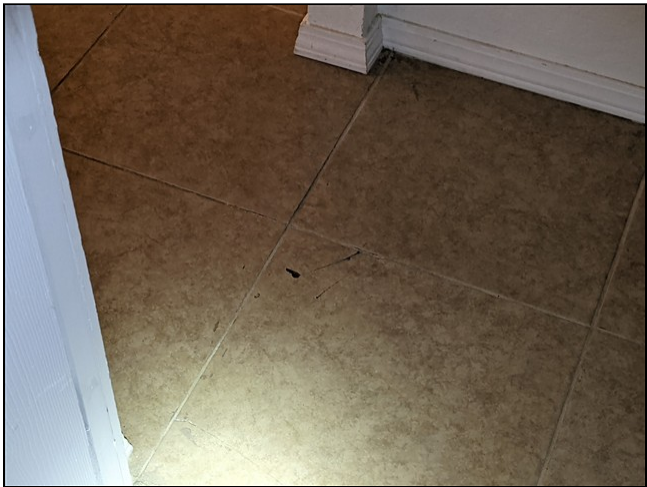
Cracked tiles noted at the living room and hallway appear stable and can be replaced as needed.

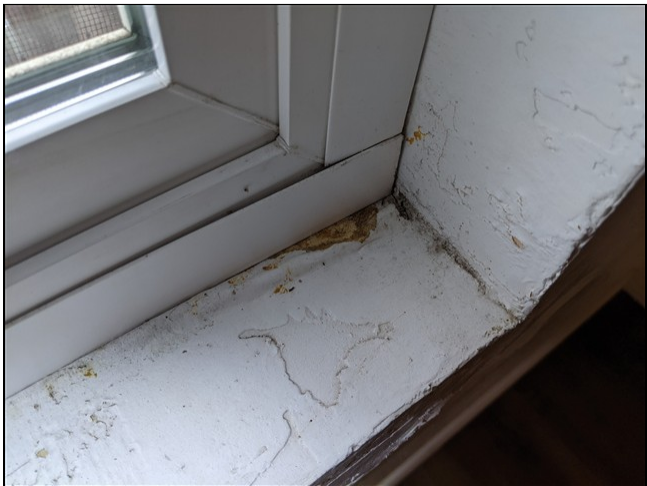
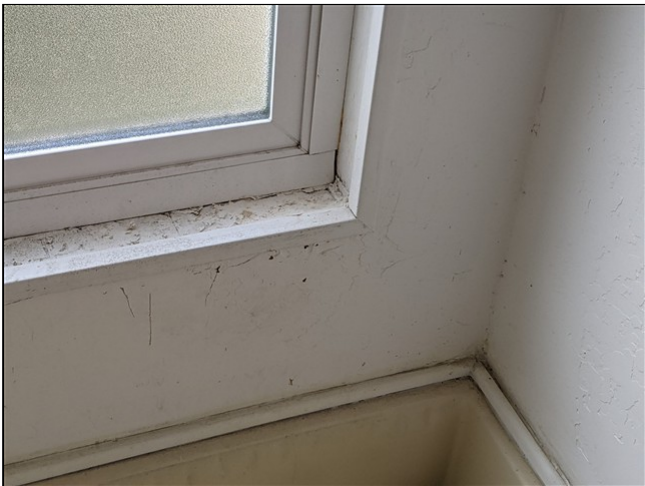
Moisture intrusion noted at the window sills and walls due to probable moisture intrusion from the windows prior to replacement. Recommend caulking the interior corner seams in the frames and repairs made to the drywall as needed.

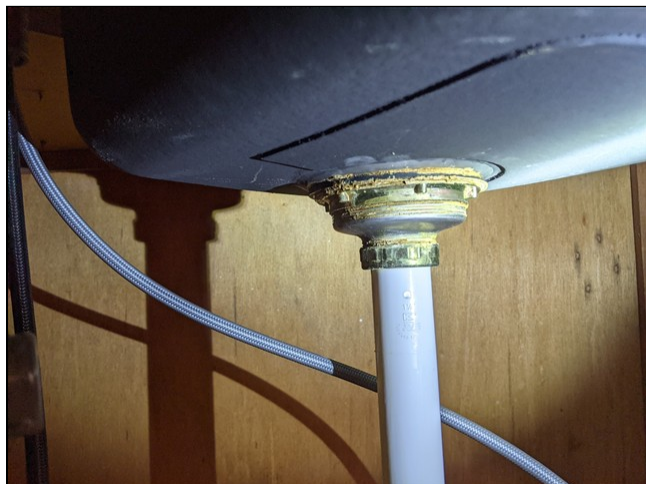
8.4 Item 1(Picture)

Drain line leak noted under the sink. Recommend repairs made before further use of the sink.
