WOOD DESTROYING PESTS AND ORGANISMS INSPECTION REPORT

#: 20223445

BUILDING NO. 2005	STREET W. CRESTWOOD	CITY RANCHO PALOS VERDES	ZIP 90275	Date of Inspection 08/16/2022	NUMBER OF PAGES 1 of 7
----------------------	------------------------	-----------------------------	--------------	----------------------------------	---------------------------

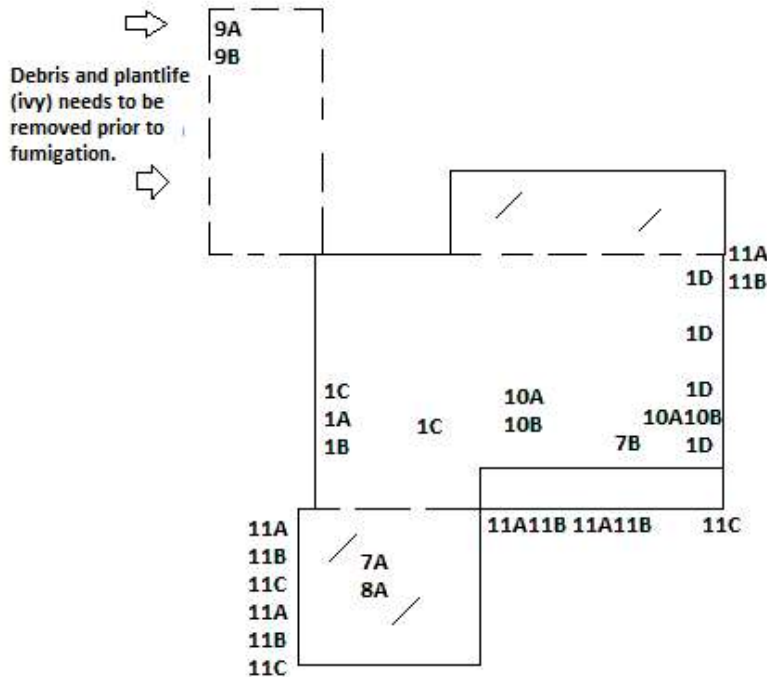
Key: 1 = Substructure 2 = Stall Shower 3 = Foundation 4 = Porches 5 = Vents 6 = Abutments 7 = Attic 8 = Garage 9 = Patio 10 = Interior 11 = Exterior

FINDING: Evidence of DRYWOOD TERMITES as indicated by 1A on the diagram. Evidence noted in or near: SUBFLOOR.

FINDING AND RECOMMENDATION: 1B Drywood termite pellets as indicated by 1B on the diagram.

ITEM NO. 1C (Section 1)
FINDING: FUNGUS DAMAGE indicated by 1C on diagram. The FUNGUS DAMAGE was noted in or near: SUBFLOOR.

ITEM NO. 1D (Section 2)
FINDING AND RECOMMENDATION: 1D Finding: Earth wood contact was visually noted at form boards/stakes as per diagram location.

ITEM NO. 7A (Section Not Determined)
FINDING AND RECOMMENDATION: 7A An INACCESSIBLE AREA exists as indicated by 7A on the diagram.
FURTHER INSPECTION after owner makes area accessible, issue supplement report with findings, recommendations and costs if any.

ITEM NO. 9A (Section 1)
FINDING: Evidence of DRYWOOD TERMITES as indicated by 9A on the diagram. Evidence noted in or near: EAVES.

ITEM NO. 9B (Section 1)
FINDING: DRYWOOD TERMITE DAMAGE as indicated by 9B on diagram. The damage was noted in or near: EAVES.

ITEM NO. 10A (Section 1)
FINDING: Evidence of DRYWOOD TERMITES as indicated by 10A on the diagram. Evidence noted in or near: HARDWOOD FLOOR.

ITEM NO. 10B (Section 1)
FINDING: DRYWOOD TERMITE DAMAGE as indicated by 10B on diagram. The damage was noted in or near: HARDWOOD FLOOR.

ITEM NO. 11A (Section 1)
FINDING: Evidence of DRYWOOD TERMITES as indicated by 11A on the diagram. Evidence noted in or near: RAFTERS, EAVES, FASCIA, VALLEY RAFTERS.

ITEM NO. 11B (Section 1)
FINDING: DRYWOOD TERMITE DAMAGE as indicated by 11B on diagram. The damage was noted in or near: RAFTERS, EAVES, FASCIA, VALLEY RAFTERS.

ITEM NO. 11C (Section 1)
FINDING: FUNGUS DAMAGE indicated by 11C on diagram. The FUNGUS DAMAGE was noted in or near: RAFTERS, EAVES, FASCIA, VALLEY RAFTERS.

RECOMMENDATION: 1A Fumigate the structure with a fumigant lethal to DRYWOOD TERMITES (Sulfuryl Fluoride). See the occupants fumigation notice for further details. This company is not responsible for delays or schedule changes due to inclement weather or other agencies, nor is it responsible for damage to roof or plants as a result of the fumigation. Refer to the occupant's fumigation notice/preparation sheet (sent separately) for additional information.

Remove or cover pellets in visible and accessible areas. NOTE: It is common for additional pellets to sift down over a period of time due to normal household vibrations. This estimate is to cover the pellets one time only.

RECOMMENDATION: 1C Remove and replace damaged wood as necessary with today's available widths and grades.

RECOMMENDATION: 1C We recommend scraping or brushing area and treating with a registered fungicide.

Recommendation: Remove form boards as practical, treat if not practical with a state approved toxic chemical (Termidor/Timbor)

RECOMMENDATION: 9B Remove and replace damaged wood as necessary with today's available widths and grades.

RECOMMENDATION: 10A Fumigate the structure with a fumigant lethal to DRYWOOD TERMITES (Sulfuryl Fluoride). See the occupants fumigation notice for further details. This company is not responsible for delays or schedule changes due to inclement weather or other agencies, nor is it responsible for damage to roof or plants as a result of the fumigation. Refer to the occupant's fumigation notice/preparation sheet (sent separately) for additional information.

RECOMMENDATION: 10B Remove and replace damaged wood as necessary with today's available widths and grades.

RECOMMENDATION: 11A Fumigate the structure with a fumigant lethal to DRYWOOD TERMITES (Sulfuryl Fluoride). See the occupants fumigation notice for further details. This company is not responsible for delays or schedule changes due to inclement weather or other agencies, nor is it responsible for damage to roof or plants as a result of the fumigation. Refer to the occupant's fumigation notice/preparation sheet (sent separately) for additional information.

RECOMMENDATION: 11B Remove and replace damaged wood as necessary with today's available widths and grades.

FINDING: Remove and replace damaged wood as necessary with today's available widths and grades.
