## RESIDENTIAL HOME INSPECTION REPORT

1628 Freeman Dr  
Pine Mountain Club,, CA 93222

11/07/2025

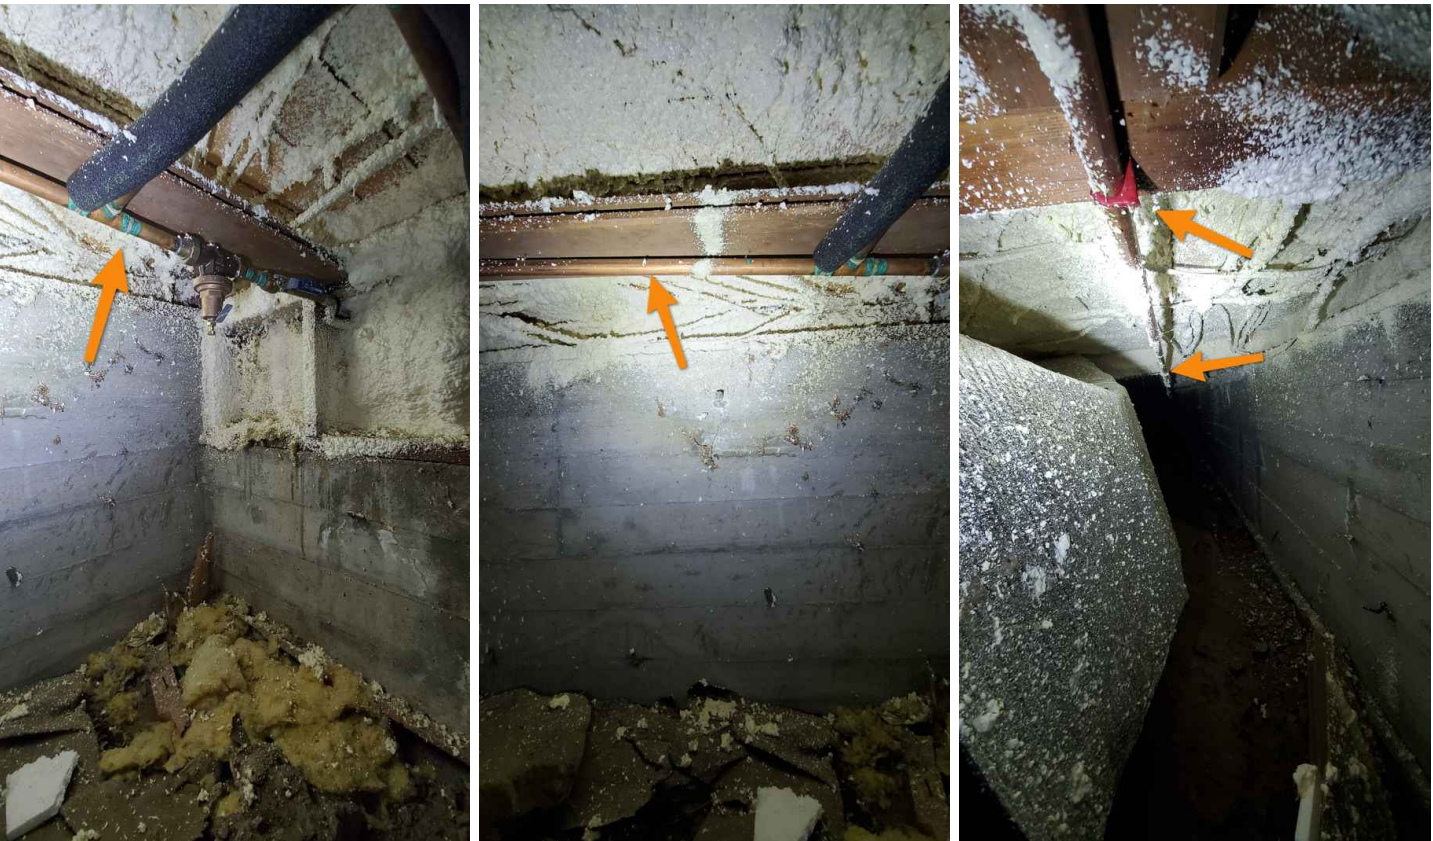
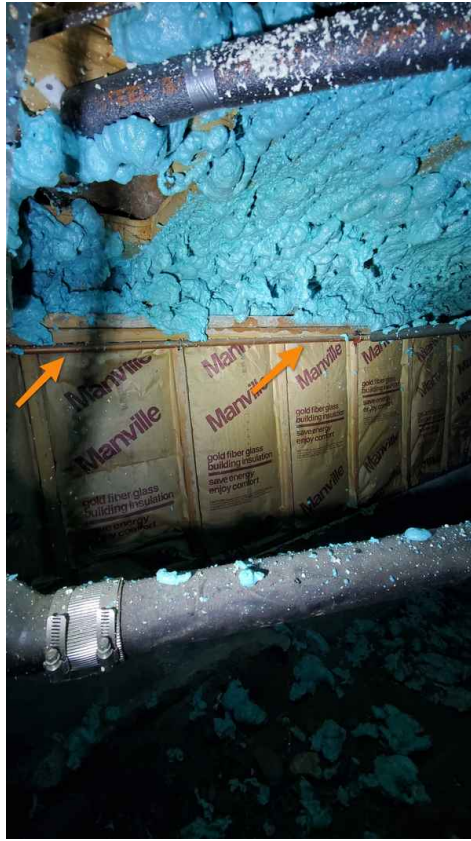
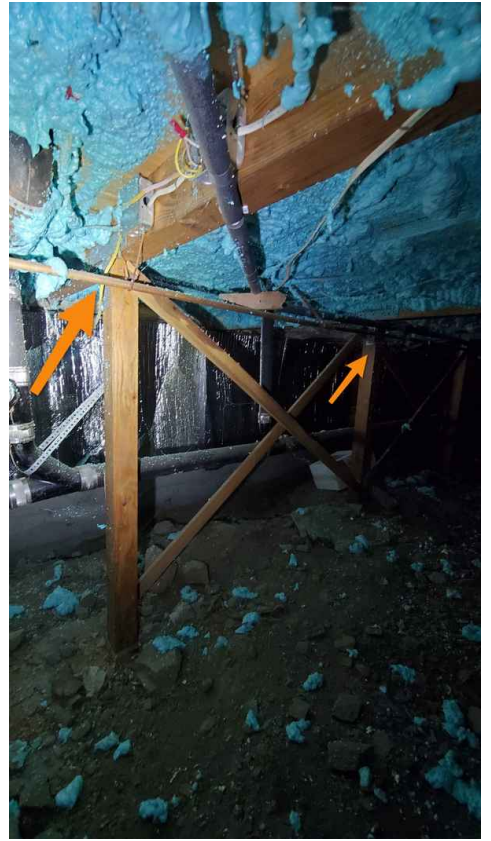
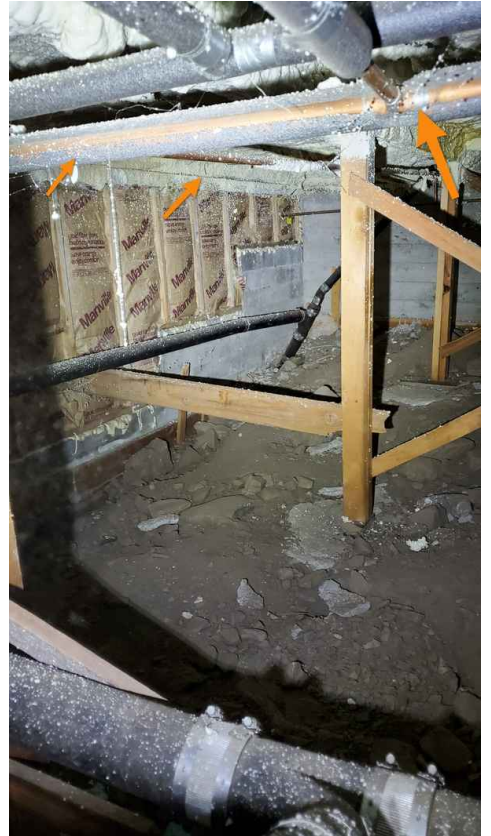
#### WATER SUPPLY LINES: INSULATION MISSING

There are water supply lines in the crawlspace that are uninsulated. These lines are out side the thermal envelope and could freeze in extreme cold. It is recommended these lines be insulated to prevent a hard freeze and potentially burst.

Contact a qualified professional.

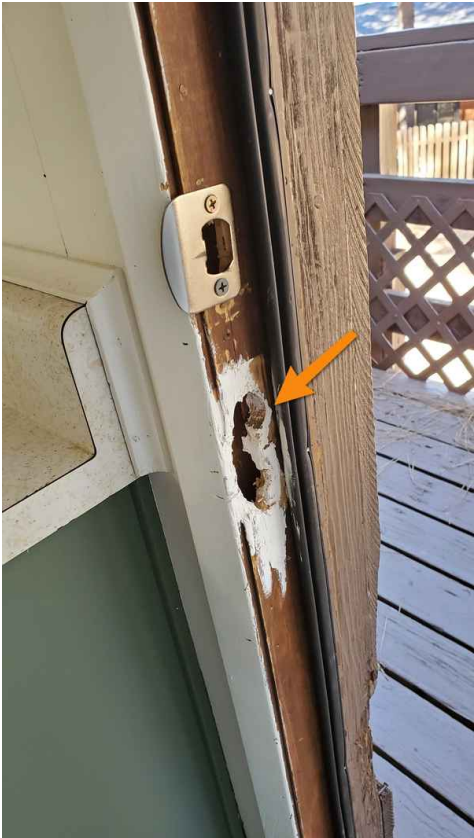
#### DOOR JAMB: DAMAGE/DETERIORATION, SEVERE

Door jamb in the kitchen had severe damage or deterioration. You should consult with a qualified contractor to discuss options and costs for repair or replacement.

Contact a qualified professional.

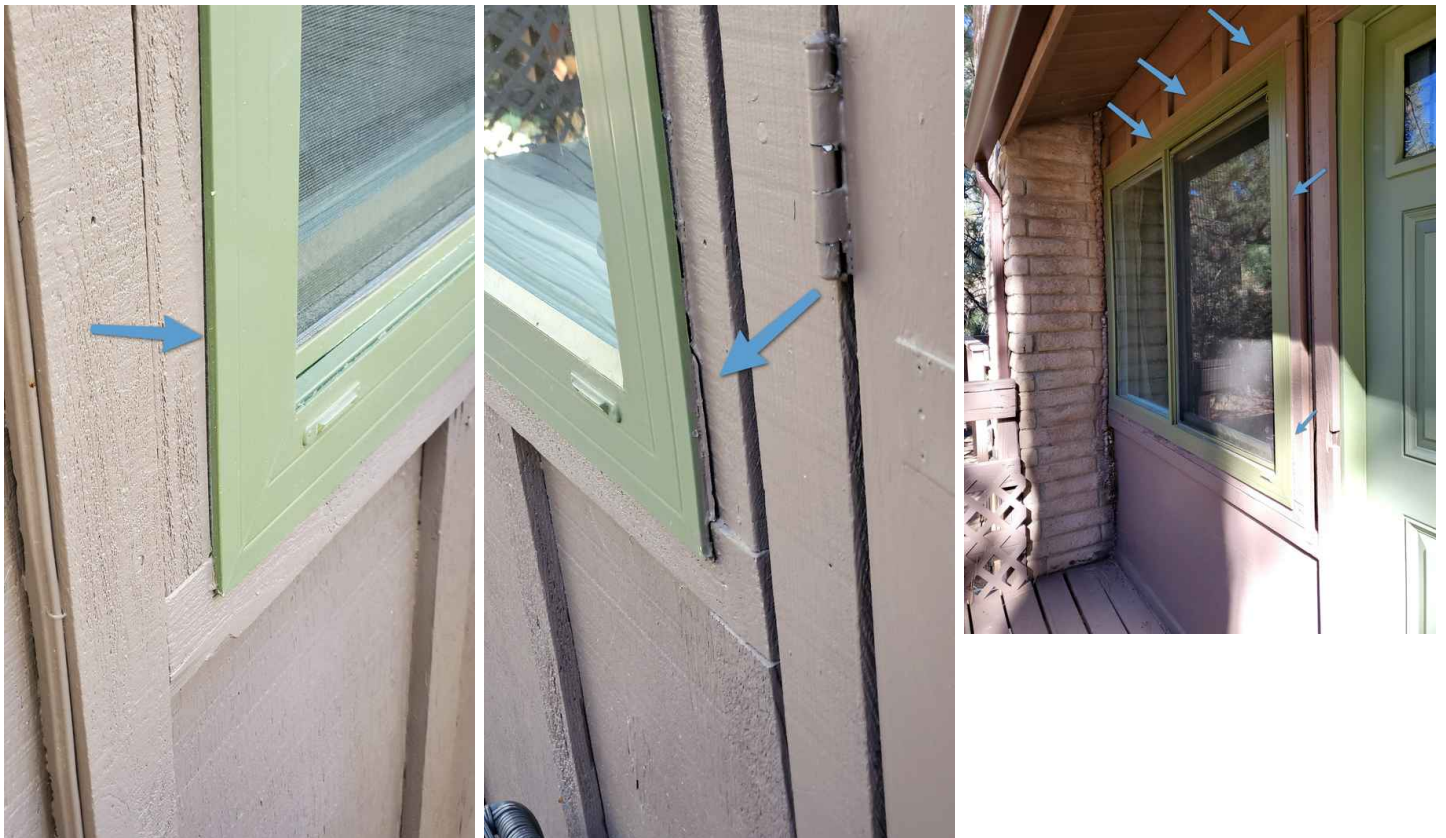
#### FLUSH FIN REPLACEMENT WINDOWS

The home has newer Flush Fin Replacement windows. These types of windows require installations that vary by the type of window they replaced and the style of new window used.

It is advised to monitor the sealant around the window frame and any trim that is around or under the new flush frame window that has been installed. Maintenance of the sealant is important to prevent leaks into the wall/home interior.

Contact a qualified professional.

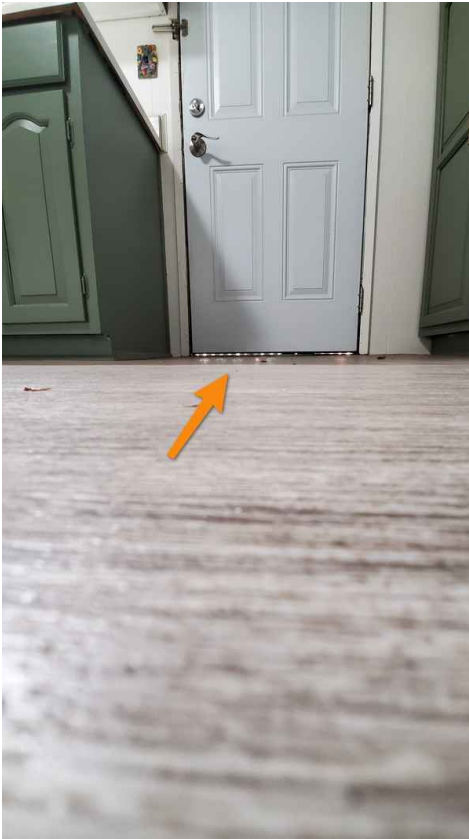
Kitchen door

##### **DOOR: THRESHOLD- WEATHER-STRIPPING MISSING**

There was thresholds and weather stripping missing on exterior doors.

This can lead to less comfort, insect intrusion and possible water damage.

Recommend installing the appropriate thresholds and weather-stripping in the locations where it is lacking.

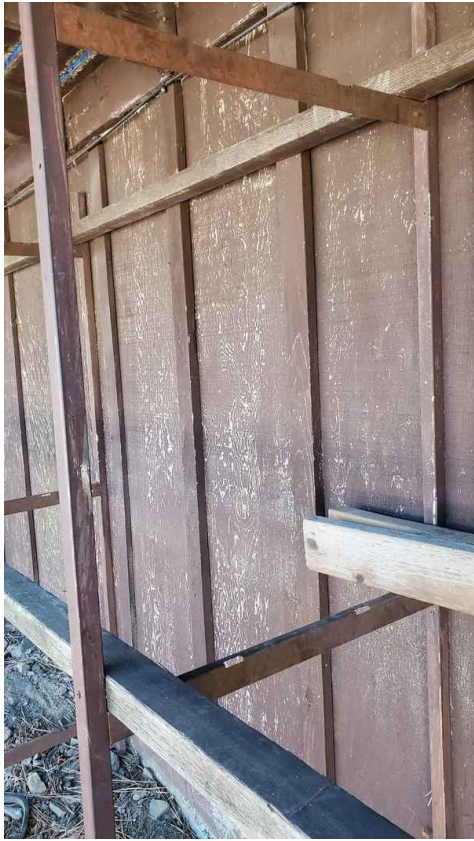
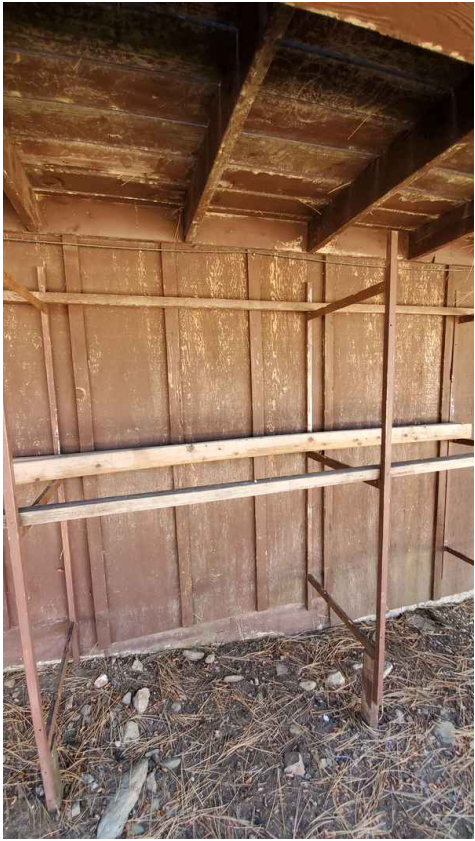
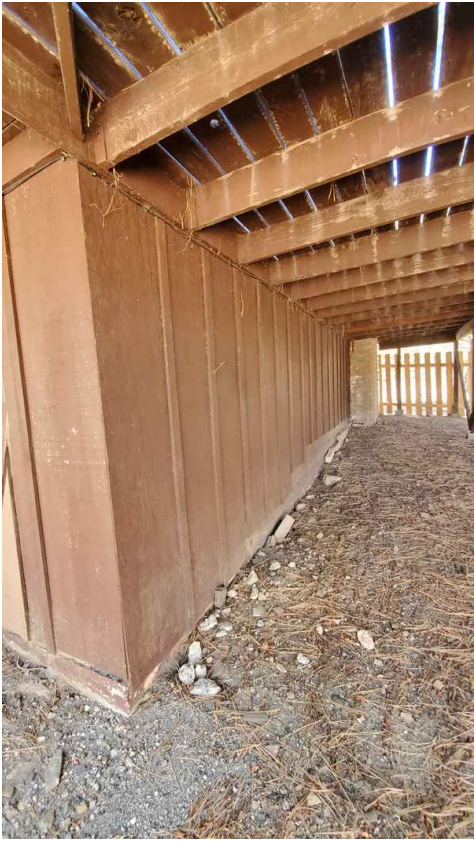
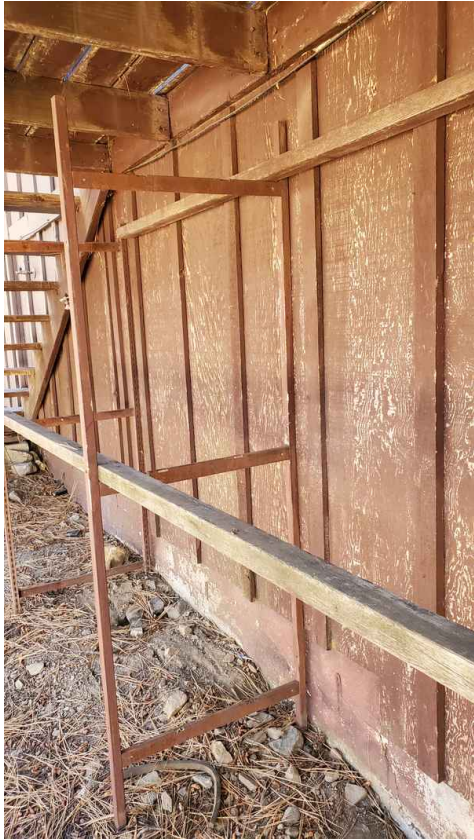
### **DETERIORATION: MINOR**

Wood siding covering the exterior walls of the home exhibited minor general weathering, wear, and deterioration commensurate with its age.

It is need of maintenance- paint or stain.

Contact a qualified professional.

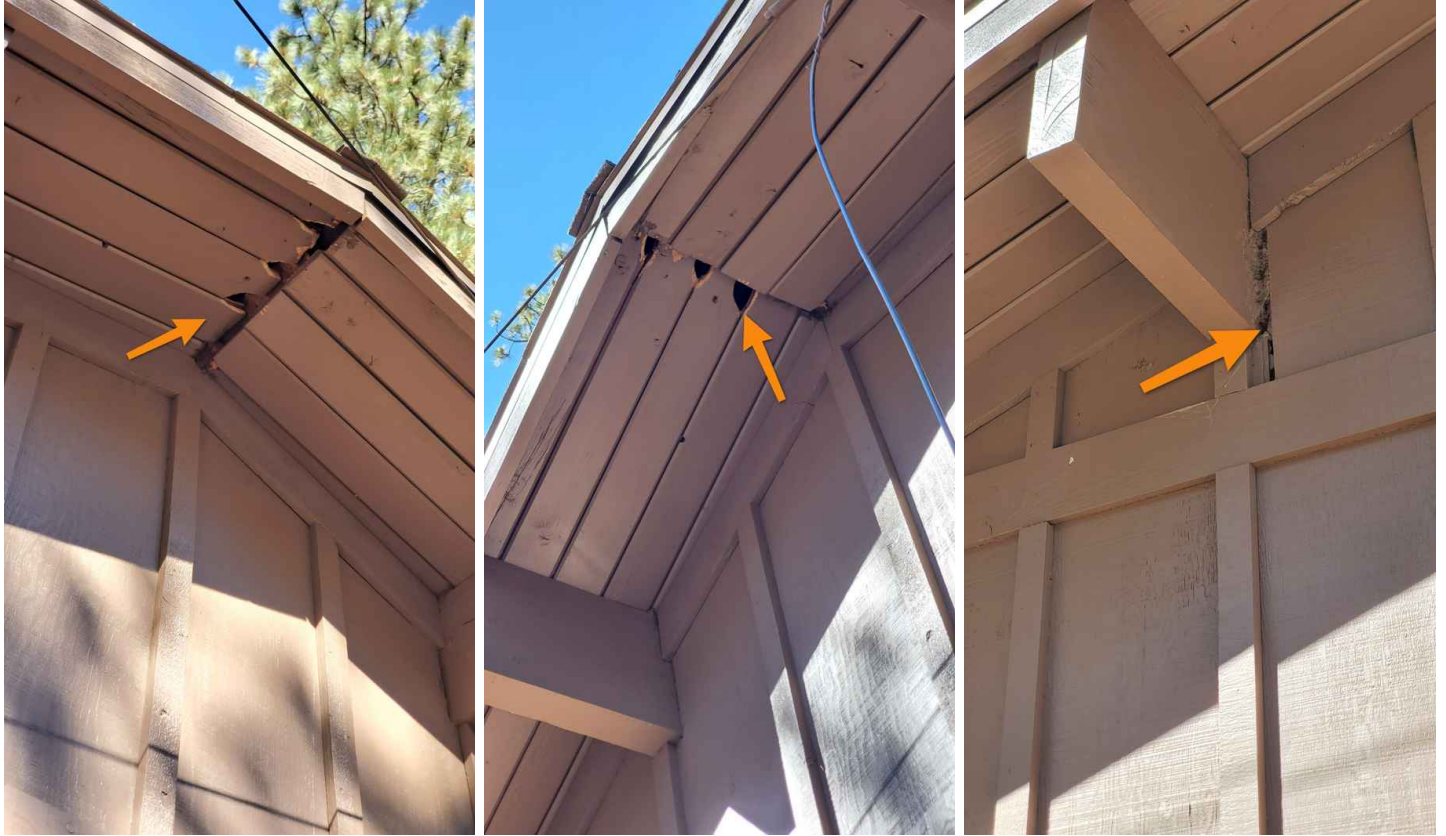
4.5.2 Wood Siding  
**DAMAGE: BIRD**

Holes in the wood were typical of those made by cavity-nesting species of birds during nesting activities. Birds can be quite persistent in creating new holes once existing holes are repaired. Plastic owls, dangling bright objects like CDs, and recordings of birds in distress are typically not effective long-term deterrents. A good way to help prevent future damage is to attach an appropriately-designed nesting box directly over a repaired hole. Nesting boxes and box designs are bird species-specific and are available online.

It is recommended that repairs be made to prevent pests and water intrusion into the wall cavity creating more damage to the home

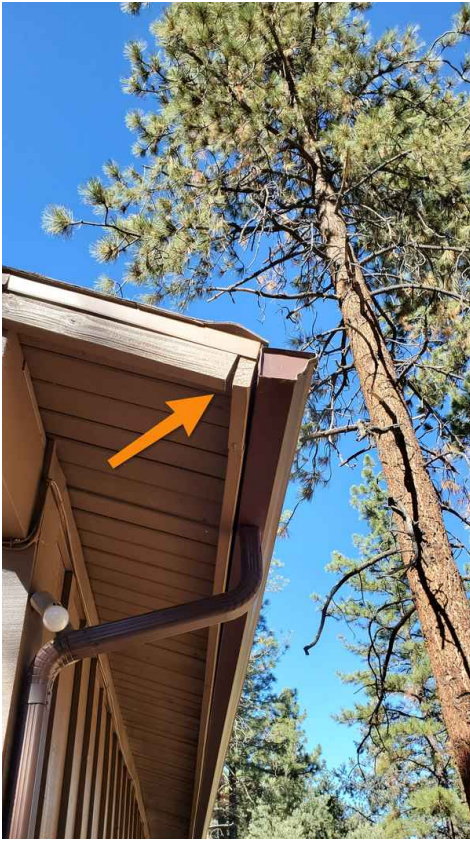
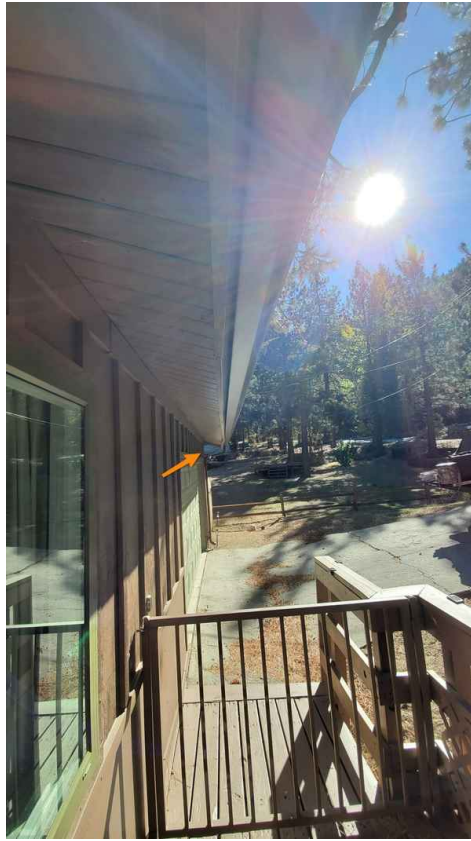
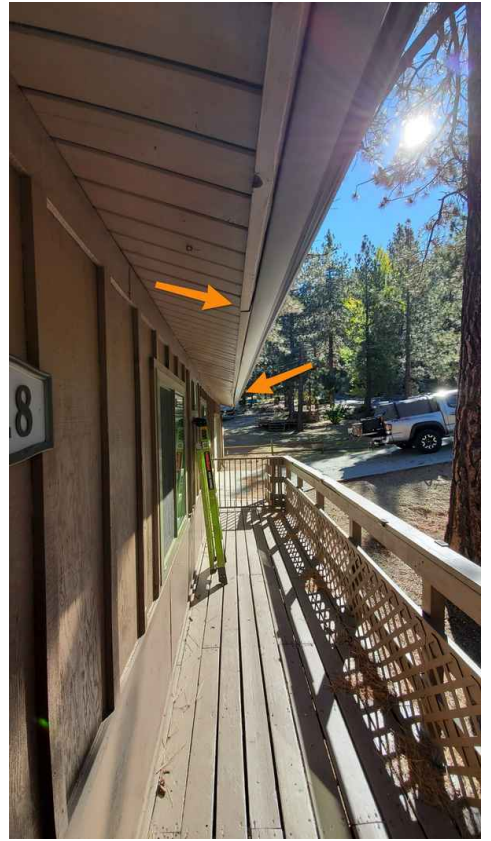
##### **FASCIA: LOOSE/DETACHED**

Fascia was loose or detached in places and needed repair or replacement. All work should be performed by a qualified contractor.

Poor repairs were done on the fascia and it is crooked.

Contact a qualified carpenter.

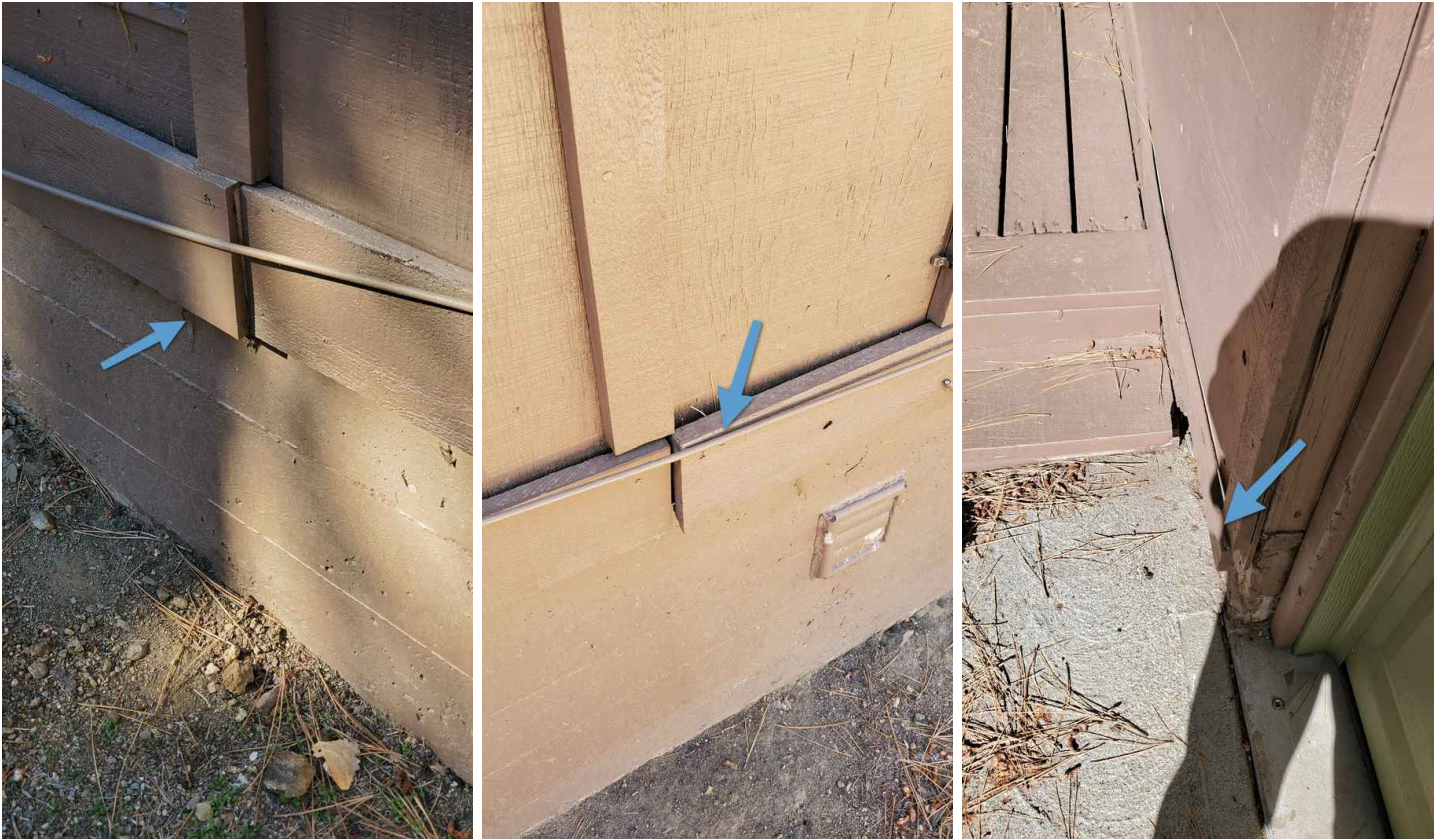
##### **CORNER TRIM: LOOSE**

Loose corner trim should be made secure by a qualified contractor.

Contact a qualified siding specialist.

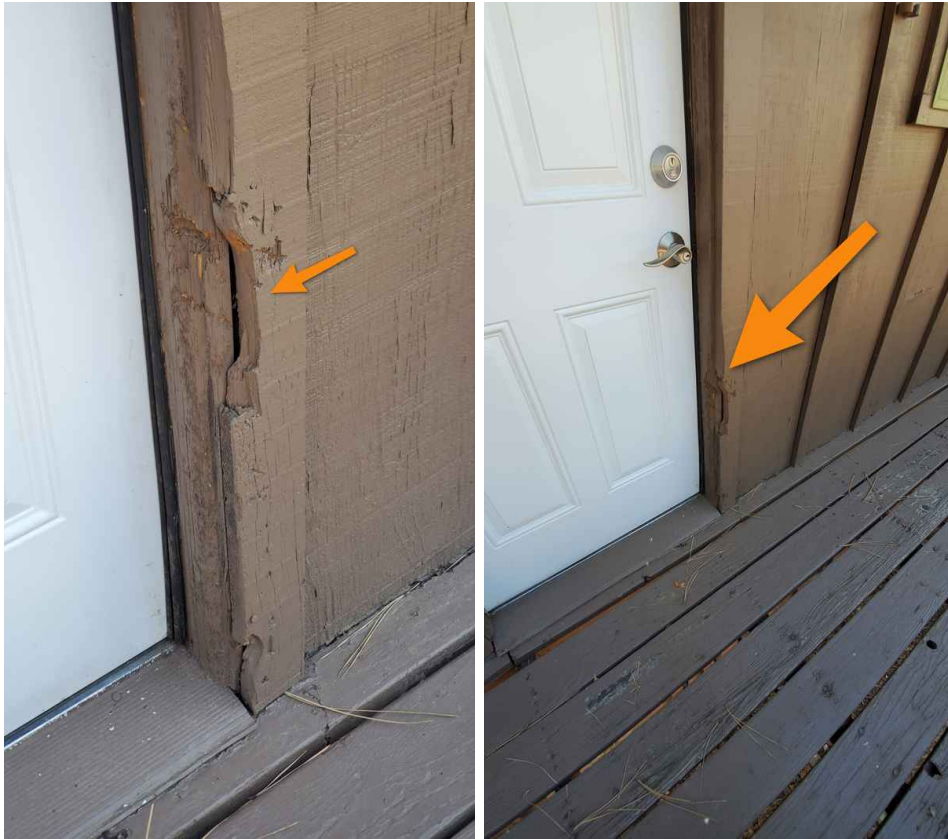
### **DOOR TRIM: DAMAGE**

Door trim was damaged and needed repair. All work should be performed by a qualified contractor.

Contact a qualified professional.

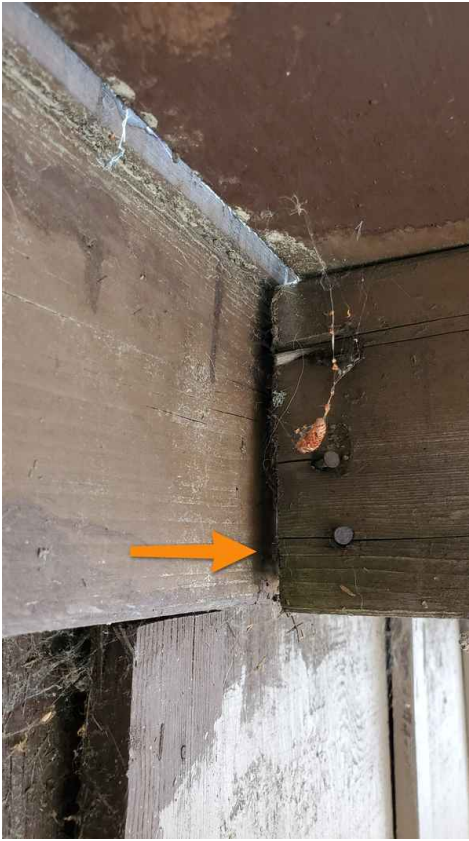
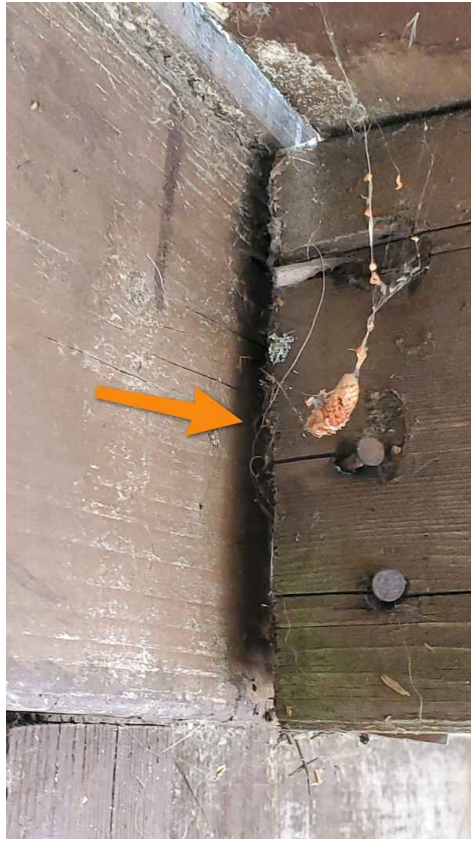
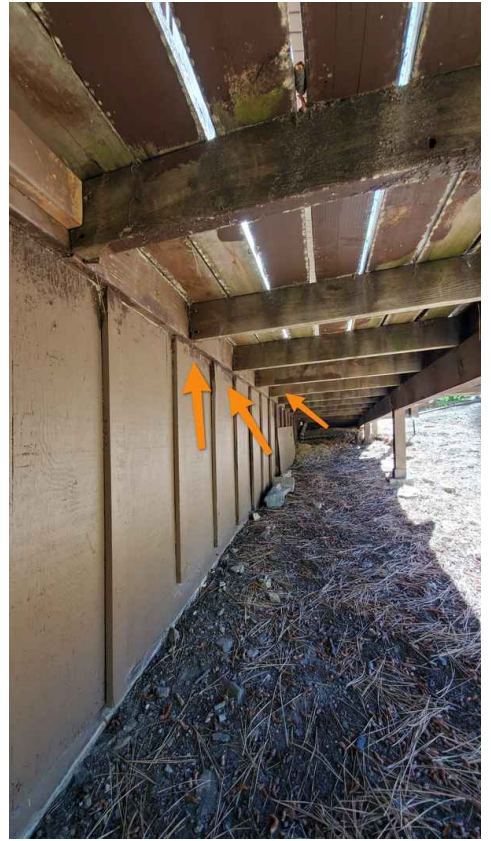
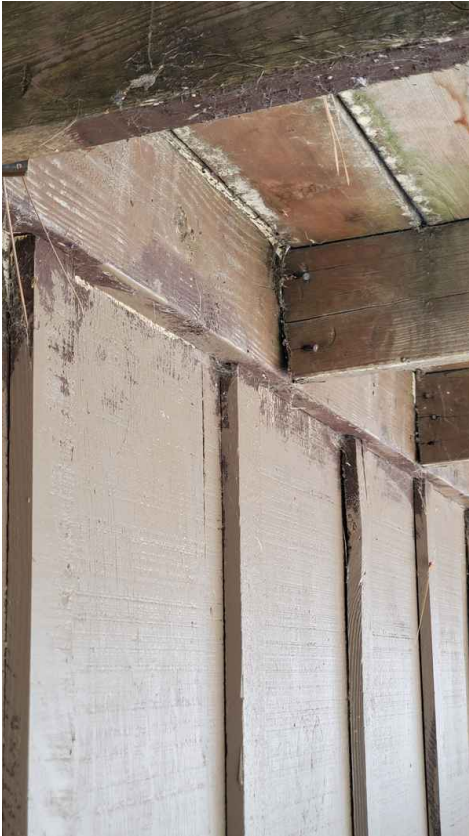
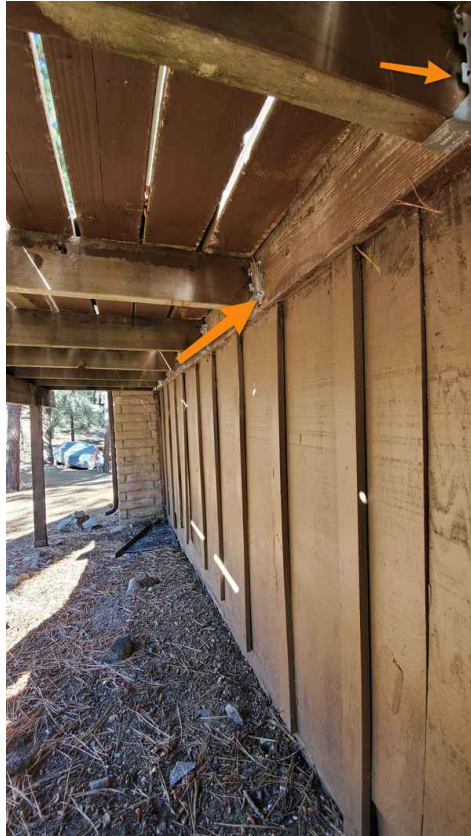
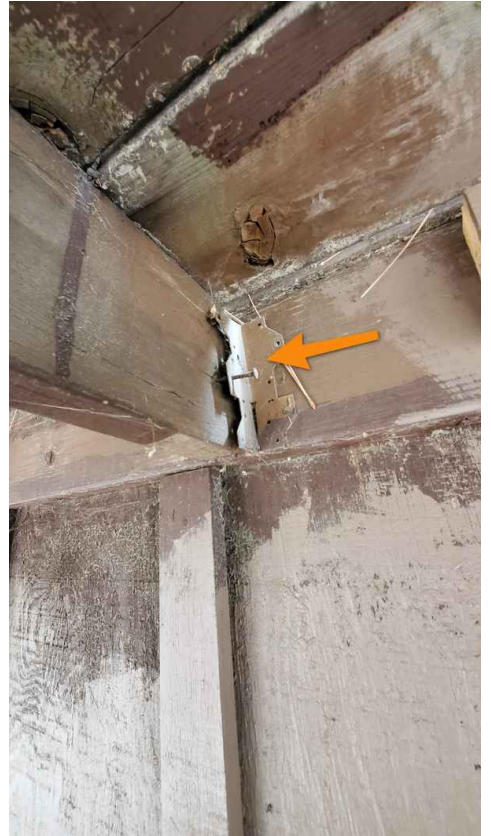
**ATTACHMENT: INADEQUATE**

The method for attaching the decks in areas to the home appeared to be inadequate. The Inspector recommends that before the expiration of your Inspection Objection Deadline you consult with a qualified contractor to gain an idea of options and costs for correction.

No fatteners of joists to hangers

Contact a qualified carpenter.

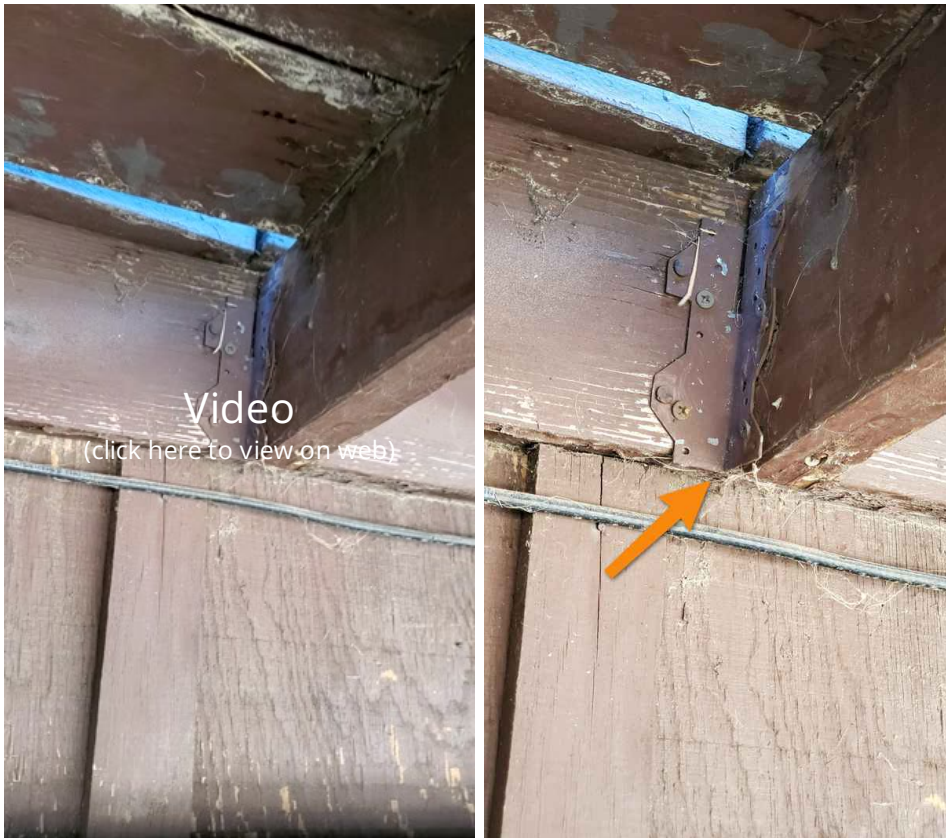
wrong type of hanger for purpose.

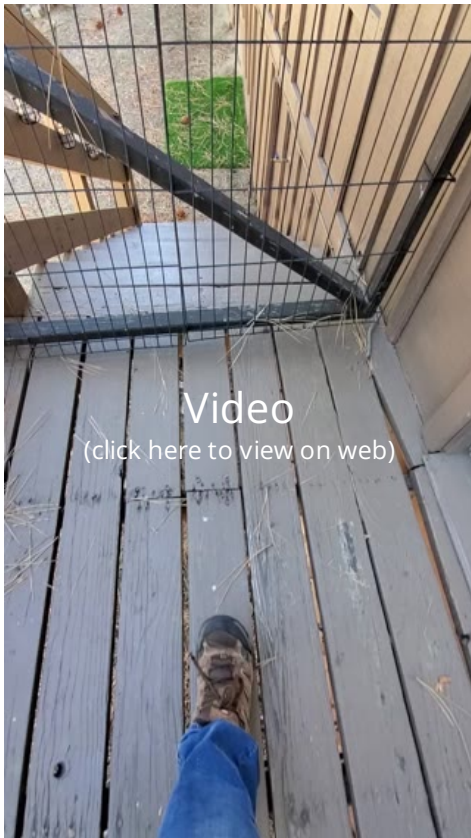
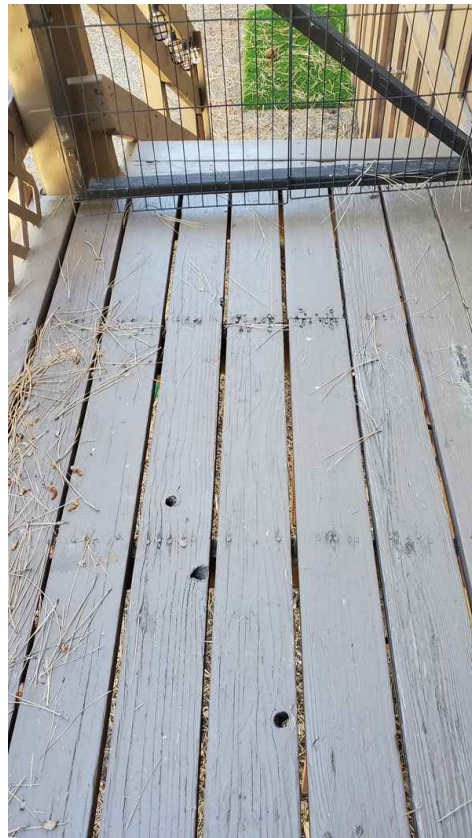
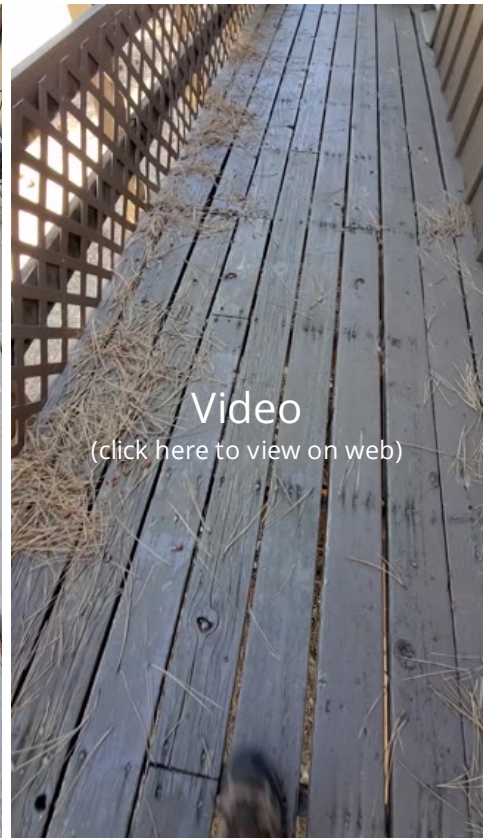
### FLOOR: WEAR/DETERIORATION, SEVERE

Deck planking (the walking surface) had areas of severe wear or deterioration that require maintenance, repair or replacement. You should consult with a qualified contractor to discuss options and costs.

Contact a qualified professional.

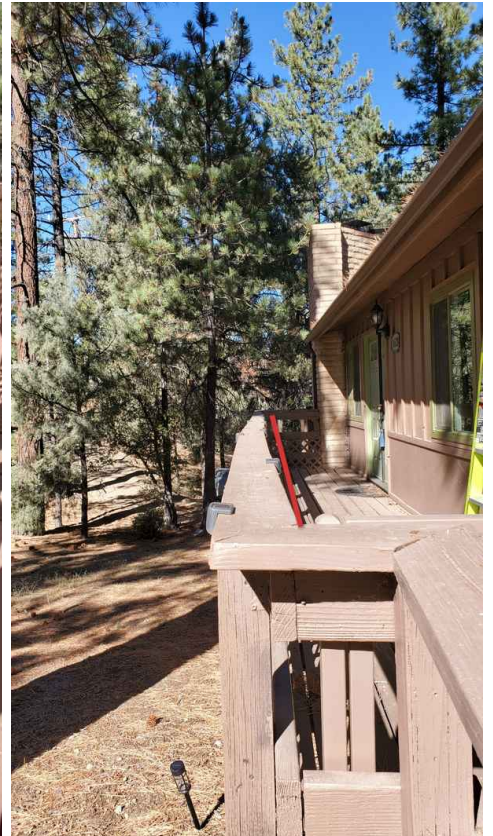
### **GUARDRAILS: LOOSE**

Deck guardrail assemblies were loose and should be made secure by a qualified contractor.

Contact a qualified carpenter.

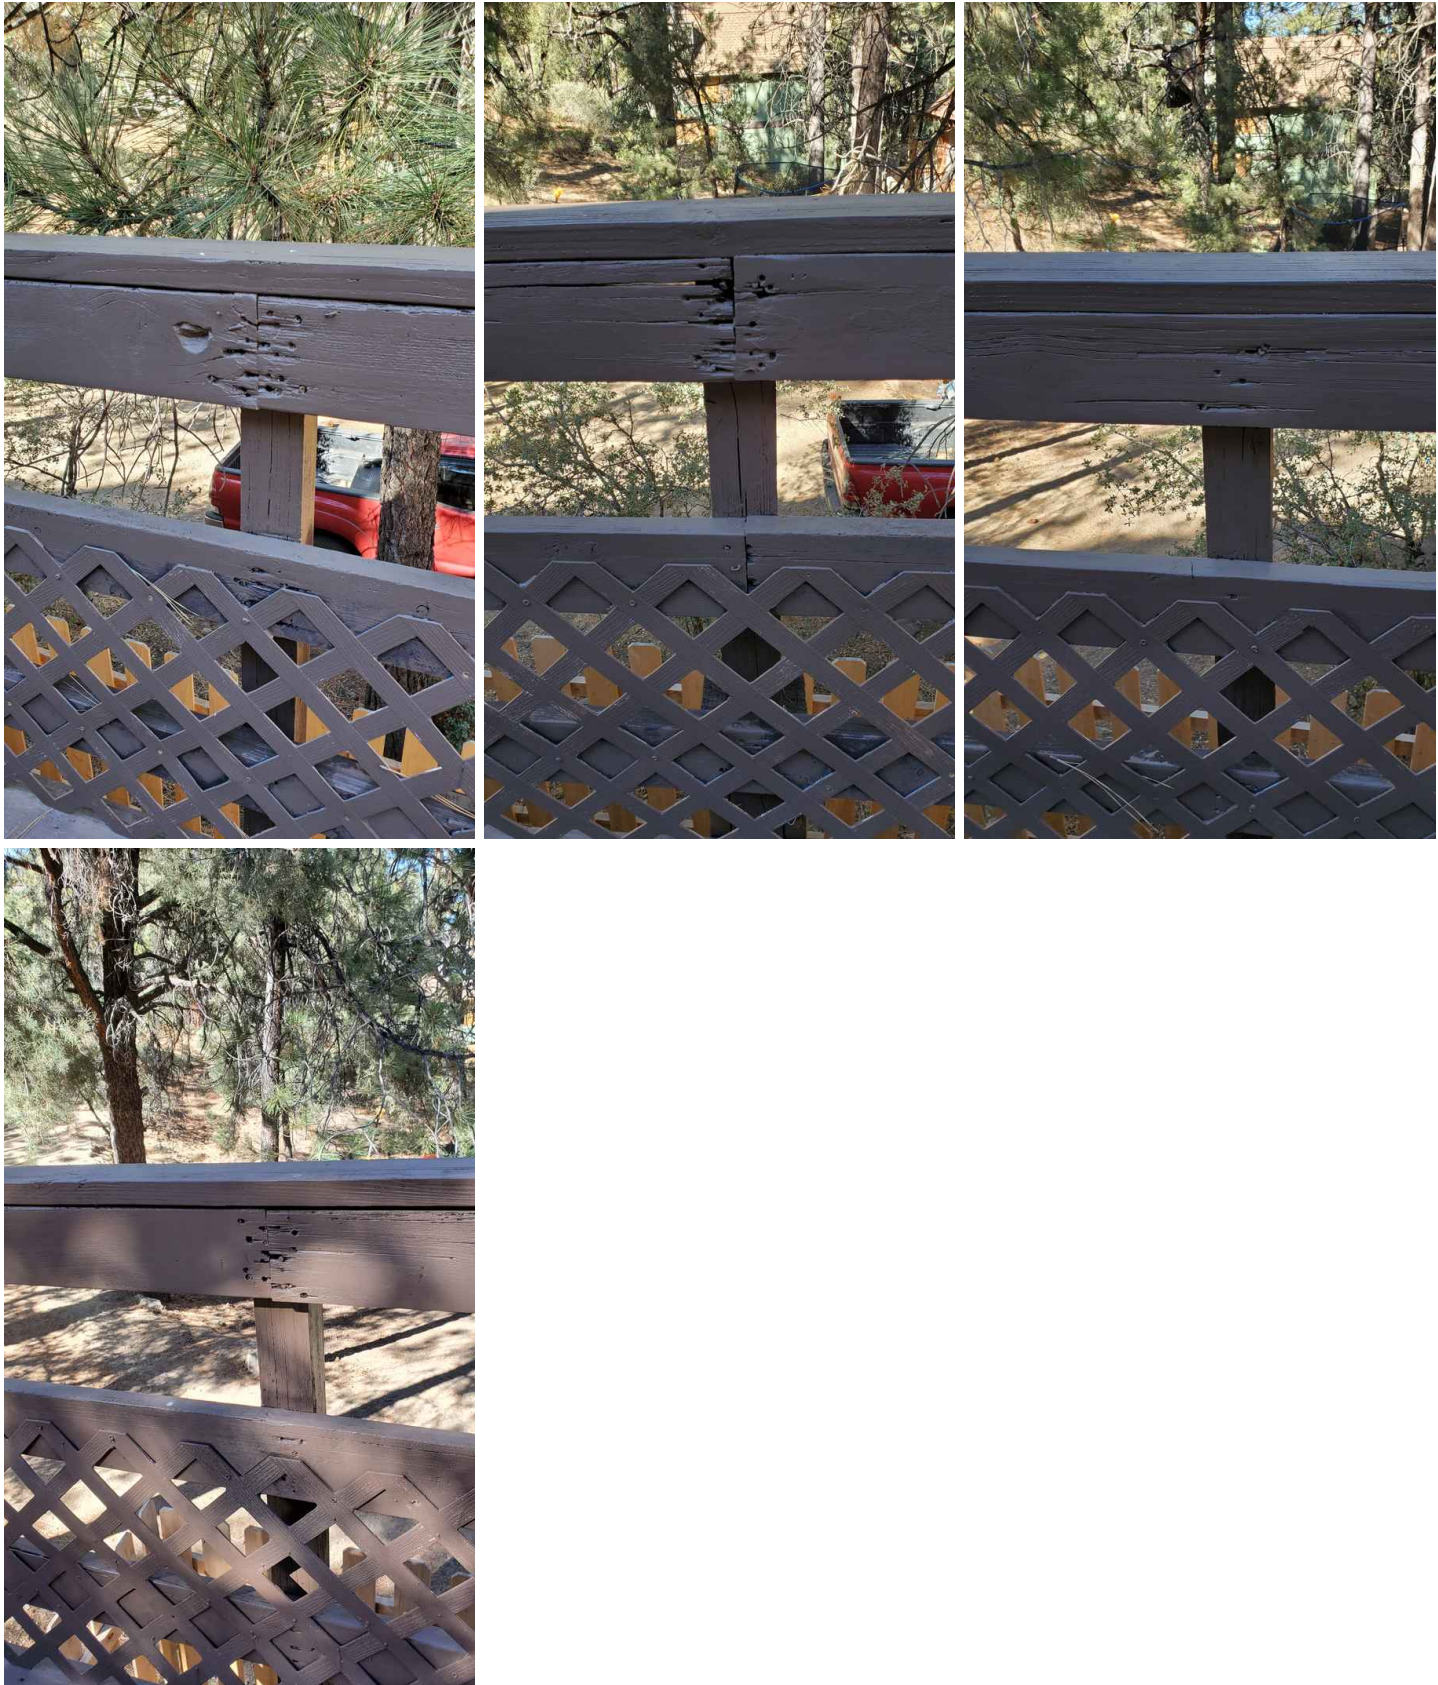
### **GUARDRAILS: DAMAGE, SEVERE**

At the time of the inspection, the deck guardrail assemblies exhibited severe damage. You should consult with a qualified contractor to gain an idea of options and costs for repair or replacement.

Contact a qualified carpenter.

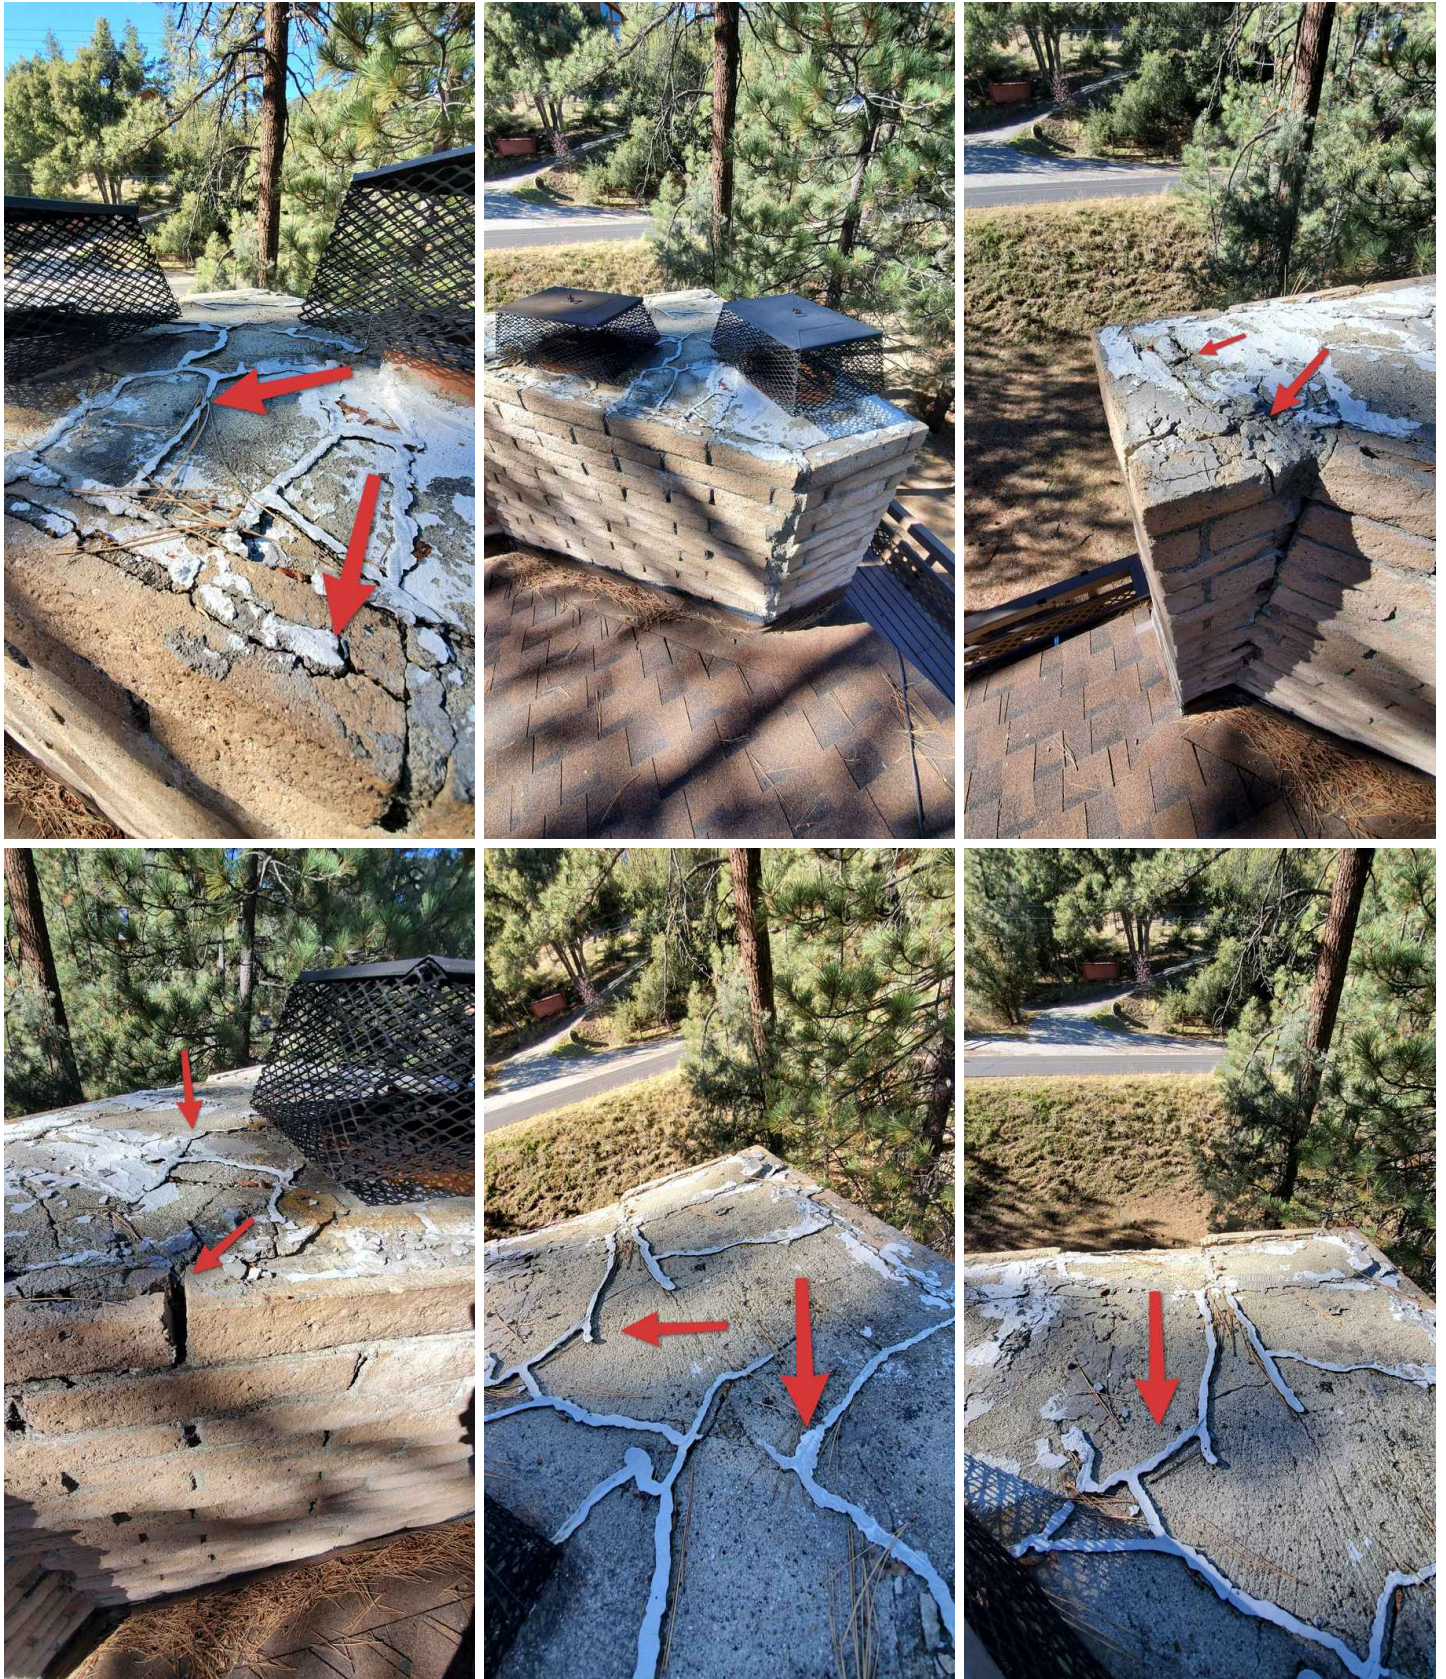
CHIMNEY CROWN: END OF USEFUL LIFE

The chimney crown was severely deteriorated and appeared to be at the end of its useful life. Failure of the crown can allow moisture intrusion of the chimney structure that can damage the structure and create unhealthy conditions. An evaluation should be performed by a qualified contractor to provide an estimate for work as necessary.

Failed caulking, inappropriate repair

Contact a qualified masonry professional.

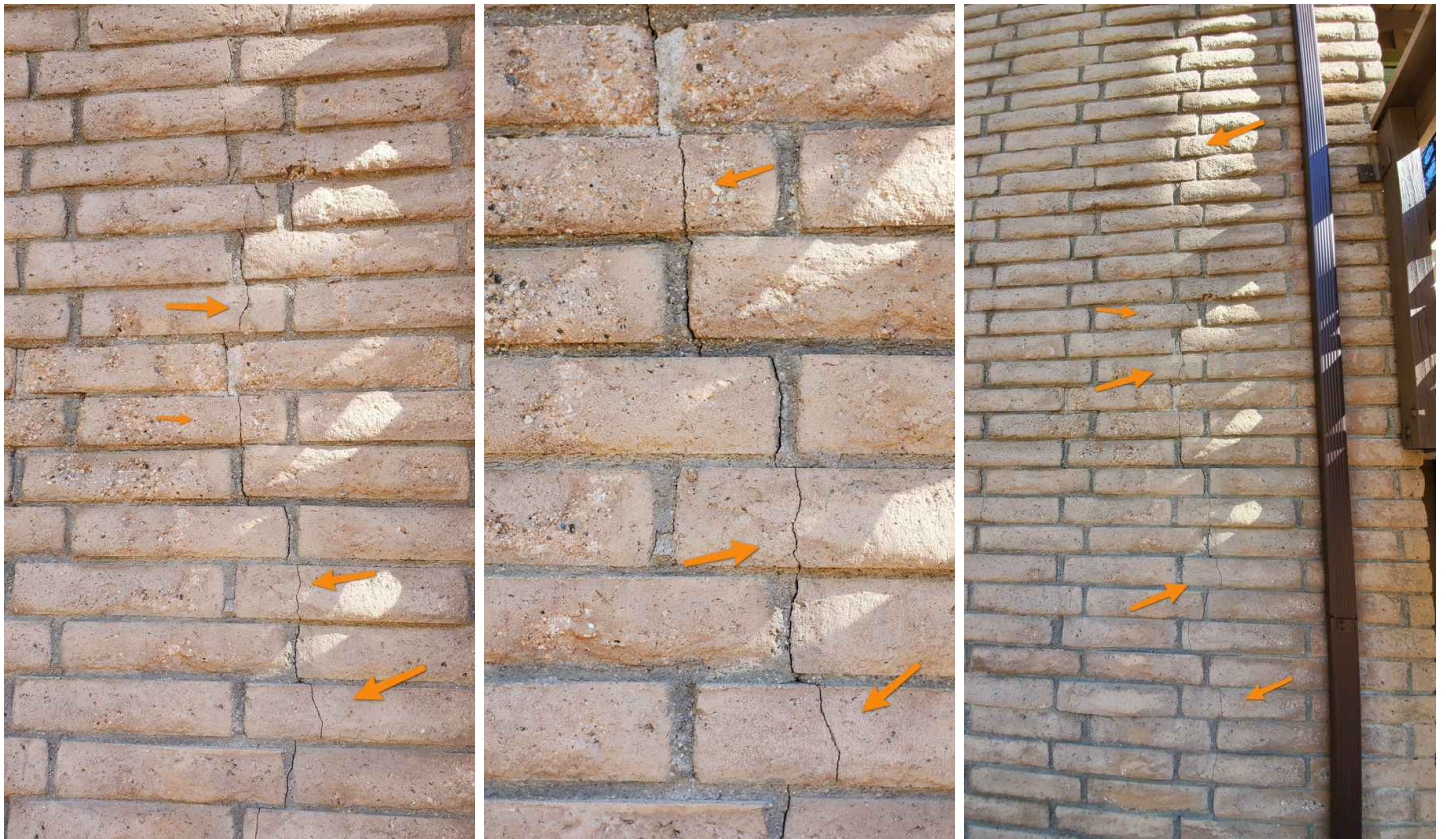
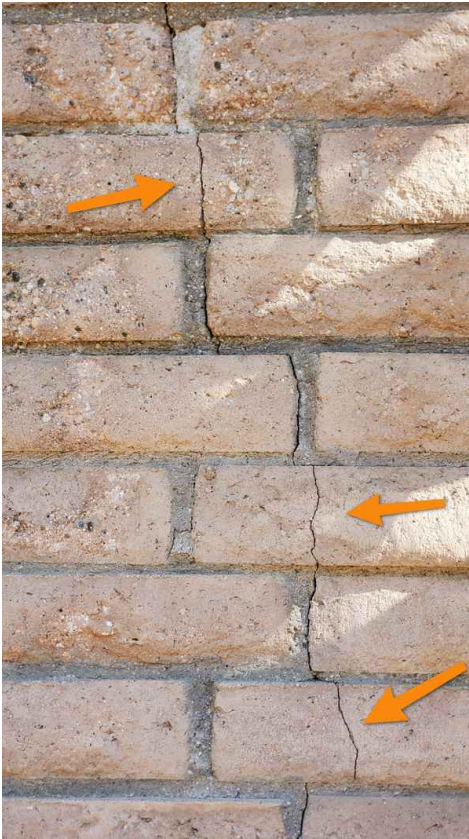
Moderate Concern**BRICK: CRACKING THROUGH BRICK**

The chimney had cracking through the brick. This condition appeared to be consistent with cracking caused by soil movement or seismic activity. If this condition was caused by inadequate compaction at the time of original construction, soil will have stabilized by now. If it was caused by expansive soil, or excessive amounts of moisture in the soil supporting the chimney, movement and cracking may continue. The Inspector recommends evaluation by a foundation repair contractor and crack repair by a qualified masonry contractor to help prevent future damage from freezing moisture.

Contact a qualified professional.
