## RESIDENTIAL HOME INSPECTION REPORT

1628 Freeman Dr  
Pine Mountain Club,, CA 93222

11/07/2025

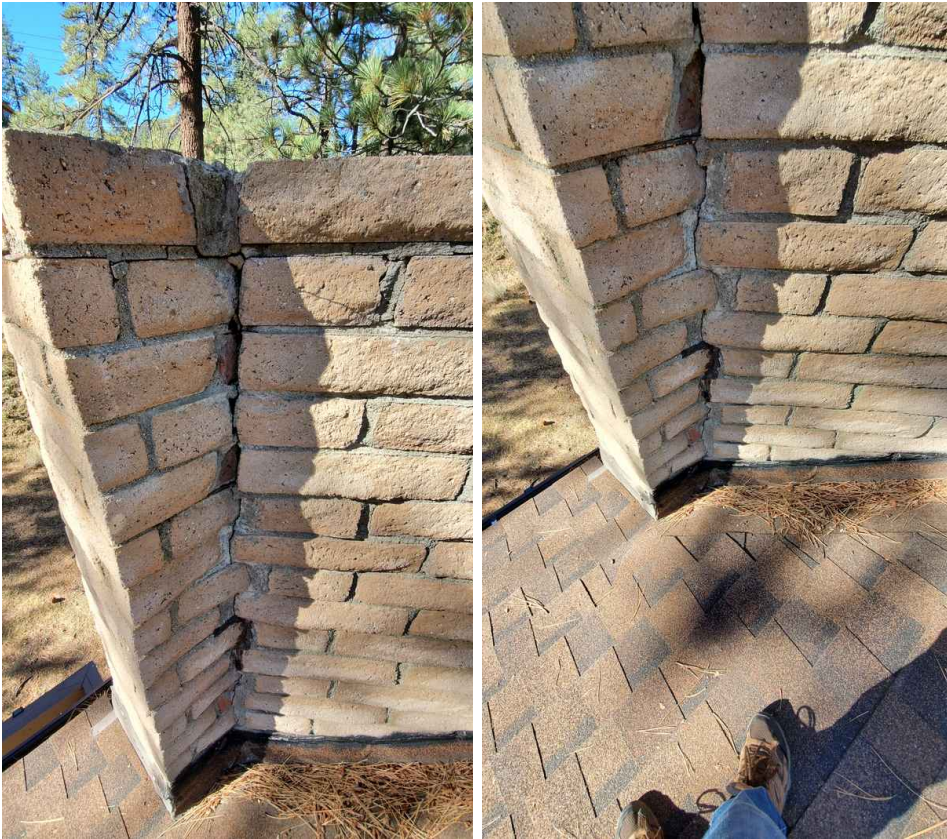
##### **BRICK: MORTAR DETERIORATED, REPOINT**

Mortar was missing or badly deteriorated at portions of the brick chimney. This condition will eventually cause bricks to loosen and fall. The Inspector recommends that before the expiration of your Inspection Objection Deadline you consult with a qualified masonry contractor to gain an idea of options and costs for re-pointing the chimney as necessary.

Contact a qualified masonry professional.

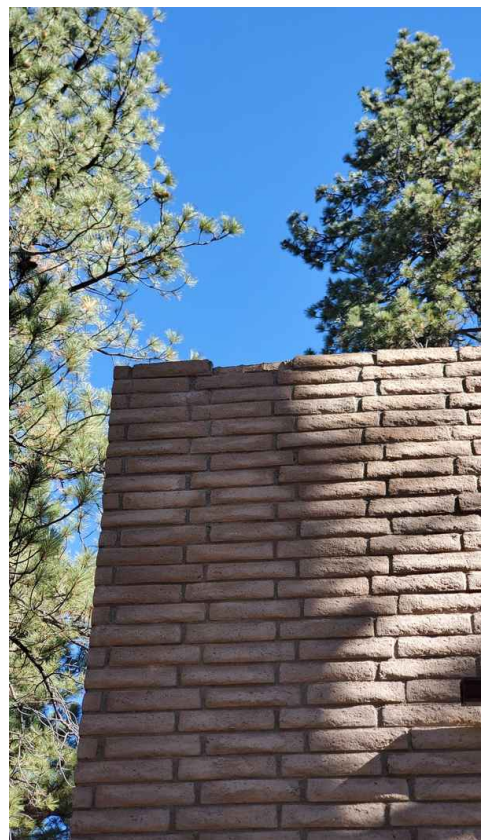
**BRICKS MISSING**

The chimney had bricks missing at the time of the inspection. This condition indicated a failure of the bond between mortar and brick and may cause other bricks to fall if not corrected. Falling bricks may cause injury or death. The Inspector recommends that before the expiration of your Inspection Objection Deadline an evaluation be performed by a qualified contractor.

Contact a qualified masonry professional.

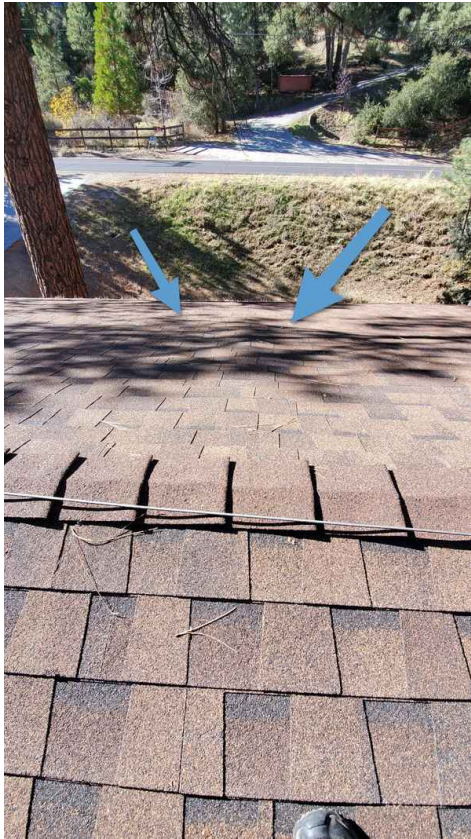
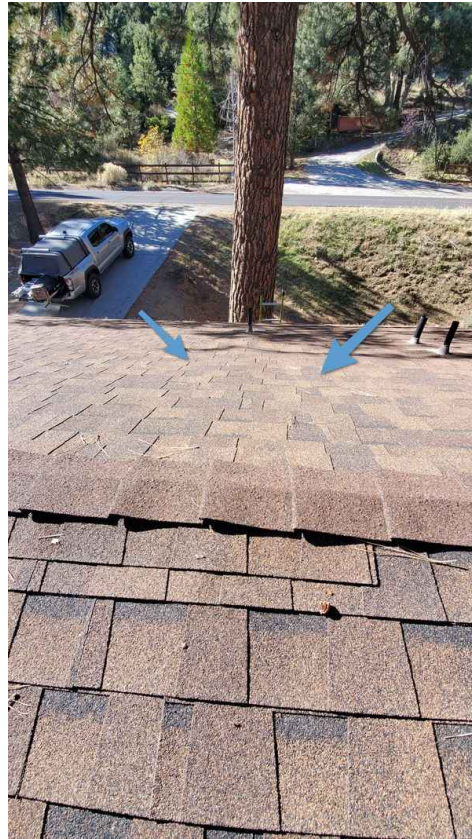
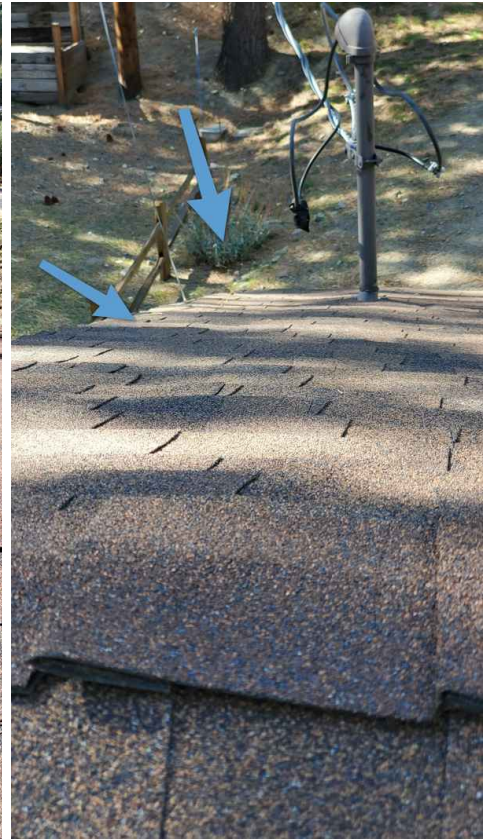
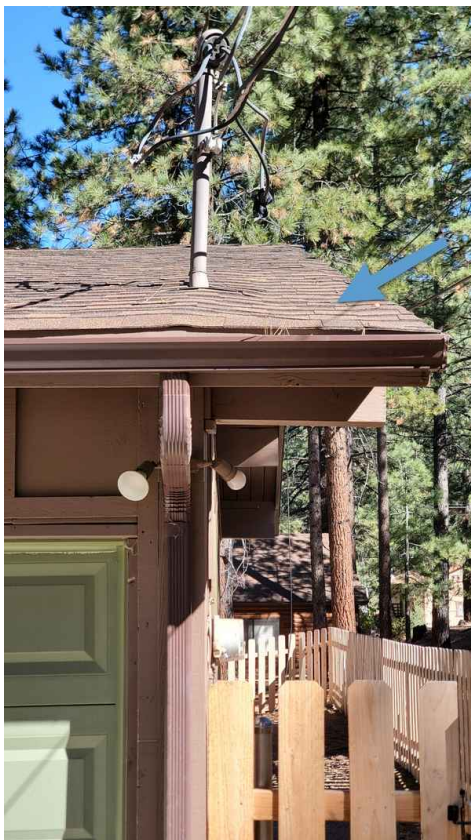
5.2.1 Roof Structure Exterior  
**LOW SPOTS: SAGGING SHEATHING**

Localized depressions (low areas) visible in the roof appeared to be the result of sagging roof sheathing. This could be from thin sheathing. The inspector was unable to access the attic space to determine the cause

Looks to be a failure of the fascia and roof deck

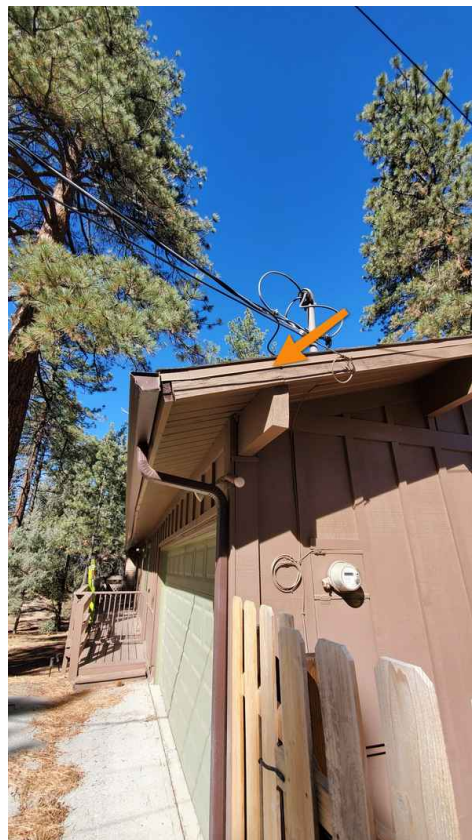
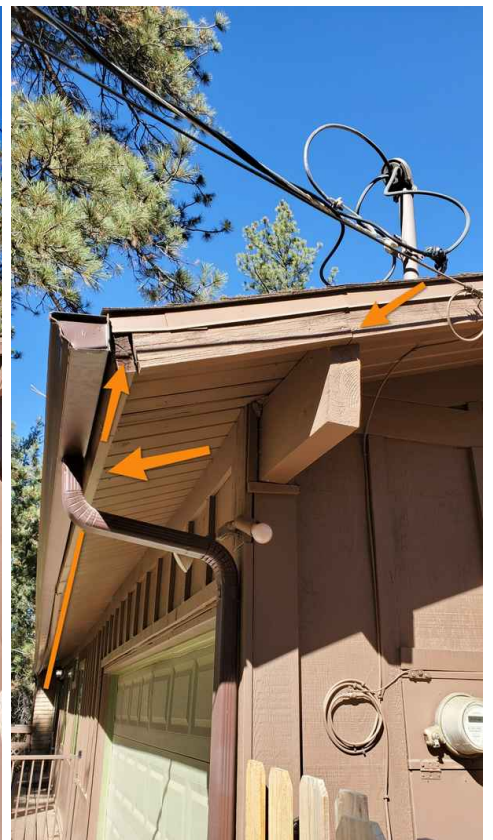
Poor workman ship, splice in the wrong place

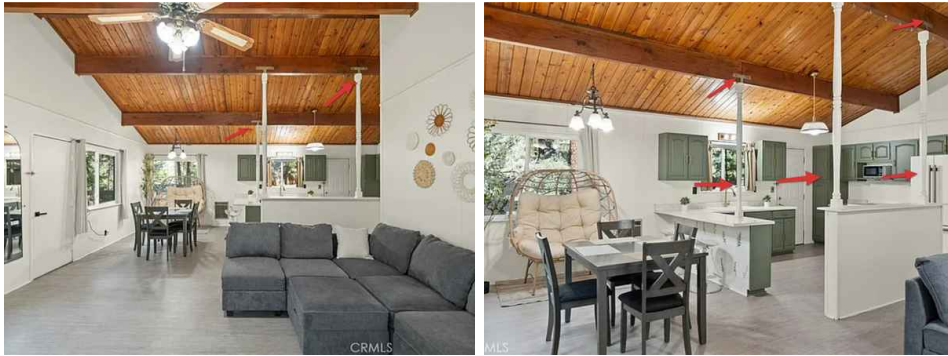
**BEAMS- SPLICES: KITCHEN AREA**

The beams in the kitchen area have splices that are strapped by T brackets. The beams are being supported by less than 4X4 material to carry a roof load. This condition is questionable and should be evaluated by an engineer to determine.

1. Are the posts adequate for the load.
2. Are the T straps and fastening sufficient to connect the beam together for the lateral shear.

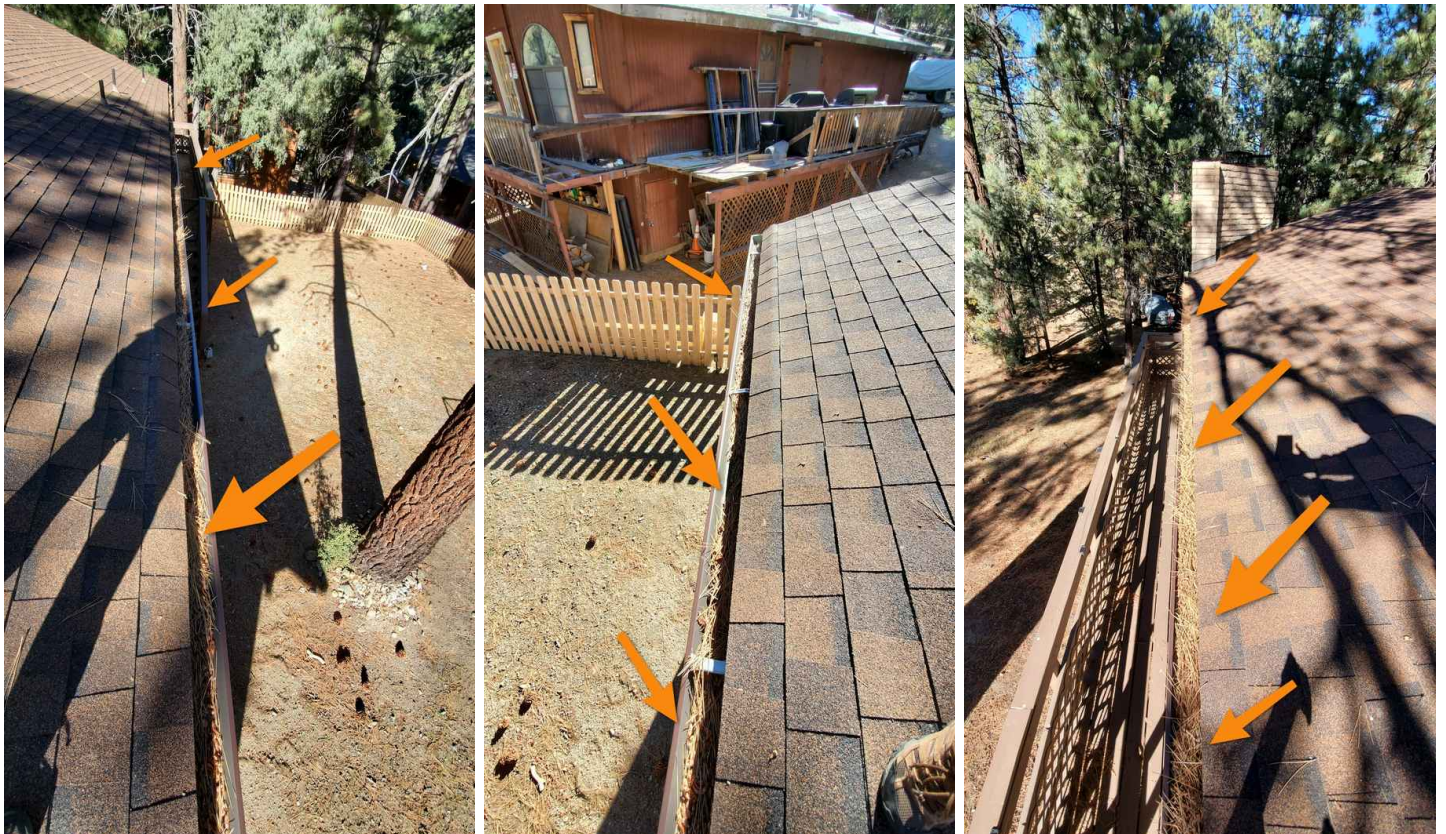
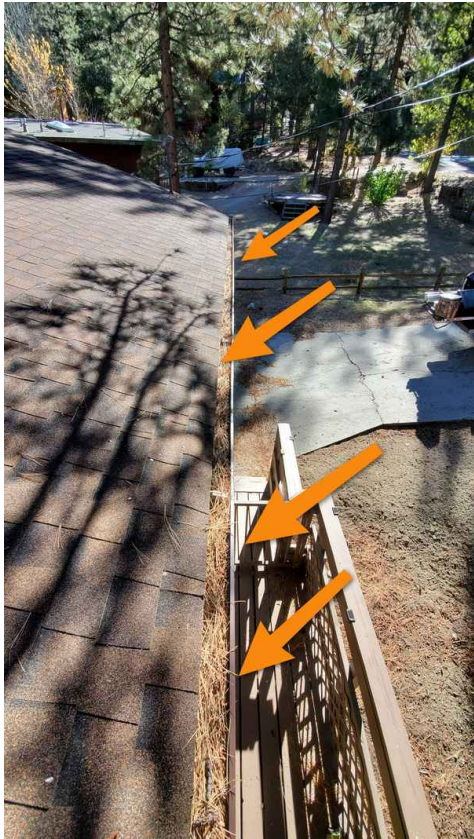
**GUTTERS: DEBRIS**

Debris accumulated in the gutters should be removed by a qualified contractor to encourage proper drainage.

Contact a qualified professional.

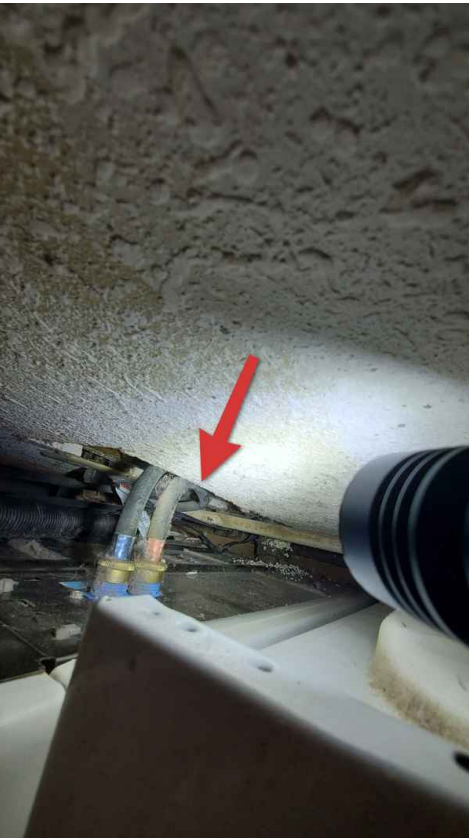
Behind washer and dryer

**WALLS: DRYWALL DAMAGE, SEVERE**

The garage walls exhibited severe drywall damage. The Inspector recommends that before the expiration of your Inspection Objection Deadline you consult with a qualified contractor to discuss options and costs for repair.

This is the fire wall and it needs to be complete.

Recommendation  
Contact a qualified drywall contractor.

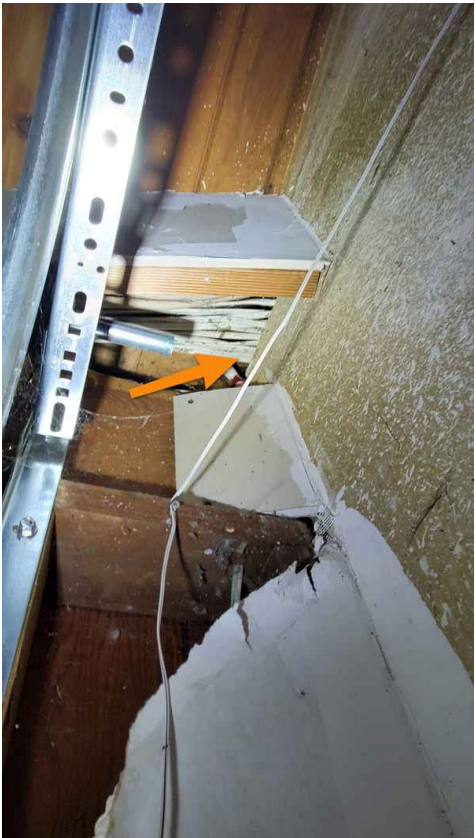
Firewall penetrations

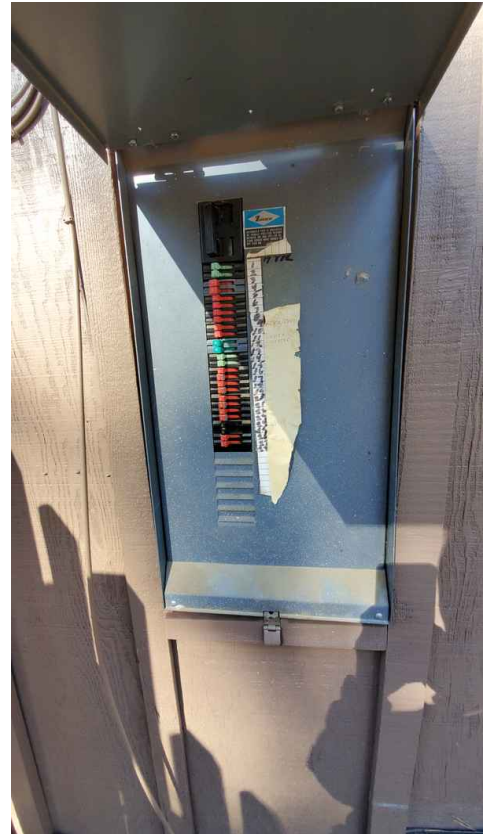
#### **LABEL: CIRCUIT DIRECTORY, MISSING**

The service panel circuit directory label was missing. A properly-marked circuit directory should be installed by a qualified electrical contractor so that individual circuits can be quickly identified and shut off during an emergency.

Contact a qualified electrical contractor.

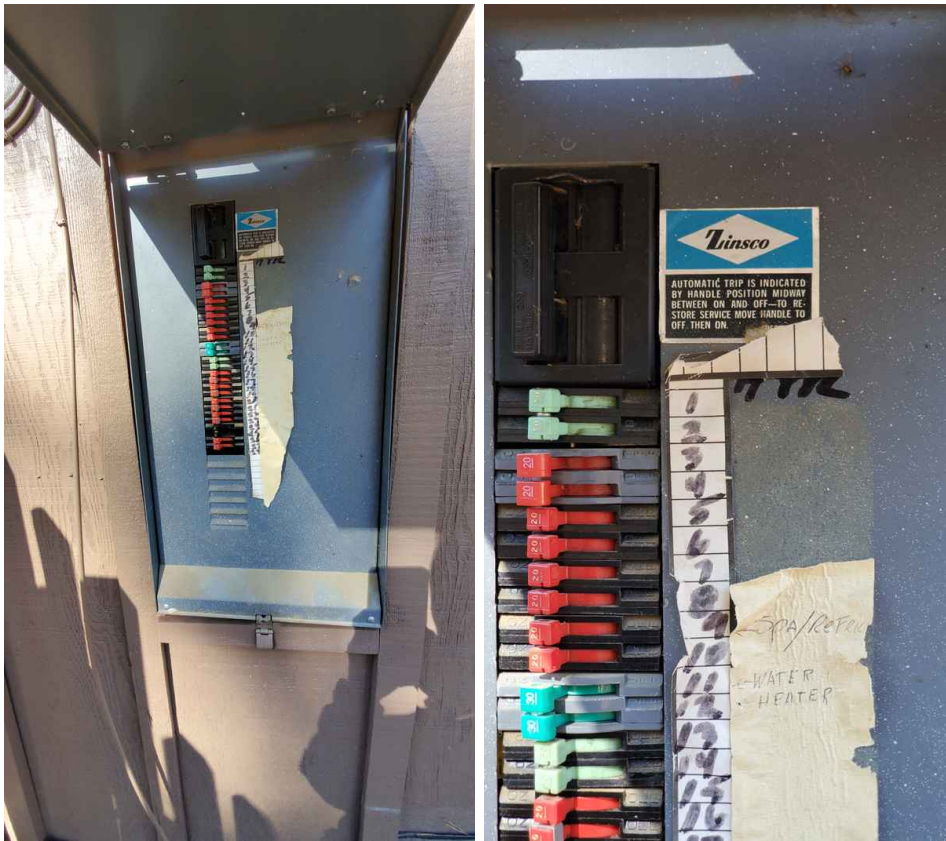
#### **MANUFACTURER: ZINSCO**

The service panel brand was Zinsco. Although there is no definitive study stating that these panels are a potential safety hazard, wide concern about their safety exists. Zinsco panels are widely reputed to have a significant rate of circuit breaker failure that can result in fire or electric shock hazard.

This panel appears to have been servicing the home for quite some time with out apparent issue. However for safety reasons, you should consult with a qualified electrical contractor to discuss the necessity, options, and costs for replacement.

Contact a qualified electrical contractor.

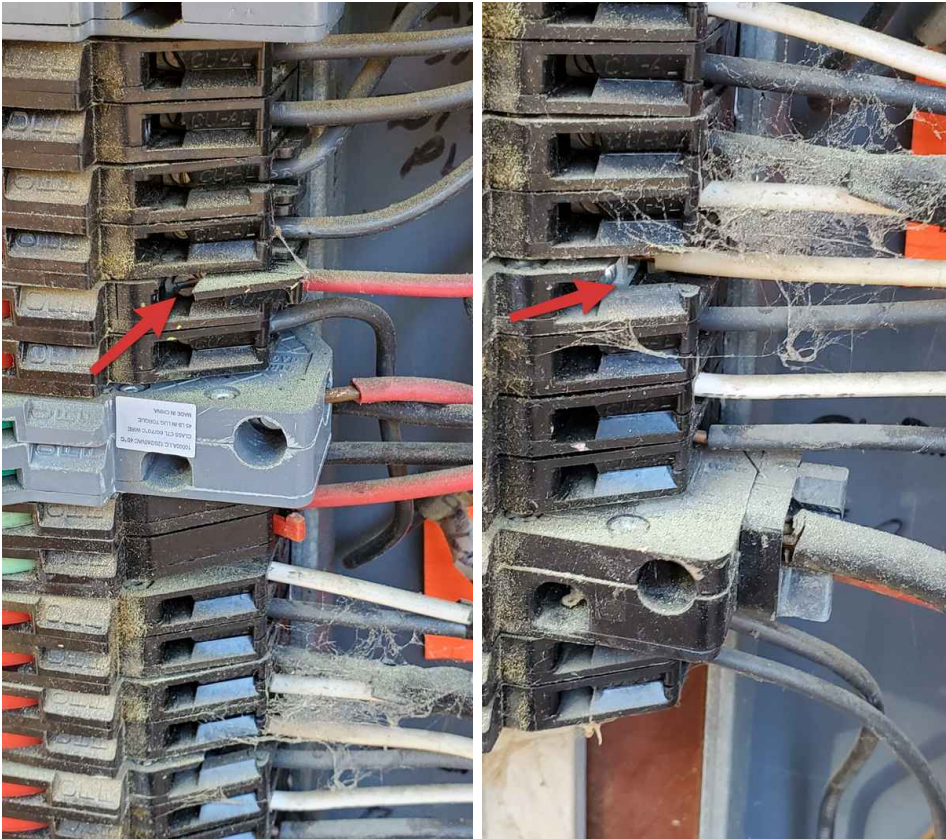
### **BREAKERS: DAMAGED**

Damaged breakers in the electrical service panel should be replaced by a qualified electrical contractor.

Contact a qualified electrical contractor.

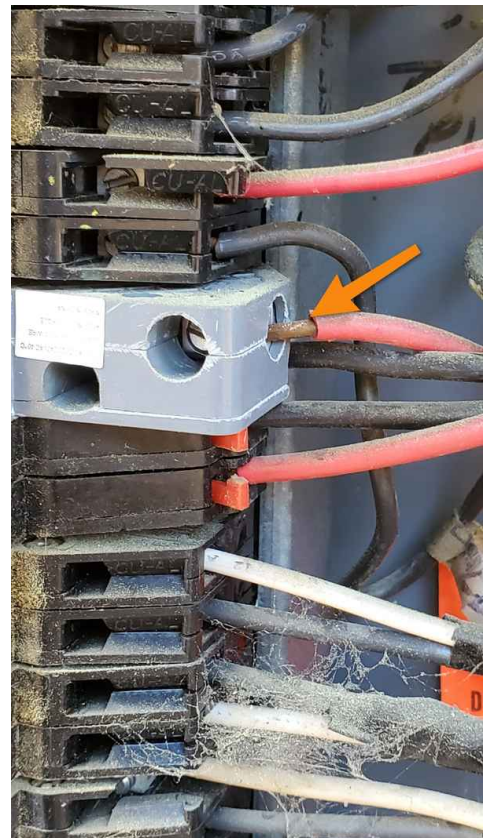
##### **WIRE: OVEREXPOSED- LOOSE WIRE**

There appeared to be a loose or overexposed conductor in the main panel. This condition should be evaluated by an electrical contractor to endure a tight connection and a safe condition.

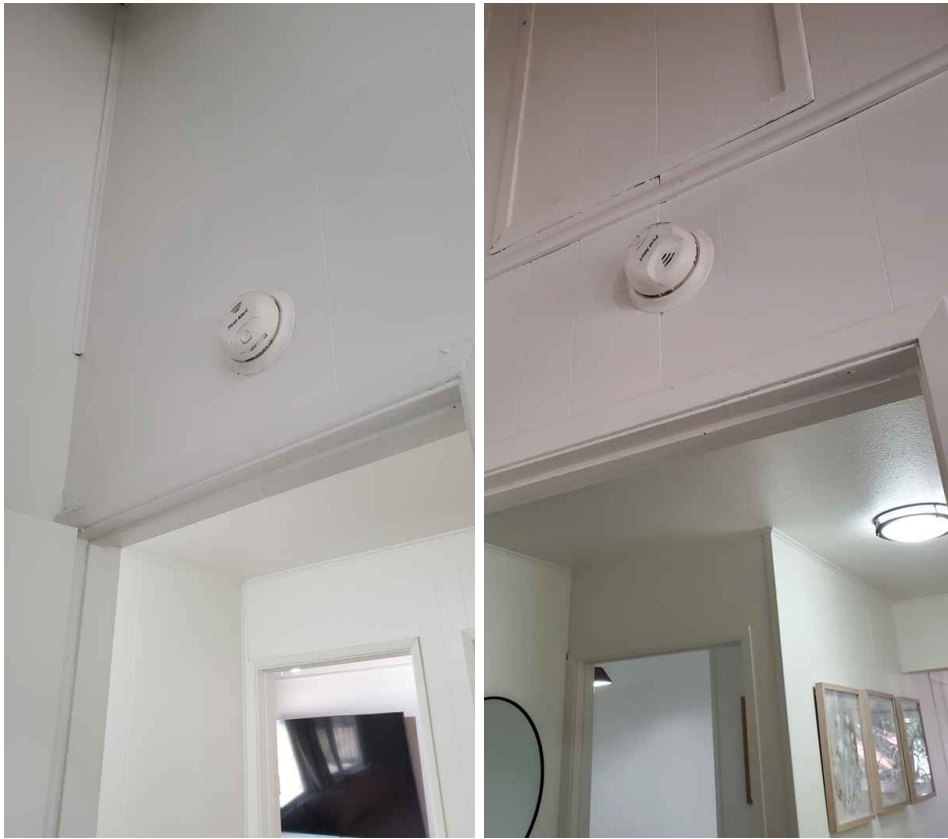
##### **SMOKE ALARM: MISSING, NOT FUNCTIONING**

There are smoke alarms missing or not functioning in the bedrooms and common aress.

Contact a qualified professional.

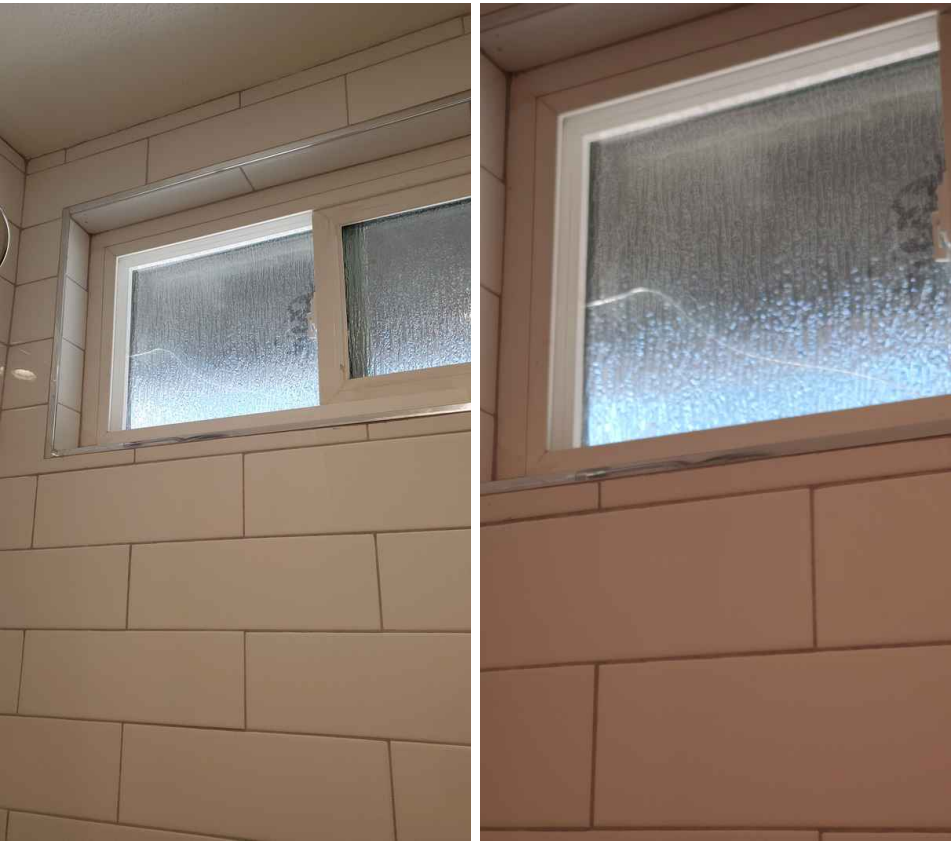
**GLAZING: BROKEN PANES**

Some windows had broken panes.

Contact a qualified window repair/installation contractor.

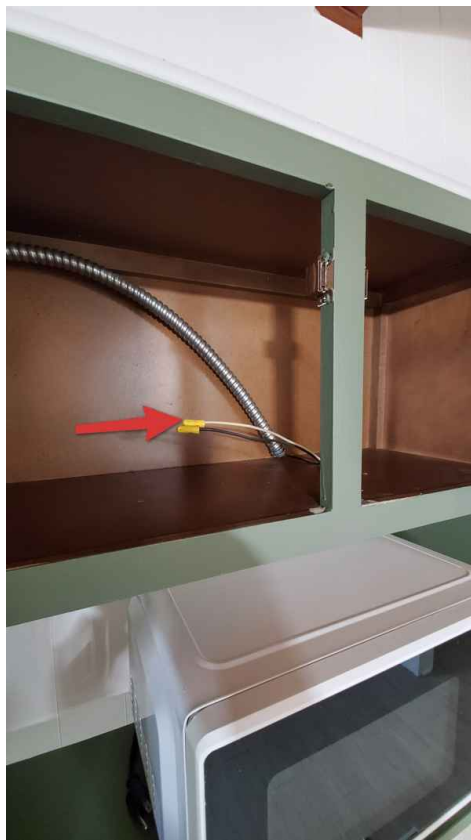
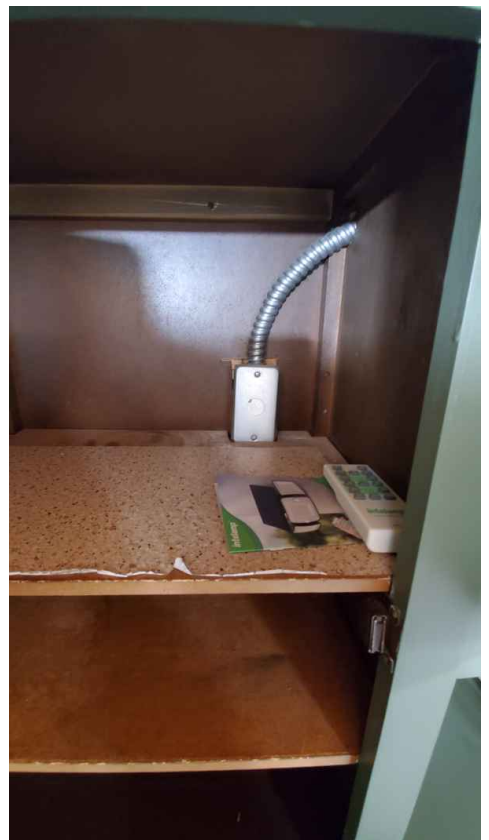
**ELECTRICAL FUTURE: MICROWAVE- UNFINISHED**

There appeared to be an electrical service for the microwave started but not completed. The exposed wires are not terminated and have wire nuts on hot wires.

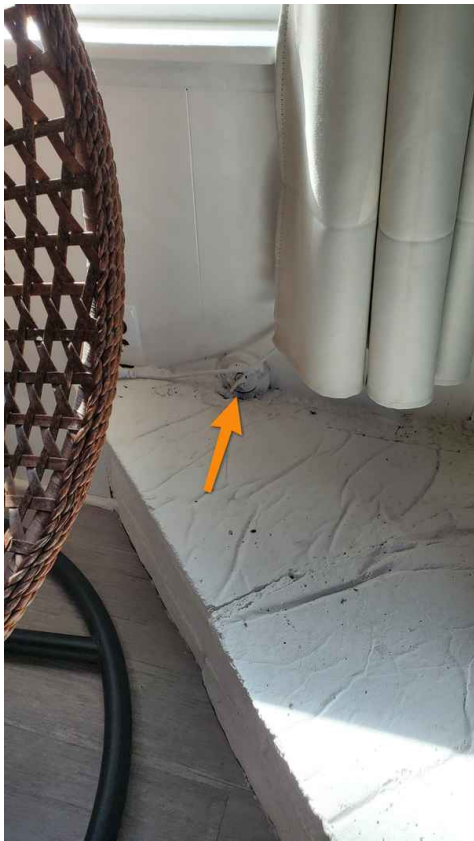
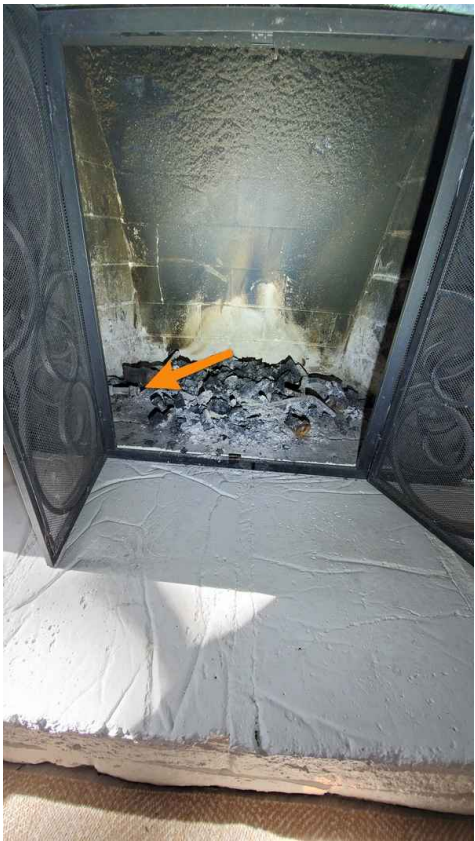
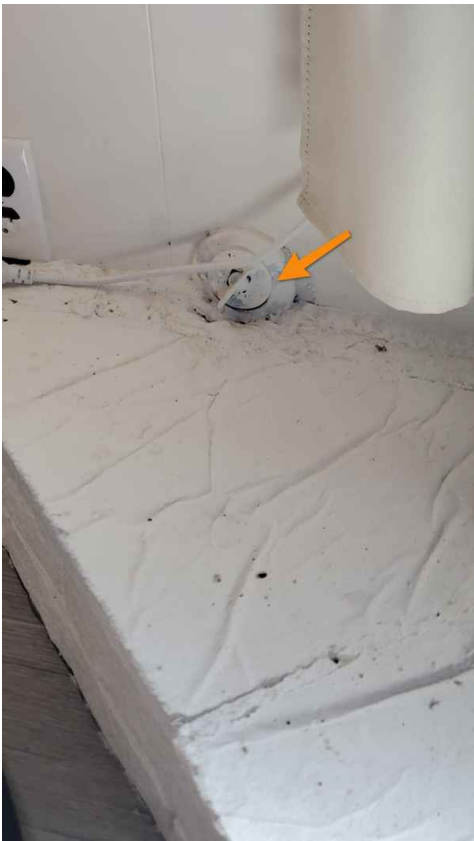
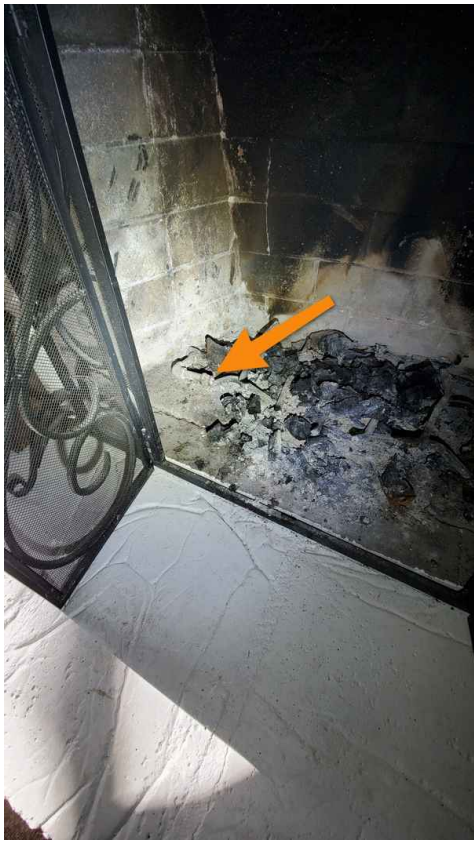
### **FIREPLACE: ABANDONED GAS SERVICE**

It appears the home had gas service at some point in its life. The fireplace appears to have a gas valve and piping for a gas burner however there is no visible gas service to the home.

Please ask the seller for more information on this condition.
