WOOD DESTROYING PESTS AND ORGANISMS INSPECTION REPORT

Building No. 1461	Street Lazy Trail Drive	City Chico	ZIP 95926	Date of Inspection 02/14/2022	Number of Pages 3
----------------------	----------------------------	---------------	--------------	----------------------------------	----------------------

Report # : 14480
 Registration # : PR5960
 Escrow # :
 CORRECTED REPORT

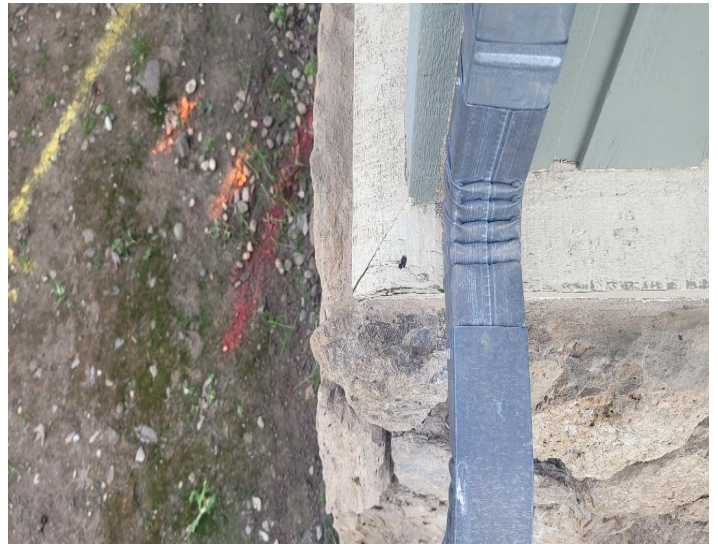
FINDING: Fungus damage was found to areas of lower siding and trim where indicated.

3A - Damaged water table trim.

RECOMMENDATION: Remove the damaged wood members and replace with new material. Prime paint only.

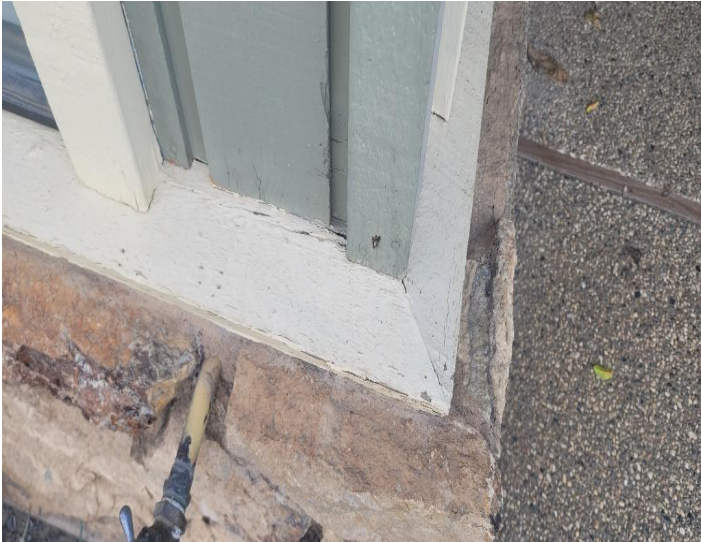
3A - Damaged corner trim.

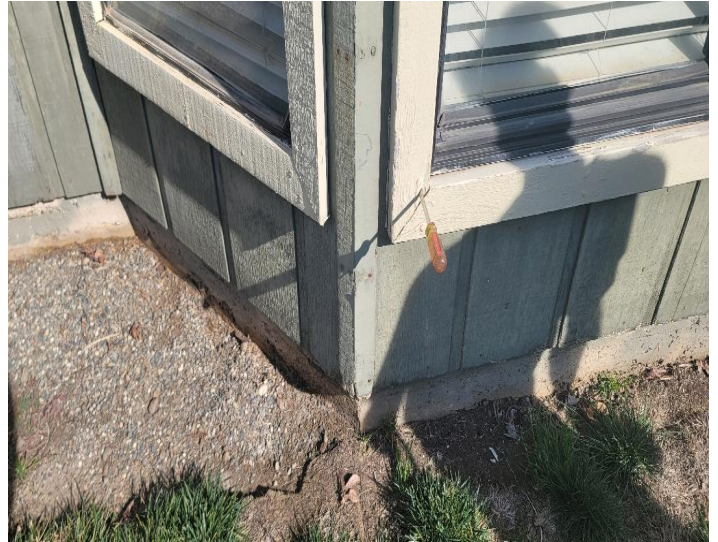
3A - Damaged window trim.

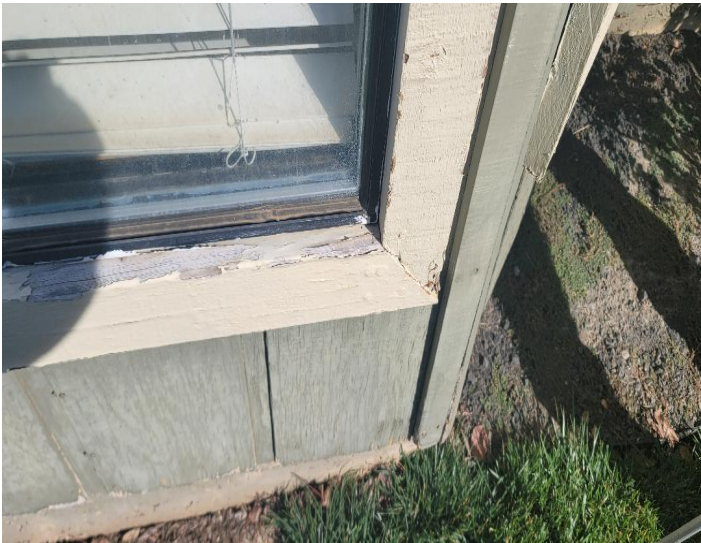
3A - Damaged window trim.

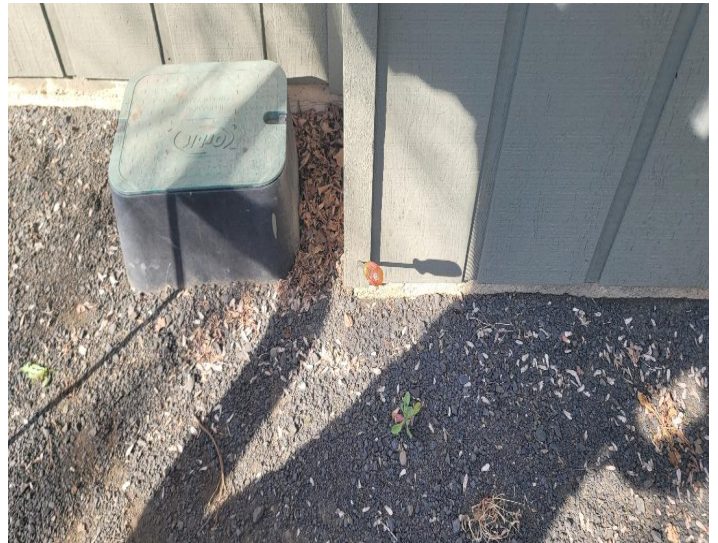
3A - Damaged trim.

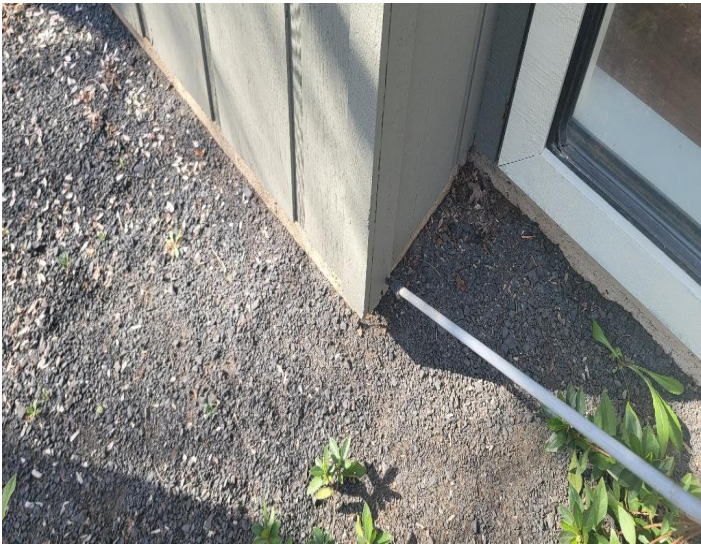
3A - Damaged trim.

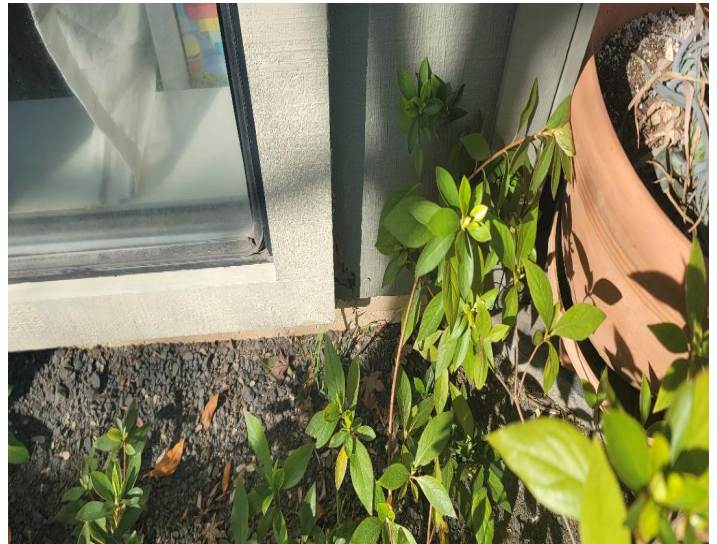
3A - Damaged siding.

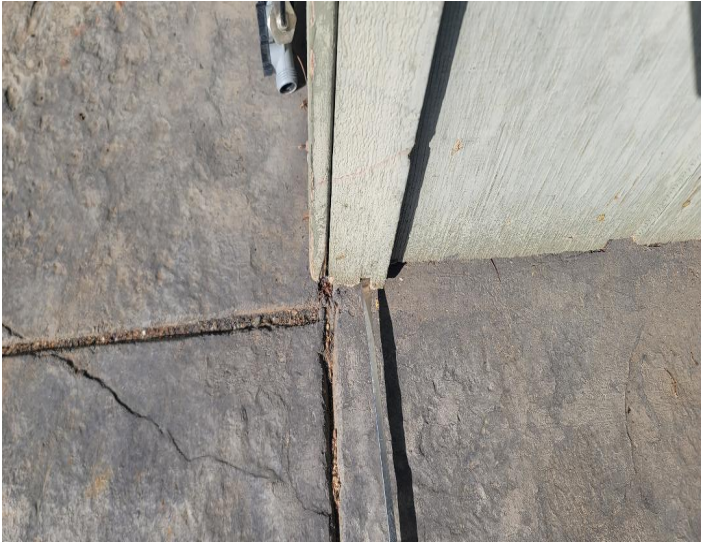
3A - Damaged trim.

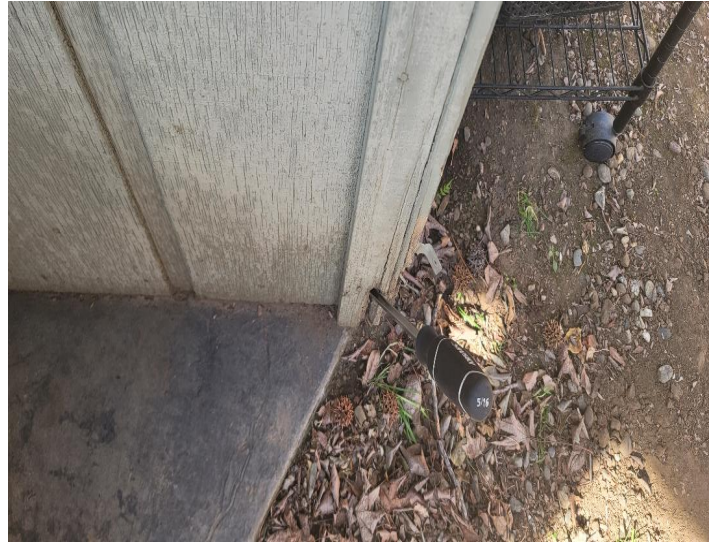
3A - Damaged trim.

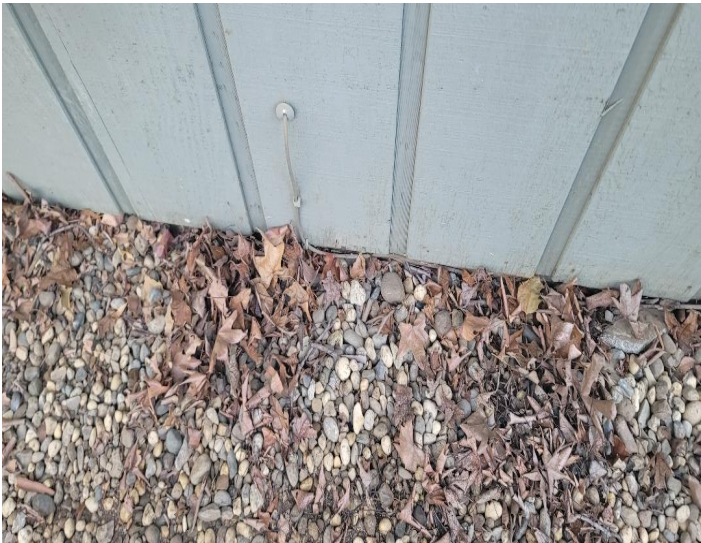
3A - Damaged siding.

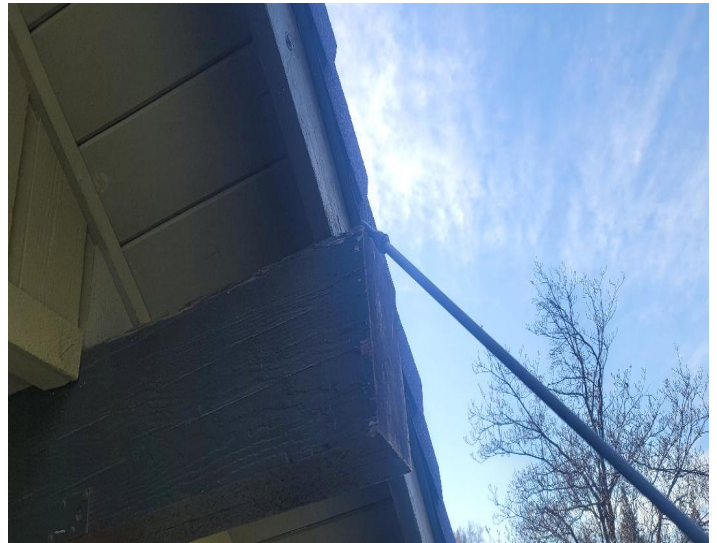
FINDING: Fungus damage was found to roof sheathing, rafter tails, barge rafters and roof beams around the structure.

3B - Damaged top of the support beam at the front of the structure.

RECOMMENDATION: We recommend the owner/agent engage the services of a licensed roofing contractor to remove all damaged members and to replace with new appropriate material.

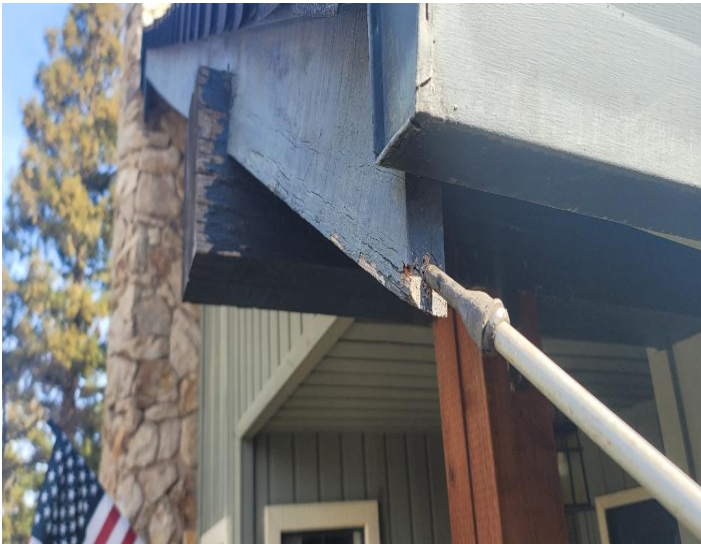
3B - Damaged barge rafter at the front of the structure.

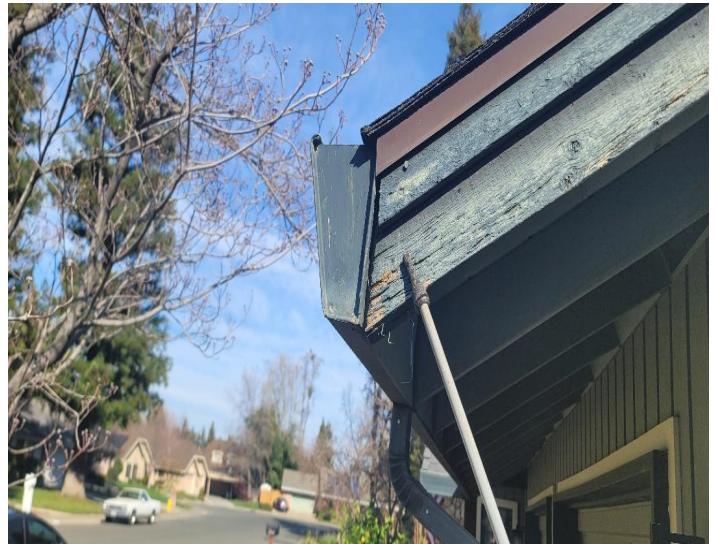
3B - Damaged barge rafter.

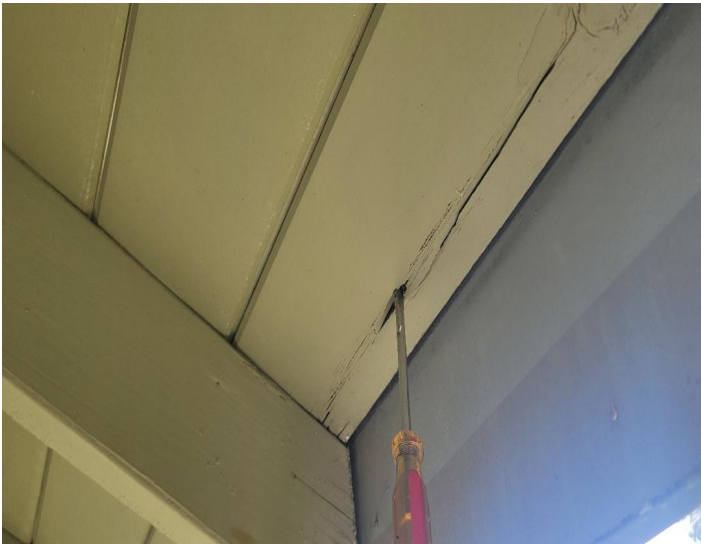
3B - Damaged roof sheathing.

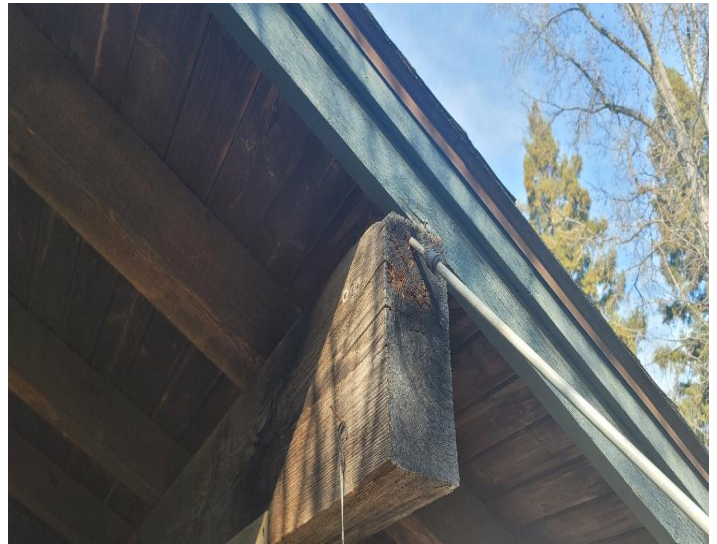
3B - Damaged roof beam end at the rear patio roof.

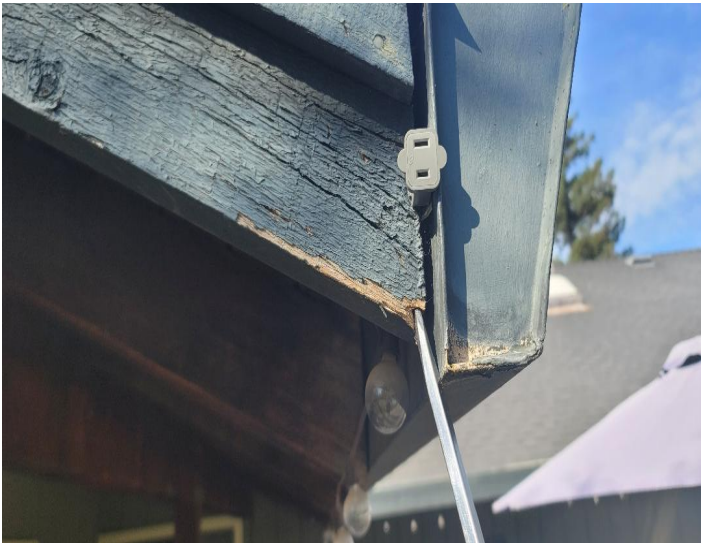
3B - Damaged barge rafter at the rear patio roof.

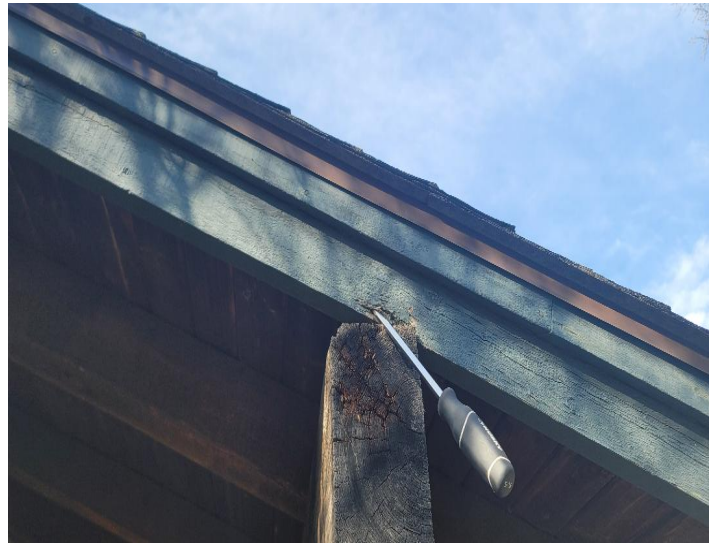
3B - Damaged barge rafter at the rear patio roof.

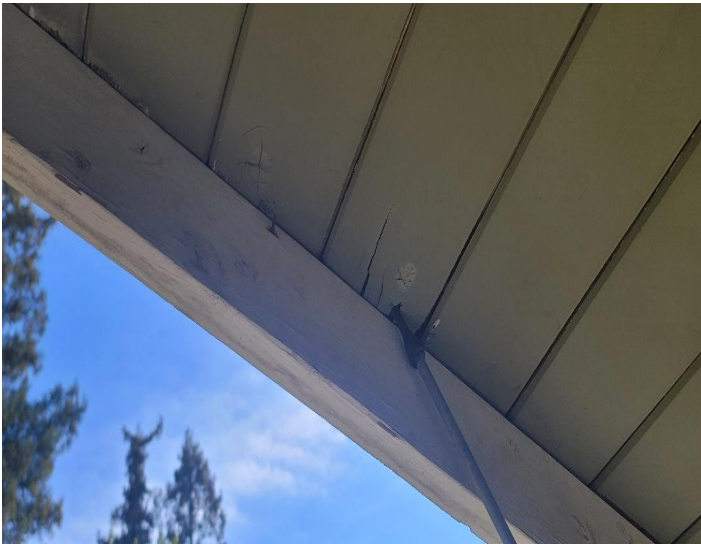
3B - Damaged roof sheathing on the rear patio roof.

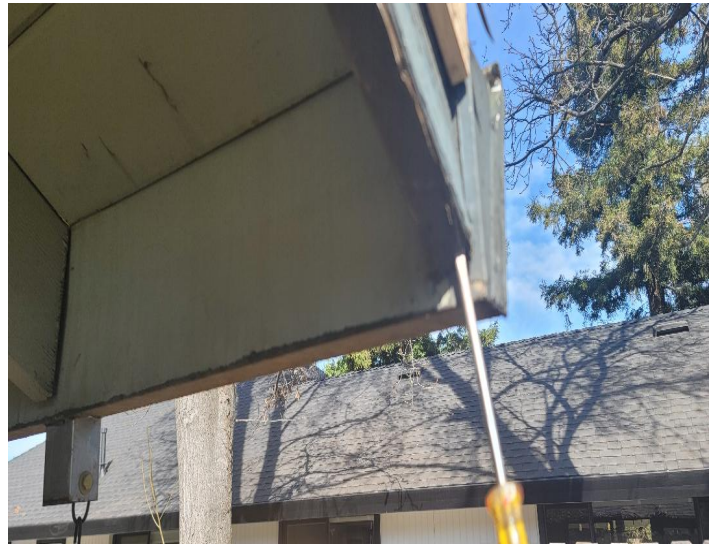
3B - Damaged barge rafter at the left rear corner.

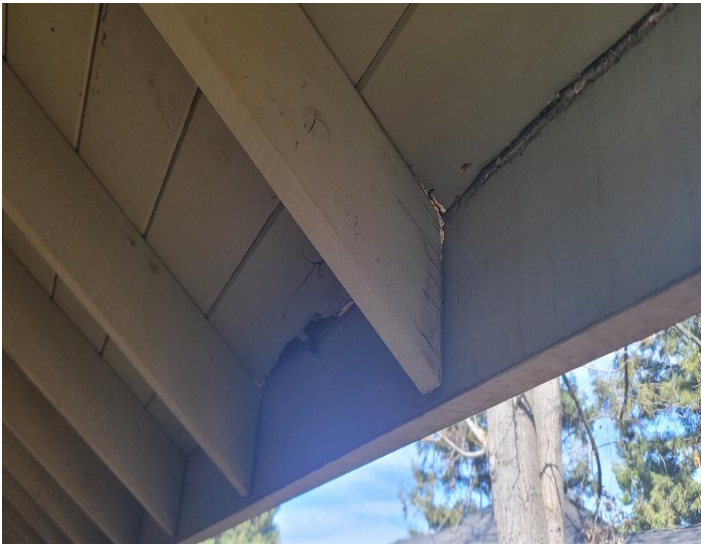
3B - Damaged roof sheathing at the left side of the structure.

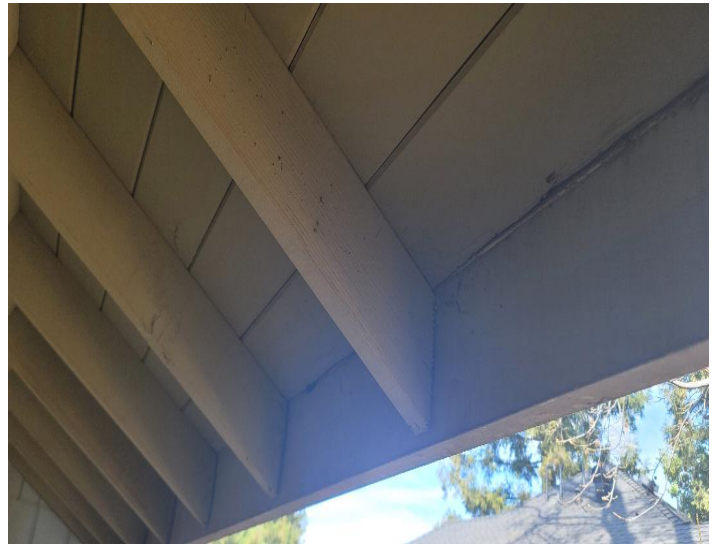
3B - Damaged roof sheathing at the left side of the structure.

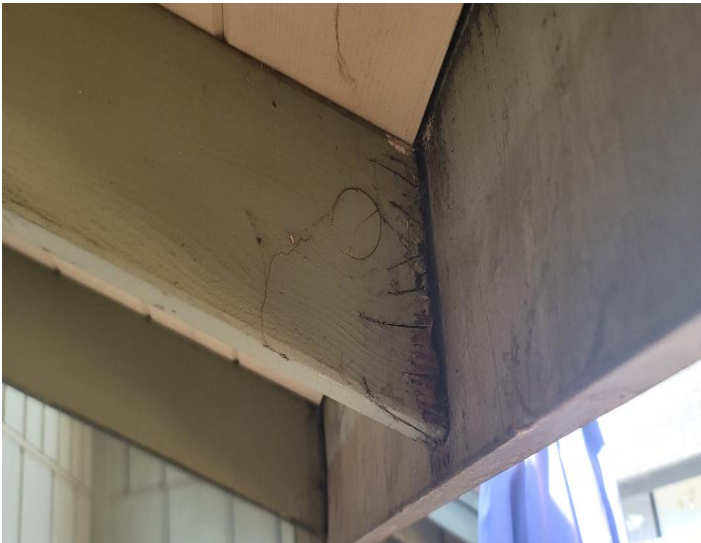
3B - Damaged rafter tail at the left side of the structure.
