Address: 3844 E 15th St, Long Beach

Date of Inspection: 2-29-24

Main Sewer Line Inspection Report

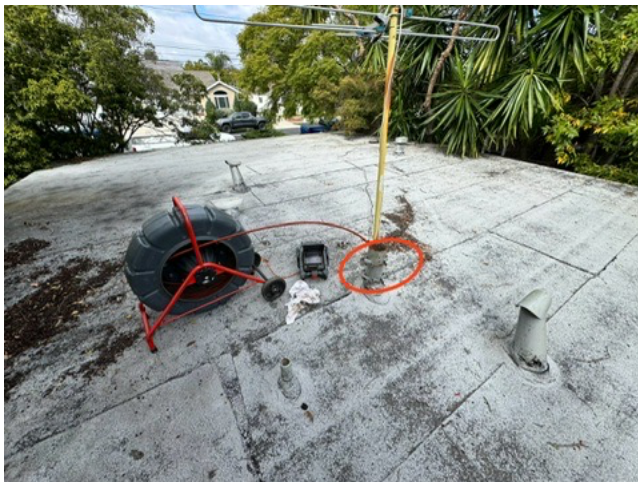
Main Sewer Line Access Points: In order to view the main sewer line for this property we used a 4" roof vent. This roof vent is insufficient access to perform routine maintenance and inspections on the main sewer line.

4" roof vent used for inspection.

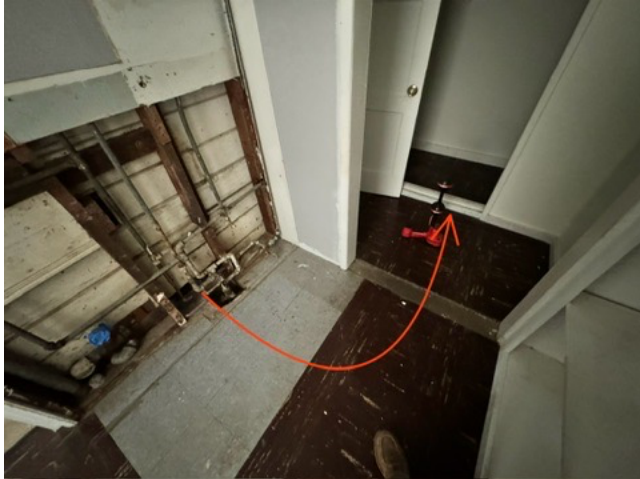
Clay is not an approved material to be used under the footprint of a structure. Clay pipe allows some moisture to exit the pipe into the surrounding soil that can create unstable soil conditions over time. It can also break under the pressure of a settling foundation. Additionally, sewer released under the house must be considered a health and safety concern.

Path of clay pipe underneath the house. 2' deep.

To replace the clay pipe underneath the home it might cost \$5,000 - \$5,300.

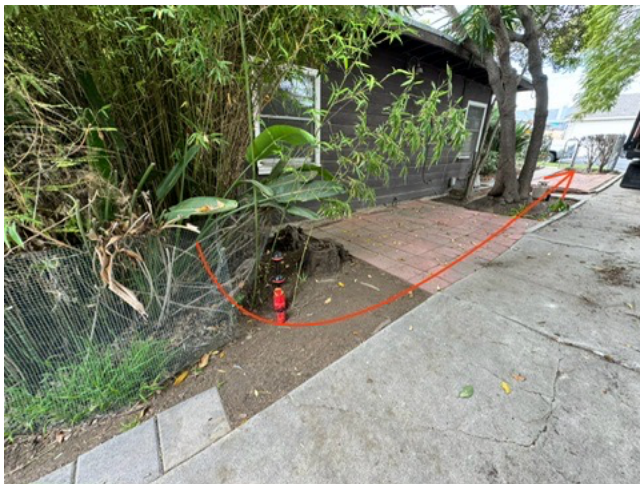
Path of sewer line. Good location for a cleanout to be installed under tool 3' deep.

Areas Needing Attention: A 2-way cleanout should be installed (see pictures for location) for routine maintenance and inspections. A cleanout is a pipe that comes out of the ground and allows cleaning tools and inspection cameras to be pushed towards the house and towards the city sewer.

Estimated Costs for Repairs: To install a cleanout it might cost \$ 1,600 - \$1,800.

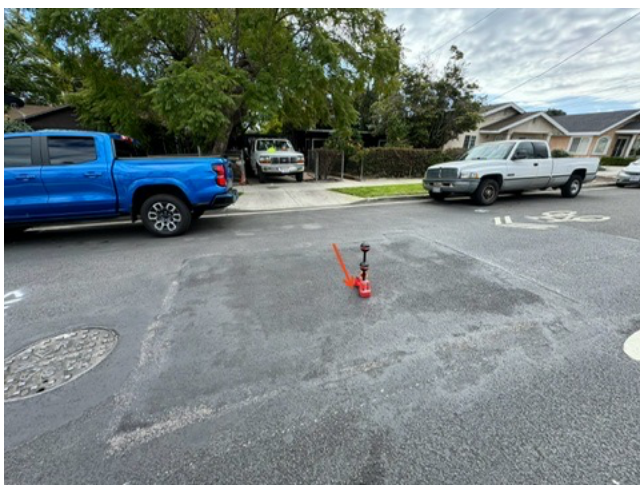
Connection to city sewer under tool.
