Inspection Report

Denis & Linda Clercq
1375 Nacimiento Lake Drive
Paso Robles, CA 93446

Report Date: 8/27/2024

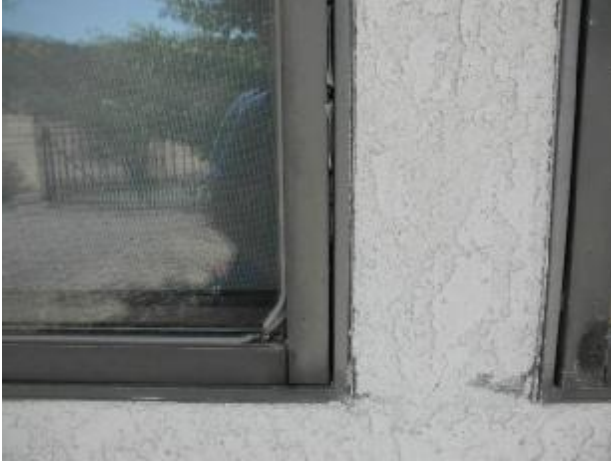
EX

1.) Part of the weather stripping is loose/damaged at the casement window on the south wall of the garage.

Loose/damaged weather stripping at the garage window.

- 1.) Part of the weather stripping is loose/damaged at the casement window on the south wall of the garage.
- 2.) There is moisture damage to the fascia board above the front entry planter area.

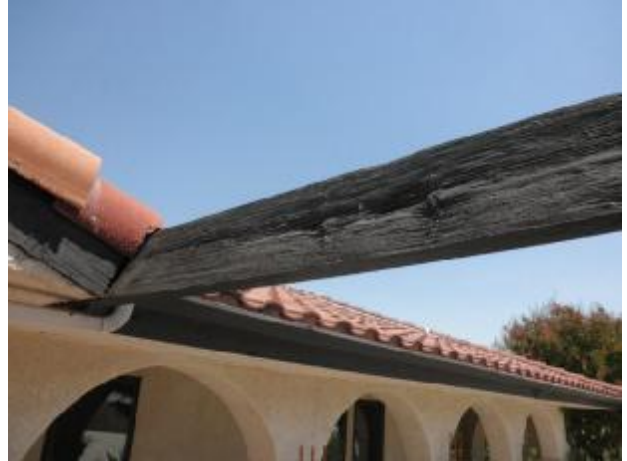
EX

2.) There is moisture damage to the fascia board above the front entry planter area.

Moisture damage at the fascia board.

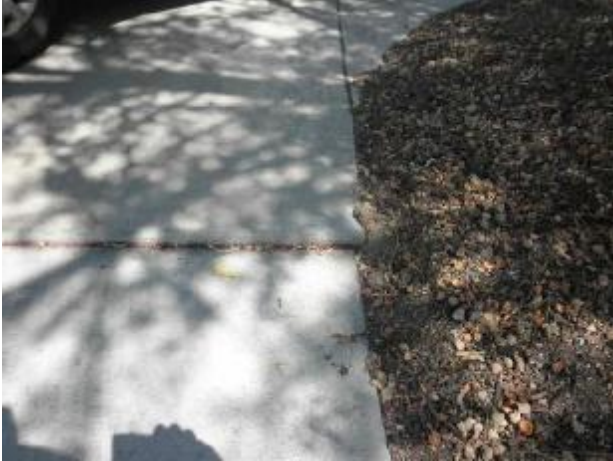
Safety Hazard Note: Part of the concrete circular driveway has been uplifted by tree roots. This has created a tripping hazard.

Tripping hazard at the uplifted concrete driveway.

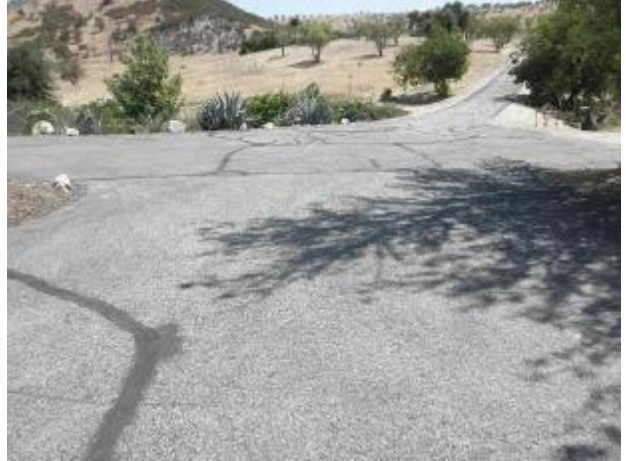
Maintenance Note: The asphalt portion of the driveway appears to be in reasonable condition but needs sealant. Cracks and general deterioration were observed.

The asphalt portion of the driveway needs maintenance sealing.

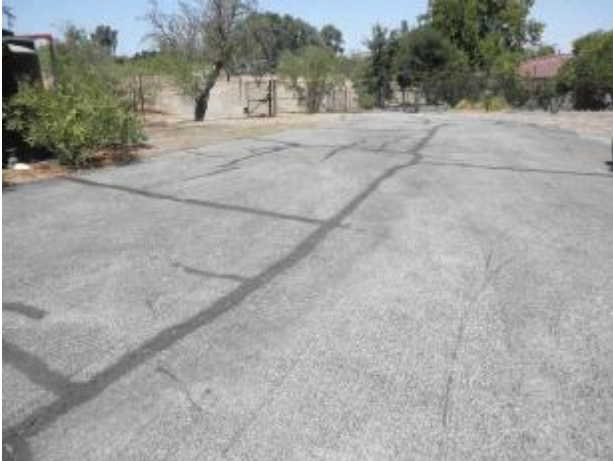
The asphalt portion of the driveway needs maintenance sealing.

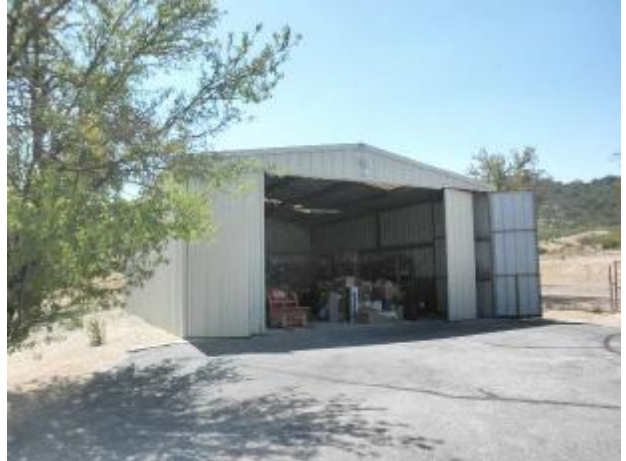
Metal Building #1 This is a pre-engineered metal building with metal roofing and metal walls. The building is supported by a concrete slab on grade. The building was manufactured by Nunno Steel Corporation. The building appears to be structurally sound. The large commercial doors operate properly and smoothly. The following electrical defects were observed:

- A.) The circuit breakers in the electrical subpanel need to be labeled.
- B.) There is over-fusing at one of the 30 amp circuit breakers. This is considered a fire safety hazard and is recommended to be corrected by a qualified and licensed Electrical Contractor.
- C.) There is no separate source of grounding for the subpanel. This is recommended to be installed as a safety upgrade.
- D.) **Info Note:** The electrical panel is wired for 110 volt circuits only.

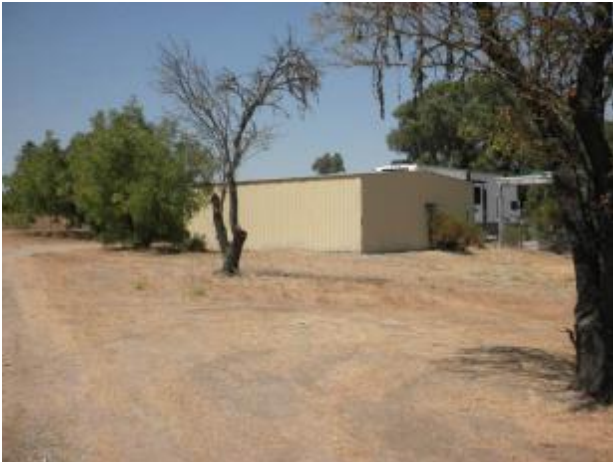
metal Building #2

Metal Building #2 This is a pre-engineered steel building with metal roofing and metal walls. The building is supported by a concrete slab on grade. The manufacturer of the building is unknown. The large swing door operate properly. The following electrical defects were observed:

- A.) The circuit breakers in the electrical subpanel need to be labeled and there is an opening in the dead front cover needs to be sealed.
- B.) There is no separate source of grounding for the subpanel. This is recommended to be installed as a safety upgrade.

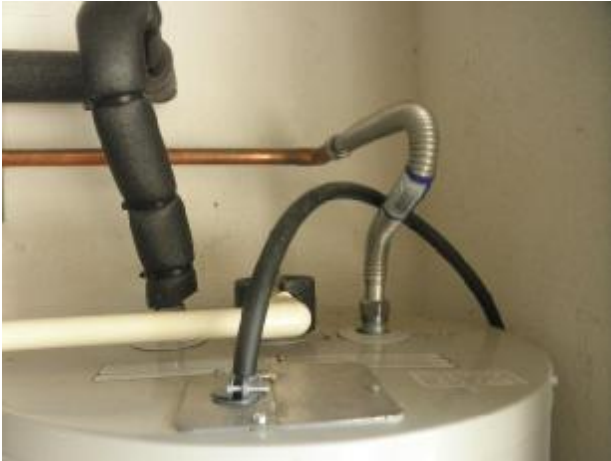
EL

Safety Hazard Note: There is exposed Romex wiring installed at the Bradford White water heater. This is required to be installed in conduit or have a wall surface installed over it for physical protection.

Exposed wiring at the Bradford White water heater.

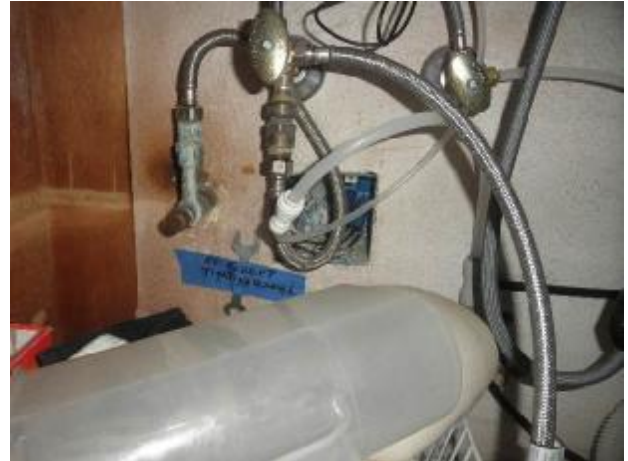
EL

Open junction box below the kitchen sink.

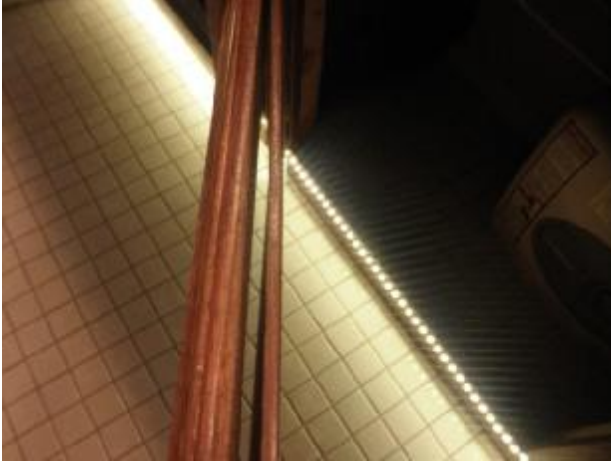
B

Delamination at the cabinet doors ate master bathroom vanity.

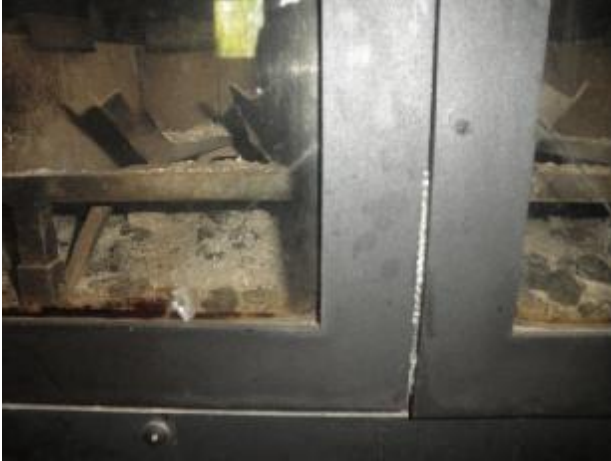
IR

1.) Both of the glass doors are cracked at the living room fireplace.

Cracks in the glass doors at the living room fireplace.

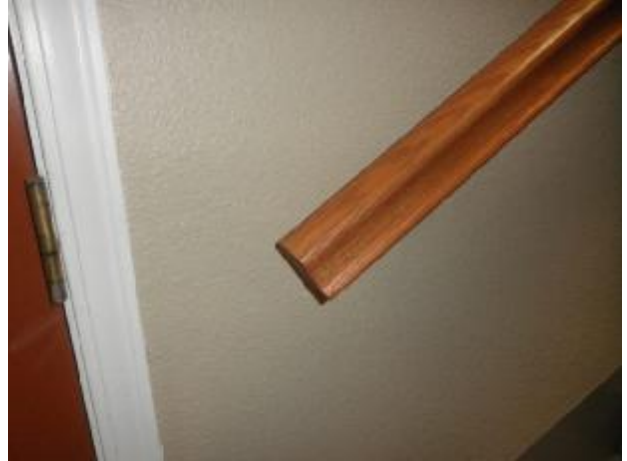
IR

Handrails at the family room do not return to the wall.

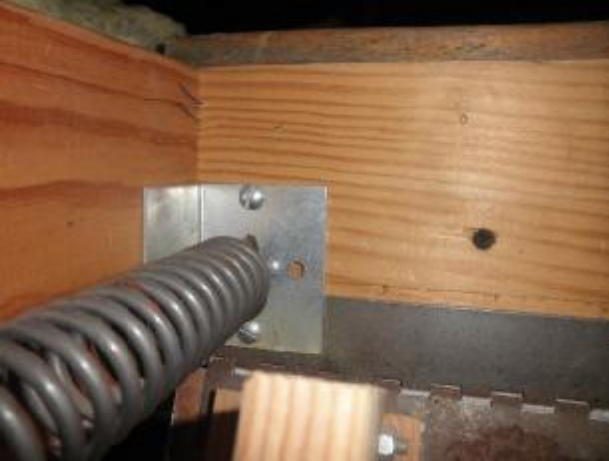
A

Safety Hazard Note: The drop down ladder in the family room has been improperly secured with screws. The manufacture requires it to be secured with nails. This is because nails have a much greater shear strength than screws. As installed, the ladder is subject to collapse.

No nails installed at the drop down ladder in the family room.
