# Imperial Home Inspection Services

**August 13th 2026, 12:04 pm**

## **General Information**

**BUILDING ADDRESS:** 3314 Rogue River Dr.  
**CITY:** Chico  
**STATE / PROVINCE:** Ca.  
**POSTAL CODE:** 95973  
**INSPECTION DESCRIPTION:** Whole Home Inspection  
**SQUARE FOOTAGE:** 2065

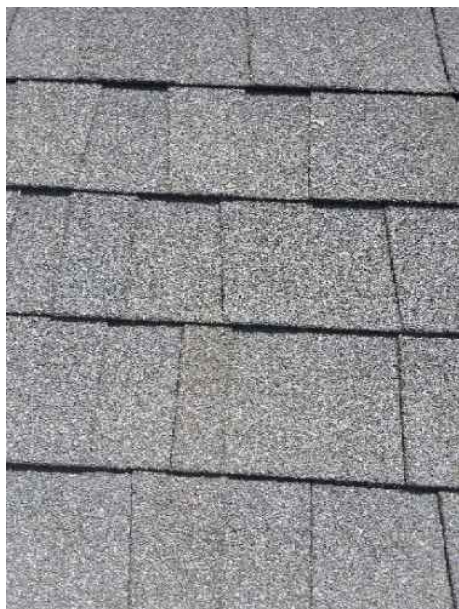
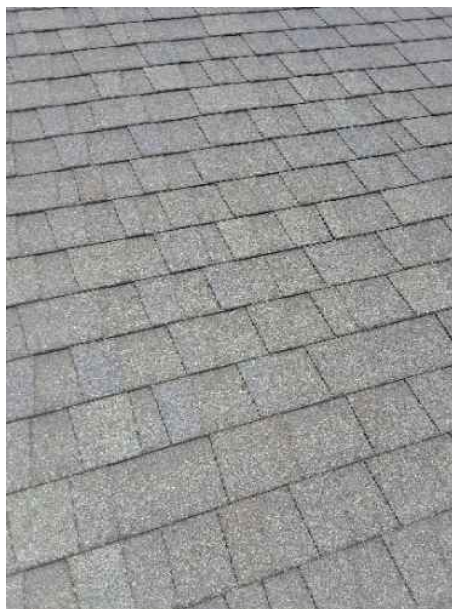
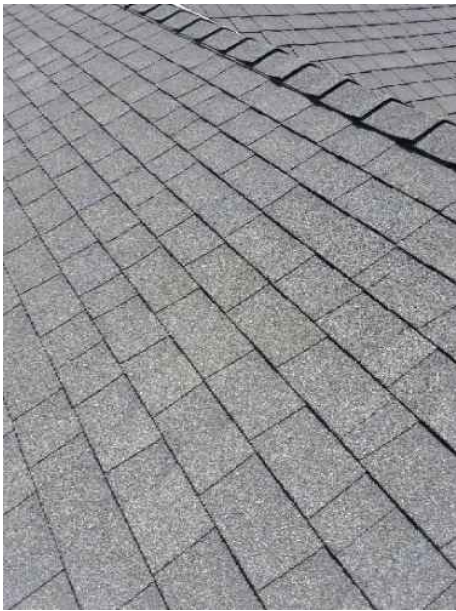
**SHINGLES MISSING / DAMAGED?** Satisfactory

This roof appears to be in the first 3rd of life.

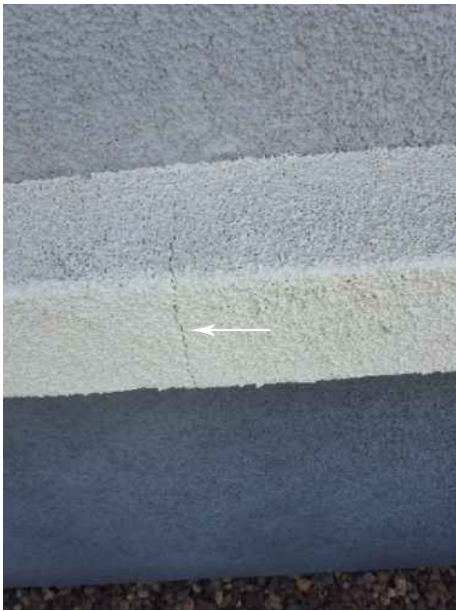
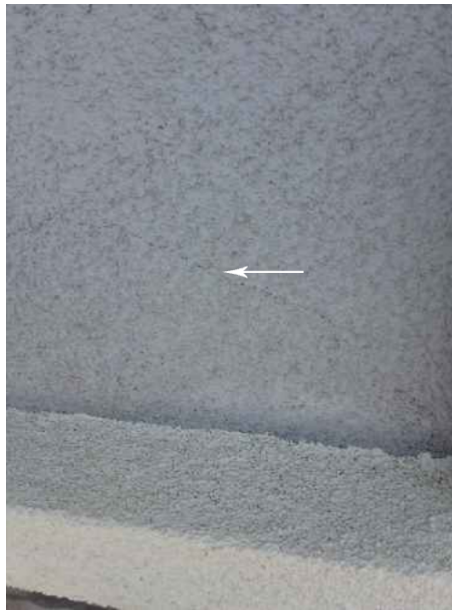
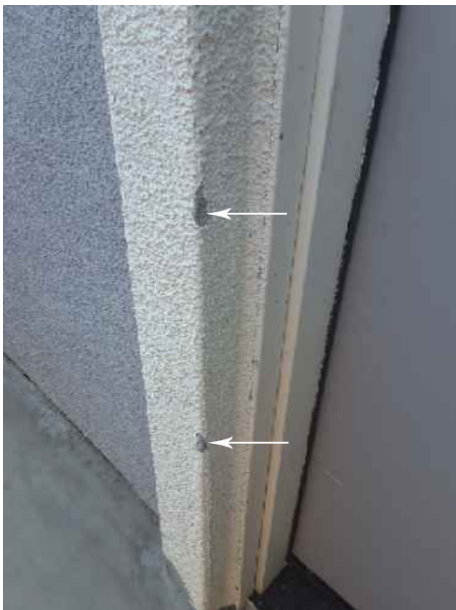
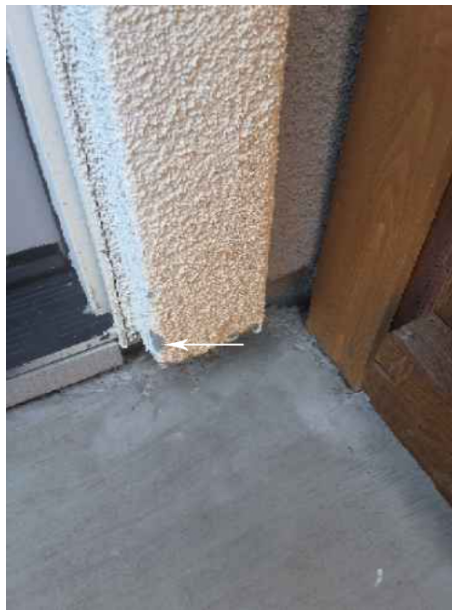
**SIDING CONDITION** Fair

The siding for this home appears to be in good overall condition, but there are some areas of common cracking of stucco and minor damage to the foam board.

Recommend application of elastomeric sealant to all gaps and cracks larger than 1/16 of an inch wide to prevent water intrusion.

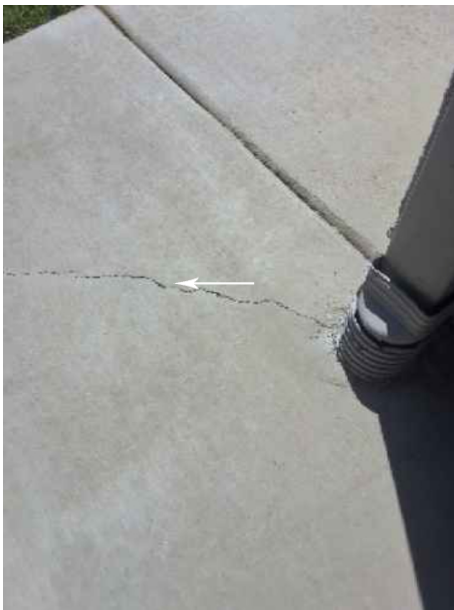
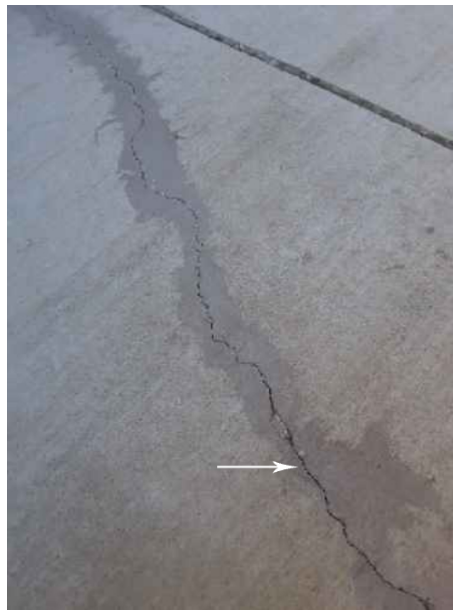
**WALKWAYS** Fair

Cracking of concrete was observed, recommend application of sealant to prevent water intrusion and further damage.

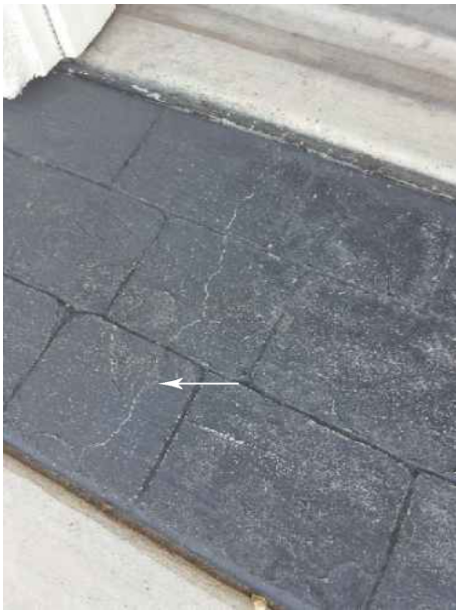
**DRIVEWAY** Fair

Common cracking of concrete was observed.

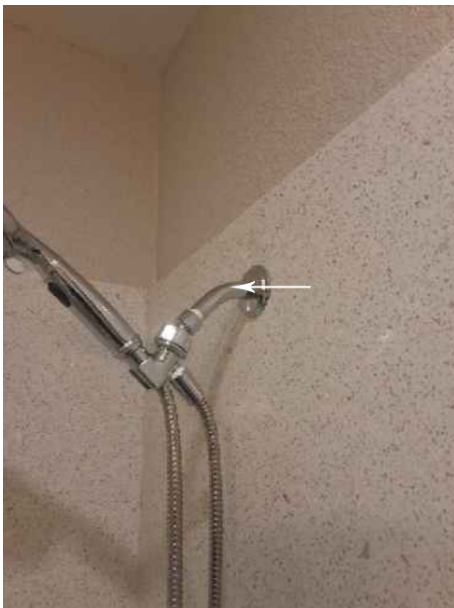
**BATHTUB / SHOWER** Fair

The shower arm is a little loose where it penetrates the wall.

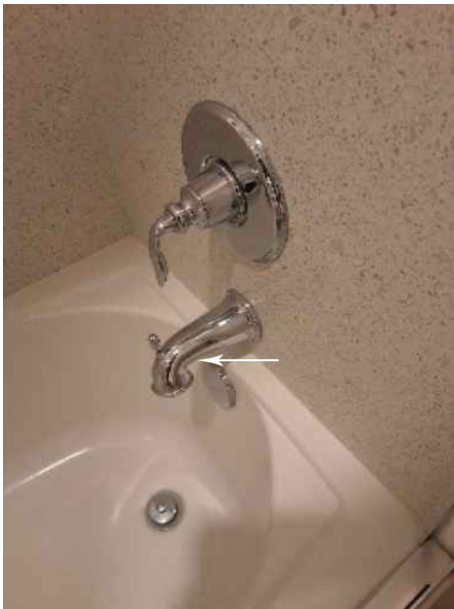
**BATHTUB / SHOWER** Fair

The faucet for the tub is a little loose and can be turned from side to side.

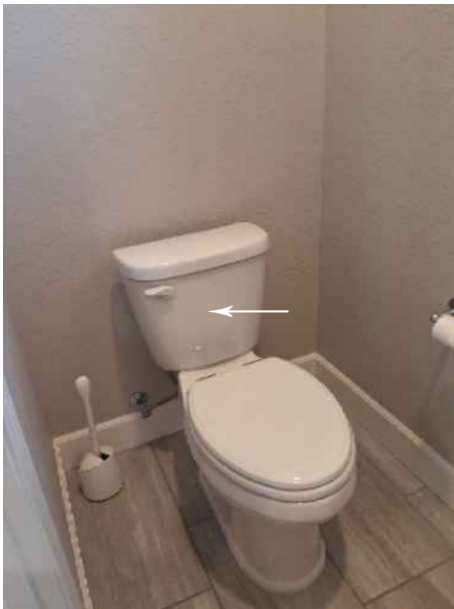
**TOILET** Fair

The toilet tank is a little loose.

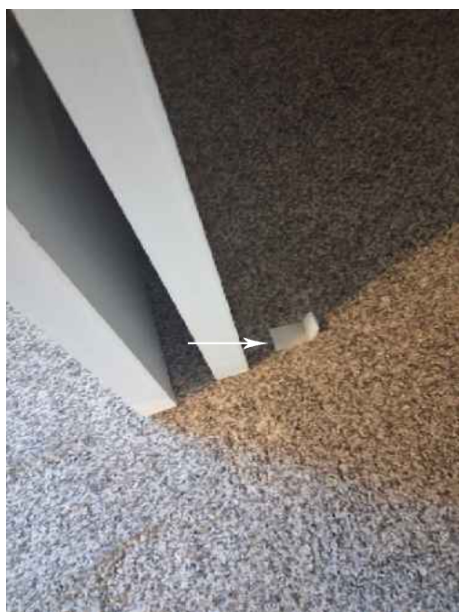
**CLOSETS** Fair

The door guide is damaged.

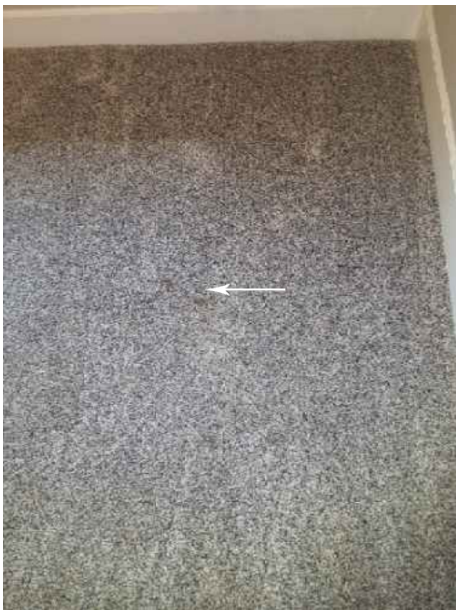
**FLOORING** Fair

Carpet stains were observed.

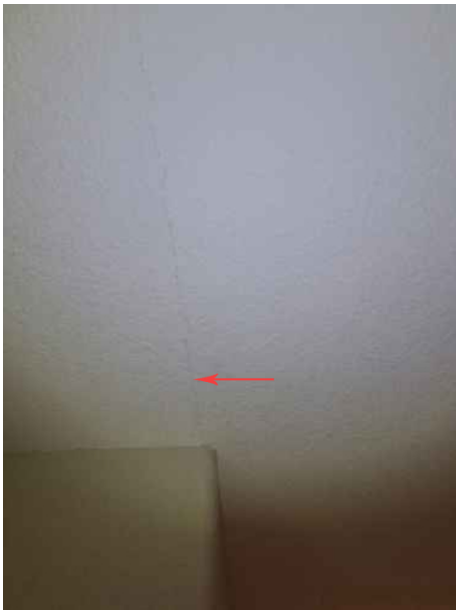
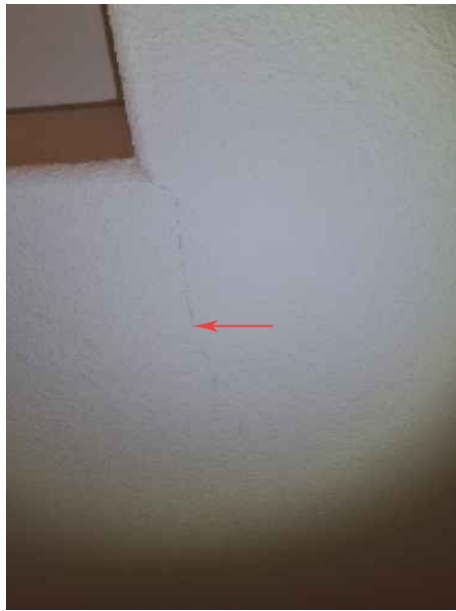
**CEILING** Fair

Several common expansion cracks were observed in the ceiling.

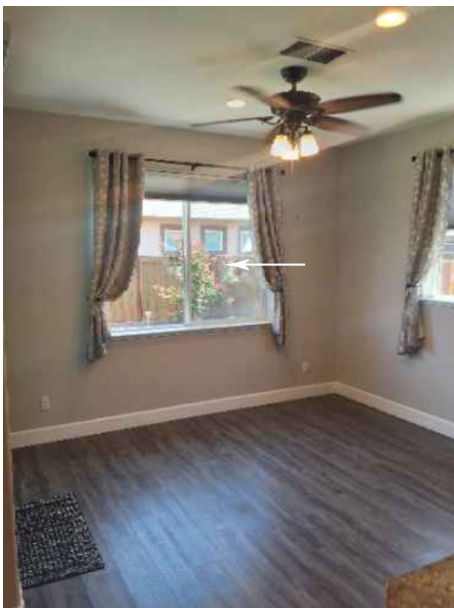
**WINDOWS** Fair

Condensation stains were observed in between the panes of glass in the window pictured in the breakfast nook, this indicates failed seals.

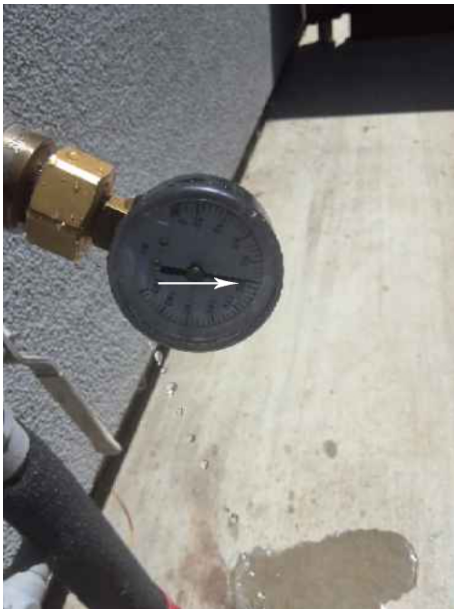
**WATER SUPPLY PRESSURE** Fair

The water supply pressure read roughly 90 PSI at the time of inspection. This is quite a bit higher than the recommended range of 40-70 PSI for a home. Recommend installation of pressure regulator and reducing the pressure to 60 PSI.

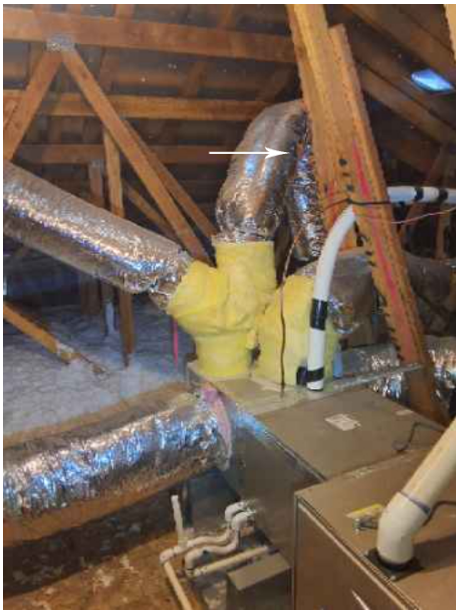
**DUCTWORK / PIPING** Fair

One run of ductwork takes an almost 180 degree turn, this will reduce the air flow.

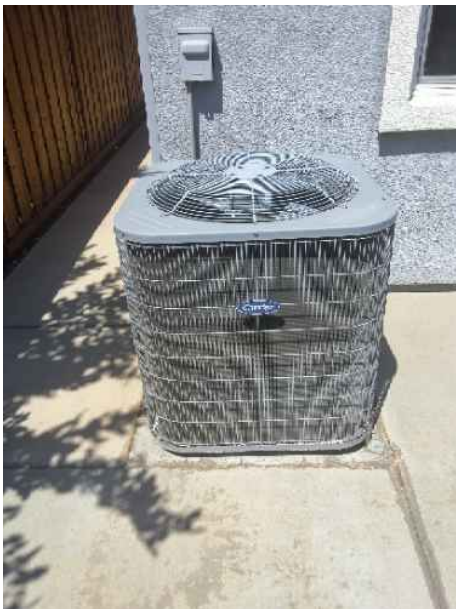
## **COOLING SYSTEM     Fair**

The cooling system is a 3 ton system, is undersized for the square footage of the home and was manufactured in 2019. The expected life span of a cooling system is 10-15 years.

A 3 ton system is rated for a home up to 1500 sq ft, a 4 ton system would be a better choice for this home.

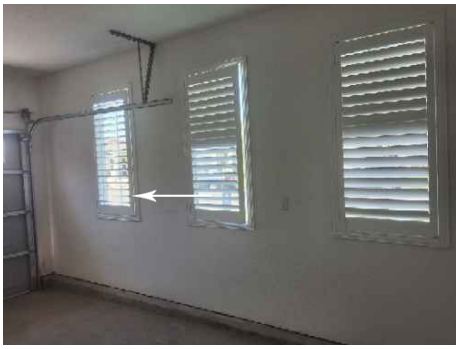
**GARAGE WINDOW** Fair

Condensation stains were observed in between the panes of glass in the window pictured in the smalll garage space, this indicates failed seals.
