## Sewer Inspection Report

**3417 Palos Verdes Drive North  
Palos Verdes Estates, California 90274**

**Friday, November 3, 2023 at 1:00 PM**

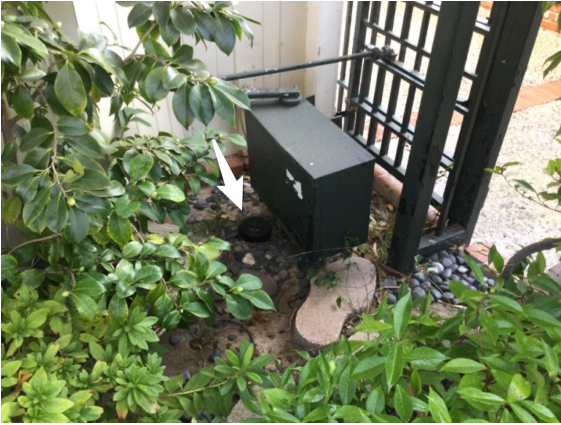
Four inch cast iron clean out.

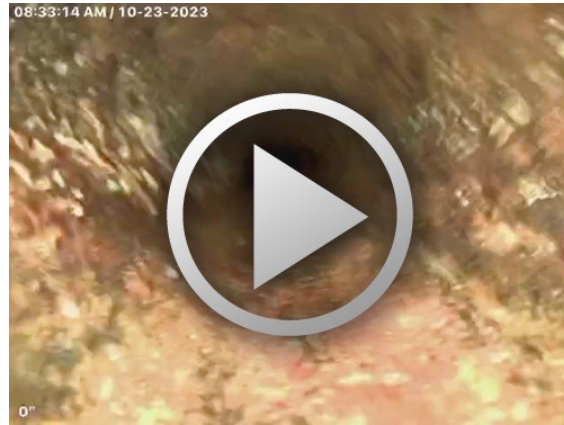
Front planter.

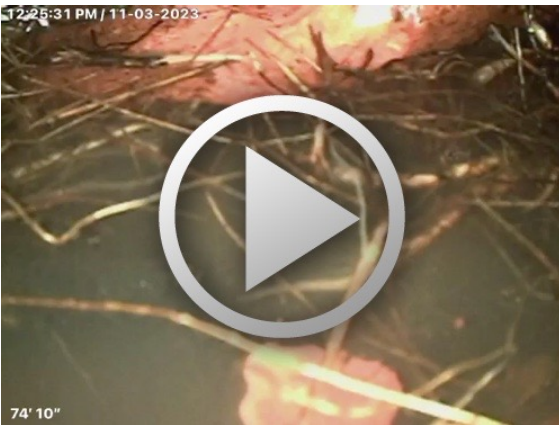
After hydrojetting.
