Angel City Inspections

Property Inspection Report

1317 & 1317 1/2 Olive Ave, Colton , CA 92324

Date of Inspection: 7/5/2023 Time: 500PM

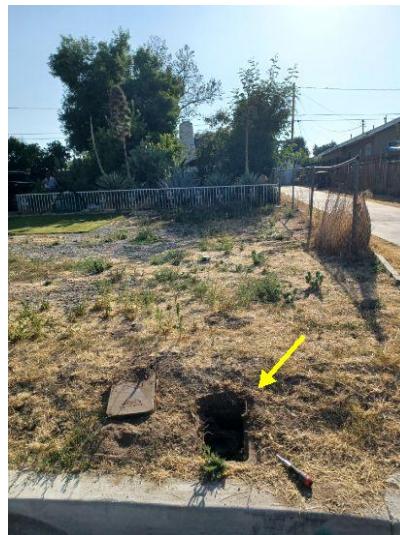
Main Water Supply

Galvanized steel piping is viewed coming out of the ground by the building and as the main water line runs underground from the street to the building, this appears to be the main water line.

The main water line supply appears to be made of a galvanized steel material. This material typically rusts and corrodes from the inside out. Since this is the main water supply from the city to the home, a majority of the line is buried and not visible. Follow up with a qualified plumber is recommended.

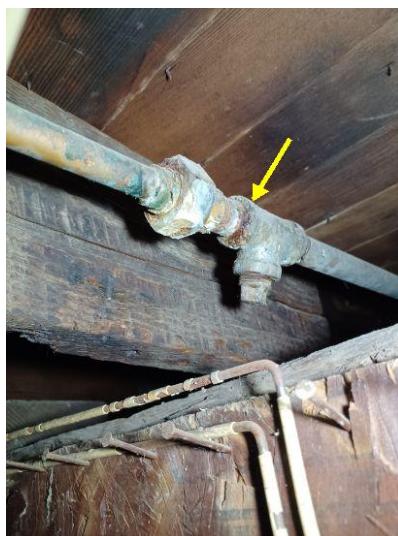
The water lines are galvanized steel pipes. These are rusting, corroded and are showing excessive deterioration and/or reduced water flow in areas.

There are copper to galvanized steel piping connections without the proper fittings that keep these dissimilar metals apart (dielectric or brass fittings). These metals react against each other without these fittings and the galvanized piping corrodes faster. Even proper fittings are just a temporary solution and will not correct or stop corrosion or handle the problems of pipes rusting out. The remaining galvanized pipes will need to be replaced in time.

The volume of water coming out of the plumbing fixtures drops when multiple fixtures are operated at one time. Sometimes this effect is due undersized piping due to loss of pipe internal diameter. Consult a plumber for further information.

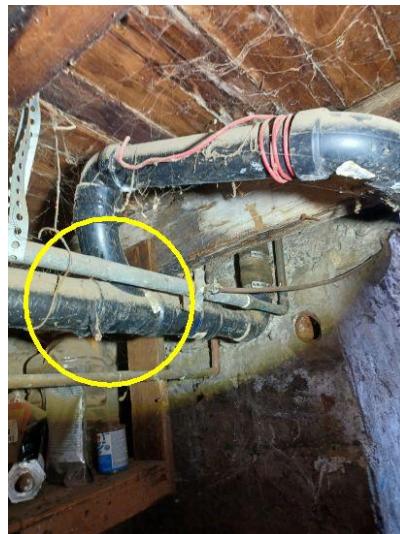
Non standard fittings are in use in areas. These should be checked by a plumber to determine if corrections are needed. (Backwards)

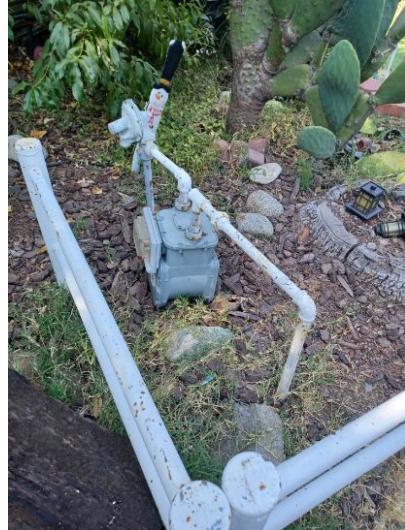
There is no automatic seismic gas shut-off valve on the main gas line. This may need to be installed in this municipality at the time of sale

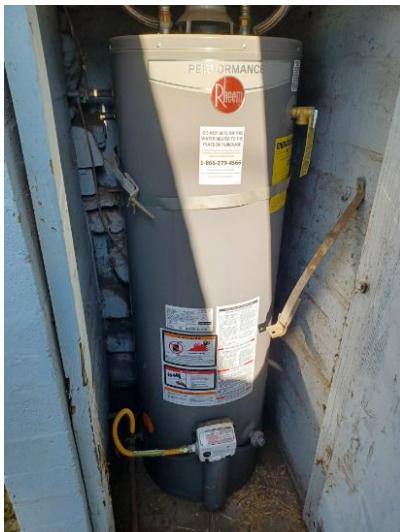
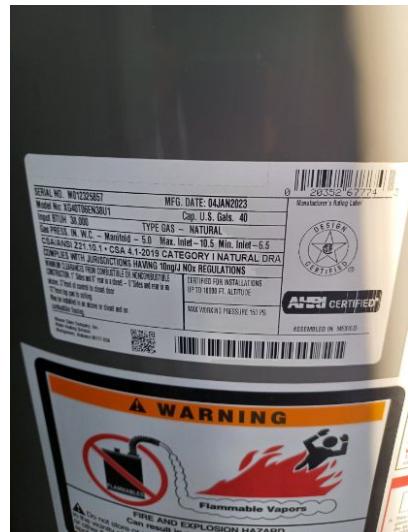
Sediment leg missing from the gas line running to water heater

The temperature/pressure relief valve has no drain line installed to take the water away to a safe location if the valve releases. We recommend this drain line be installed in case this valve ever released

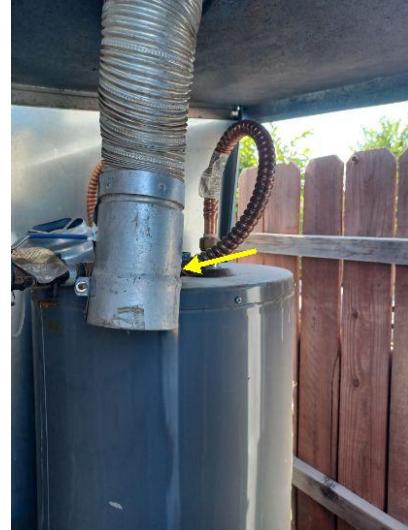
The vent line is disconnected and exhaust gases from the water heater are escaping. This is a safety hazard and needs to be repaired

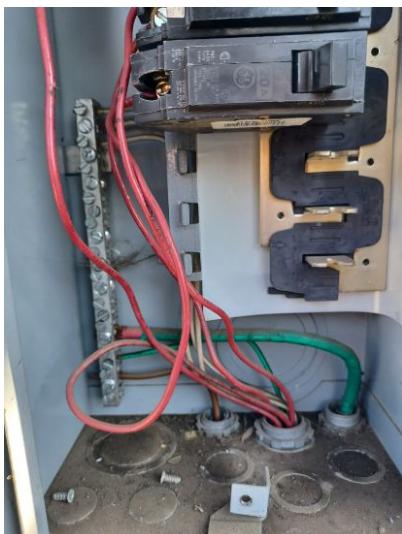
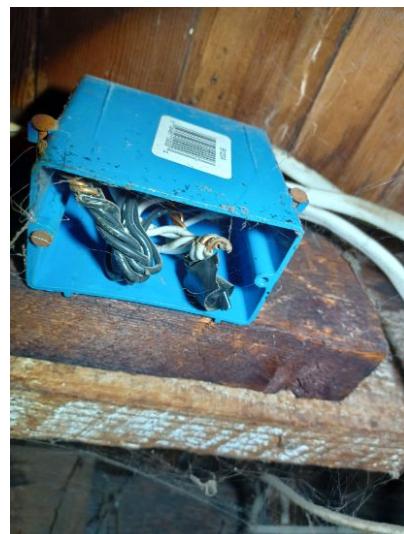
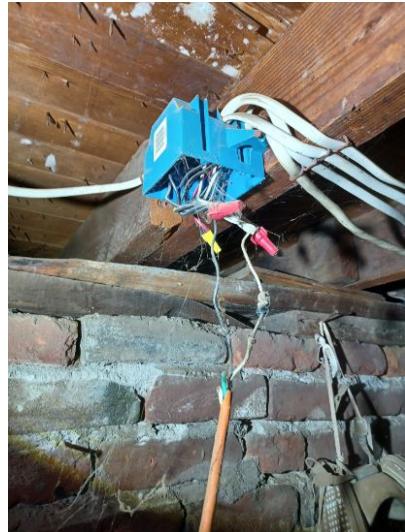
There are open junction boxes in the crawl space with wires exposed. These need to have covers installed over them

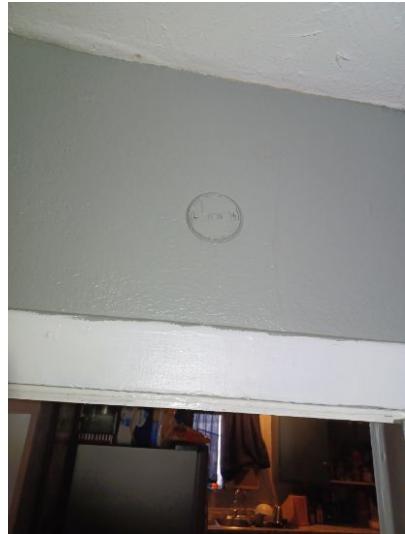
Faltan detectores de humo en áreas (front)

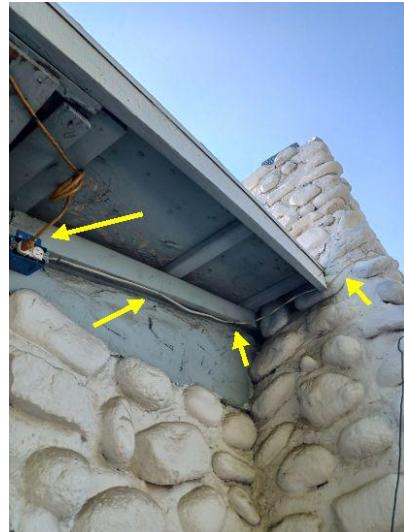
Proper weatherproof covers are recommended

Exterior outlet did not appear to be GFCI protected. Upgrade recommended

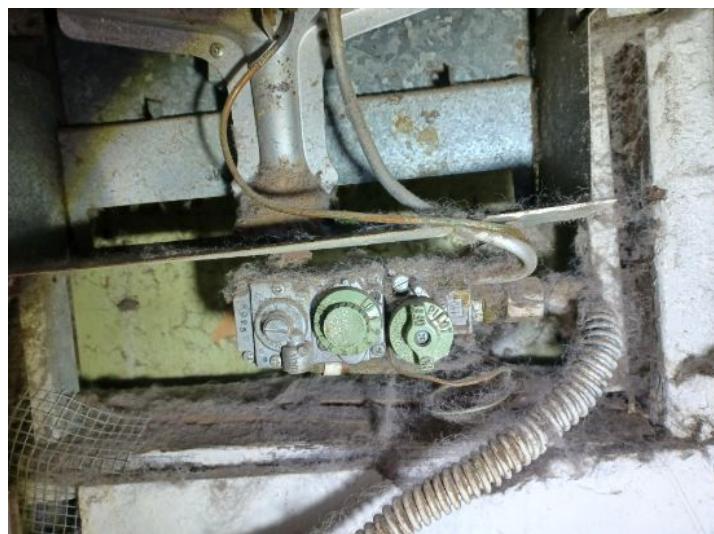
Parece que el horno sufre mantenimiento diferido en general. Está sucio y necesita ser limpiado y reparado. (Back House)

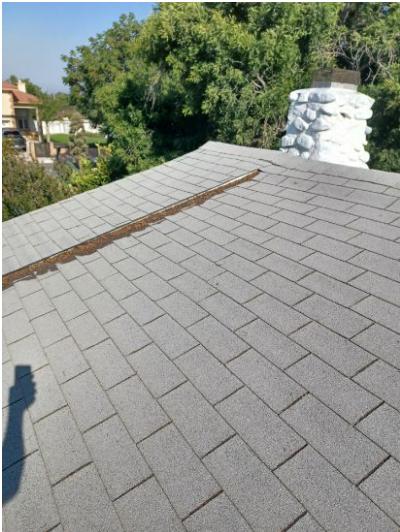
Front house

The shingles are older, deteriorating and losing their surface granules. It is nearing the time to replace this roof.

The shingles are older, brittle and falling apart. They are at the end of their life and ready for replacement at this time.

The nails heads are exposed on the roof surface, not only will this allow them to rust but it is a potential leak hazard. This is generally considered a poor / unreliable installation method.

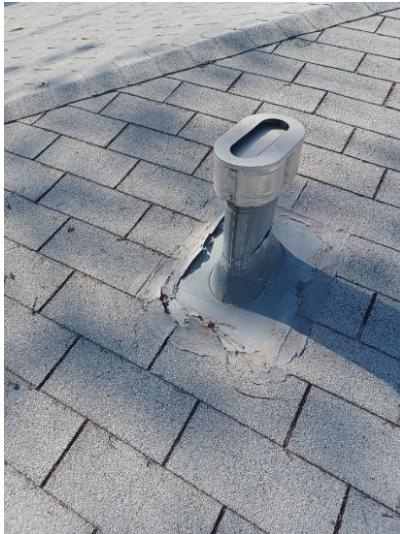
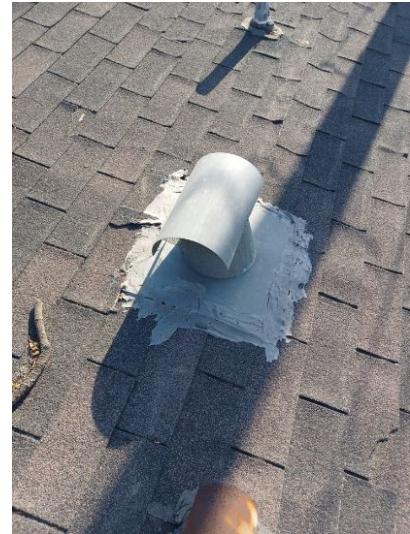
Back

The flashings have been covered over with mastic which is a temporary solution and will require regular maintenance to help ensure a leak free condition

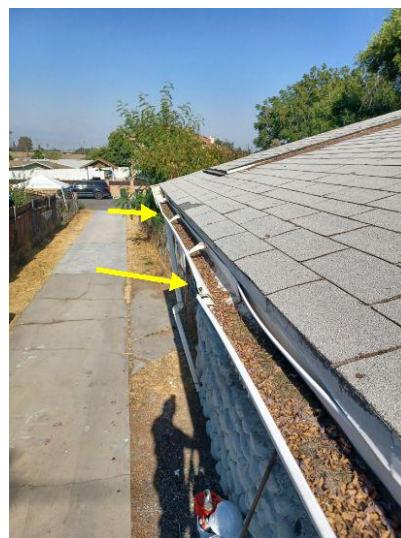
There are damaged areas of gutters

The gutters and downspouts on the building are made of plastic. These tend to leak and are of a lesser quality material and installation than metal ones.

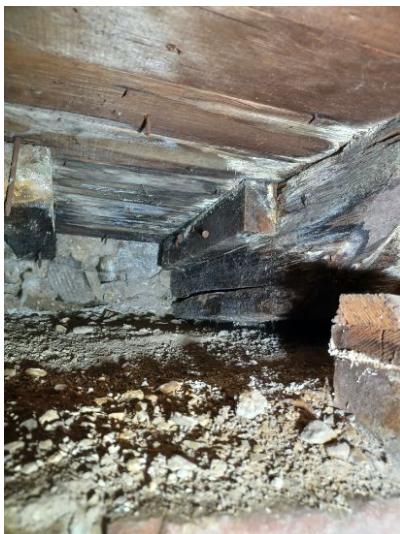
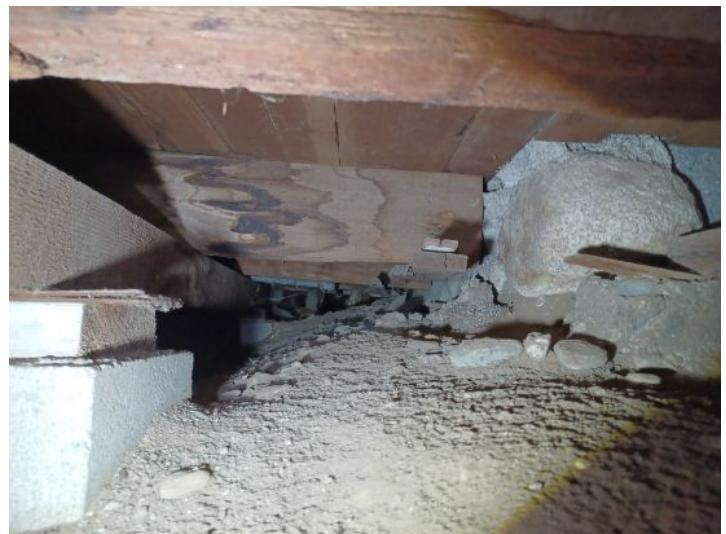
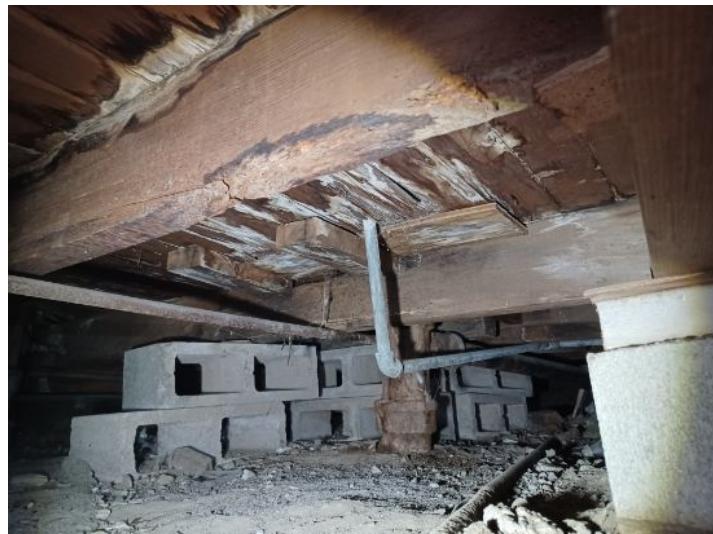
Hay áreas manchadas en la estructura del piso. Se recomienda consultar el informe del operador de control de plagas estructurales para obtener más información sobre esta situación.

Se observa contacto de tierra a madera en áreas, consulte el informe del operador de control de plagas estructurales para obtener más información

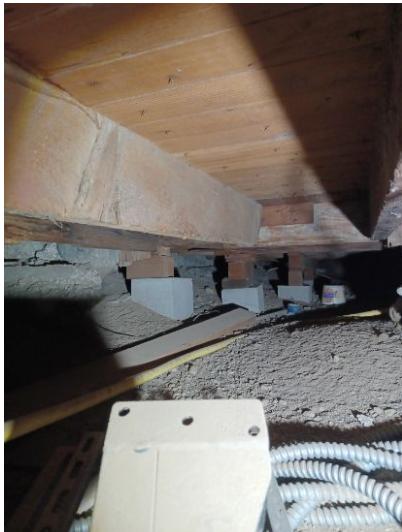
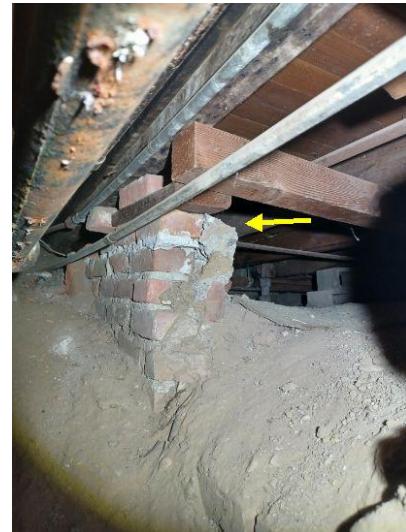
A number of pieces of wood such as shims are being used in place of a single support post in areas. These tend to fall out during seismic activity and are not attached to each other or the framing of the structure

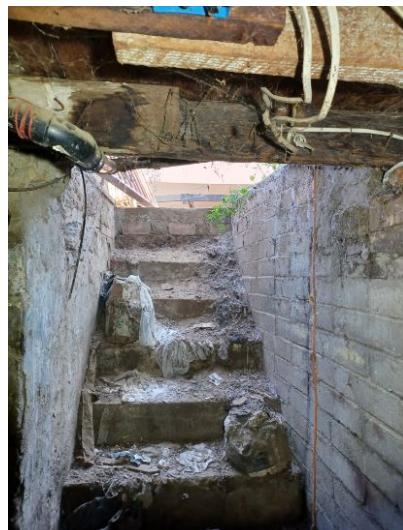
Las contrahuellas y/o los peldaños de las escaleras del sótano tienen medidas desiguales y pueden ser un peligro de tropiezo

No hay barandilla en las escaleras del sótano, todas las escaleras requieren una barandilla y se debe instalar una para un acceso seguro

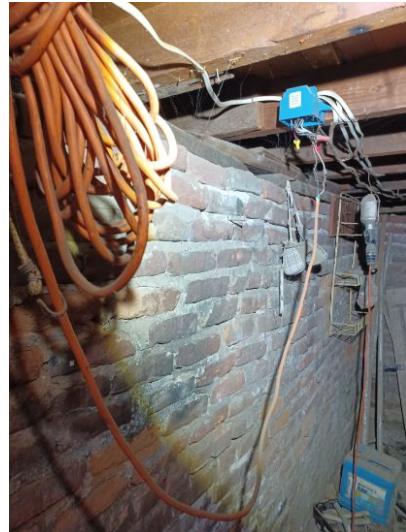
Basement walls show signs of deterioration, characterized by crumbling mortar joints, cracks, spalling, and efflorescence. The extent of deterioration varies throughout the basement but is consistent. Recommend evaluation.

Las paredes del sótano muestran signos de deterioro, caracterizados por juntas de mortero que se desmoronan, grietas, desconchados y eflorescencias. El grado de deterioro varía a lo largo del sótano, pero es constante. Recomendar evaluación.

It is advised to have the basement further evaluated by a structural engineer or a foundation specialist

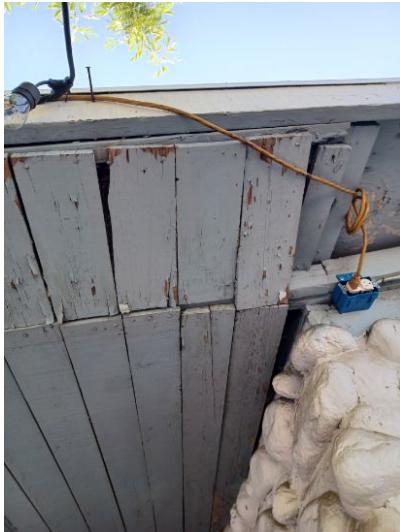
The surfaces are weathered and have peeling paint.

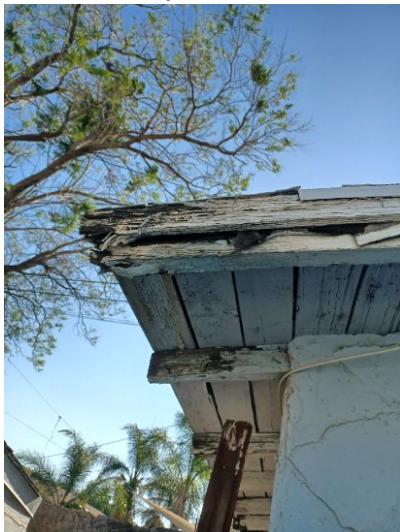
The fascia is damaged. (Back House)

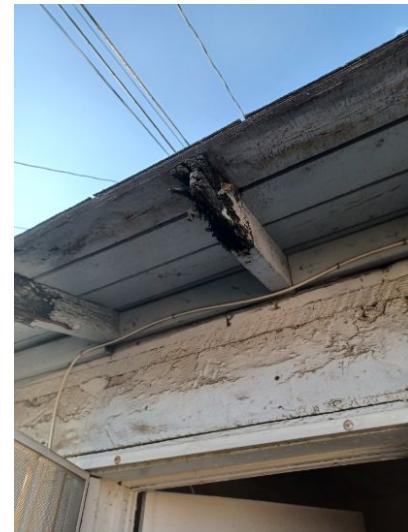
The rafter tails are deteriorated. (Back House)

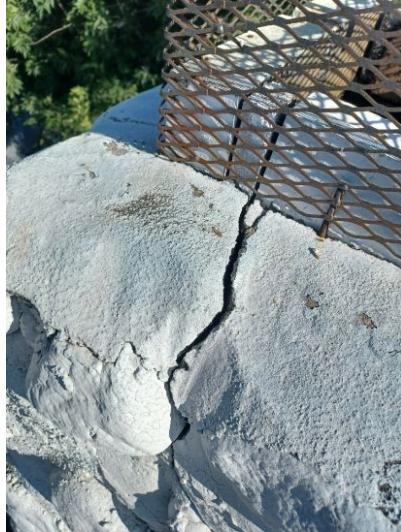
This chimney is cracked. Significant repair or replacement costs should be expected with this chimney.

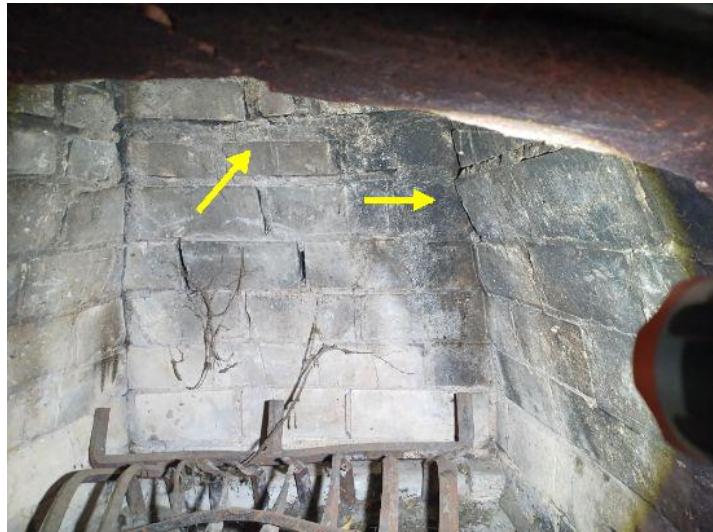
La cámara de combustión está dañada y es necesario repararla o reemplazarla.

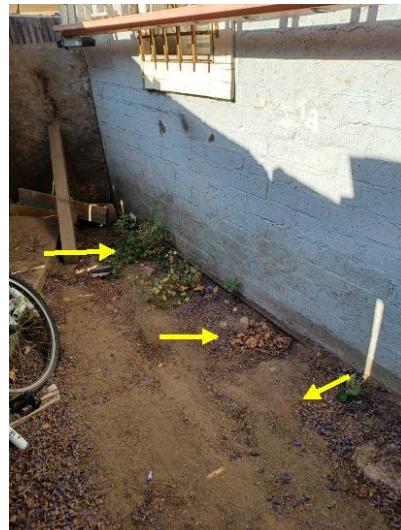
Hay áreas donde el agua puede acumularse en lugar de fluir fuera del sitio durante las lluvias

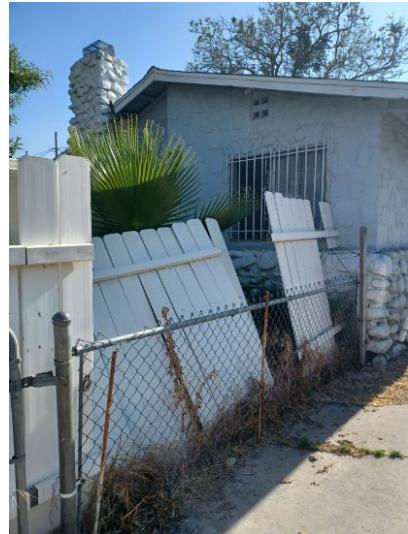
Damaged fencing noted in areas

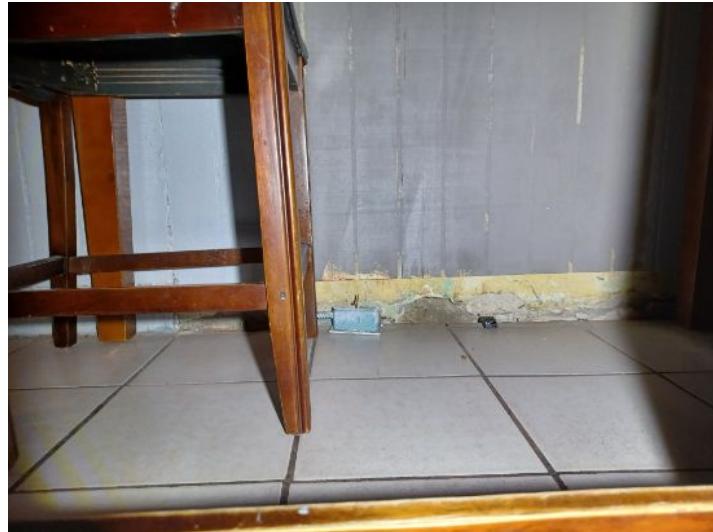
The baseboard is missing. front

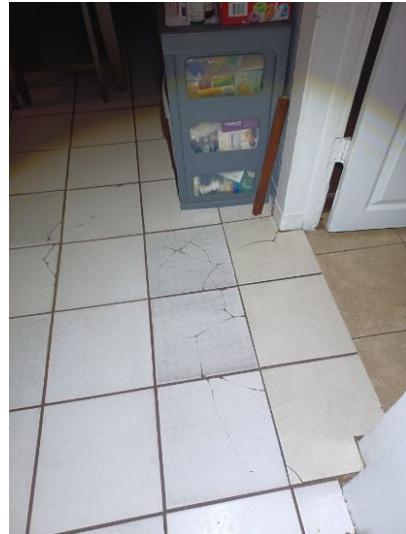
front house

The floor tiles have cracks in areas.

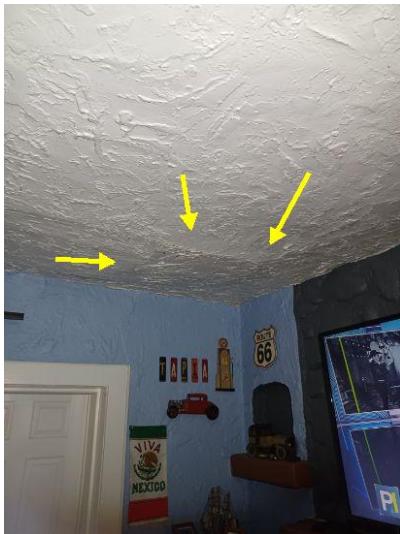
front house

Hay áreas de grietas por tensión en las paredes y los techos debido al movimiento del edificio en el pasado

Hay áreas dañadas en el techo

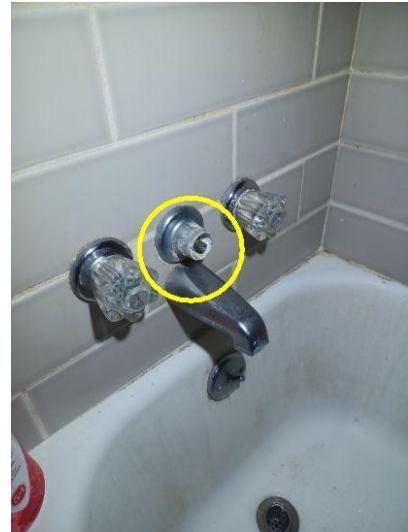
The shower diverter is frozen and would not operate

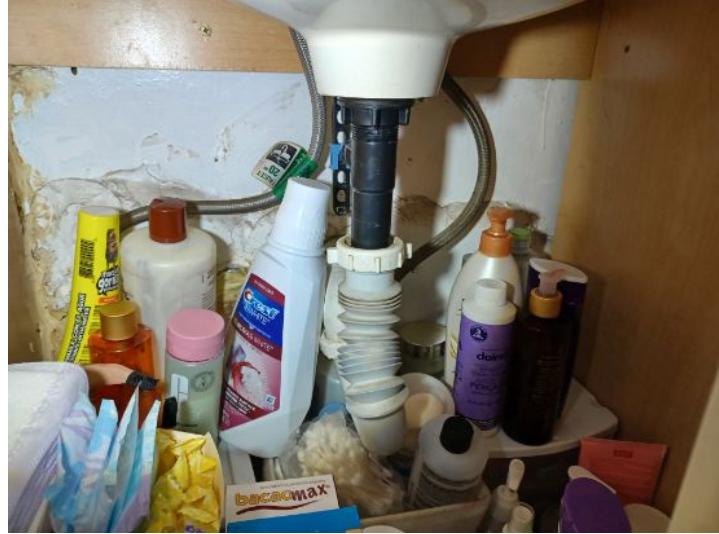
Se están utilizando materiales de tubería flexibles inadecuados como parte de la línea de drenaje debajo del fregadero. Este material corrugado no es estándar y debe ser un tipo de tubería de pared lisa.

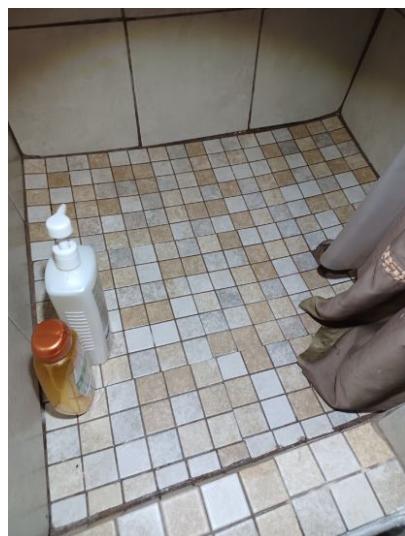
Shower pan installed poorly.
