HOME INSPECTION REPORT

Client: ~~XXXXXXXXXXXX~~
Inspection Address: 4935 Lakeshore Blvd. Lakeport

PREPARED BY: CRAIG NORGARD
Date of Inspection: 4/12/23

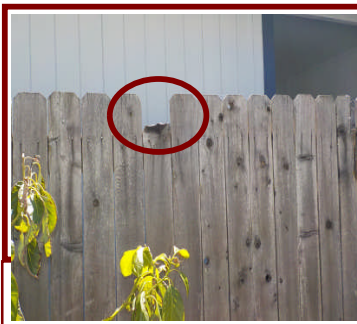
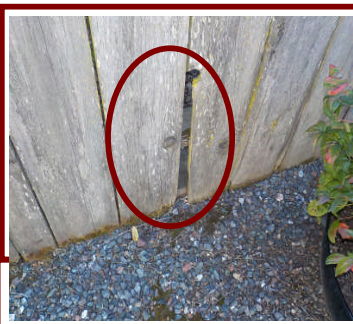
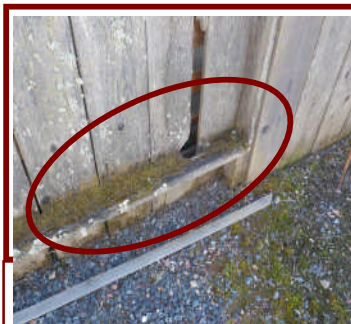
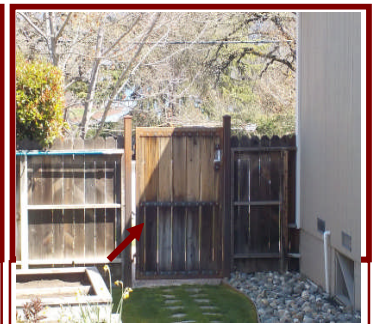
The right gate is locked and unable to test. The fence has some organic growth and deterioration. A few of the boards are cracked / broken.

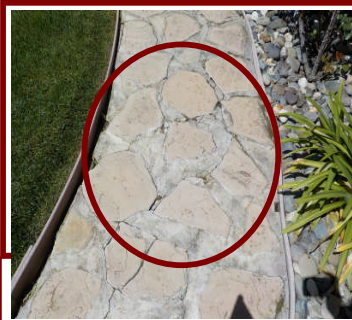
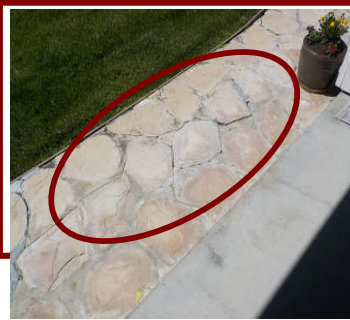
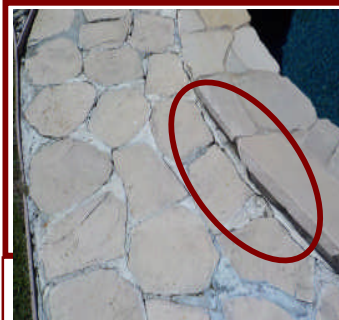
The rear yard stone walkway is loose in places.

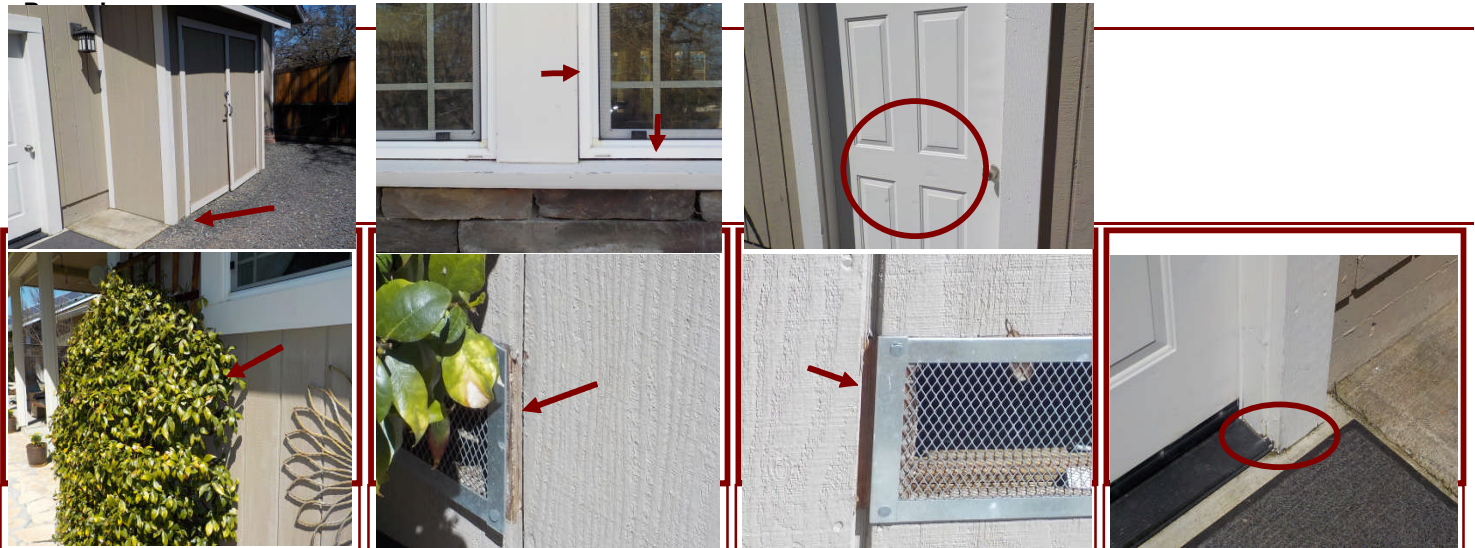
Vegetation is growing against the home which can lead to damage in the siding. Recommend creating proper clearance as preventative maintenance. Some paint is incomplete in the siding grooves at the foundation vents that is recommended to be painted. A storage structure has been added on the left exterior that is creating earth contact with the home, recommend clearing some gravel away from the base creating clearance. The trim at the side garage door shows some minor deterioration at the base. The side garage door is dented. Some voids are present at window frames, recommend caulking to prevent moisture damage.

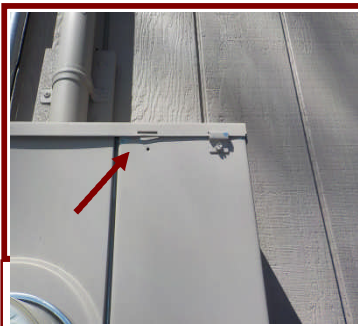
One of the panel cover hinges is missing.

Recommend a Licensed Electrician evaluate further for any needed repairs or replacements.

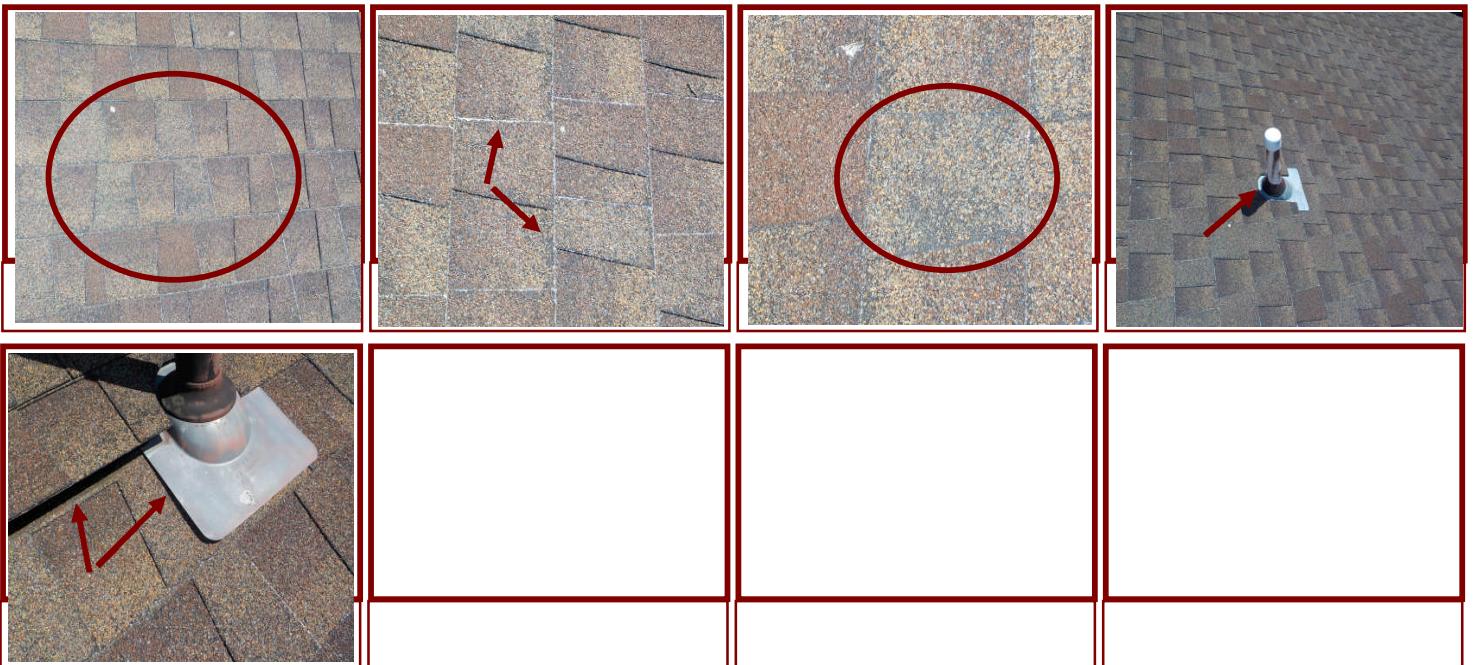
The shingles show beginning stages of granular loss. Some plumbing pipe flashings are not properly sealed to the roofing. A loose vent pipe is present over the furnace area. This pipe is also capped. The flashing gasket at this location is cracked.

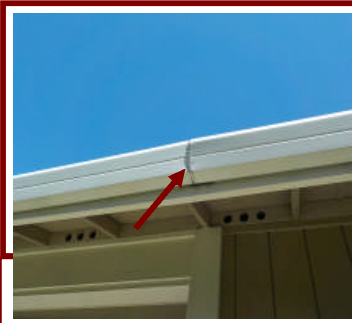
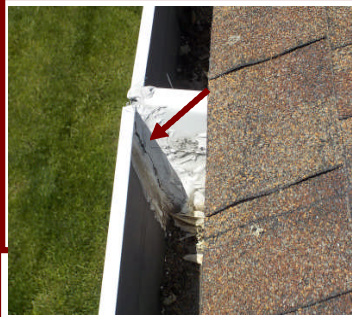
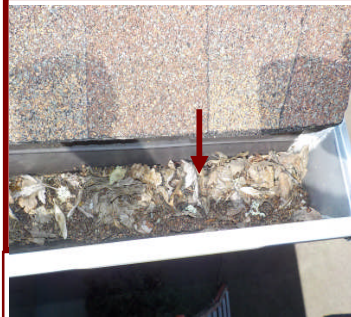
The rear gutter is two sections that are butted together. The sealant at this location has failed allowing water to pass between which can lead to damage at the fascia board.

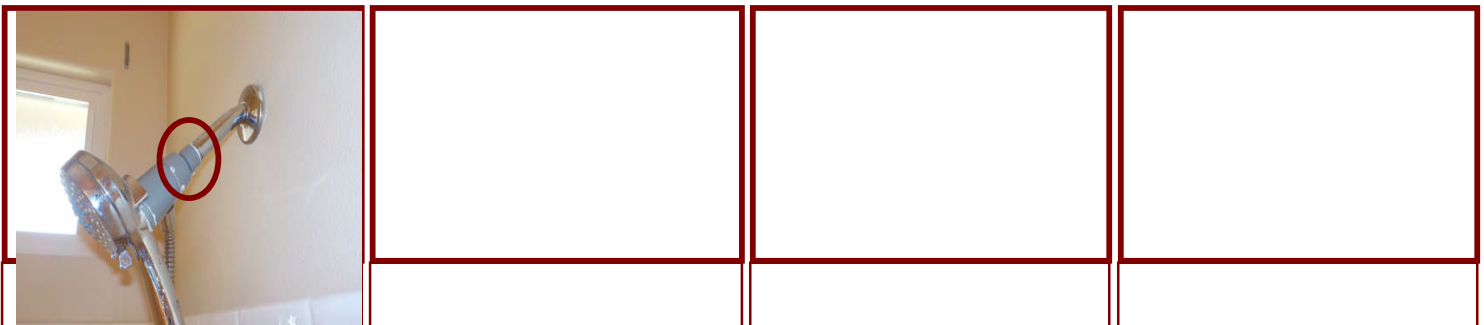
Remarks: The shower head leaks where it attaches to the arm.

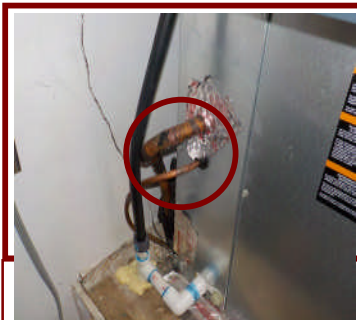
Some insulation is missing on the AC coolant line at the furnace, recommend repair.

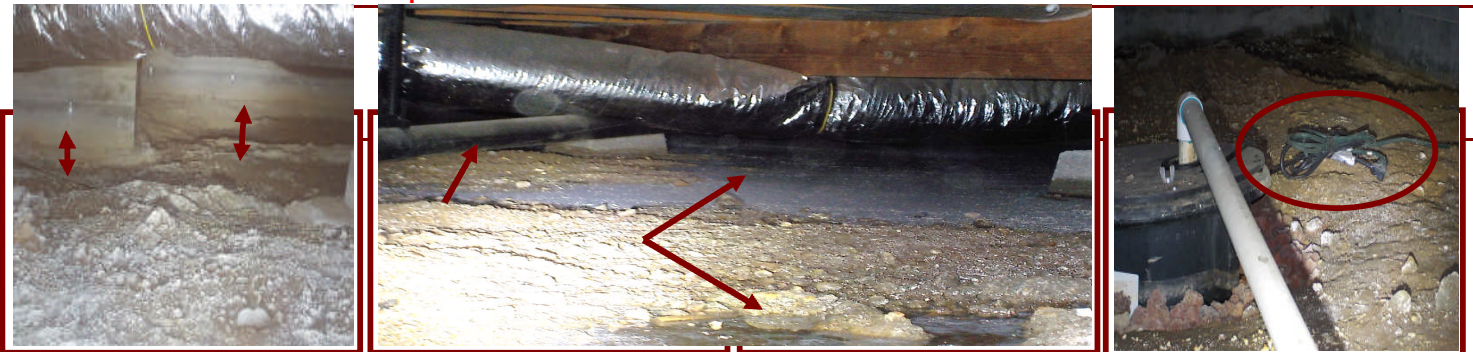
The soil is damp and muddy. Water shows to pond at the front end of the home up to six inches. Water is currently ponding under the master bedroom and bathroom restricting some access for viewing. A moisture barrier is recommended. A sump pump is present that may not be properly located. The power cord should also not be in contact with the ground. Recommend further review for repair.
