# **Cornerstone Inspection**

## **Property Inspection Report**

**2400 El Camino Real, Atascadero, CA 93422**

**Date of Inspection: 8/26/2025 Time: 9:00 AM**

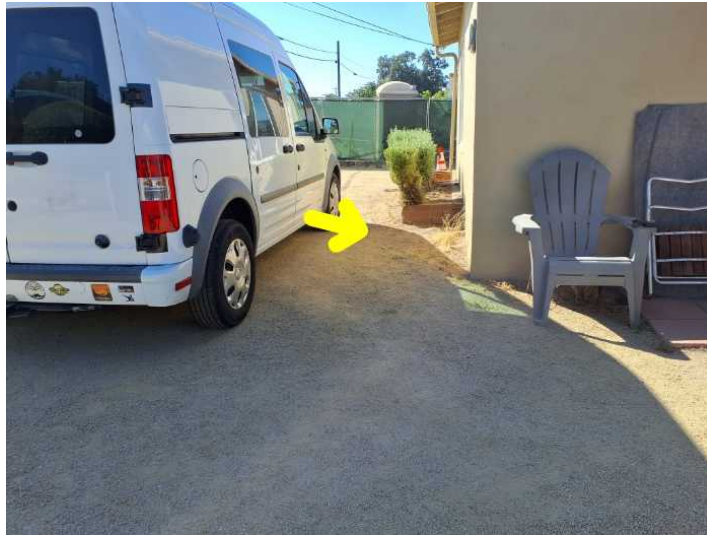
2.4. The residence is surcharged by a slope at the front that will direct water toward the residence. Subsurface drainage may have been installed when the site was graded, but we have no knowledge of this. Therefore, it will be important to maintain the slope, and any area drainage system. Soil erosion can result in slippage, which can impede drainage and result in moisture intrusion.

The residence is surcharged by a slope at the front that will direct water toward the residence. Subsurface drainage may have been installed when the site was graded, but we have no knowledge of this. Therefore, it will be important to maintain the slope, and any area drainage system. Soil erosion can result in slippage, which can impede drainage and result in moisture intrusion.

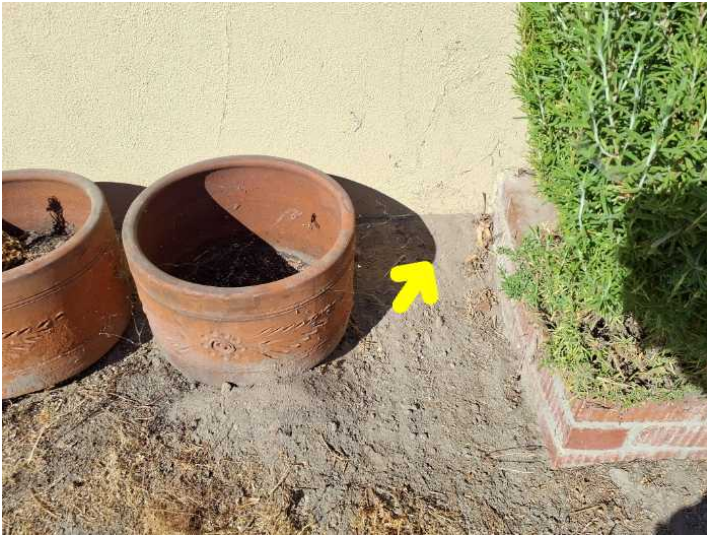
The soil is too high against the home at various areas around the residence, which should be serviced.

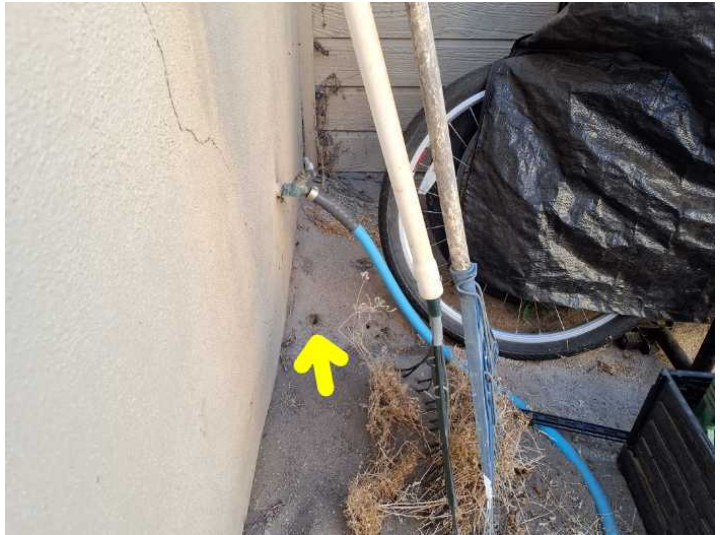
The soil is too high against the home at various areas around the residence, which should be serviced.

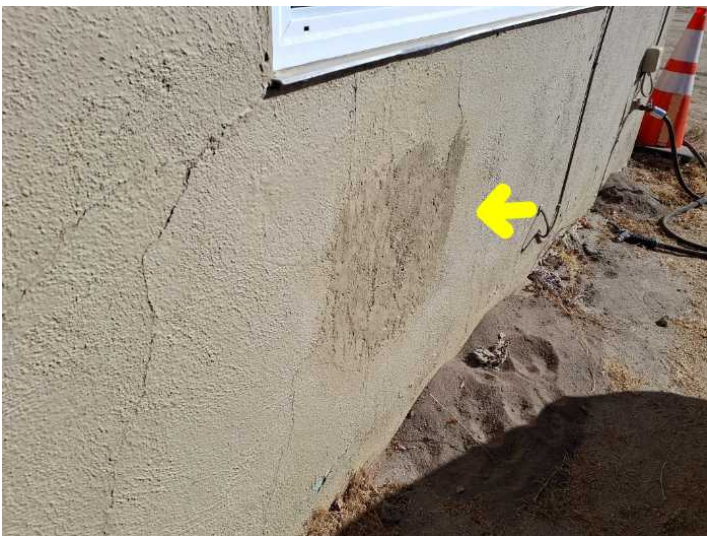
3.5. There are stucco patches or repairs that should be explained by the sellers.

There are stucco patches or repairs that should be explained by the sellers.

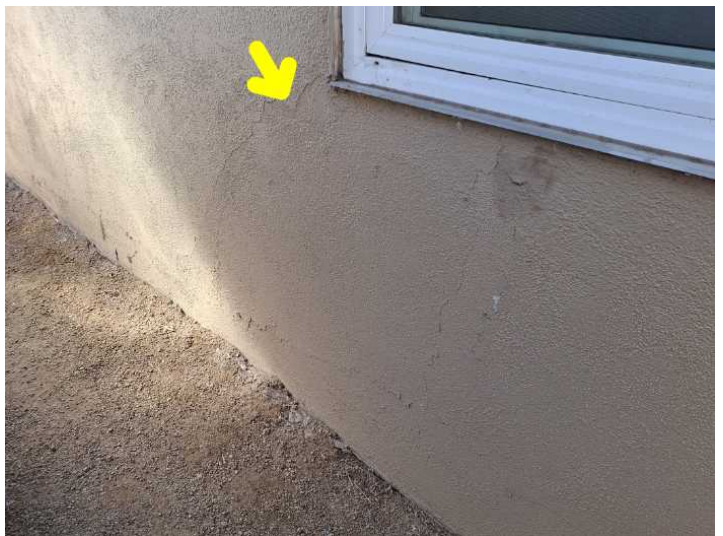
There are stucco patches or repairs that should be explained by the sellers.

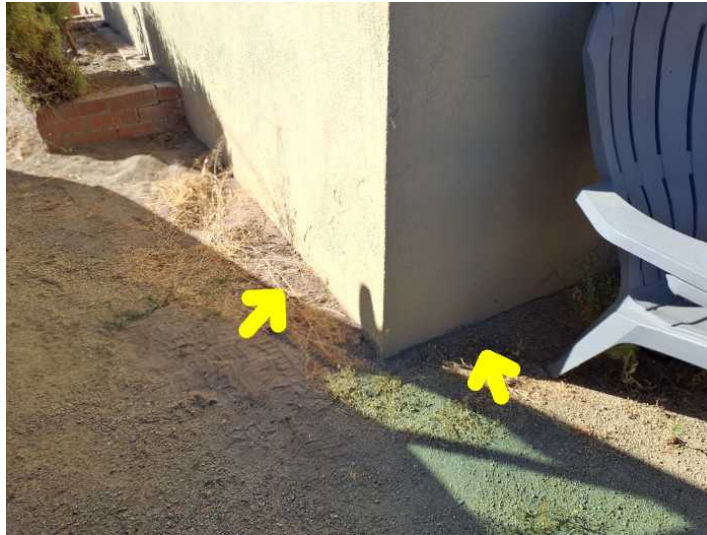
3.6. The stucco extends down to the soil without the benefit of a weep screed. A weep screed is a horizontal strip of metal that isolates the stuccoed house walls from the foundation and allows them to move independently of the foundation. This not only prevents horizontal cosmetic cracks that are commonly seen at the base of many stuccoed walls, but also isolates the stucco from the soil and inhibits the wicking effect of moisture being drawn up into the stucco, which in turn creates the flaking and peeling that is common on such surfaces.

The stucco extends down to the soil without the benefit of a weep screed. A weep screed is a horizontal strip of metal that isolates the stuccoed house walls from the foundation and allows them to move independently of the foundation. This not only prevents horizontal cosmetic cracks that are commonly seen at the base of many stuccoed walls, but also isolates the stucco from the soil and inhibits the wicking effect of moisture being drawn up into the stucco, which in turn creates the flaking and peeling that is common on such surfaces.

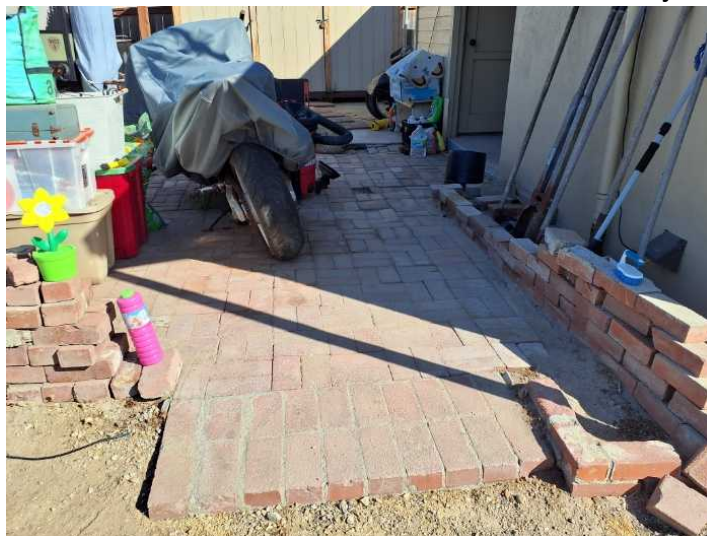
4.2. The brick/masonry patio or walkway has one or more offsets that may prove to be trip-hazards. This may be by design or due to unsuitable soil below the brick/masonry.

The brick/masonry patio or walkway has one or more offsets that may prove to be trip-hazards. This may be by design or due to unsuitable soil below the brick/masonry.

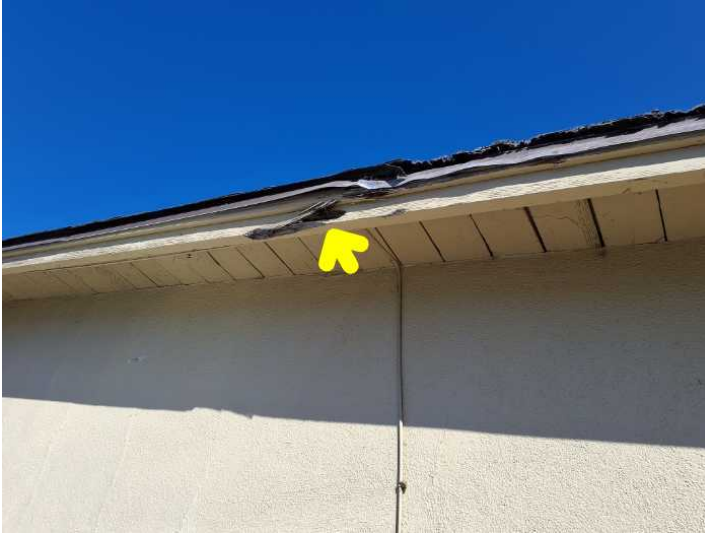
5.1. Sections of the fascia, trim and/or eaves need maintenance type service, such as sealing and painting.

Sections of the fascia, trim and/or eaves need maintenance type service, such as sealing and painting.

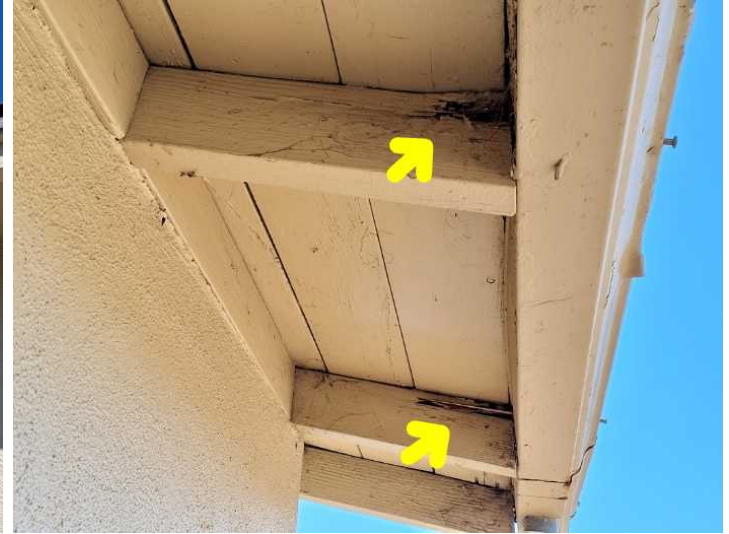
The pest inspector report should confirm moisture, dry rot, or insect damage to the wood trim, fascia boards, and/or eaves.

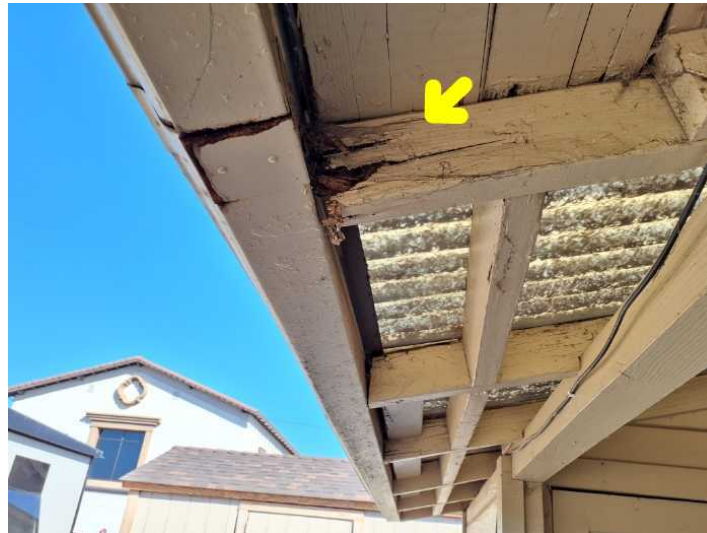
The pest inspector report should confirm moisture, dry rot, or insect damage to the wood trim, fascia boards, and/or eaves.

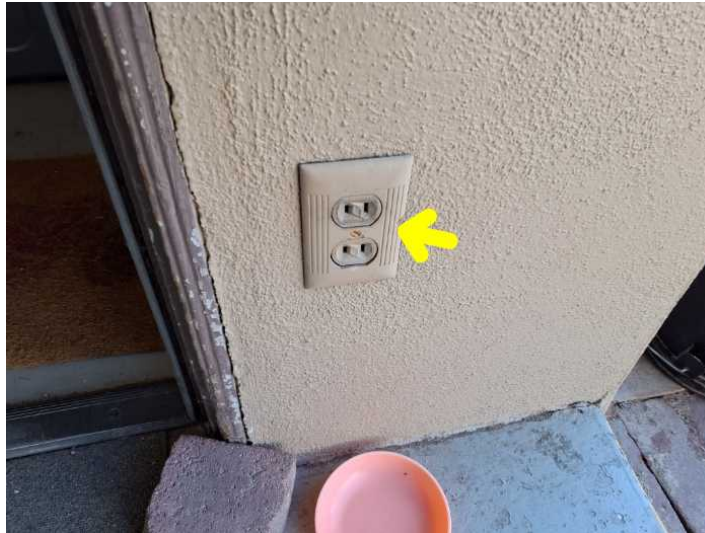
6.2. One or more outlets are an obsolete, two-prong, ungrounded type that should be upgraded by a qualified tradesperson to have ground-fault protection.

One or more outlets are an obsolete, two-prong, ungrounded type that should be upgraded by a qualified tradesperson to have ground-fault protection.

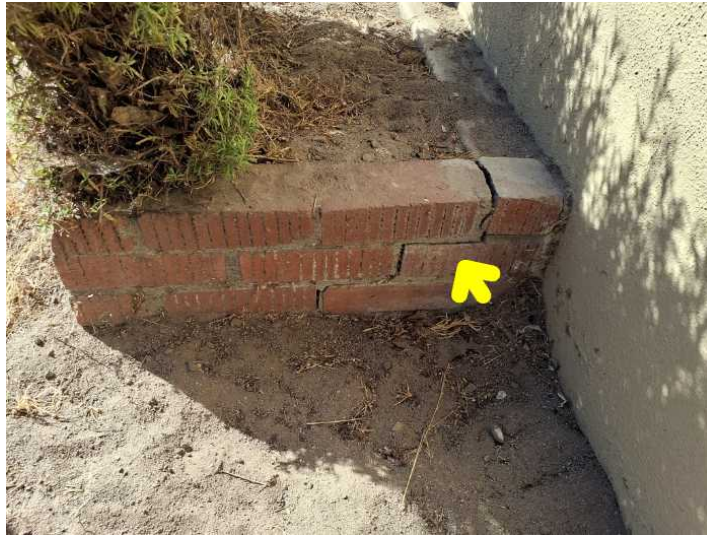
9.1. There are typical stress fractures or grout joint separations in the brick yard walls, but they are reasonably firm and do not appear to be in danger of falling at this time.

There are typical stress fractures or grout joint separations in the brick yard walls, but they are reasonably firm and do not appear to be in danger of falling at this time.

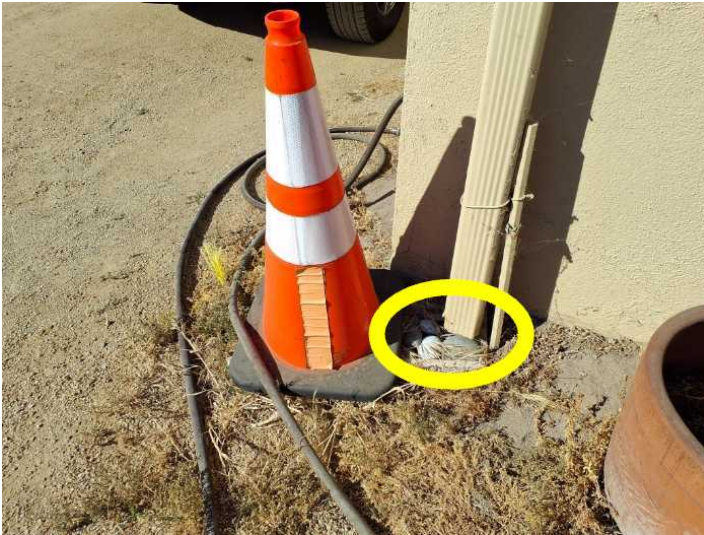
1.4. Some downspouts are missing or need to be reconnected, and should be serviced.

Some downspouts are missing or need to be reconnected, and should be serviced.

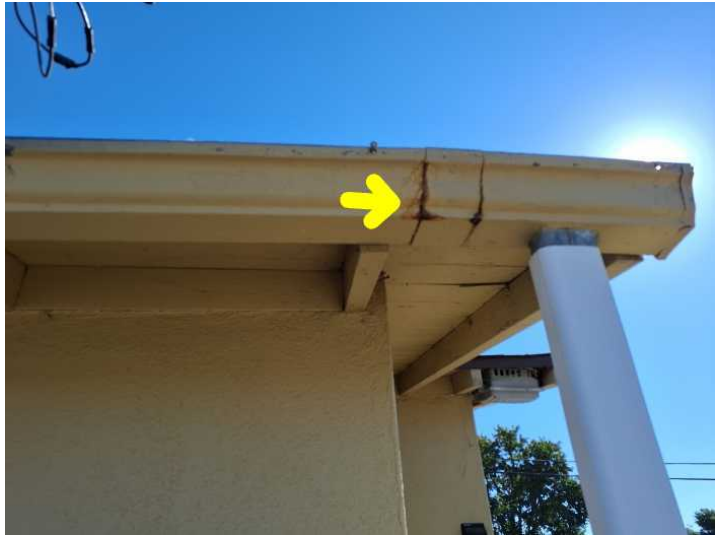
The gutters need to be serviced, such as reconnecting, sealing separated seams, cleaning, or making sure they are secure.

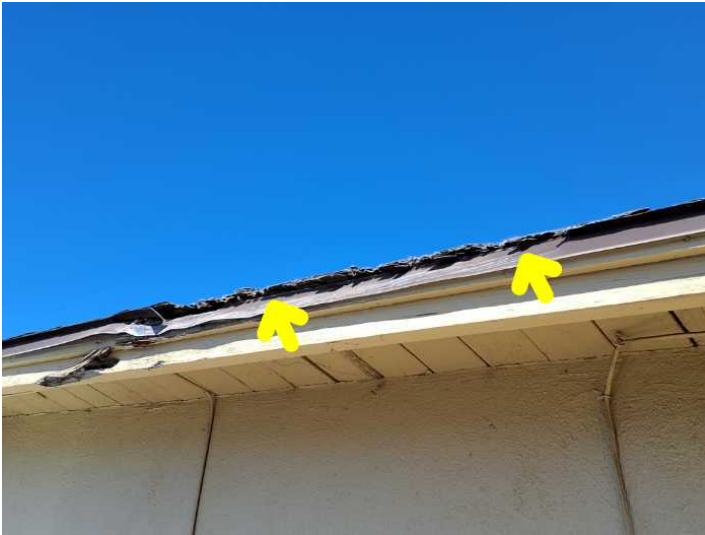
| Page 15 Item: 2 | Composition Shingle Observations | 2.5. The roof has one or more damaged or missing shingles that should be repaired or replaced by a licensed roofing contractor. |

2.5. The roof has one or more damaged or missing shingles that should be repaired or replaced by a licensed roofing contractor.

The roof has one or more damaged or missing shingles that should be repaired or replaced by a licensed roofing contractor.

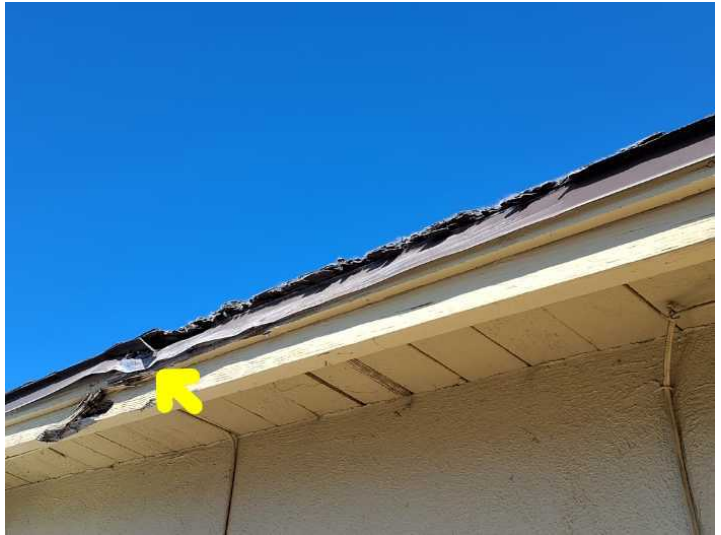
2.4. One or more of the roof flashings need to be sealed or serviced. They are comprised of metal that seals valleys, vents, and other roof penetrations, and are the most common point of leaks. This is particularly true of the flashings on a layered roof, which are covered by the roofing material and are even more susceptible to leaks.

One or more of the roof flashings need to be sealed or serviced. They are comprised of metal that seals valleys, vents, and other roof penetrations, and are the most common point of leaks. This is particularly true of the flashings on a layered roof, which are covered by the roofing material and are even more susceptible to leaks.

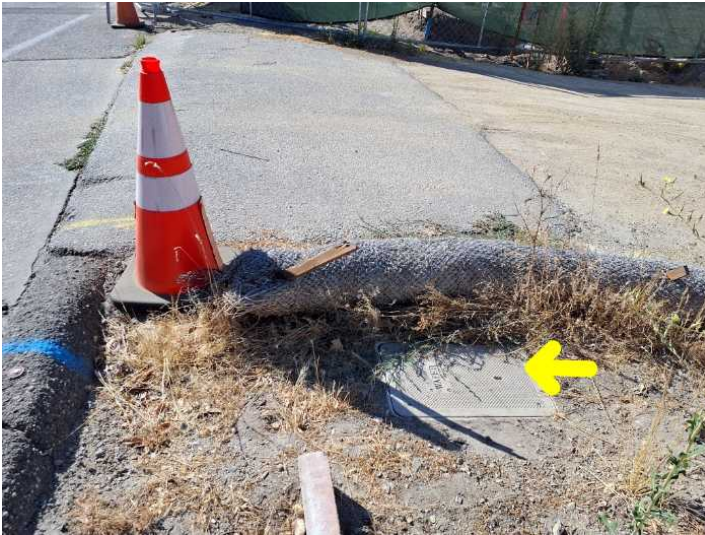
There is no apparent shut-off valve at the residence to facilitate an emergency shut-off of the water. This means that the water would have to be turned off at the street with a large specialized tool called a plumbers key.

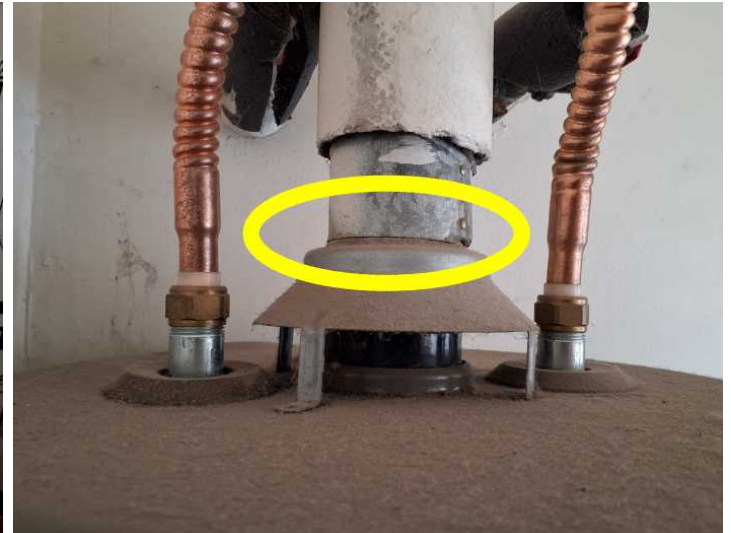
The vent pipe is not properly connected. It is required to have a minimum of 3 fasteners where the pipe connects to the draft hood or other single wall vent pipes.

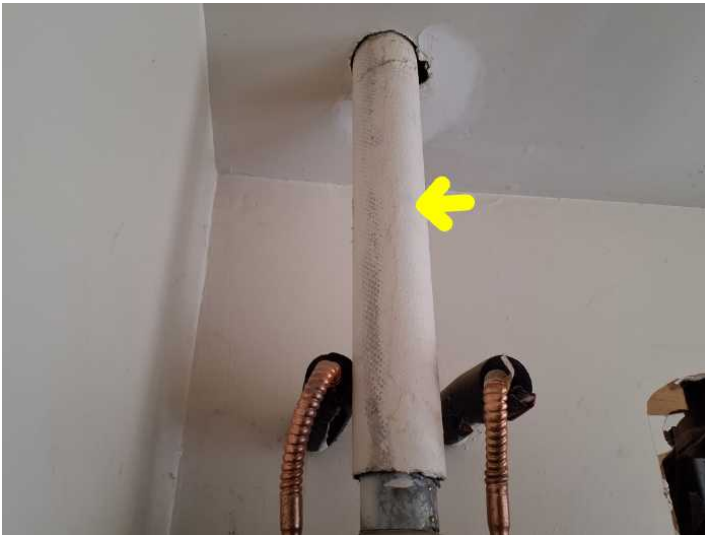
The heat vents include a clay-based type, known as a transite pipe, that contains asbestos fibers, but which are encapsulated and thereby do not pose any viable health threat.

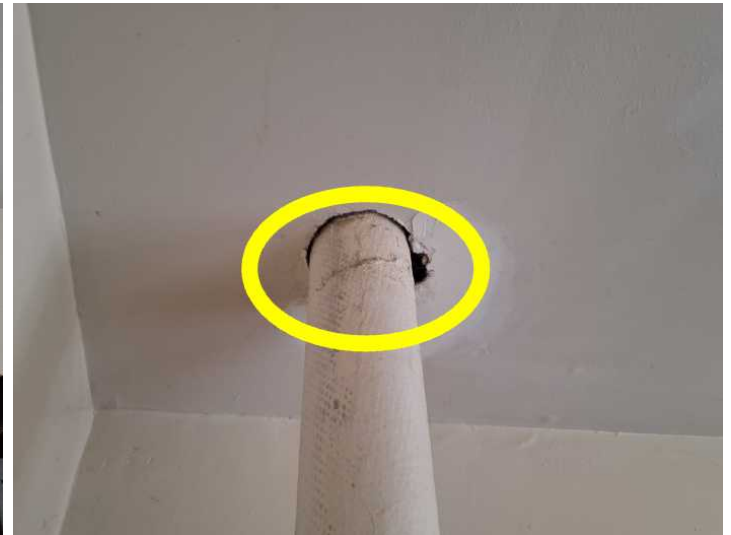
The vent pipe is too close to combustible material, and should be serviced before the close of escrow. A single-walled vent pipe should be six inches away from any combustible material, and a double-walled vent pipe should be one inch away.

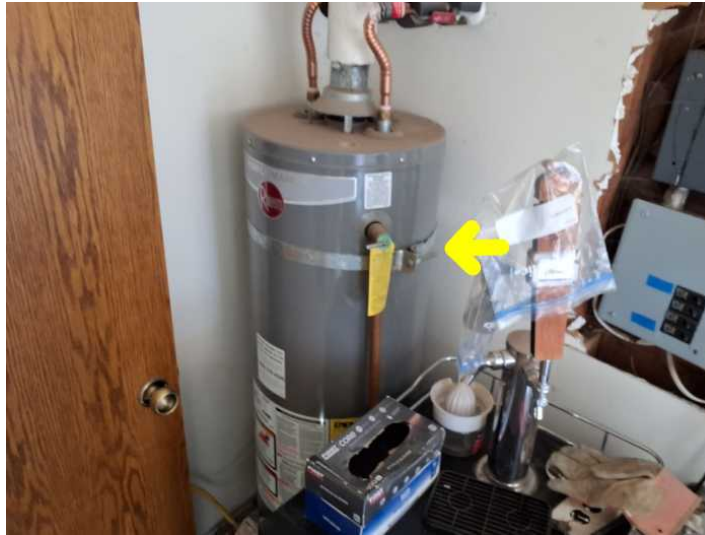
- 4.16. The hot water heater is strapped but not braced properly and should be serviced. Current standards require that the water heater must be strapped AND braced to resist seismic motion.

The hot water heater is strapped but not braced properly and should be serviced. Current standards require that the water heater must be strapped AND braced to resist seismic motion.

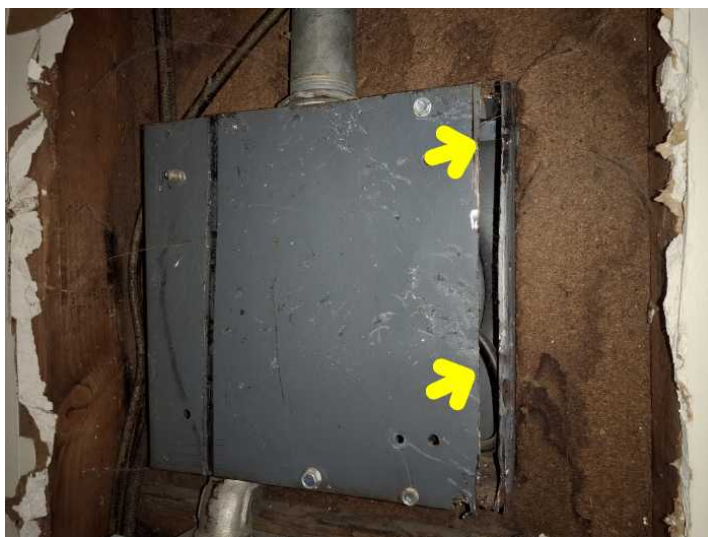
The exterior cover for the main electrical panel is damaged, and should be replaced by a qualified tradesperson.

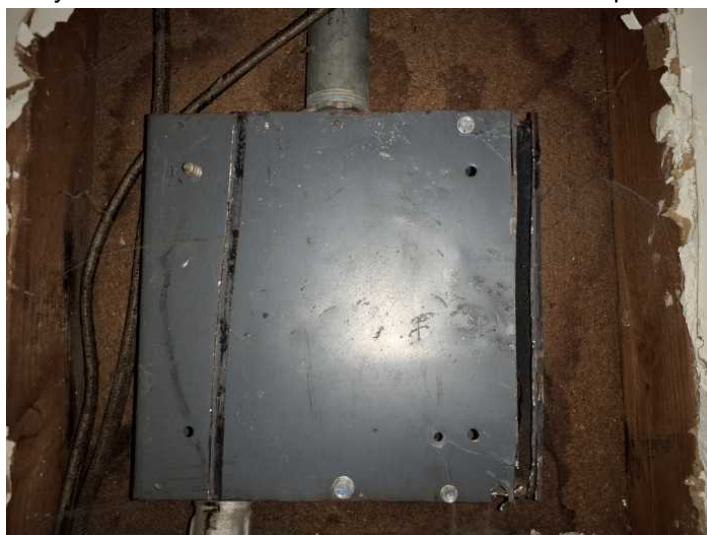
1.12. The panel does not have a main disconnect, which is required by current standards. We recommend an evaluation by a qualified electrical contractor and service as necessary,

The panel does not have a main disconnect, which is required by current standards. We recommend an evaluation by a qualified electrical contractor and service as necessary,

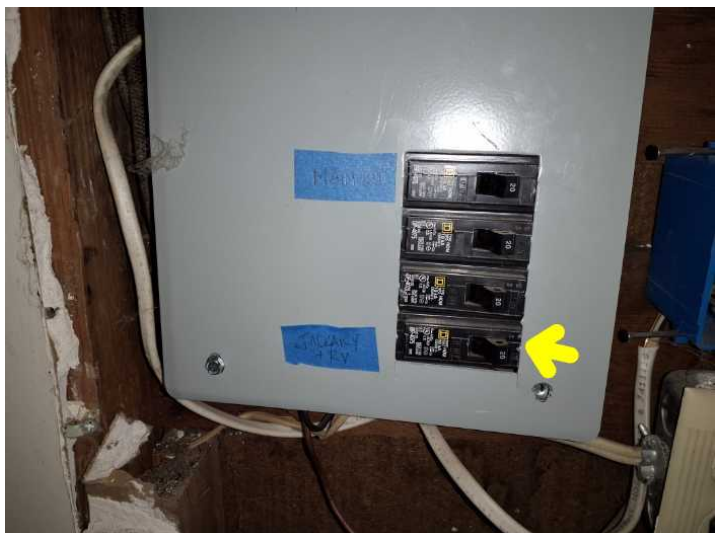
| Page 24 Item: 2 | Sub Panel Observations | <p>2.7. One or more of the breakers do not properly fit within the buss bar. Because of this the breaker is loose, which can cause arcing and should be evaluated and serviced by a qualified electrical contractor.</p> <p>2.8. The neutral and ground wires are together on the same buss bar and should be separate. The ground wires should be bonded to the panel and the neutral wires should be separate and "floating" from the panel. We recommend that a licensed electrician evaluate and service the sub panel.</p> |

2.7. One or more of the breakers do not properly fit within the buss bar. Because of this the breaker is loose, which can cause arcing and should be evaluated and serviced by a qualified electrical contractor.

One or more of the breakers do not properly fit within the buss bar. Because of this the breaker is loose, which can cause arcing and should be evaluated and serviced by a qualified electrical contractor.

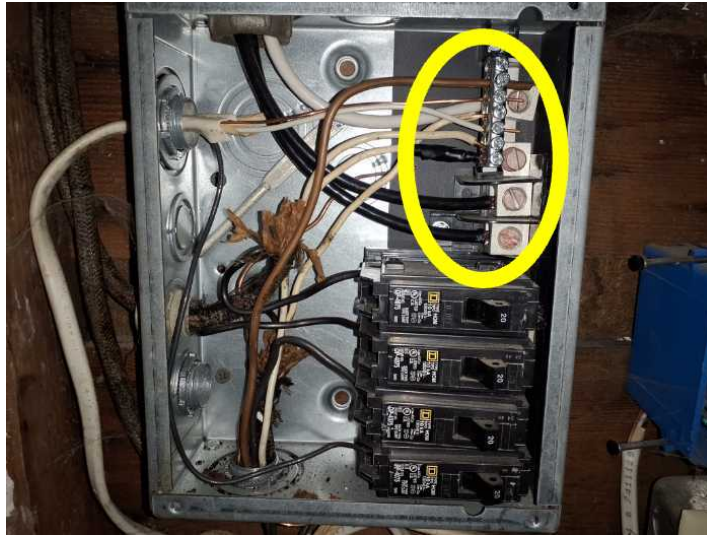
2.8. The neutral and ground wires are together on the same buss bar and should be separate. The ground wires should be bonded to the panel and the neutral wires should be separate and "floating" from the panel. We recommend that a licensed electrician evaluate and service the sub panel.

The neutral and ground wires are together on the same buss bar and should be separate. The ground wires should be bonded to the panel and the neutral wires should be separate and "floating" from the panel. We recommend that a licensed electrician evaluate and service the sub panel.

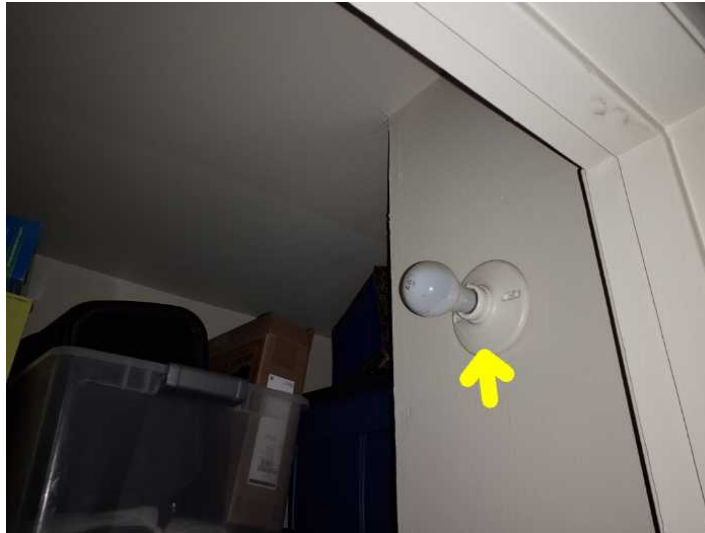
3.4. A closet light is missing its globe or cover and should be serviced.

A closet light is missing its globe or cover and should be serviced.

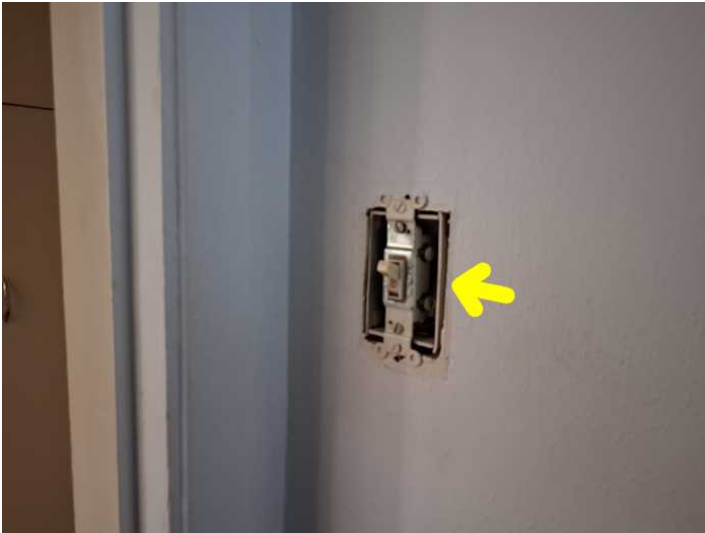
One or more light switch covers are missing and should be installed.

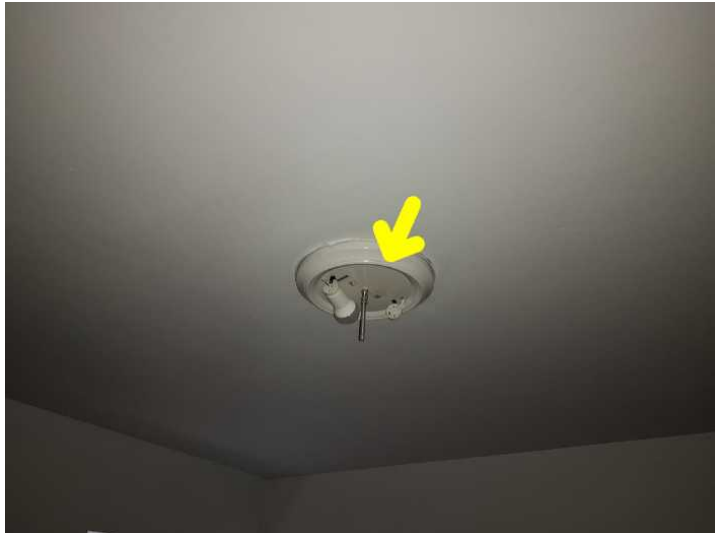
A light cover or globe is missing and should be installed.

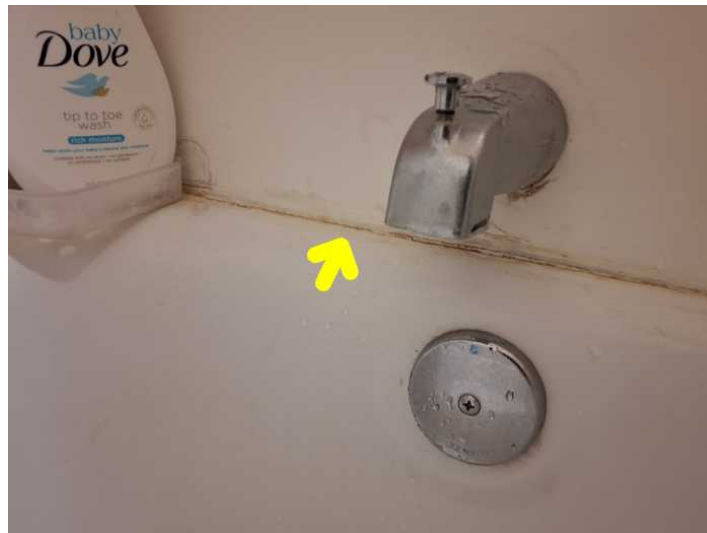
One or more open seams in the tub/shower area need to be caulked or re-grouted to forestall moisture intrusion.

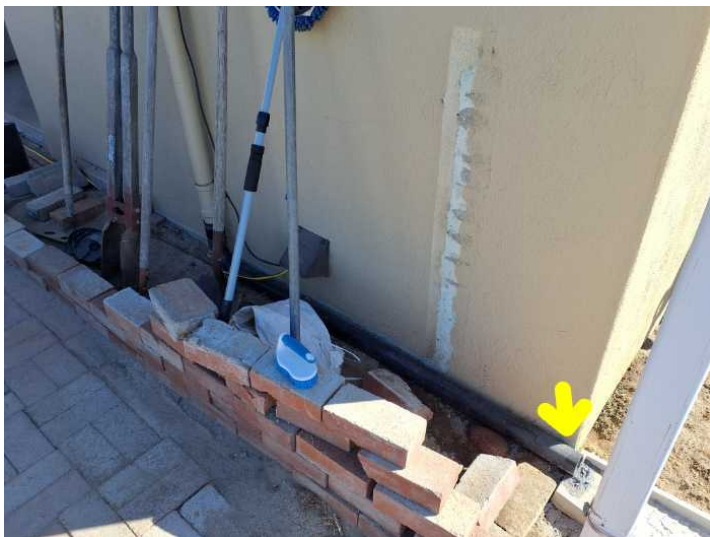
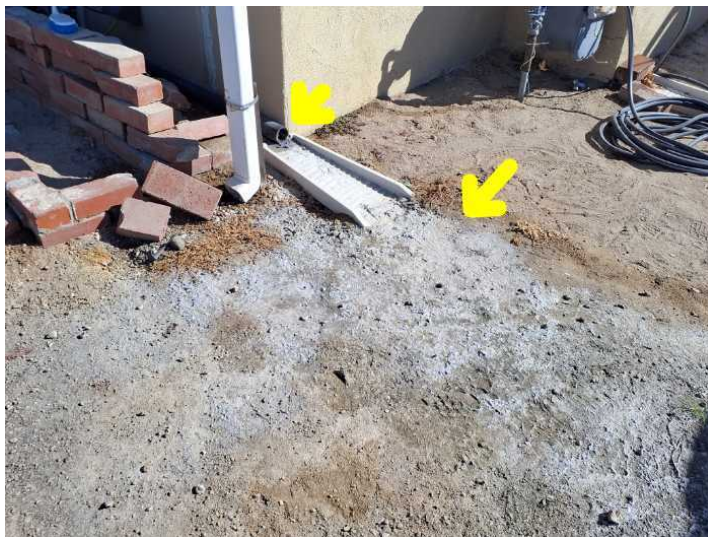
The laundry drains to the exterior, which is not allowed by current standards, and should be evaluated by a qualified tradesperson and serviced as necessary.

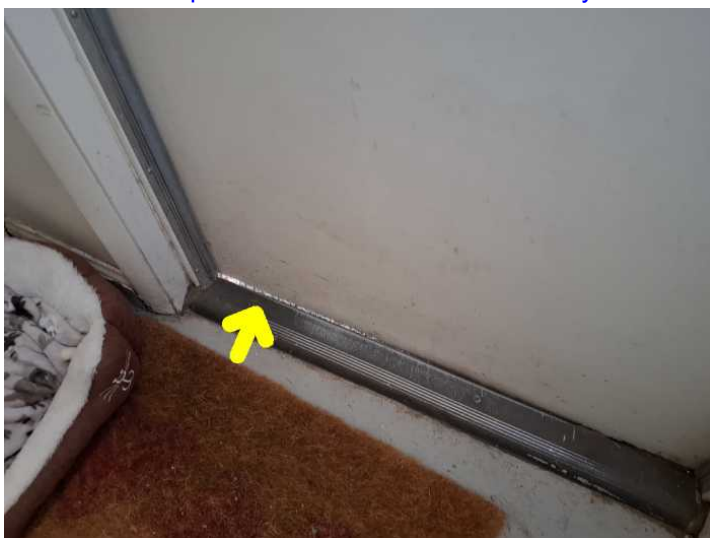
The exterior door is functional but it is not fully weather sealed.

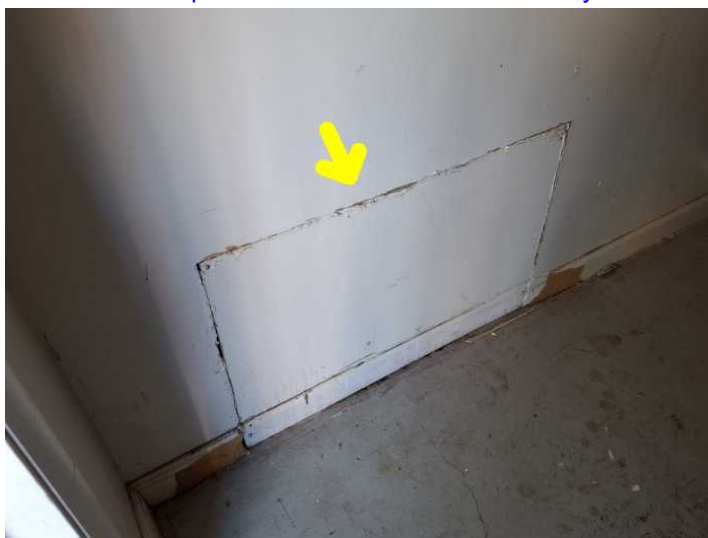
- 1.13. The walls or ceiling have cosmetic damage, which you may wish to view for yourself.
- 1.14. There has been a drywall/plaster repair that should be explained by the seller.

There has been a drywall/plaster repair that should be explained by the seller.

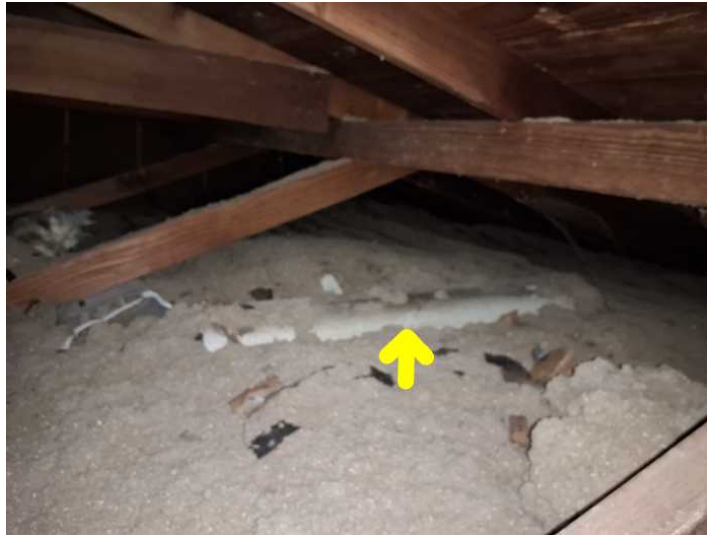
There are abandoned heat vents in the attic which include a clay-based type, known as a transite pipe, that contain asbestos fibers, but which are encapsulated and thereby do not pose any viable health threat.
