Inspection Report

Phil & Linda Bertenthal
3921 Carissa Court
San Luis Obispo, CA 93401

Report Date: 4/5/2024

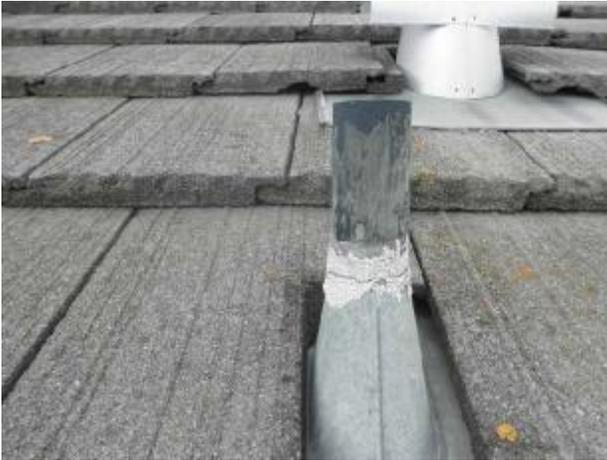
Roof # R

Maintenance Note: The sealant at the flashings has become cracked and deteriorated from exposure to the sun. Recommend resealing the flashings to prevent water intrusion.

The roof vent flashings need to be resealed.

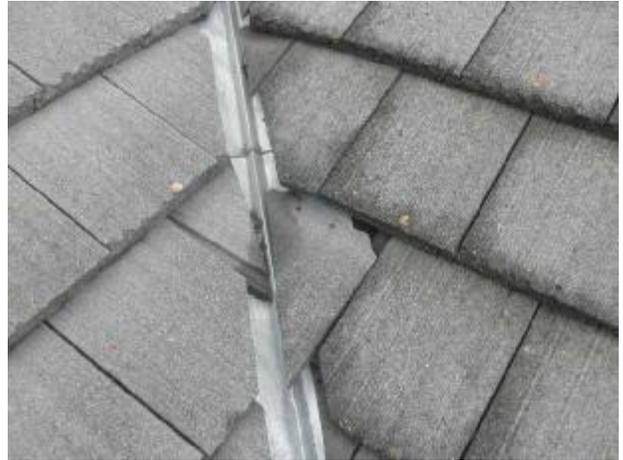
Roof # R

1.) There are two cracked and displaced roof tiles on the second story west facing slope.

Cracked and displaced roof tile.

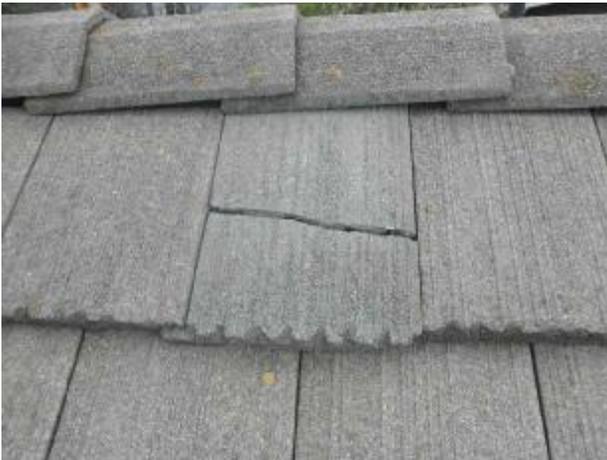
Roof # R

Cracked and displaced roof tile.

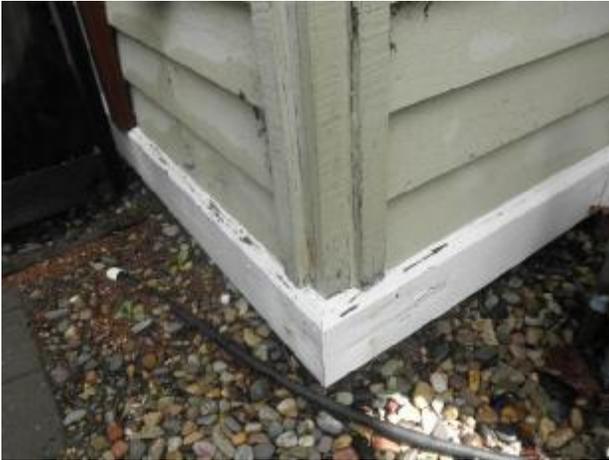
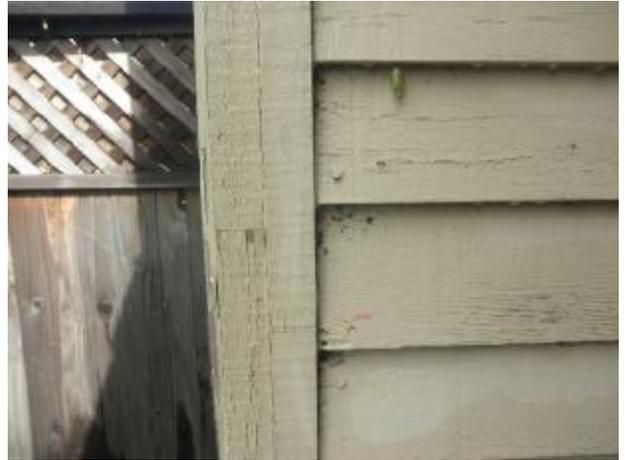
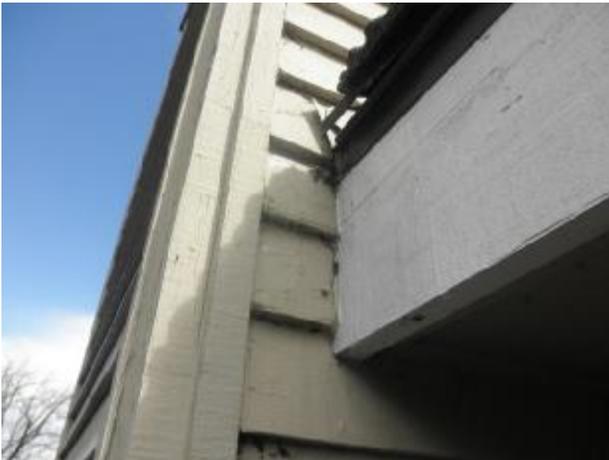
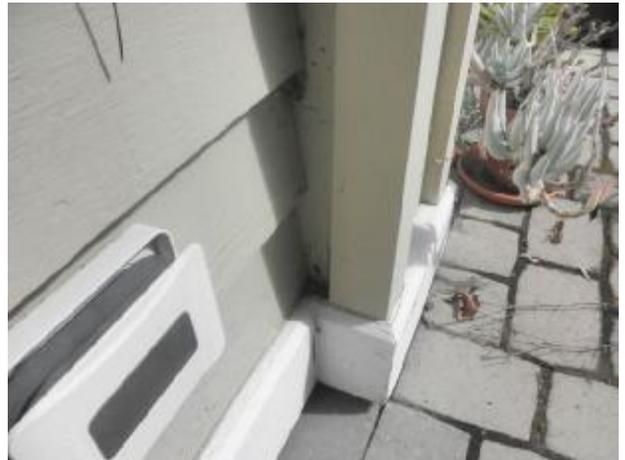
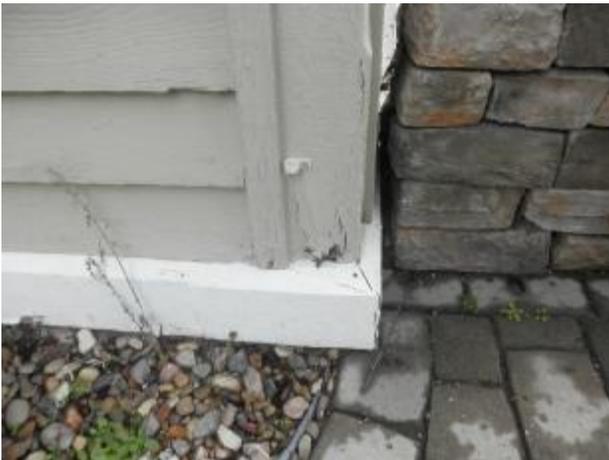
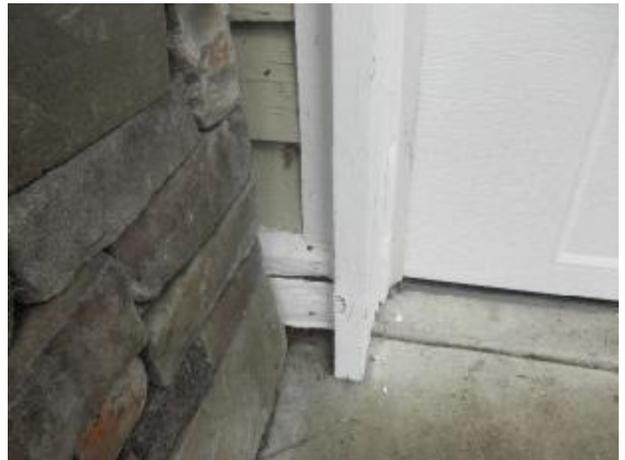
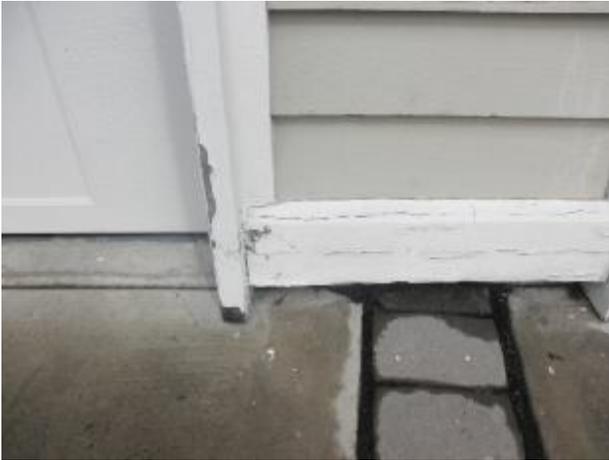
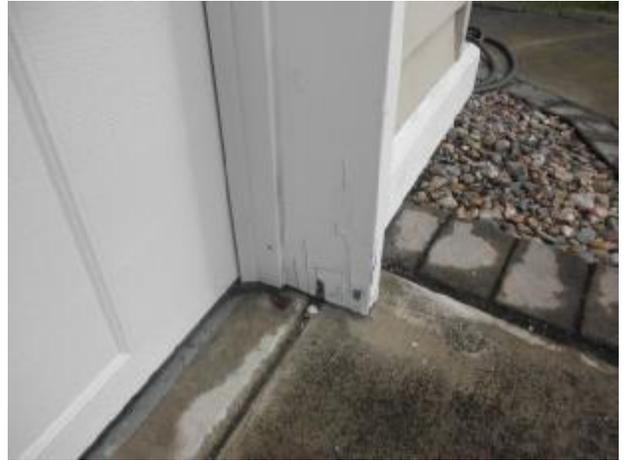
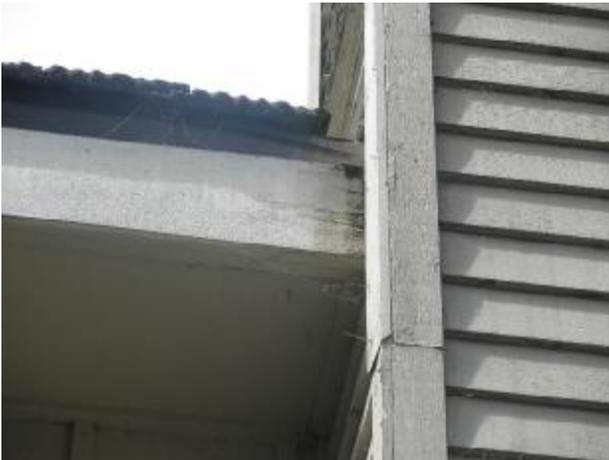
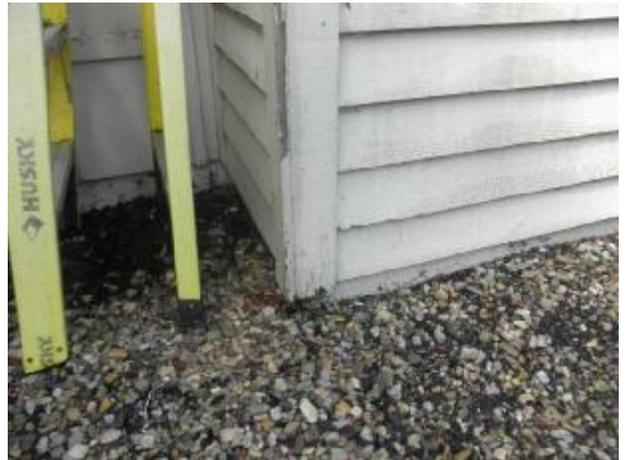
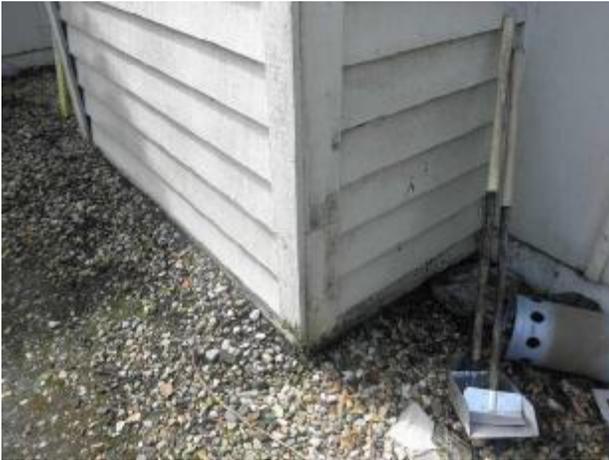
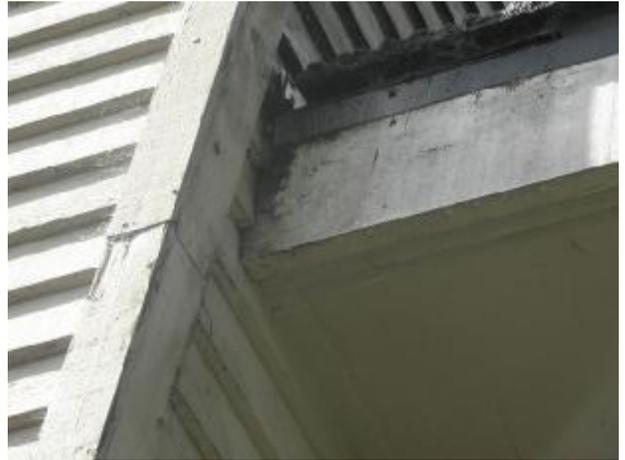
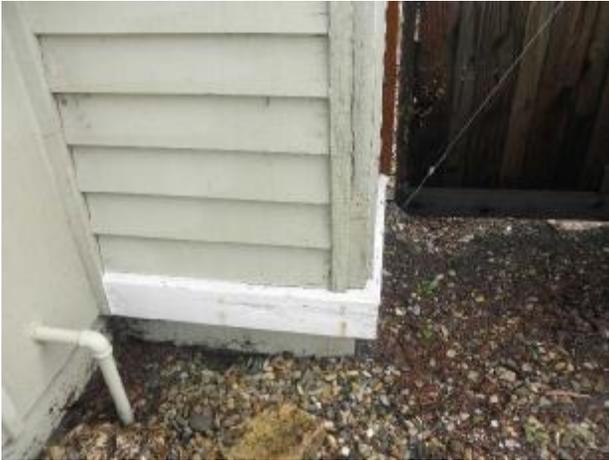
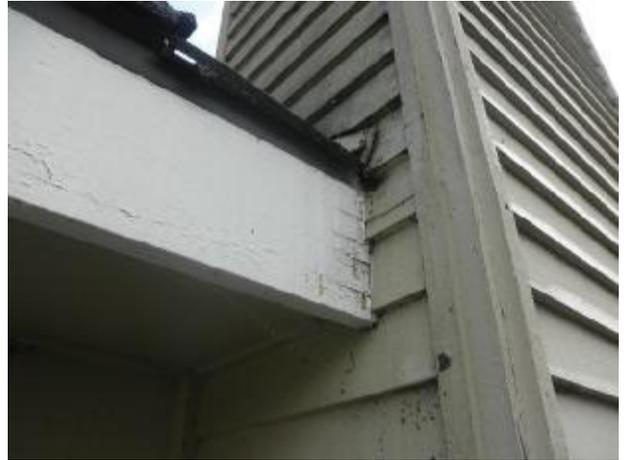
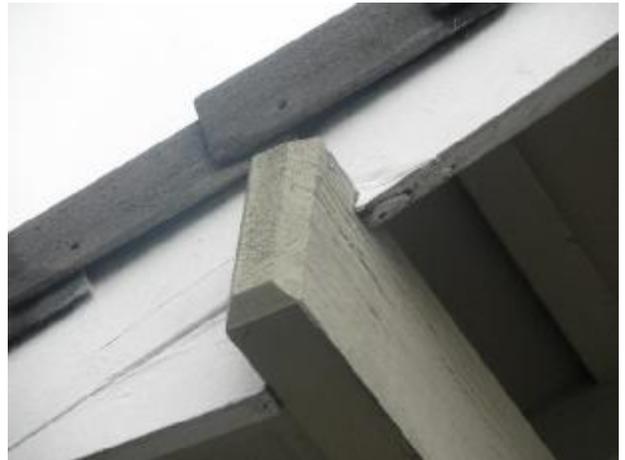
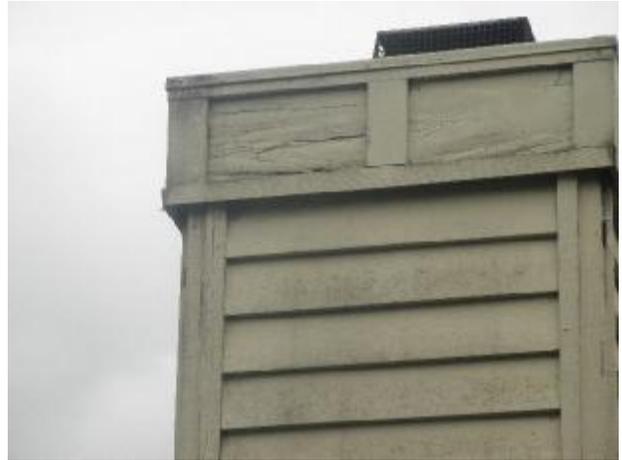
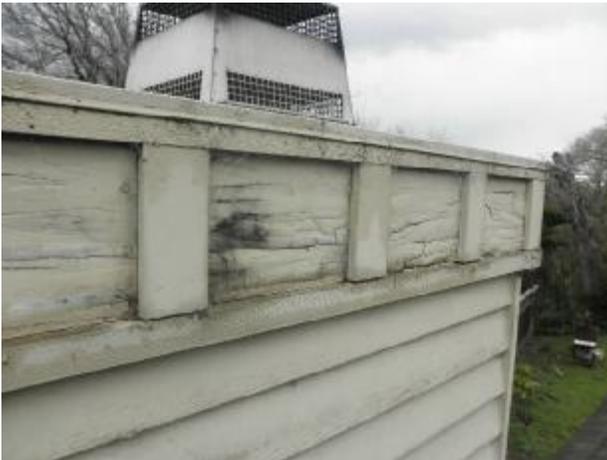
16 6.) There is moisture damage in numerous locations at the exterior wood siding, trim and fascia boards. Refer to the Pest Control Report for a full accounting of this damage and the costs associated with repairing this damage. (See photos)

Example of the moisture damage at the exterior wood siding, fascia boards and trim.

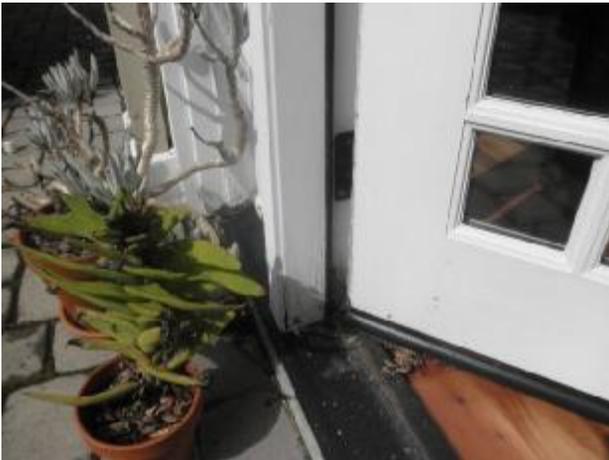
Exterior # EX

- 5.) The double exterior doors in the living room are swollen so they rub/stick and are somewhat difficult to fully close and latch. There is moisture damage to the base of the jamb and the dead bolt needs adjustment. Several of the built in panes are fogged at the door and the adjacent side lite.

Moisture damage to the base of the jamb at the exterior doors in the living room.

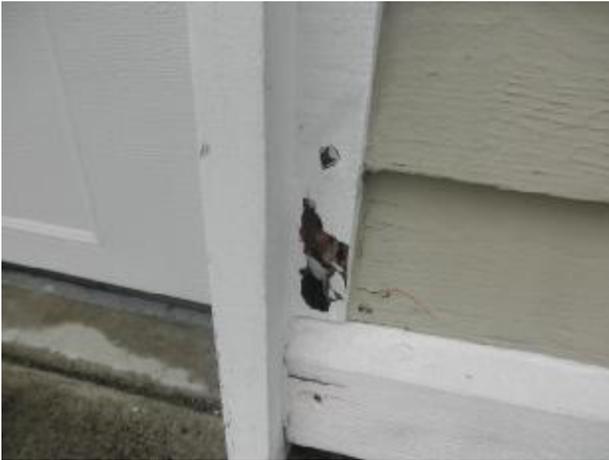
Exterior # EX

7.) There is evidence of possible subterranean termite infestation/damage at the base of the wood trim adjacent to the garage vehicle door opening. This condition is recommended to be evaluated by a qualified and licensed Pest Control inspector prior to close of escrow.

Evidence of possible subterranean termite damage/infestation at the wood trim.

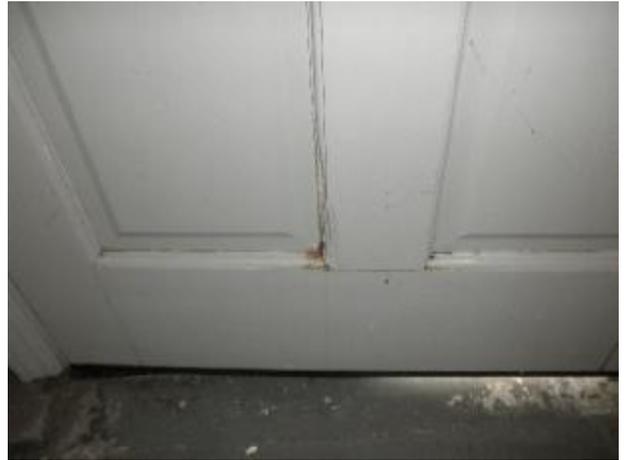
Exterior # EX

- 2.) There are two damaged window screens.
- 3.) The front entry door bell is inoperable.
- 4.) The garage side door has moisture damage to the base of the door and jamb. The door rubs/sticks on the threshold so it is difficult to fully close and latch.

Moisture damage to the garage side door.

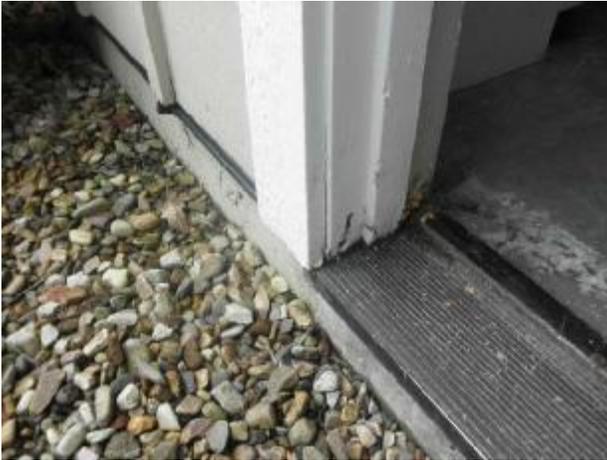
EX

Moisture damage to the base of the jamb at the garage side door.

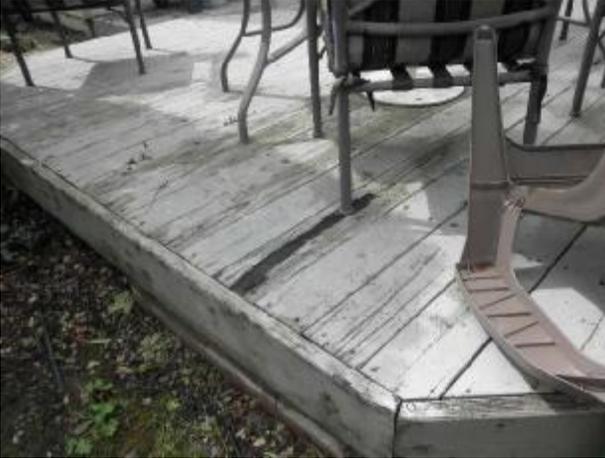
GD

- 1.) There is some moisture damage at the perimeter fascia board and parts of the planks at the wood deck in the backyard. Due to the low clearances the deck framing could not be evaluated.

Moisture damage to parts of the fascia boards and planks at the wood deck.

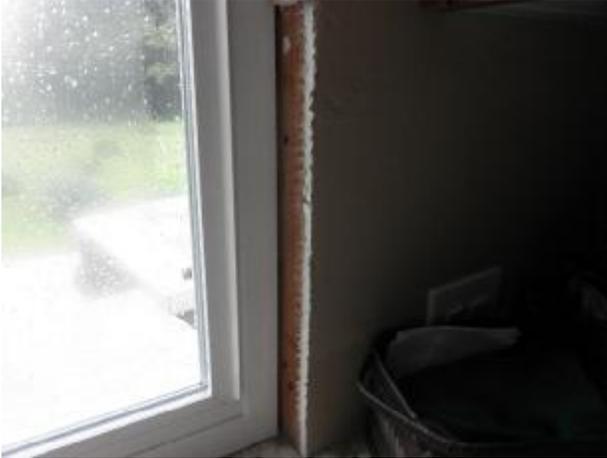
K

- 26
- 1.) There is unfinished drywall at the window frame in the kitchen.
 - 2.) The igniters are faulty/work sporadically at the burners for the kitchen range.
 - 3.) There are two missing rollers at the bottom rack in the dishwasher.

Unfinished drywall at the kitchen sink.

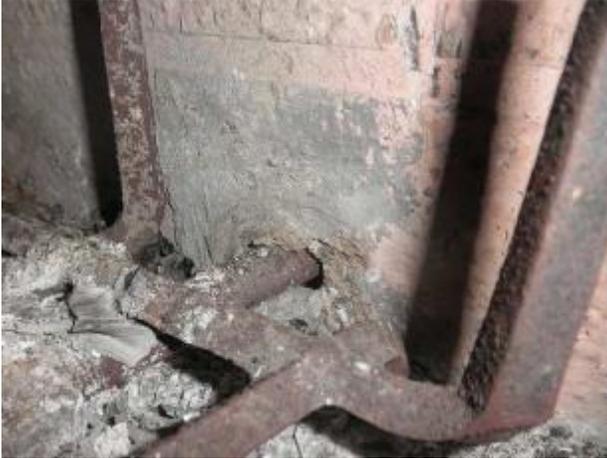
IR

- 17 **Fire Safety Hazard Note:** Noncombustible caulking is needed in the gaps where the gas lighter log for the living room fireplace penetrates the side wall refractory plate.

Seal the gaps at the gas starter pipe inside the firebox.

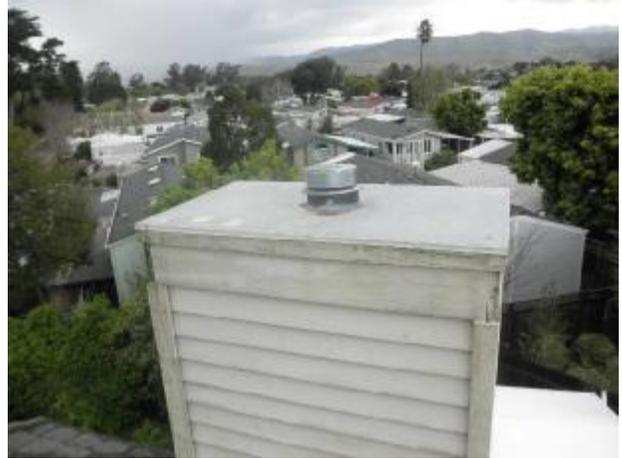
IR

Safety Hazard Note: The exhaust vent for the gas fireplace in the family room has been capped off. The fireplace itself however is still operable creating a carbon monoxide hazard. The fireplace either needs to be disconnected and abandoned or a proper exhaust vent cap installed.

The exhaust vent for the gas fireplace in the family room is capped off creating a CO hazard.

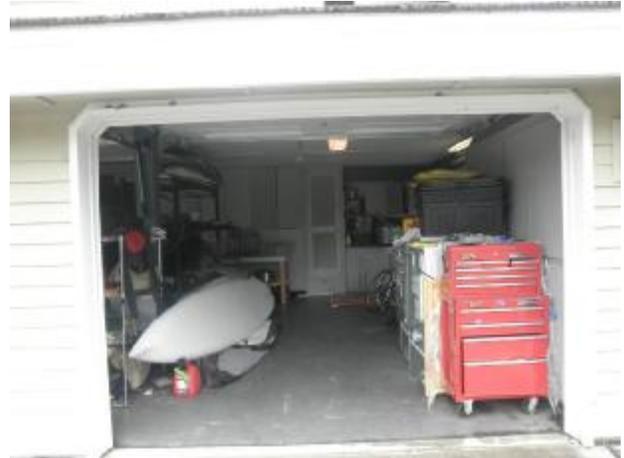
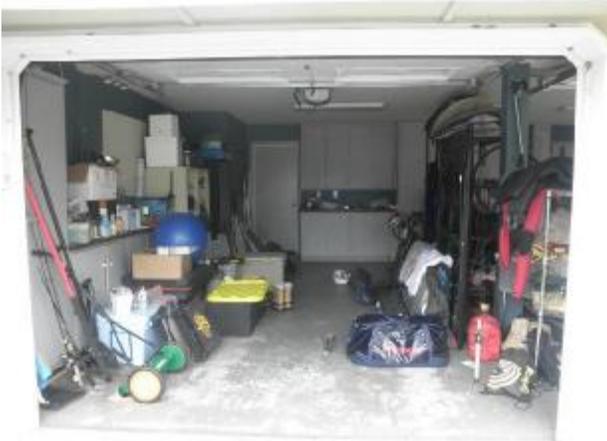
The garage was 90% blocked by storage at the time of inspection.

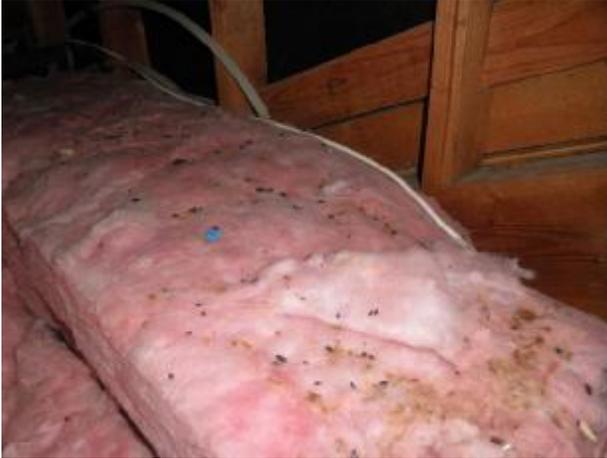
A

Evidence of rodents in the attic space.
