Real Estate Inspection Report

Monday, February 25th, 2019.

**171 Glorieta St.
Pasadena, CA 91103**

Inspector - Marshall Voeks
Confidential and Proprietary

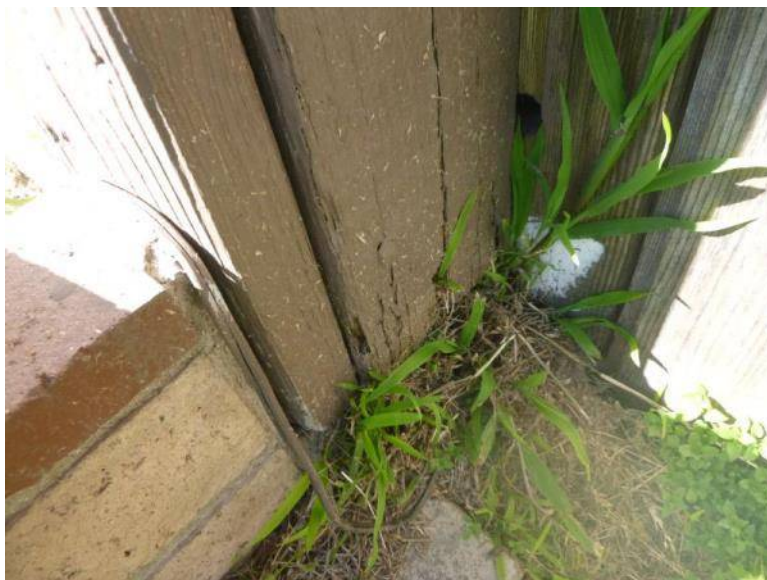
There appear to be areas of wood damage or deterioration, see the structural pest control report for more information, This inspection is not a structural pest control inspection, otherwise known as a termite inspection. The "termite" inspection also covers such things as dryrot and wood damage and deterioration as well as wood destroying organisms. Any and all of these items need to be examined and any repairs completed in a timely manner.

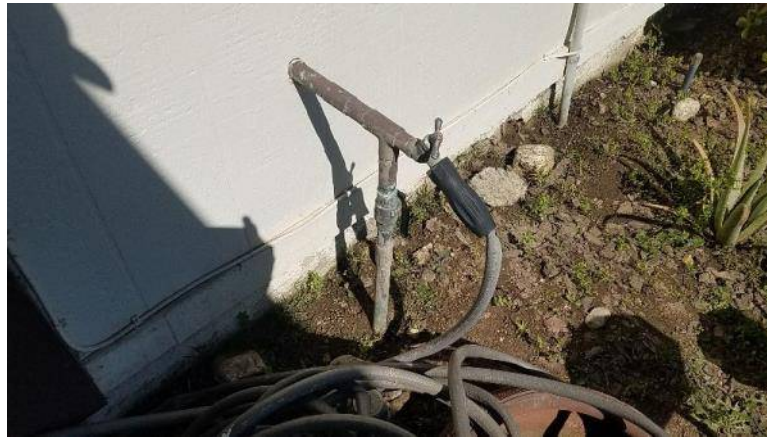
In the front of the building.

Needs Attention: No pressure relief valve was located as part of the water supply system. It is recommended to have this installed for safety and to prevent damage to the system in the event of a pressure buildup. Consult a qualified plumber for more information.

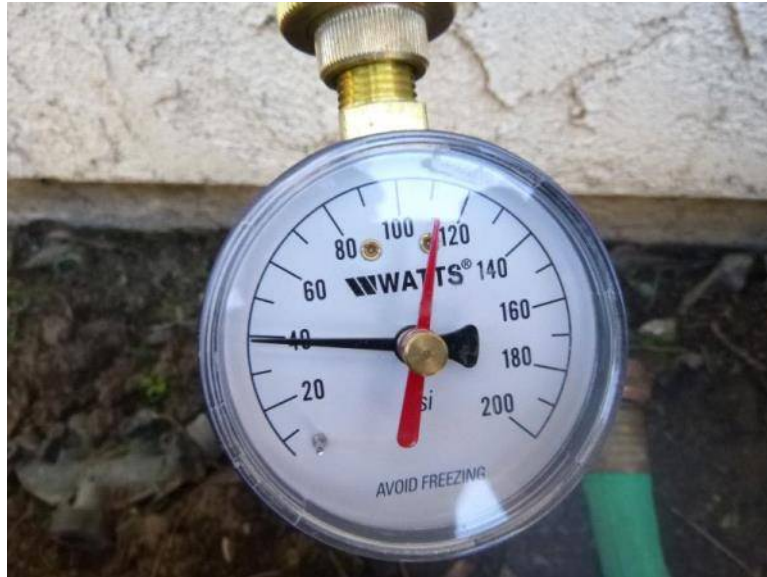
Needs Attention: The pressure is under 40 psi. This is too low, it should be between 40 and 80. There may be a pressure regulator that could be repaired or replaced. The pipes may also need to be replaced to increase the flow or a 'booster pump' may be needed.

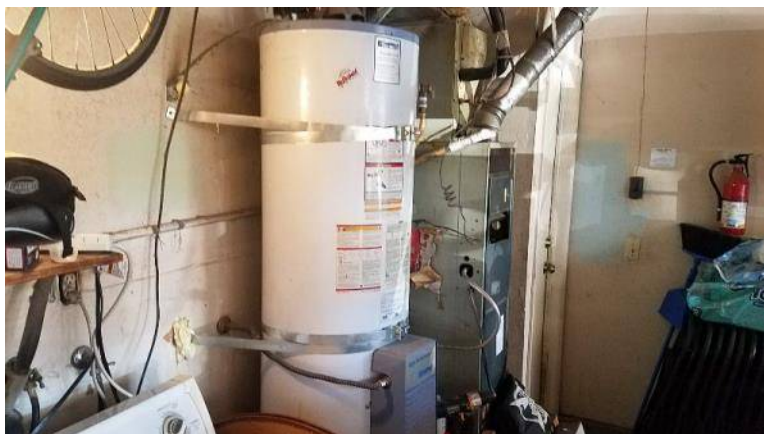
The water heater is located in the garage.

Needs Attention, there is no drain pan below the water heater, this is advised in case the water heater leaks so that the water can be carried away from the living space.

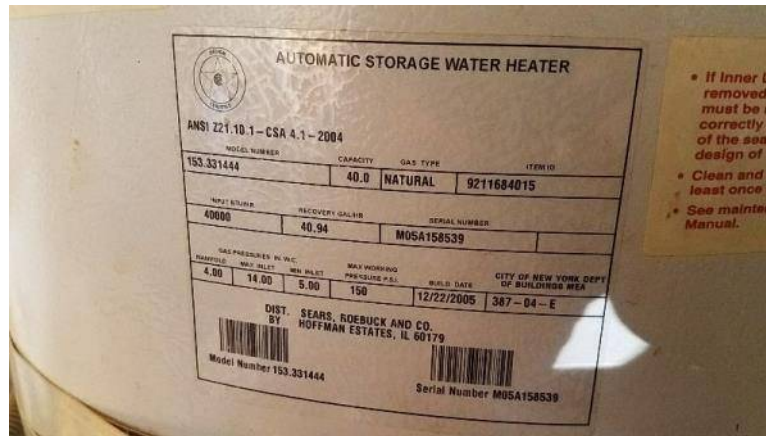
14 years old. Water heaters have an expected life of 8 - 12 years.

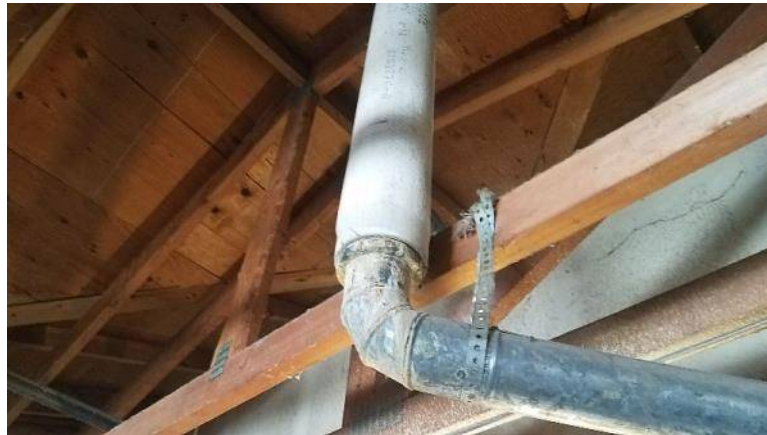
Needs Attention, the water heater vent line goes into an older vent system. Most manufacturers require a new metal vent pipe be installed when the new system is installed. The old piping may allow condensation to run back into the water heater causing it to rust prematurely.

The water heater vent line is corroded and rusting out. This is usually due to condensation running back down the line. The corroded piping needs repair and the entire vent line needs to be examined and any corrections made to it to correct what is causing the condensation in the piping.

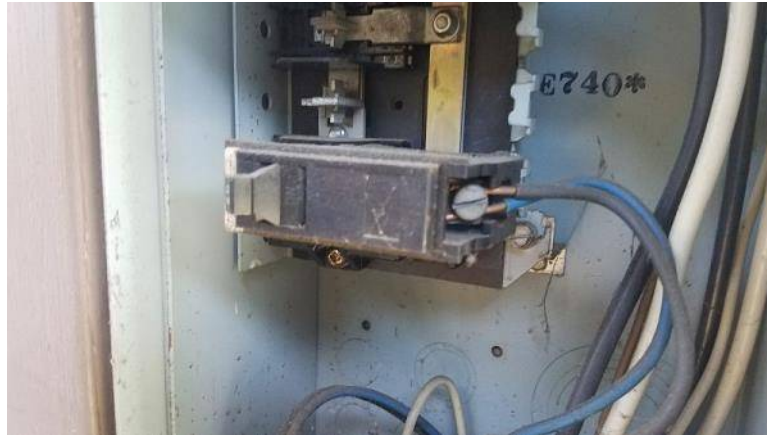
Not Acceptable: There is more than one wire connected to a single circuit breaker, where only one wire should be connected to each breaker. This can sometimes cause overloading of the wires or breakers. It also can cause the wires to have improper contact with the breaker and arc between the wire and the breaker.

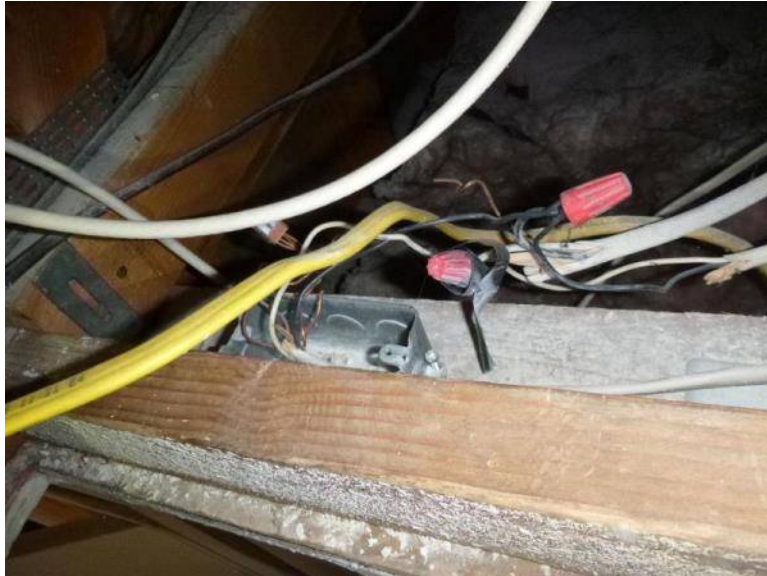
Not Acceptable: There are areas of exposed electrical wiring connections made outside of junction boxes, such as in the attic. This should be corrected for safety.

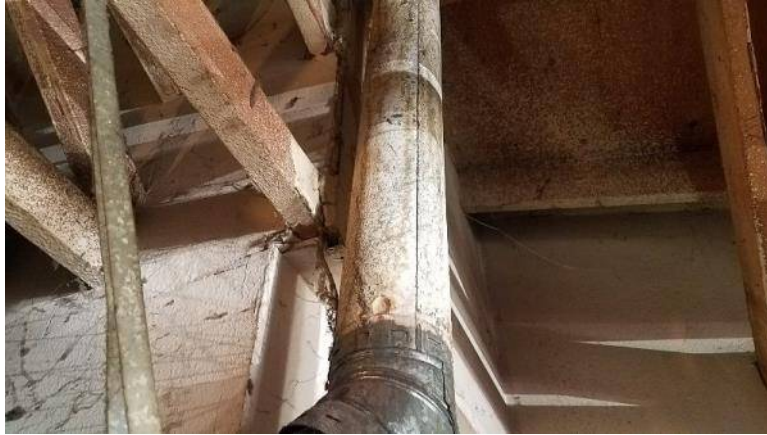
Not Acceptable, the furnace vent pipe is too close to combustible materials. This is a hazard and the vent line needs to be repaired to have the proper clearances.

Needs Attention. There are areas of moisture staining or rust staining on the vent line as from past leakage or condensation running down the line.

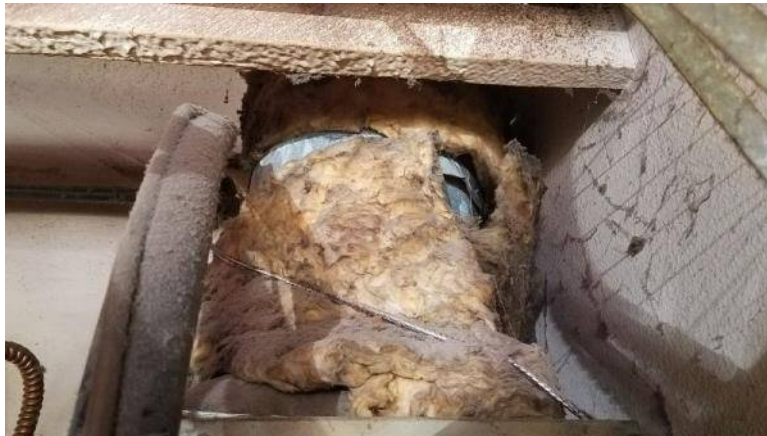
Needs Attention, there is ducting that is damaged or separated, such as in the garage.

There are damaged areas of duct insulation.

It is advised to have a licensed heating contractor examine the heating system and make all needed repairs to ensure a safe and properly operating system. It is expected that the heating specialist may find additional items that need repair as the general inspection is designed to turn it over to them when problems show up in a system so it can be further investigated.

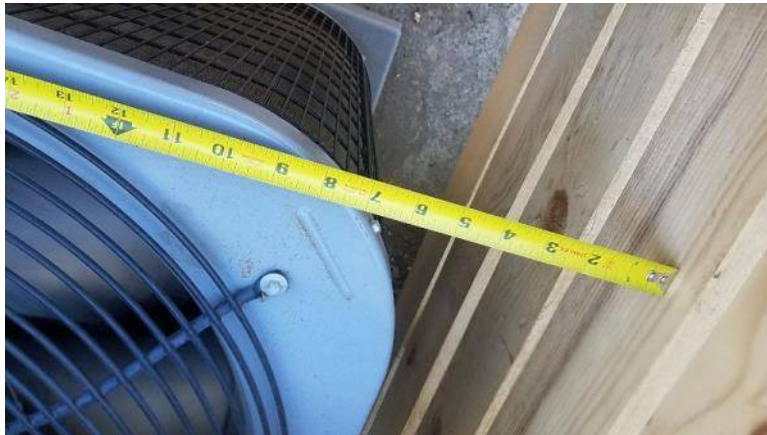
The condenser is about 5 years old.

Needs Attention, there is insufficient clearance around the condenser for it to operate properly. A minimum of 12 inches on the sides of the condenser is needed for an ideal air flow around its fins.

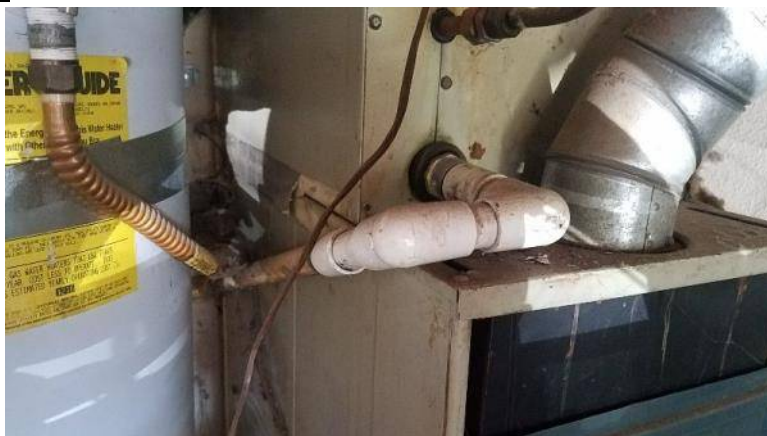
Needs Attention, there is no secondary condensate line installed. All air conditioning pulls moisture from the air and this moisture has to be taken somewhere. There is supposed to be a

main condensate line to do this and a back up in case the primary line fails. The secondary backup line is missing.

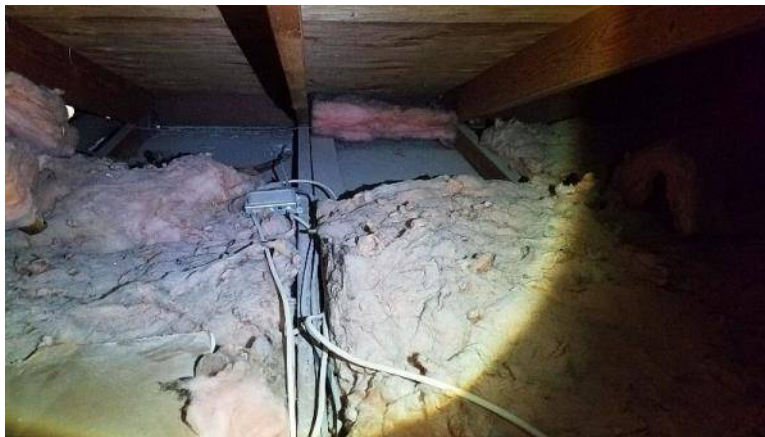
Needs Attention: The insulation has been disturbed and good coverage is no longer present in some portions of the attic. 8 - 12 inches of insulation is standardly recommended in the attic for energy savings.

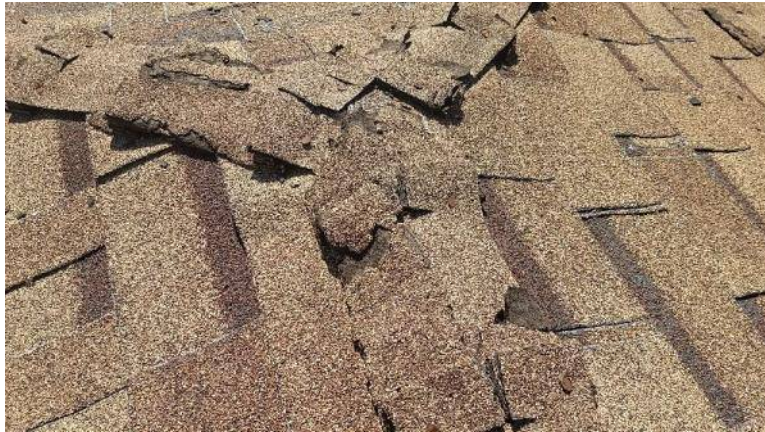
Needs Attention: On the composition roof the ridge caps installed at the peak of the roof are worn out and falling apart. These typically do not last as long as the rest of the roof and have to be replaced while the rest of the roof is still in serviceable condition. This roof is currently at that stage and the ridge caps need replacement.

The roofing feels soft and buckled in some areas. This can be caused by a variety of factors; further evaluation by a qualified professional is recommended.

A licensed roofing contractor should examine the roof and make all needed repairs (or replacements) to ensure a long lasting leak free condition. The roofing contractor may find more problems with the roof and this is why it is being referred to a specialist so they can determine all the problems and give an accurate estimate of the costs involved.

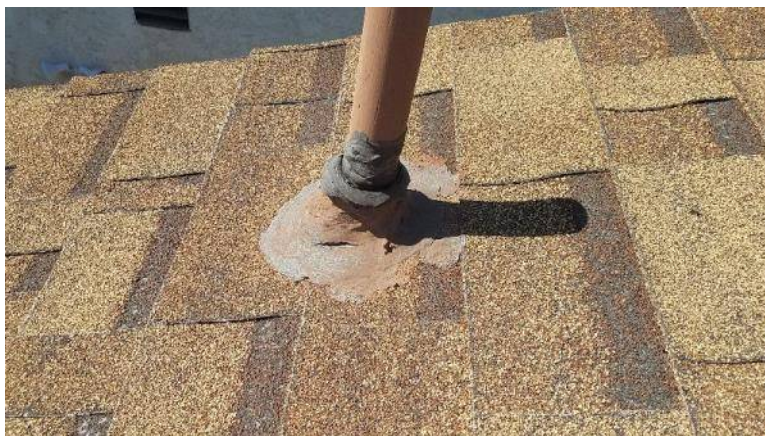
Needs Attention: The flashings have been covered over with mastic which is a temporary solution and will require regular maintenance to help ensure a leak free condition.

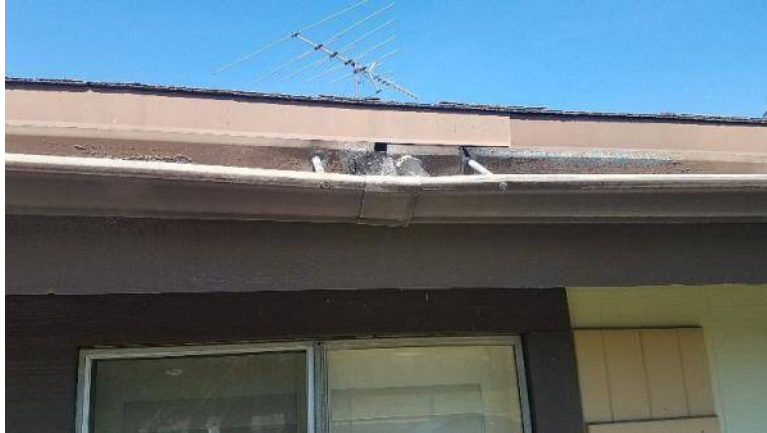
Needs Attention: There are damaged areas of gutters.

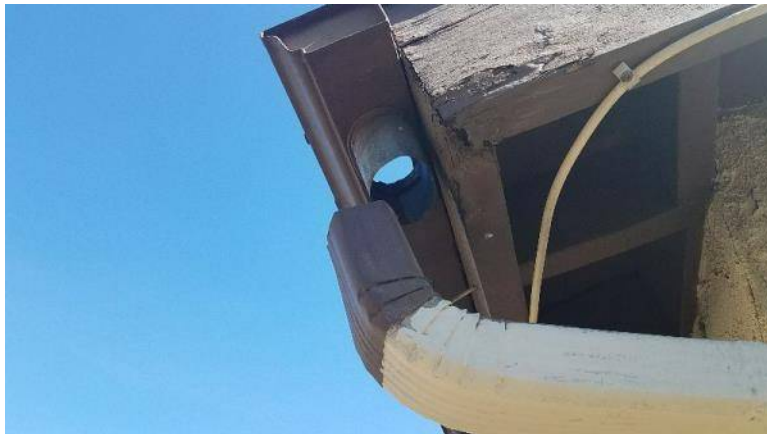
Needs Attention: there are disconnected downspouts in areas, such as at the rear left.

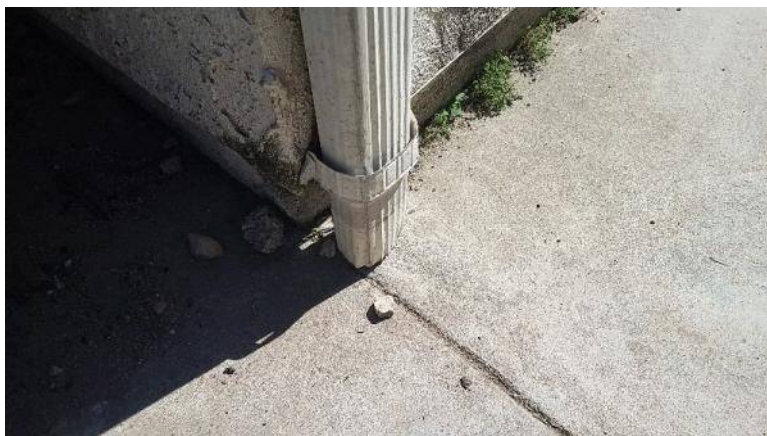
Needs Attention: The downspouts do not all route the water away from the building but instead deposit it next to the structure which can cause problems to the foundation over time.

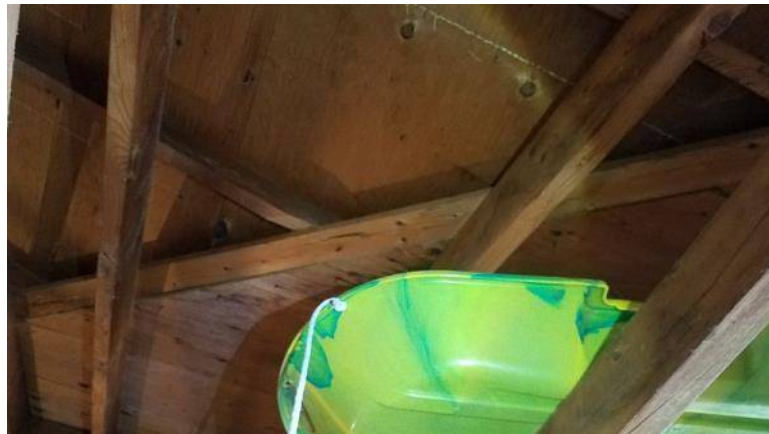
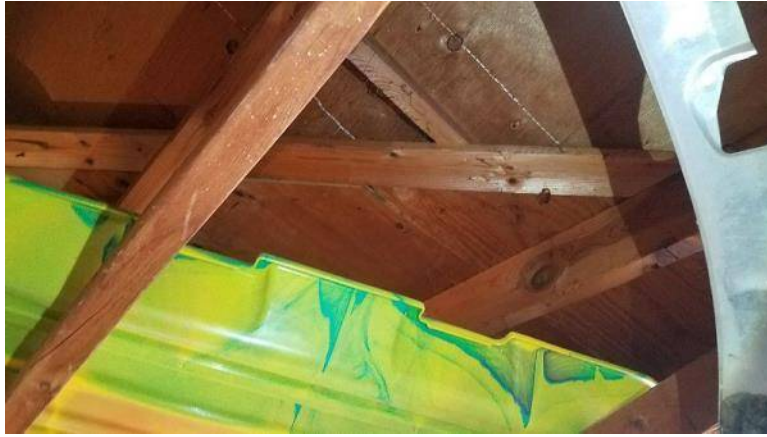
Not Acceptable: There are areas of sagging or damaged roof framing. Further evaluation and correction by a qualified expert is advised.

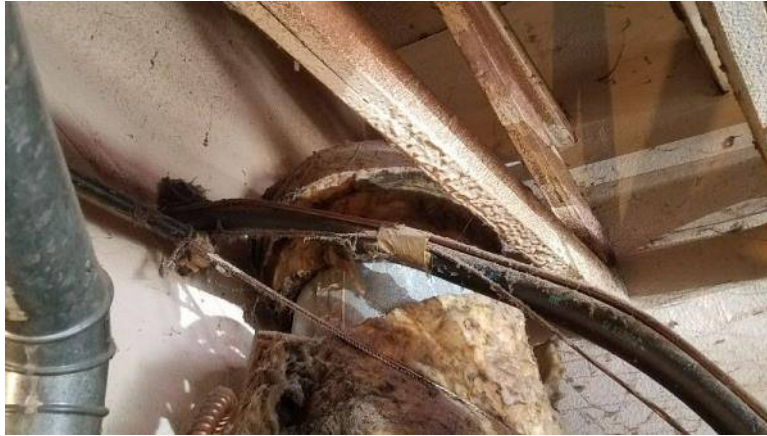
Not Acceptable: The wall and ceiling between the house and the garage is a fire separation safety barrier between the parking area and the living space. It is supposed to give someone 20 minutes to get out of the building in case of fire. There are not supposed to be any gaps or openings in this surface to maintain this rating. It has been compromised and needs repair.

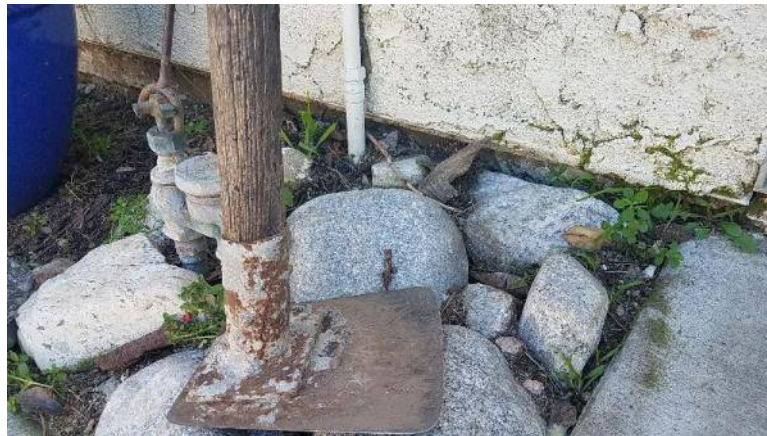
Needs Attention: There are areas where the weep screed (flashing metal) at the bottom of the stucco does not have the appropriate clearance to the ground. The earth should be 4 - 6 inches and concrete 2 inches below the bottom of the weep screed to allow for proper drainage.

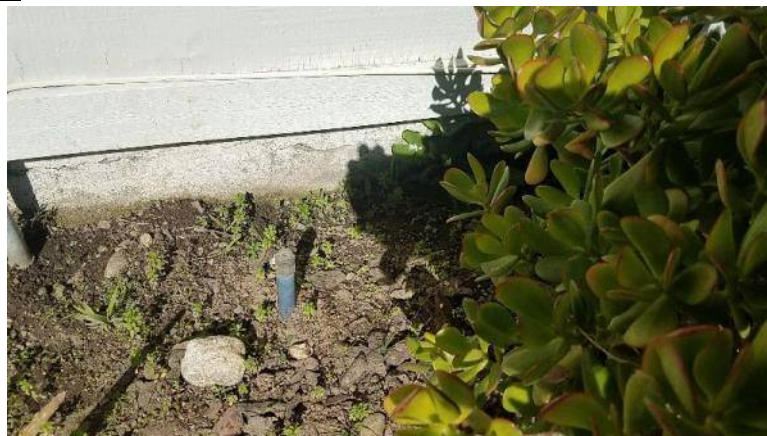
The water from the sprinklers appears to hit the exteriors of the building, this can cause deterioration and/or damage and moisture intrusion, water should be directed away from the structure.

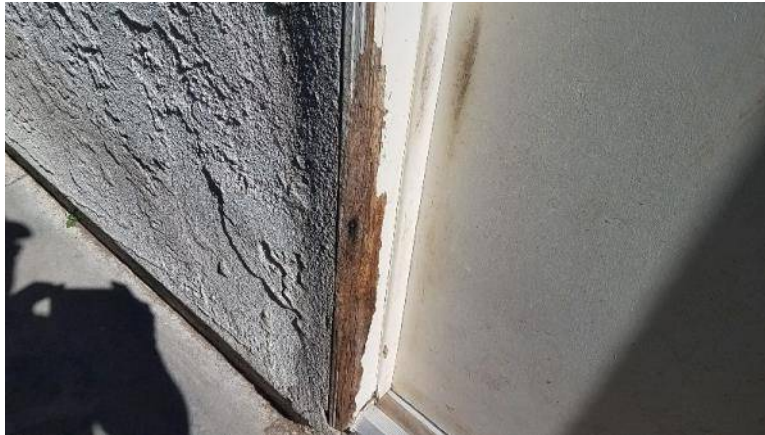
Needs Attention: There are areas of weather beaten wood and peeling paint.

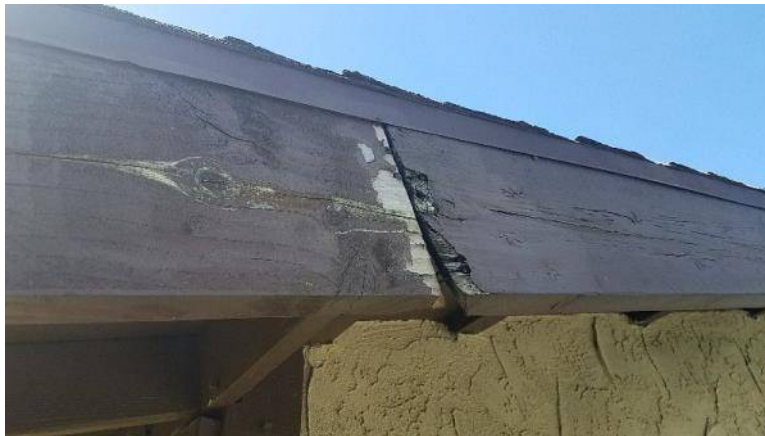
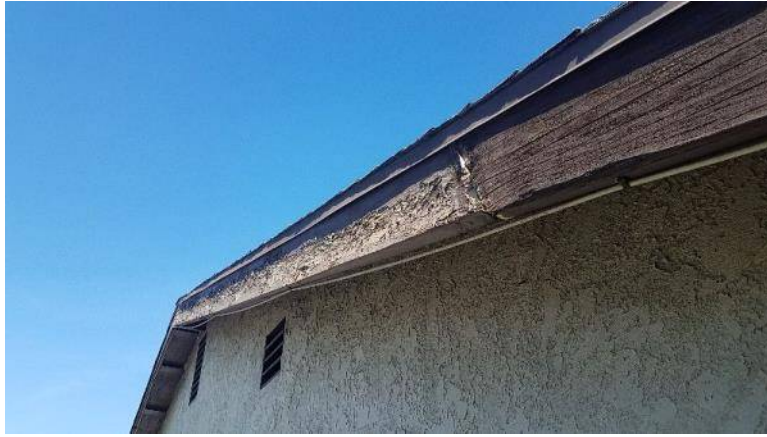
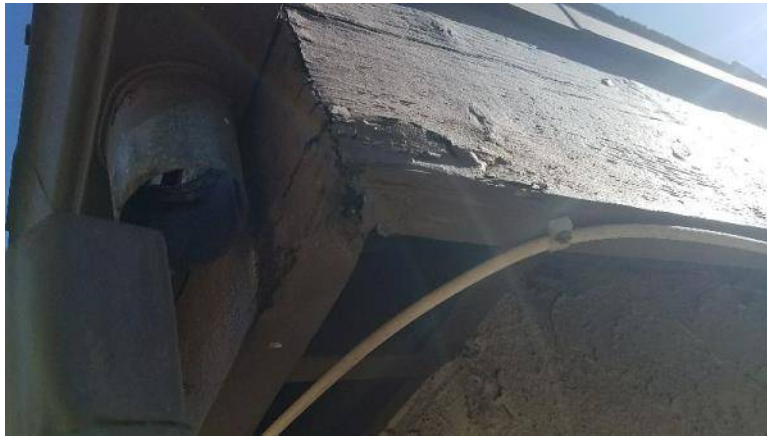
Needs Attention: The trim has a few areas of damage, deterioration, and weather- beaten wood / paint. Consult a termite expert for more information and further evaluation.

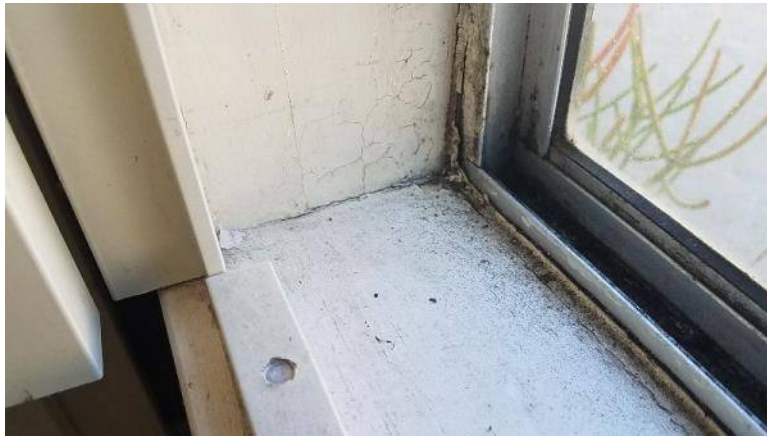
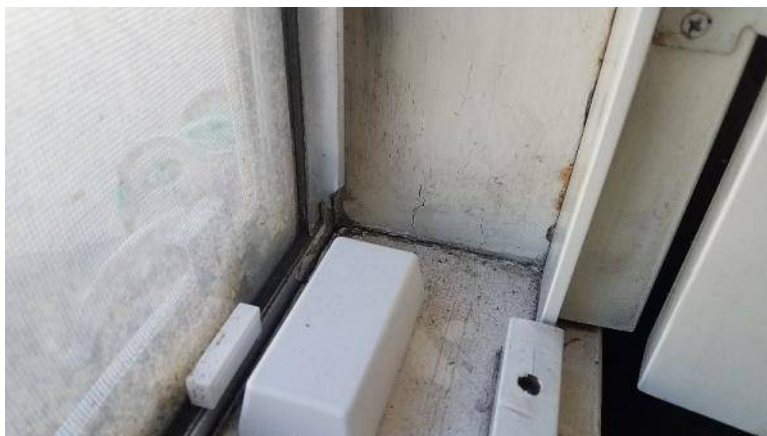
Needs Attention: there are areas of moisture damage by the windows likely indicative of past leakage, such as at the master bedroom, second bedroom.

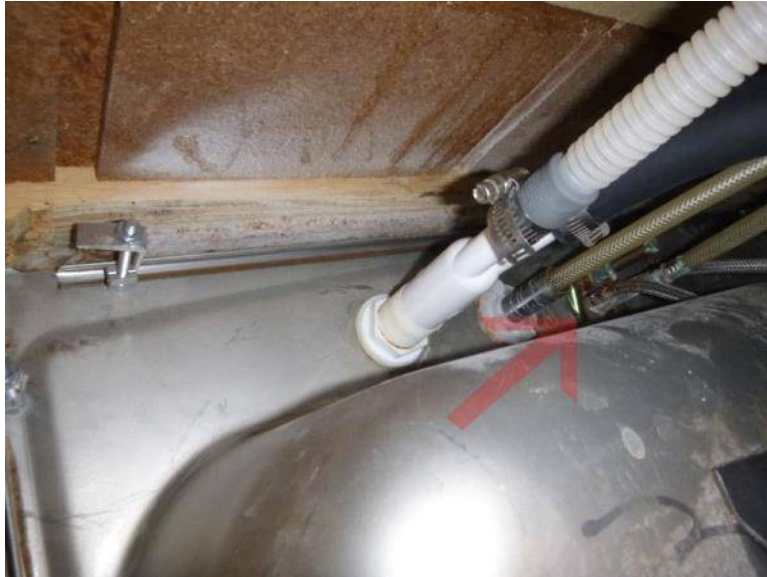
Needs Attention: There are areas of corrosion or rusting at the sink water supply piping, possibly caused by past leakage.

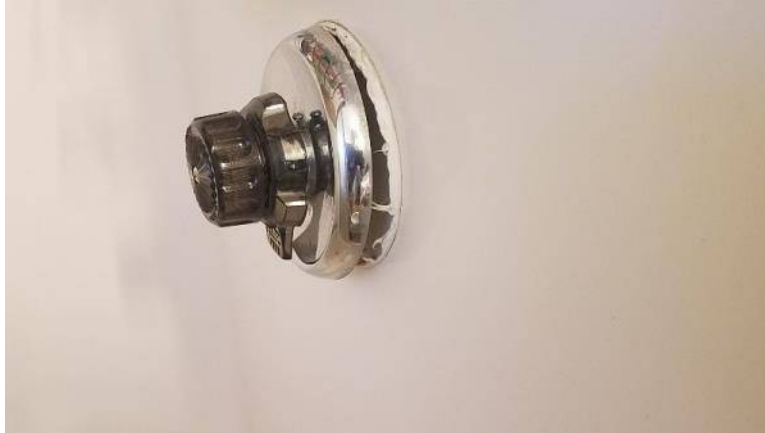
Needs Attention: the shower handle trim is loose and not sealed properly.

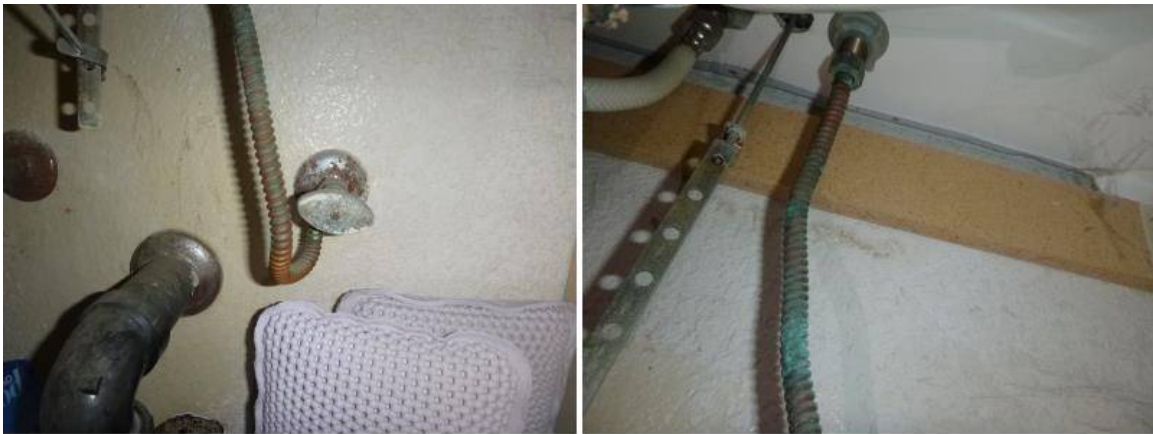
Needs Attention: The bathroom sink stopper(s) is missing.

One of the flex connectors for the sink is older and has areas of corrosion.
