## Chimney Inspection Report

For:  
426 Camino Real,  
Redondo Beach, CA 90277  
[@gmail.com](mailto:agentabbyw@gmail.com)

Date: 2/18/2026

The 2 reinforced masonry fireplaces at the property were inspected today.

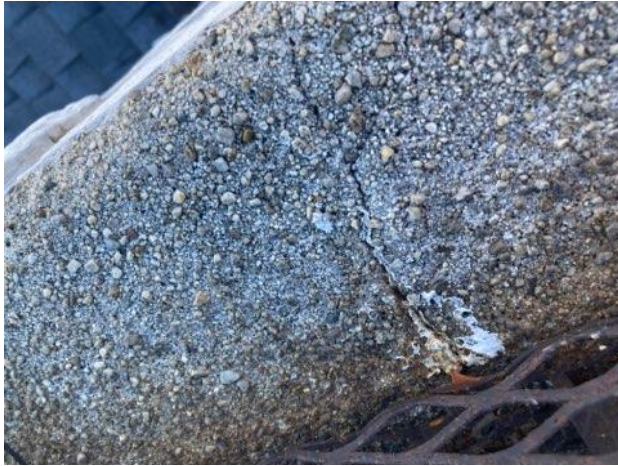
At the top of the chimney, the crown is shared by both fireplaces/chimneys. It has some cracks. This will allow moisture intrusion into the chimney structure and masonry and deteriorate it over time. The crown should be sealed and painted with waterproof sealant.

1. Thoroughly sweep and wash the chimney's interior surfaces.
2. Seal and paint the chimney crown with waterproof sealant.
3. Remove the damper and a couple of courses of bricks from the top of the back wall to access the smoke chamber to patch and seal any gaps.

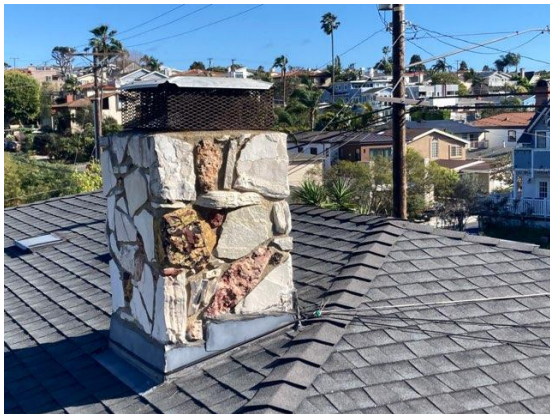
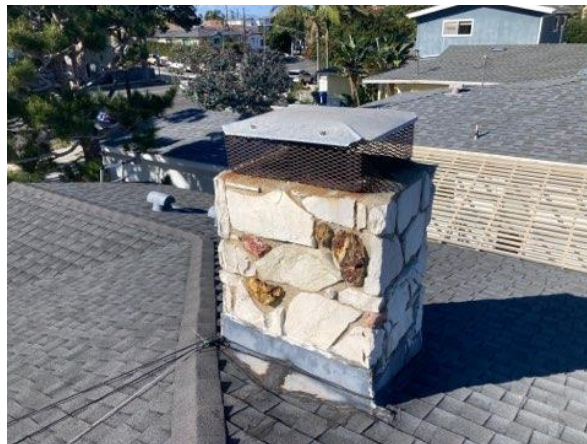
The chimney structure is shared by both fireplaces/chimneys. It seems structurally sound. When I exerted pressure on the chimney from the roof, there was no movement at all. There are no horizontal cracks on the exterior stone facing walls of the chimney. The video inspection shows that there are no horizontal cracks in the interior walls of the flue. Vertical cracks are not an indicator of structural compromise.

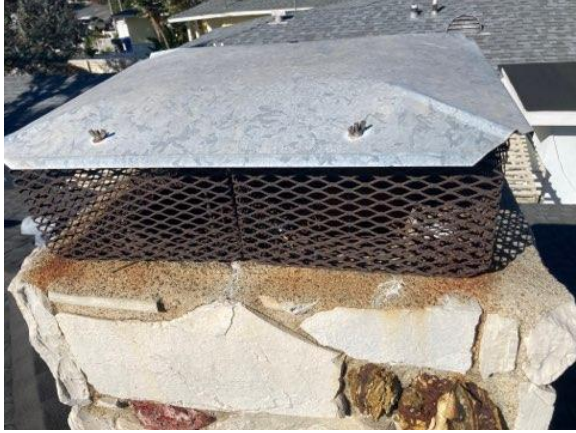
There is an approved spark arrester chimney cap on top of the chimney.

Additionally, the two flues exit the chimney right next to each other and at the same height as each other. This could result in back drafting between them and cause smoke to come into the living space. A baffle should be installed between them to prevent back drafting.

6. Seal the cracks/gaps in the firebox walls.
7. Re-tuck the firebox and face seal.
8. Re-set the couple of courses of bricks on the back wall.
9. Install a baffle between the two flue openings on the roof.

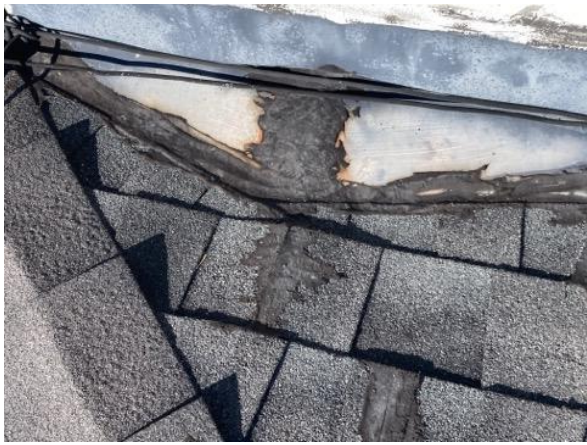
The chimney is 30 inches or more in width. It has a cricket. (a cricket is a metal saddle that diverts rainwater away from the base of the chimney). This is a positive feature of this chimney.

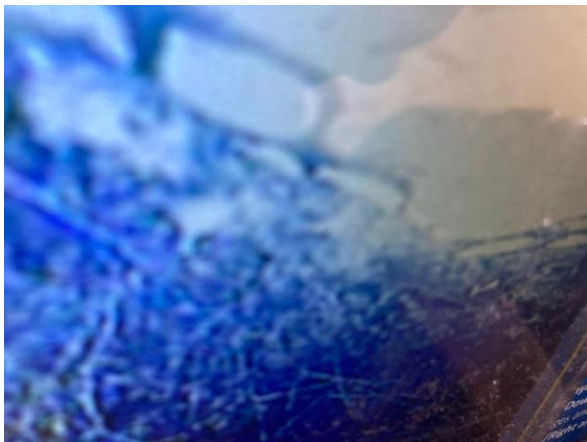
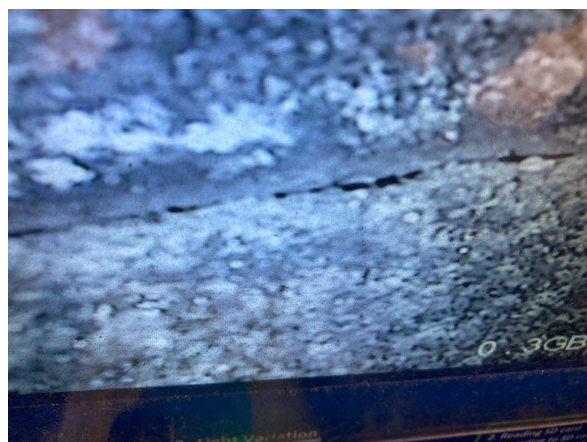
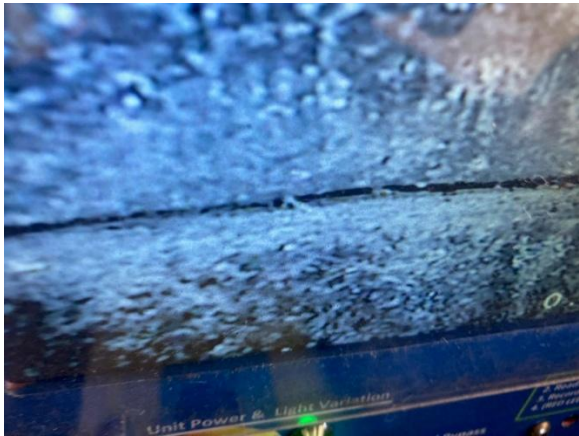
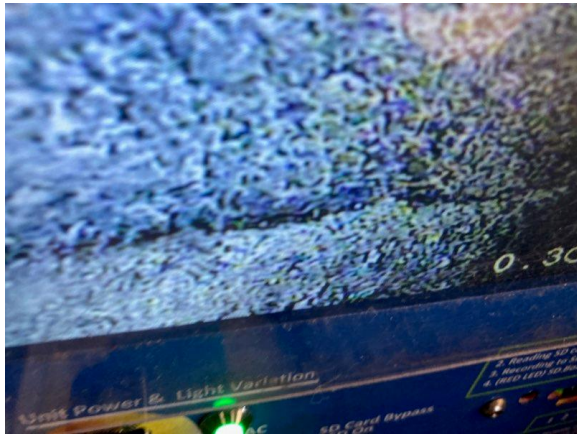
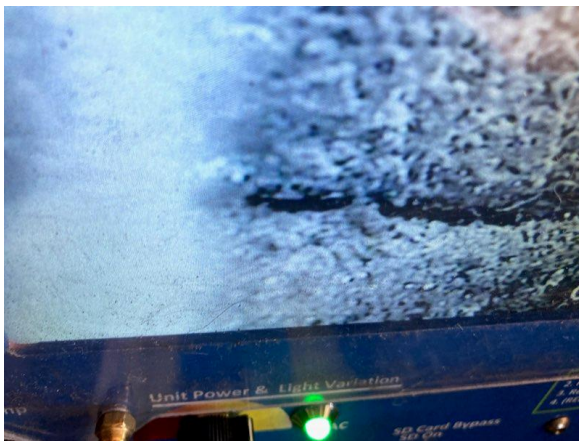
The video inspection of the interior of the flue shows that there are gaps and offsets between the clay liners which are potential fire hazards as hot gases can travel between them. Usually, there is wood framing or roofing near the chimney. They should be sealed with high temperature mortar.

4. Re-tuck the gaps in the 1-story flue. May want to use a bell tool. Flue dimension is about 8 by 15 (clay liners).
5. Apply some high temperature mortar to create a 3D shell in the smoke chamber to insulate the masonry and help funnel the combustion gas upwards.

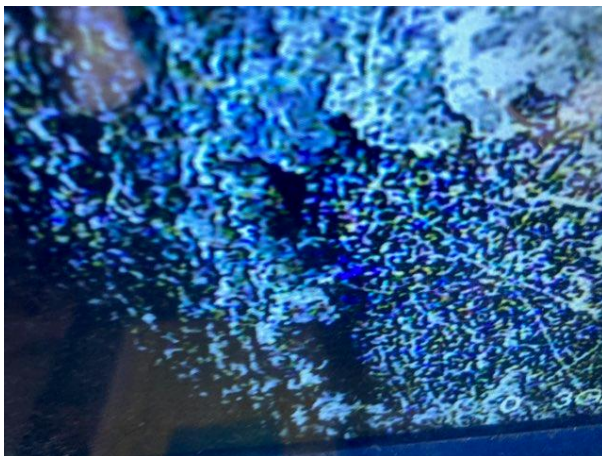
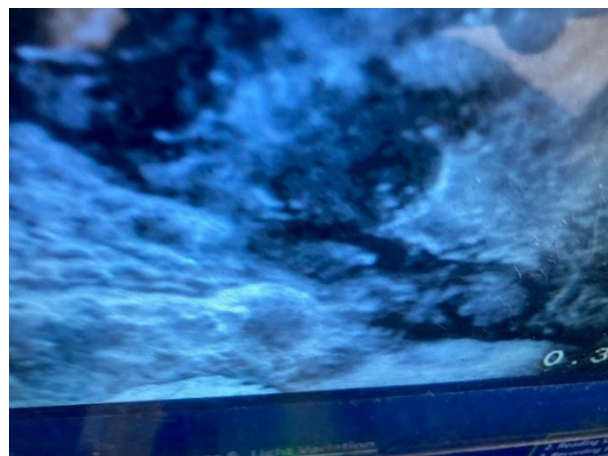
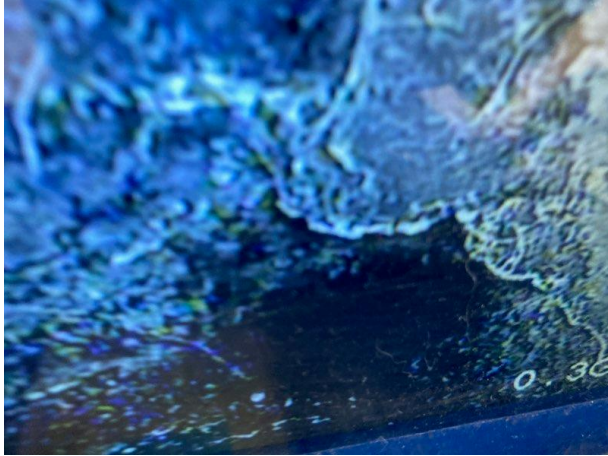
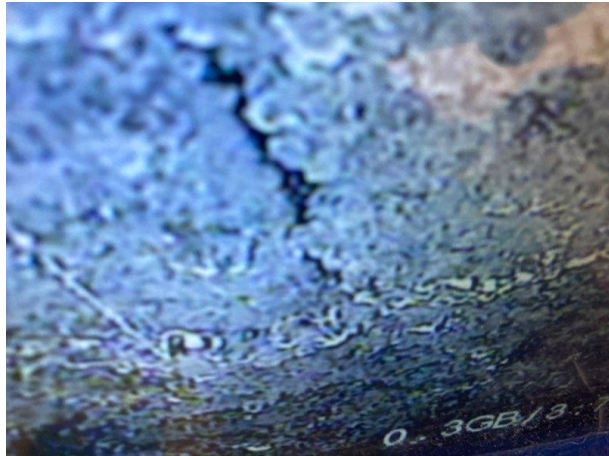
The smoke chamber space has gaps in the masonry surfaces and creosote buildup. The masonry is old and with time loses its heat insulating properties.

The smoke chamber needs to be coated with a layer of high temperature mortar that insulates the heat and smoothly channels the combustion gas up the flue. To get to the smoke chamber, the damper and a couple of rows of bricks from the back wall need to be removed.

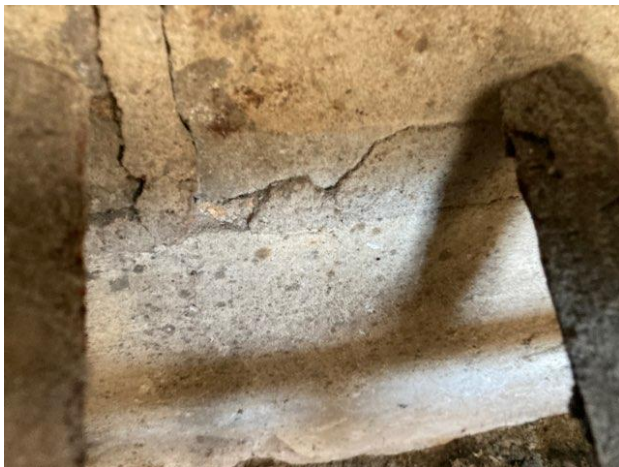
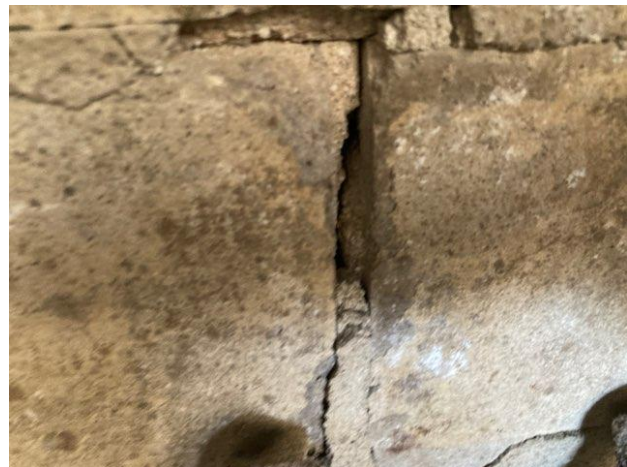
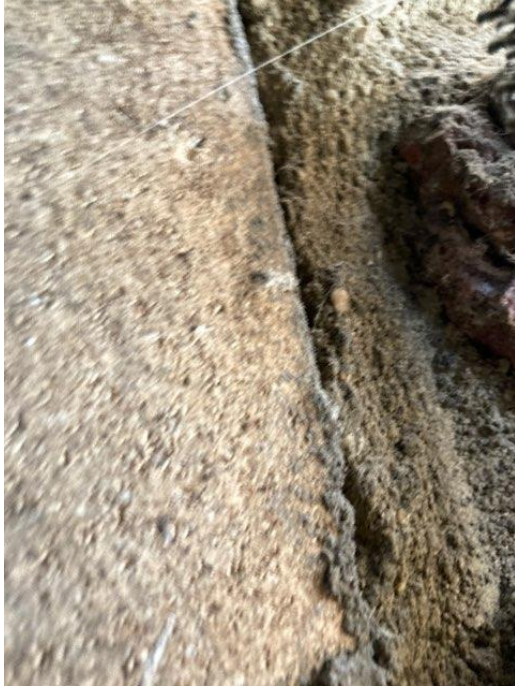
There are some gaps and cracks in the floor and walls of the firebox. These are potential hazards and should be sealed with high temperature mortar.

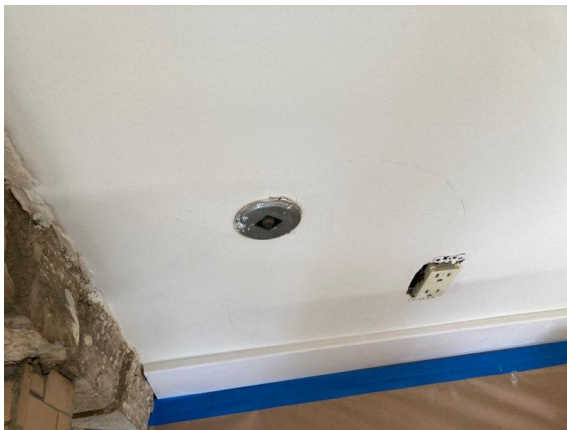
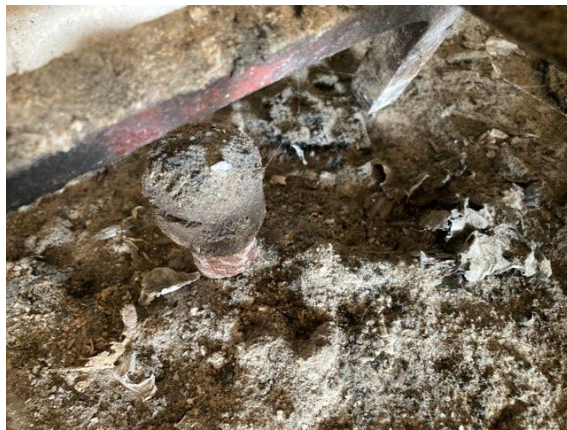
There is a gas line into the firebox which is capped. The gas valve turned and gas flow was verified. Gas valves sometimes go bad. At the time of the inspection, this one functioned normally. We do not check for gas leaks. The gas company offers that service for free.

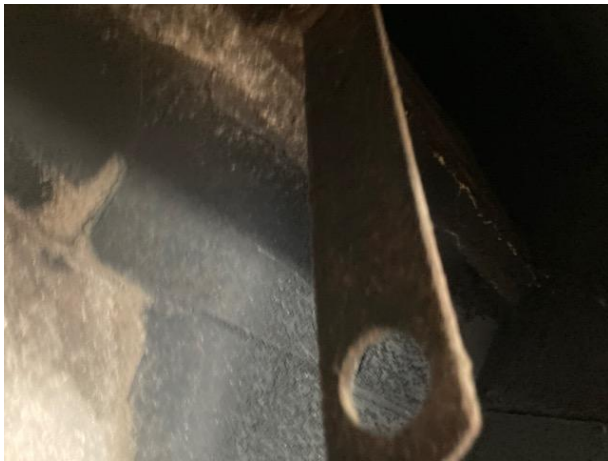
If the intention is to install a gas log kit and gas log burner, it is recommended that a clamp is installed onto the damper to keep it fully open as a precaution against combustion gas emission as per CA code.

10. Install a top damper.
11. If a gas log set and gas log burner is installed, then install a clamp on the top damper to keep it FULLY open at all times per CA code.

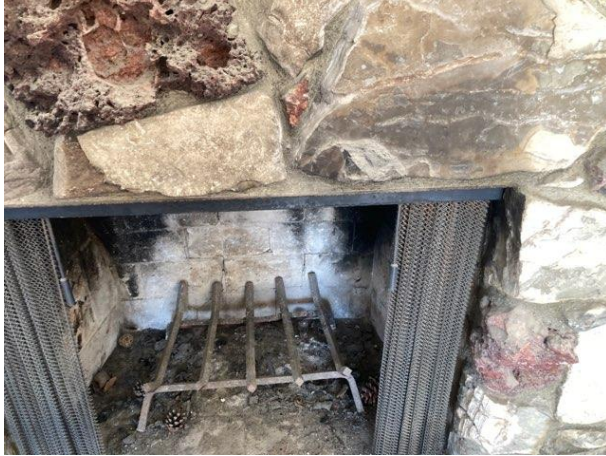
There are some smoke stains above the firebox opening. This is indicative of poor drafting. Because the two flue opening at the roof are right next to each other and they are at the same height as each other, this can result in back drafting and cause smoke to go into the living space. A baffle should be installed between them.

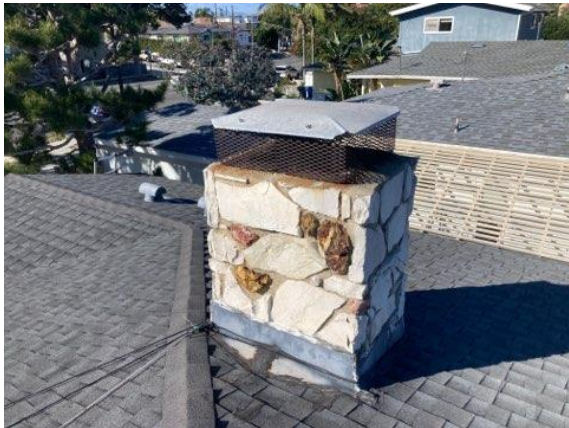
There is an approved spark arrester chimney cap on top of the chimney.

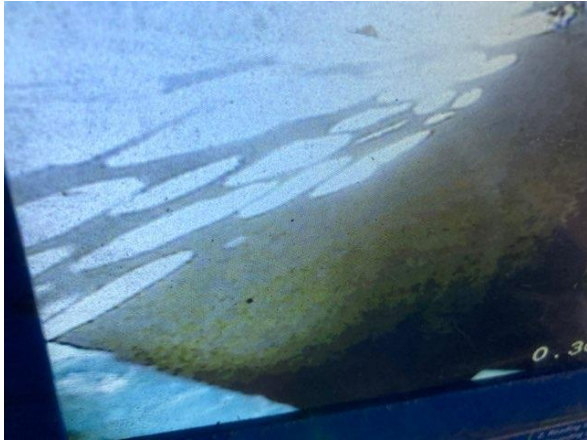
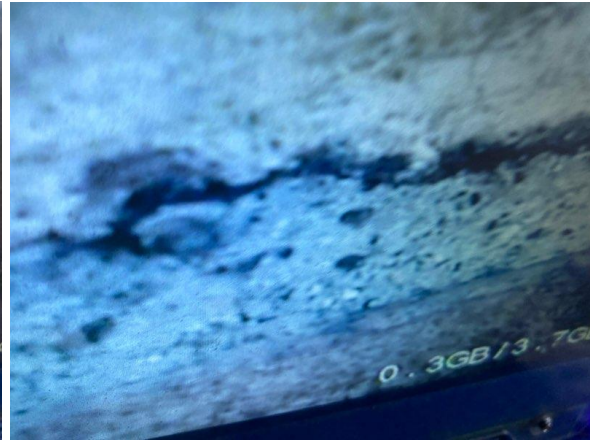
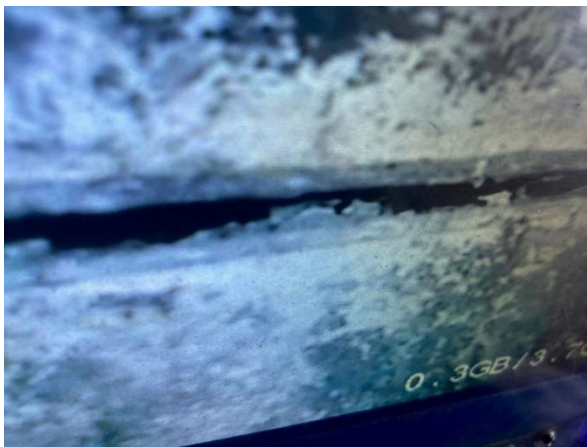
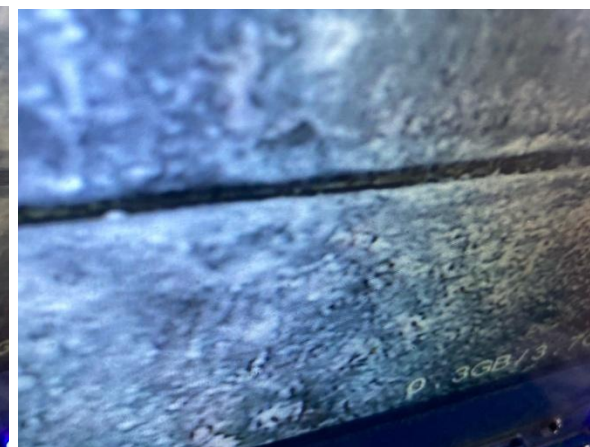
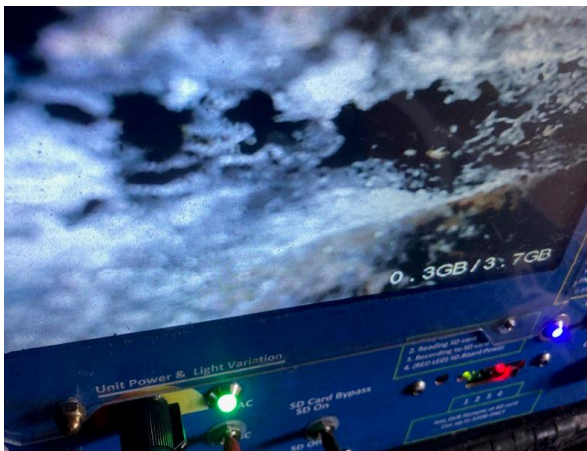
The video inspection of the interior of the flue shows that there are gaps and offsets between the clay liners which are potential fire hazards as hot gases can travel between them. Usually, there is wood framing or roofing near the chimney. They should be sealed with high temperature mortar.

3. Re-tuck the gaps in the 2-story flue. May want to use a bell tool. Flue dimension is about 8 by 15 (clay liners).
4. Apply some high temperature mortar to create a 3D shell in the smoke chamber to insulate the masonry and help funnel the combustion gas upwards.

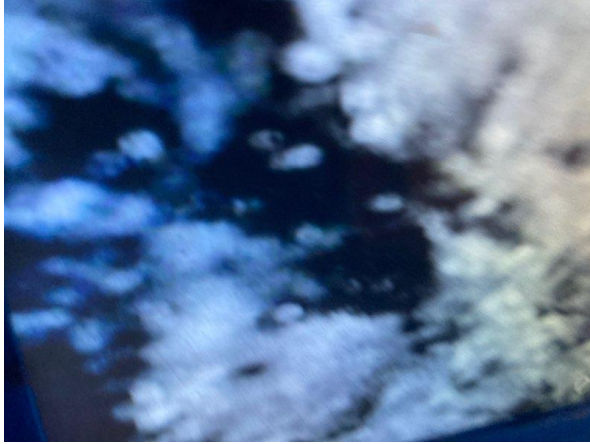
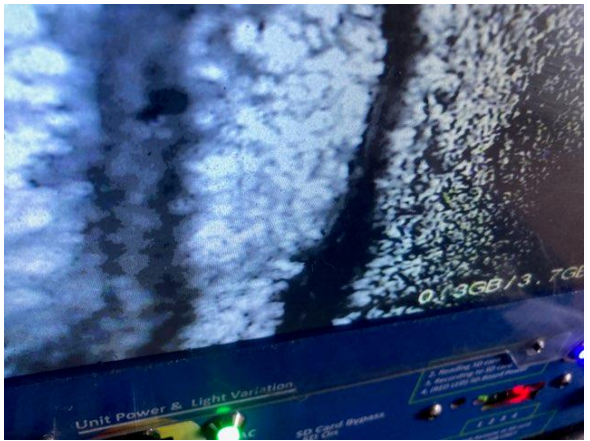
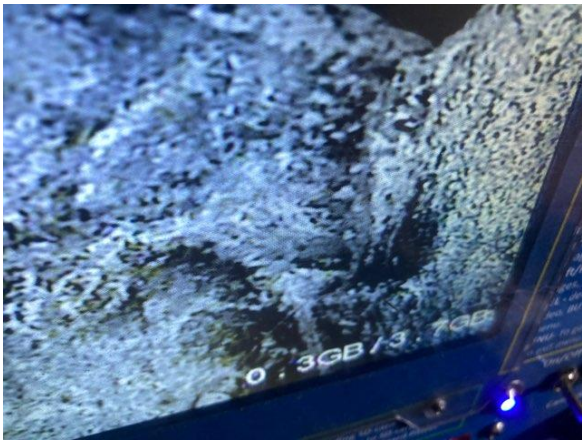
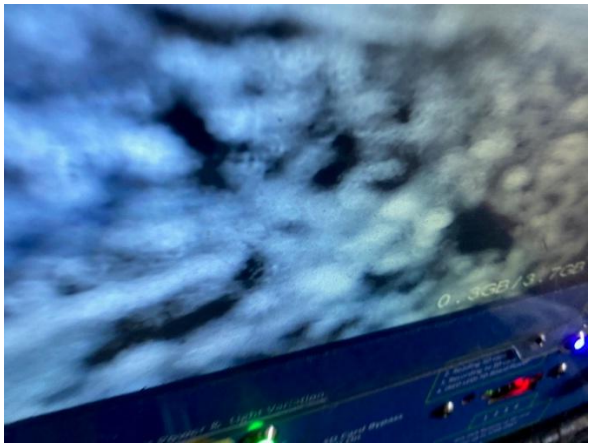
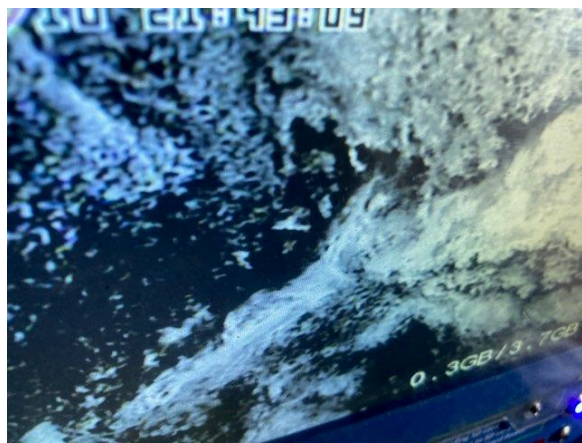
The smoke chamber space has gaps in the masonry surfaces, gaps in the transition to the flue and creosote. The masonry is old and with time loses its heat insulating properties.

The smoke chamber needs to be coated with a layer of high temperature mortar that insulates the heat and smoothly channels the combustion gas up the flue. To get to the smoke chamber, the damper and a couple of rows of bricks from the back wall need to be removed.

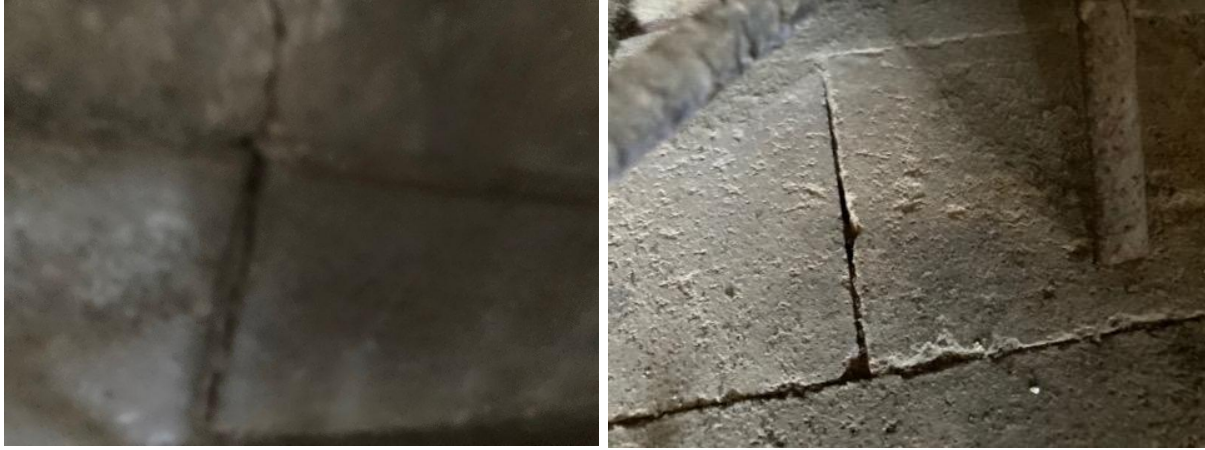
There are some gaps/cracks in the floor and walls of the firebox. These are potential hazards and should be sealed with high temperature mortar.

5. Seal the cracks/gaps in the floor and walls.
6. Re-tuck the firebox and face seal.
7. Re-set the couple of courses of bricks on the back wall.
8. Reinstall the fire screen so that it is flush with the chimney wall and does not have any gaps between it and the chimney wall.

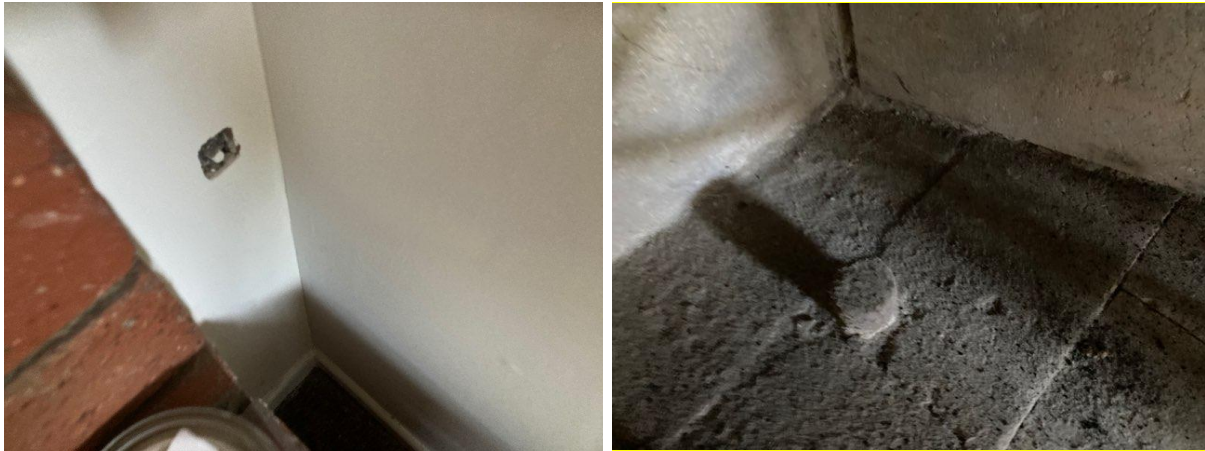
There is a gas line into the firebox which is capped. The gas valve turned and gas flow was verified. Gas valves sometimes go bad. At the time of the inspection, this one functioned normally. We do not check for gas leaks. The gas company offers that service for free.

The damper is frozen in a partially open/closed position. It should be repaired/replaced.

If the intention is to install a gas log kit and gas log burner, it is recommended that a clamp is installed onto the damper to keep it fully open as a precaution against combustion gas emission as per CA code.

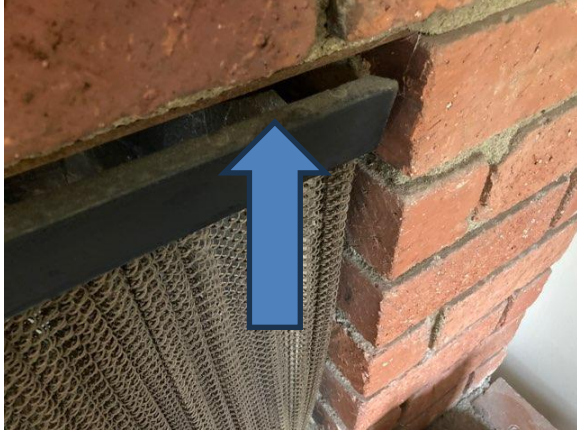
Fire screens were present at the time of the inspection. Fire screens are required when burning wood. However, the fire screen is not flush with the fireplace wall and should be reinstalled so that there is no gap between the metal frame of the fire screen and the chimney wall.
