Physical Inspection Report

LOCATED AT:
2407 Carnegie Lane #2
Redondo Beach, CA

INSPECTED ON:
Tuesday, January 3, 2017 at 2:00 PM

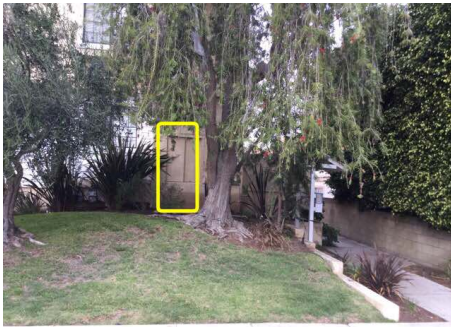
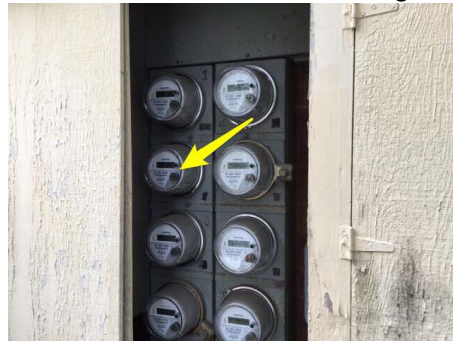
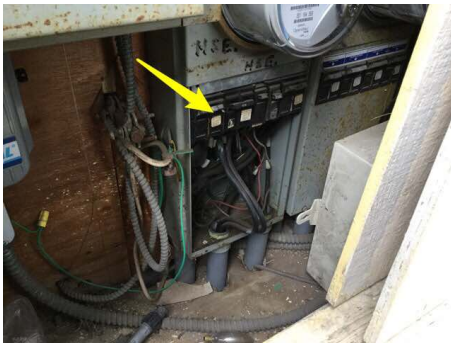
The main electrical shutoff breaker was located at the front of the building.

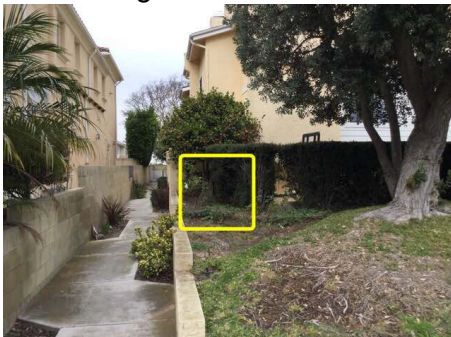
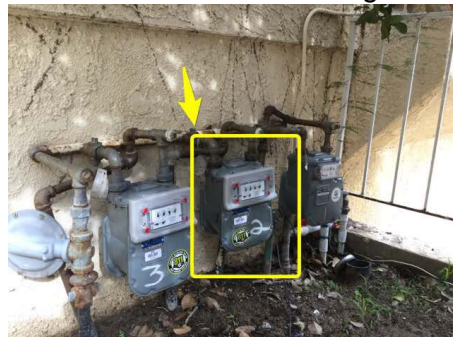
The main gas shutoff valve was located at the front of the building.

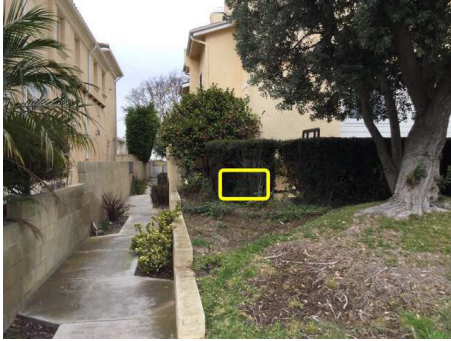
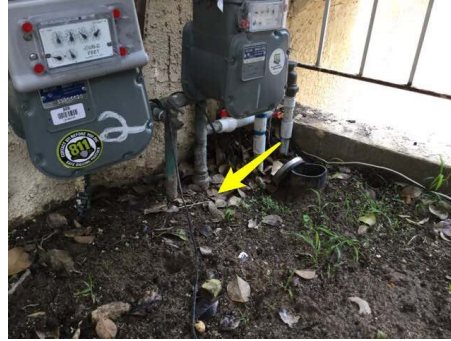
The main water shutoff valve was located at the front of the building.

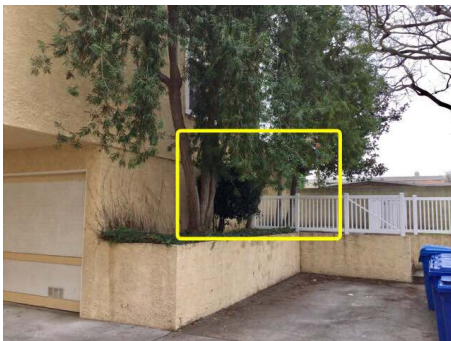
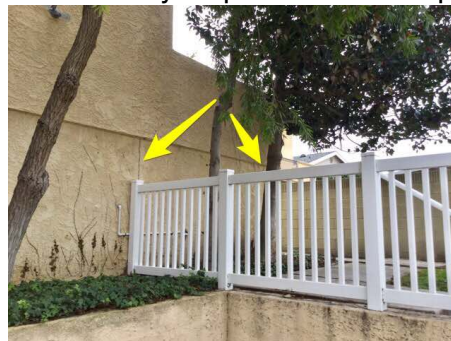
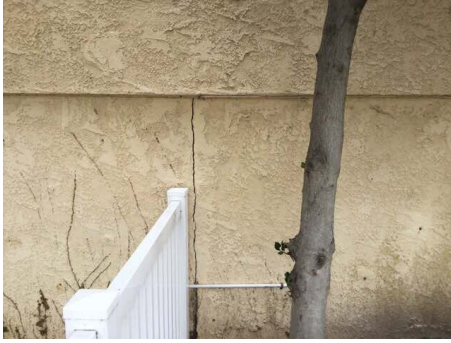
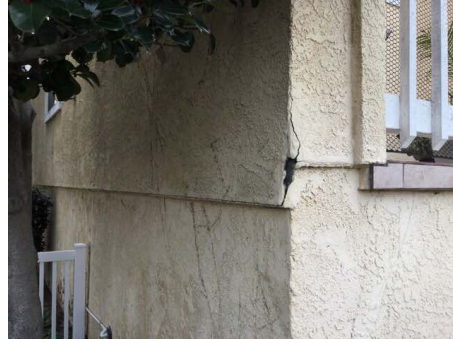
STUCCO SIDING

FE CR There were cracks/possible signs of movement in the rear left building stucco siding at the foundation area. These conditions are conducive to moisture intrusion/deterioration. We recommend further evaluation of the source and corrections by a specialist in the appropriate trade.

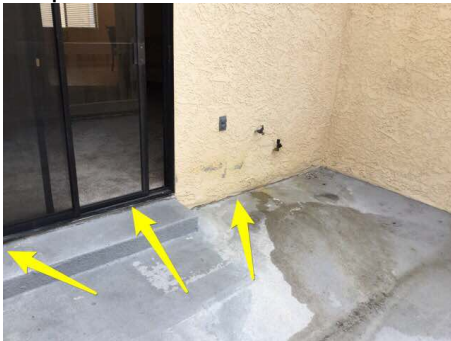
CR There was a gap between the patio and the foundation/door area. We recommend sealing the gap to keep moisture out.

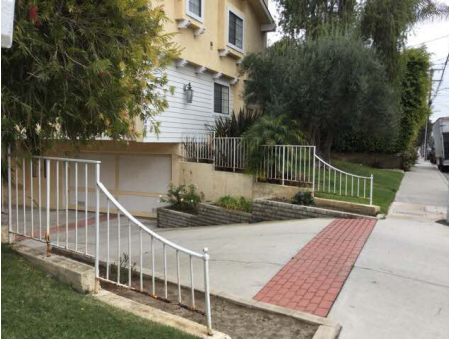
FE CR The front metal guard railings were damaged/rotted. We recommend further evaluation and corrections by a specialist in an appropriate trade. We also recommend inquiring with the Seller/Association on conditions known.

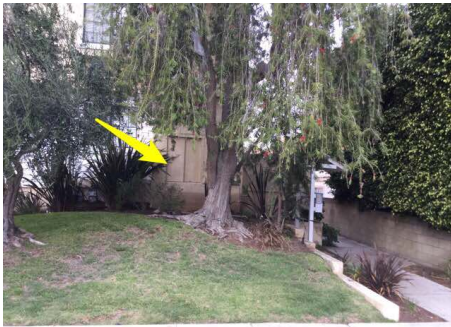
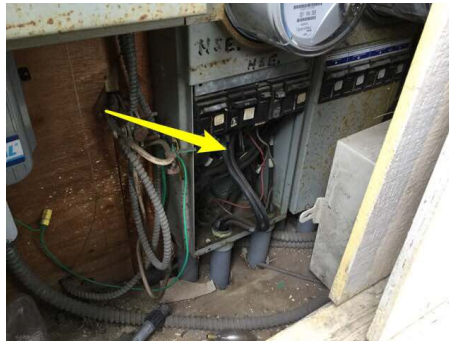
MAIN PANEL

SC The protective "dead front" cover was missing from the panel. We recommend correcting the condition noted.

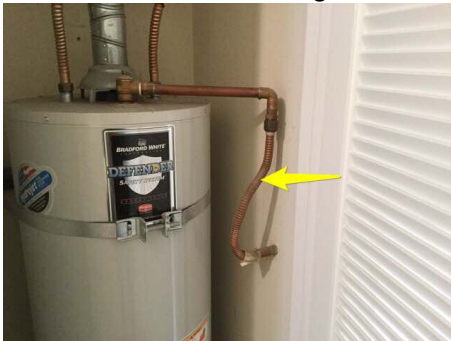
T&P VALVE

CR The temperature & pressure relief valve discharge line was routed in a material that was not rated for this application. We recommend installing an approved discharge line that extends to the exterior and terminates close to the ground facing downward.

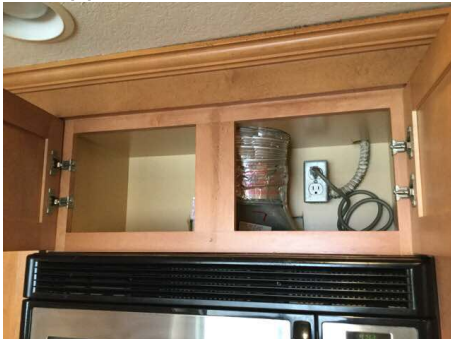
CR The visible portion of the exhaust vent ducting was a corrugated flexible material, these products were not approved for kitchen exhaust vents. We recommend correcting the condition(s) noted.

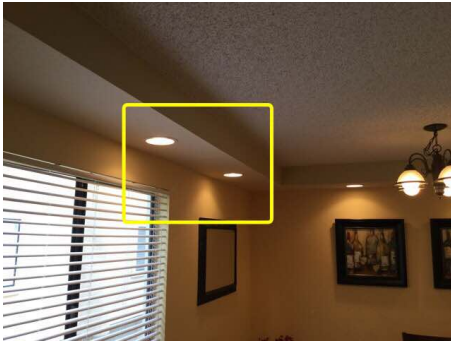
WALLS/CEILING

FE Past repairs were noted on the walls/ceiling. We recommend inquiring with the sellers about the condition noted.

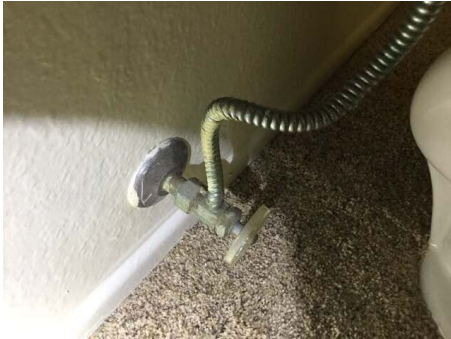
TOILETS

RU Due to the type and age of the shut-off valve(s) (no leakage observed), we recommend changing (upgrading) the older type shut-off valve/hose by a specialist in an appropriate trade.
