Professional Inspection Network

832 W 95th St 7/31/2024 20240731-832-W-95th-St

Los Angeles CA 90044

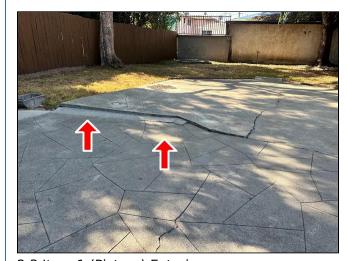
2.3 Item 1 (Picture) Exterior

(1) <u>Safety Issue:</u> The rear concrete patio exhibits an uneven surface, which poses a potential trip hazard. The safety of individuals utilizing the walkway is of utmost importance, and it is strongly advised to rectify this issue to prevent accidents or injuries. The unevenness in the patio can result from factors such as settling, shifting of the ground, or general wear and tear over time. The irregular surface may create unexpected changes in elevation, leading to trips and falls, particularly for individuals with limited mobility or impaired balance. To mitigate the trip hazard, it is recommended to engage the services of a professional concrete contractor or a qualified mason. They should assess the condition of the patio and propose appropriate corrective measures.
