STRUCTURAL DRYING / REMEDIATION PROJECT SUMMARY**COMPANY INFORMATION:**

PROJECT ID: IMR10199045

August 31, 2022

REMEDIATION: ACTIONS PERFORMED

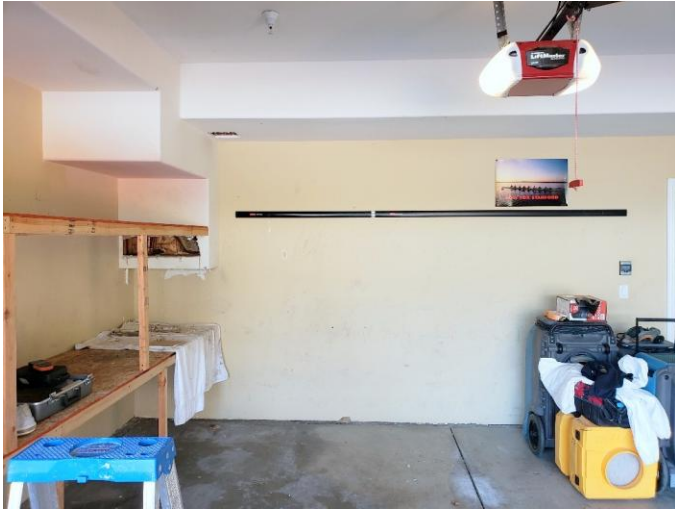
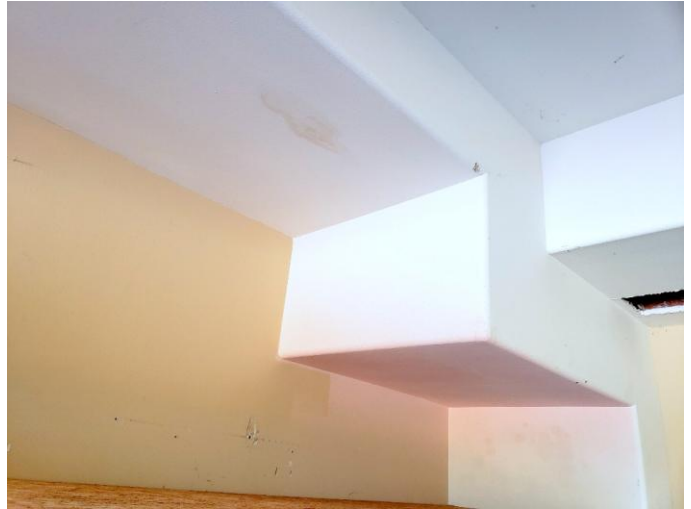
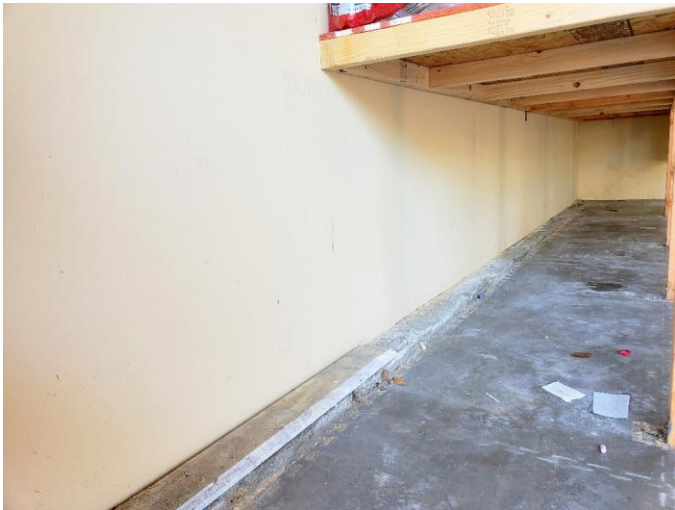
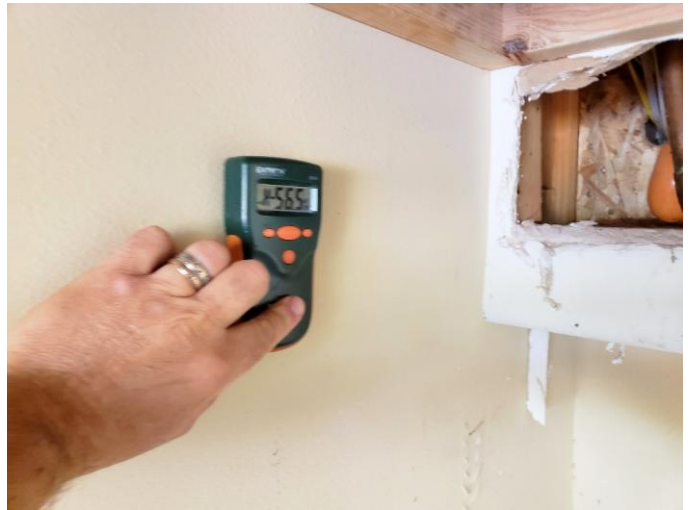
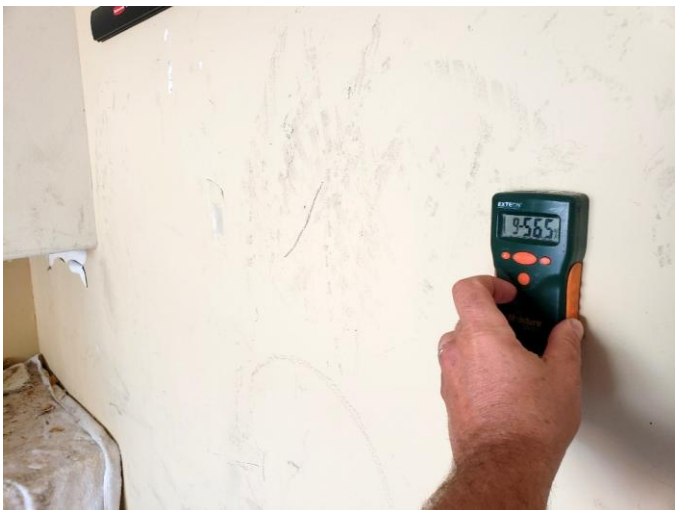
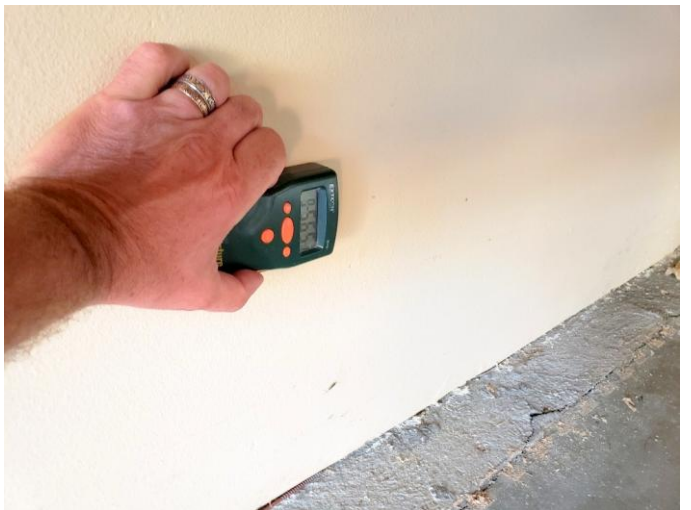
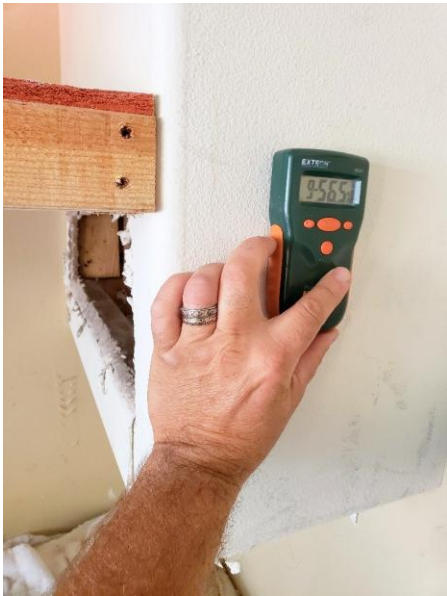
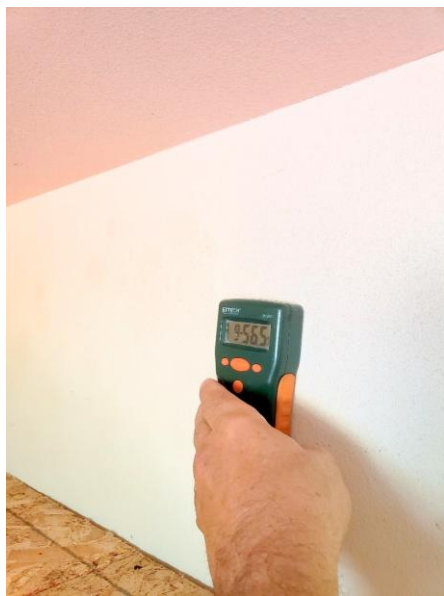
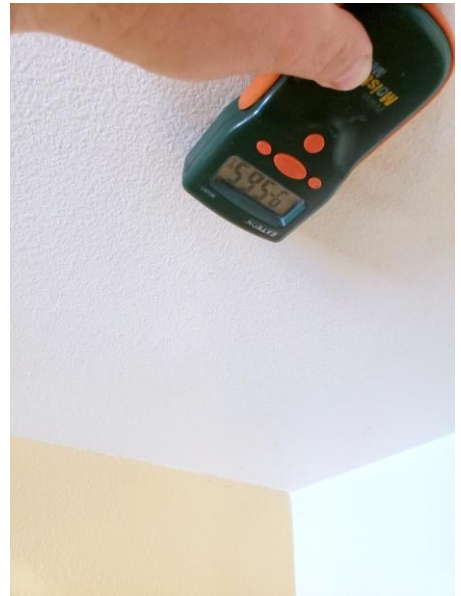
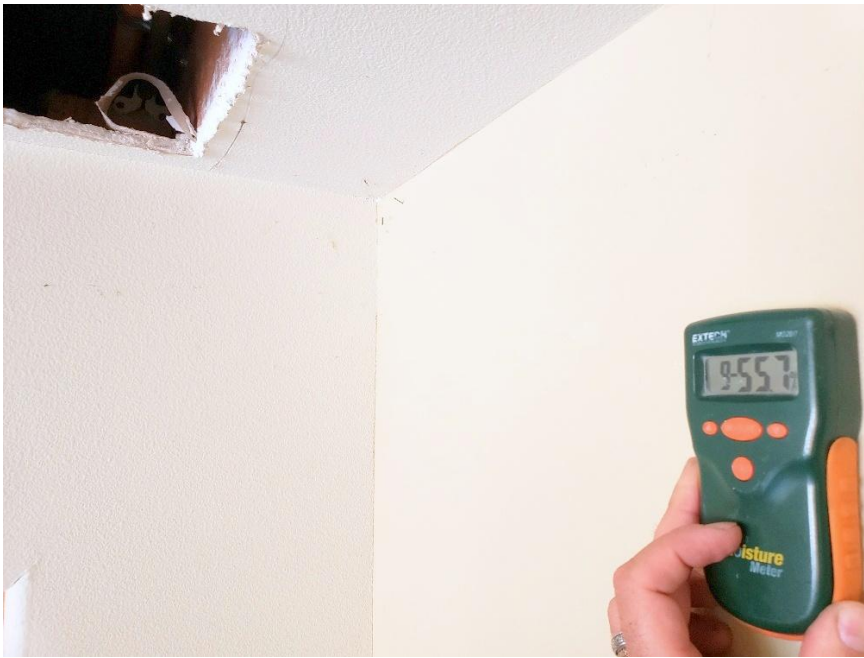
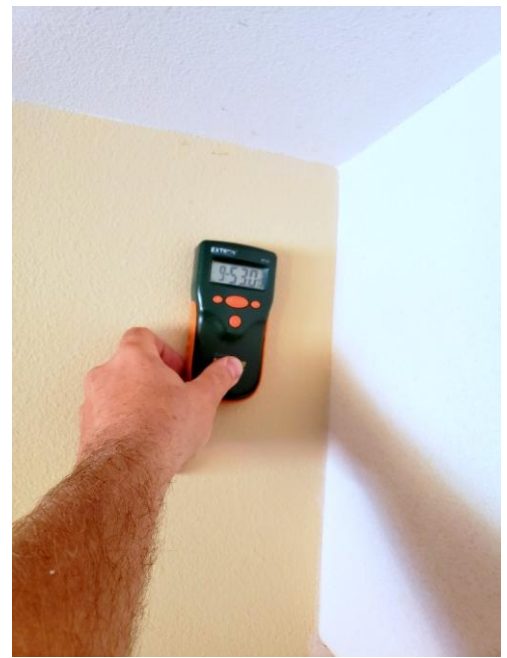
GARAGE AREA PHOTOS

SUBJECT AREA #1: GARAGE: SOUTH WALL, EAST WALL, CEILING (AT SOUTH EAST CORNER), WOODEN SHELVING, FLOOR

Property:	3 Story single family
Days since flooded:	>2
Elevated moisture content:	Detected in the subject area: >56% (High) Extech pinless moisture meter used
Visual fungal infestation:	Observed during non-destructive visual inspection on south and east walls
Signs of water intrusion:	Observed on the affected parts of ceiling and walls
Musty / Moldy odor:	Moldy or musty odor not detected (garage door was opened at the time of inspection). The client stated that the moldy/musty odor was present prior to the inspection

MOISTURE CONTENT OF PROBLEM AREA: > 56% (High) Extech pinless moisture meter used

POSSIBLE SOURCE: Plumbing leak

Asbestos sampling and lab testing of the materials marked for removal must be conducted prior to the demolition activities.

The remediator should set up plastic containment(s) to separate the water-damaged / contaminated areas from unaffected indoor areas to prevent cross-pollution.

The remediator should remove and safely dispose of all (removable) water damaged materials: drywall, insulation, water-damaged/contaminated parts of wooden shelving etc. The remediator should clean/grind all visible mold growth off the affected in-ceiling/in-wall framing and joints. The remediator should treat the affected areas with anti-microbial/antifungal agents. The remediator should install high-efficiency commercial dehumidifier(s) necessary to remove excess moisture from the building materials. The remediator should set up high-efficiency HEPA filtered air scrubber(s)/negative air machine(s) inside the containment necessary to remove any disturbed mold spores from the air inside the containment. At the end of the remediation the remediator should apply antifungal coating/encapsulant to all remediated in-wall areas to prevent re-contamination.

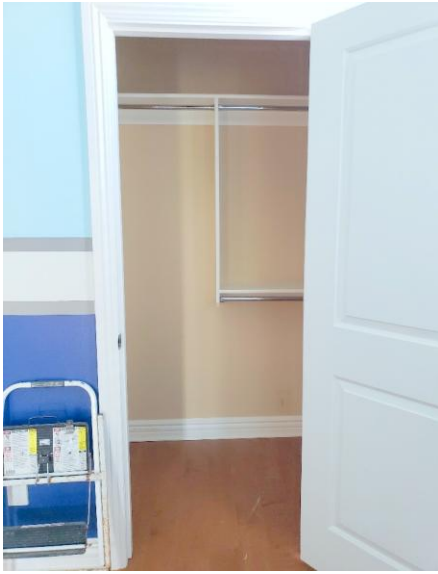
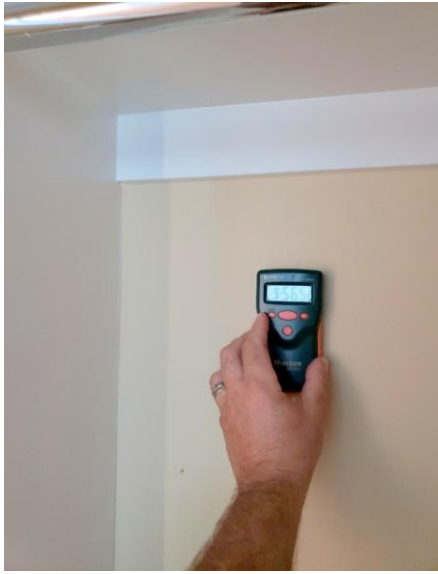
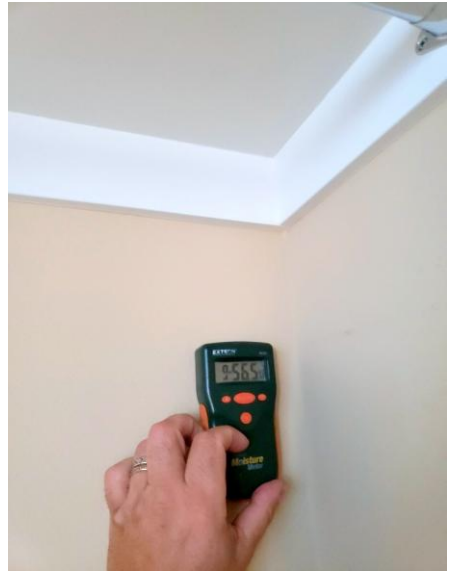
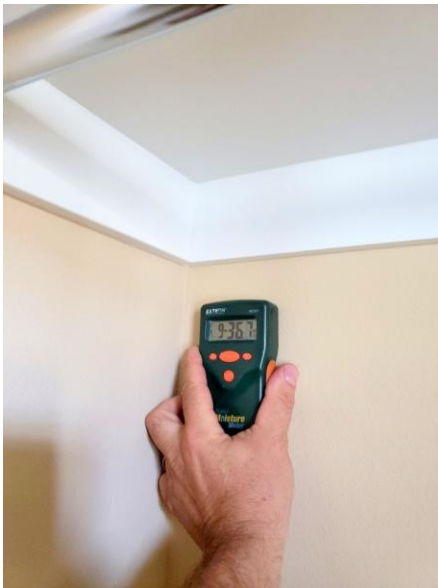
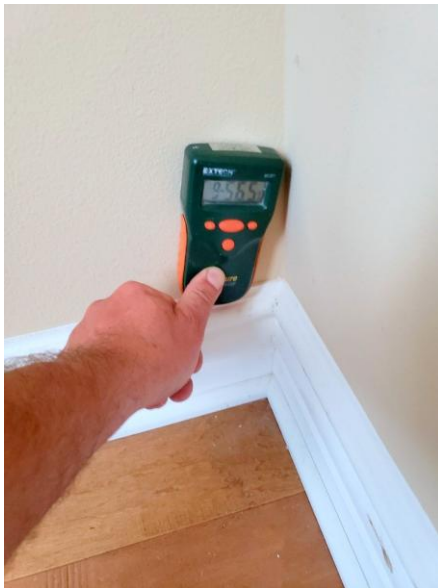
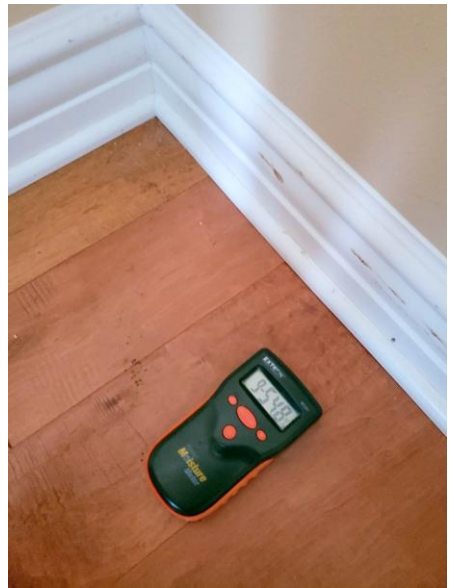
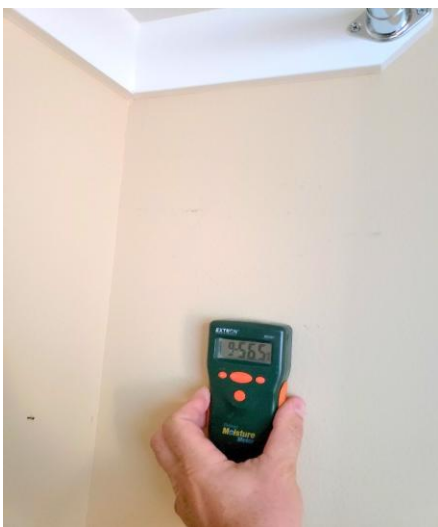
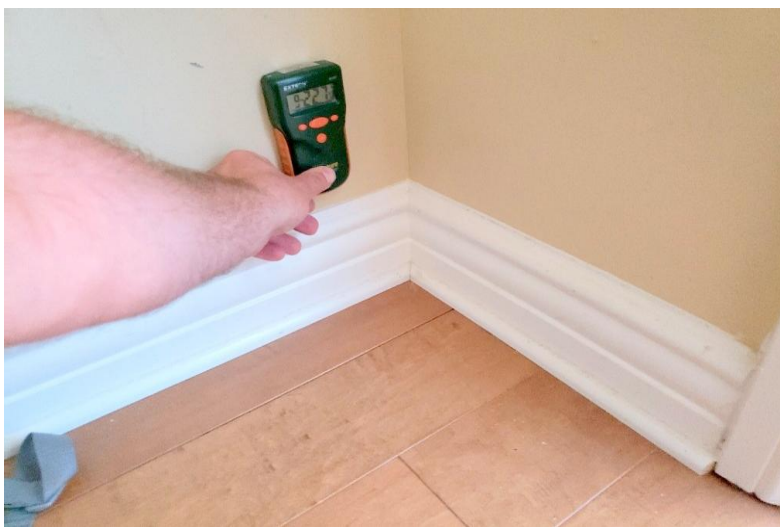
BABY ROOM CLOSET PHOTOS

SUBJECT AREA #2: BABY BEDROOM CLOSET: CEILING AND WALLS AND FLOORING**OBSERVATION:**

Property: 3 Story single family
Days since flooded: >2
Elevated moisture content: Detected in the subject area: >56% (High) Extech pinless moisture meter used
Visual fungal infestation: No mold growth observed during non-destructive visual inspection *
Signs of water intrusion: No visual signs of water intrusion observed on the affected parts of ceiling and walls
Musty / Moldy odor: No moldy or musty odor detected non-destructive visual inspection.

MOISTURE CONTENT OF PROBLEM AREA: > 56% (High) Extech pinless moisture meter used

POSSIBLE SOURCE: Plumbing leak

* After removal of baseboards, visual fungal growth was detected between baseboard and north wall (please, see pics on page 18)

Asbestos sampling and lab testing of the materials marked for removal must be conducted prior to the demolition activities.

The remediator should set up plastic containment(s) to separate the water-damaged / contaminated areas from unaffected indoor areas to prevent cross-pollution.

The remediator should remove and safely dispose of all (removable) water damaged materials: drywall, insulation, baseboards, laminate flooring etc. The remediator should clean/grind all visible mold growth off the affected in-wall framing and joints. The remediator should treat the affected areas with anti-microbial/antifungal agents. The remediator should install high-efficiency commercial dehumidifier(s) necessary to remove excess moisture from the building materials. The remediator should set up high-efficiency HEPA filtered air scrubber(s)/negative air machine(s) inside the containment necessary to remove any disturbed mold spores from the air inside the containment. At the end of the remediation the remediator should apply antifungal coating/encapsulant to all remediated in-wall areas to prevent re-contamination.

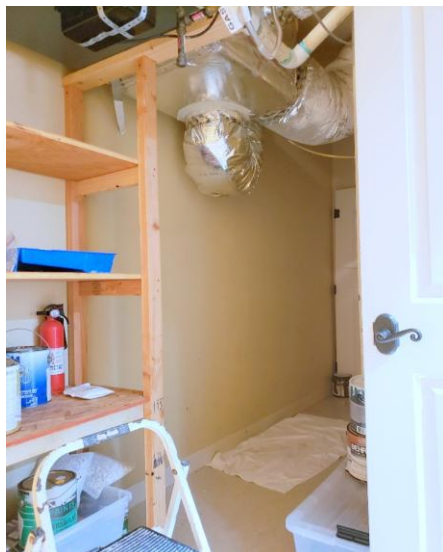
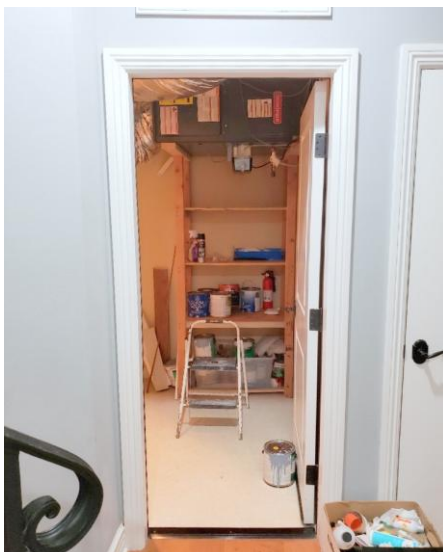
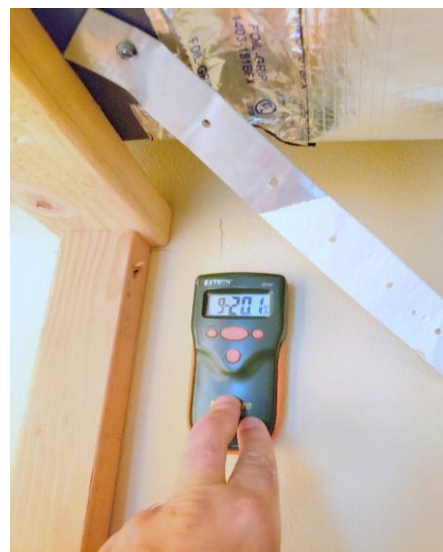
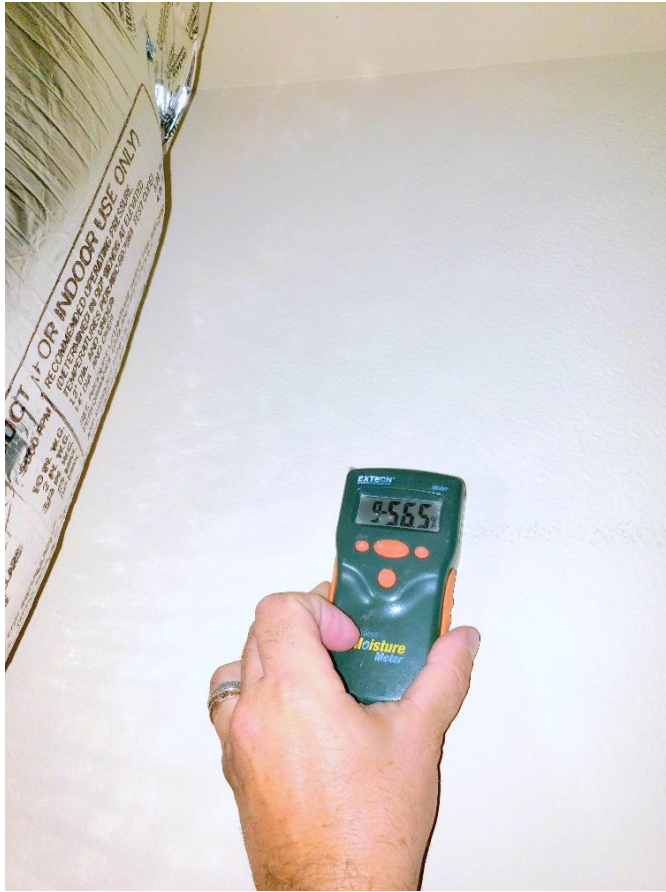
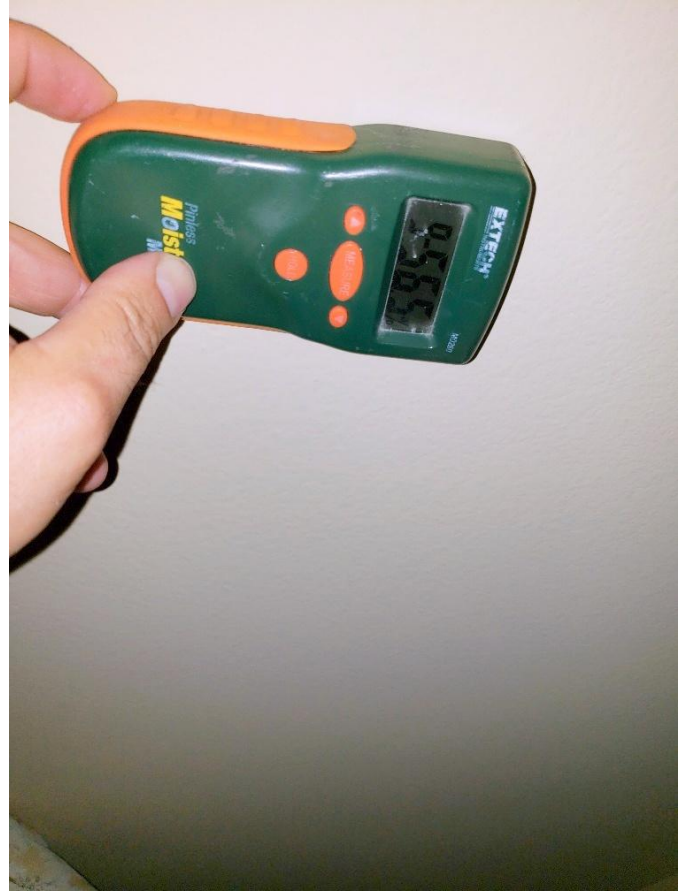
HVAC CLOSET PHOTOS

SUBJECT AREA #3: HVAC CLOSET: PARTS OF NORTH WALL AND CEILING**OBSERVATION:**

Property: 3 Story single family
 Days since flooded: >2
 Elevated moisture content: Detected in the subject area: >56% (High) Extech pinless moisture meter used
 Visual fungal infestation: No mold growth observed during non-destructive visual inspection
 Signs of water intrusion: No visual signs of water intrusion observed on the affected parts of ceiling and walls
 Musty / Moldy odor: No moldy or musty odor detected non-destructive visual inspection.

MOISTURE CONTENT OF PROBLEM AREA: > 56% (High) Extech pinless moisture meter used

POSSIBLE SOURCE: Plumbing leak

Asbestos sampling and lab testing of the materials marked for removal must be conducted prior to the demolition activities.

The remediator should set up plastic containment(s) to separate the water-damaged / contaminated areas from unaffected indoor areas to prevent cross-pollution.

The remediator should remove and safely dispose of all (removable) water damaged materials: drywall, insulation etc. The remediator should clean/grind all visible mold growth off the affected in-ceiling/in-wall framing and joints. The remediator should treat the affected areas with anti-microbial/antifungal agents. The remediator should install high-efficiency commercial dehumidifier(s) necessary to remove excess moisture from the building materials. The remediator should set up high-efficiency HEPA filtered air scrubber(s)/negative air machine(s) inside the containment necessary to remove any disturbed mold spores from the air inside the containment. At the end of the remediation the remediator should apply antifungal coating/encapsulant to all remediated in-wall/in-ceiling areas to prevent re-contamination.

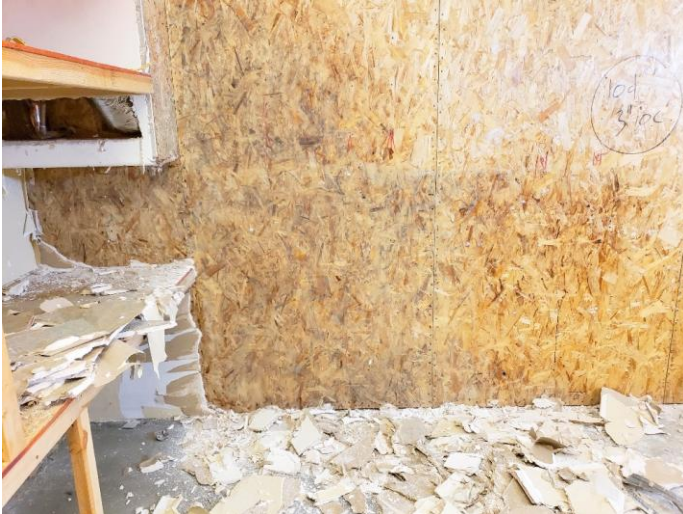
1. South wall

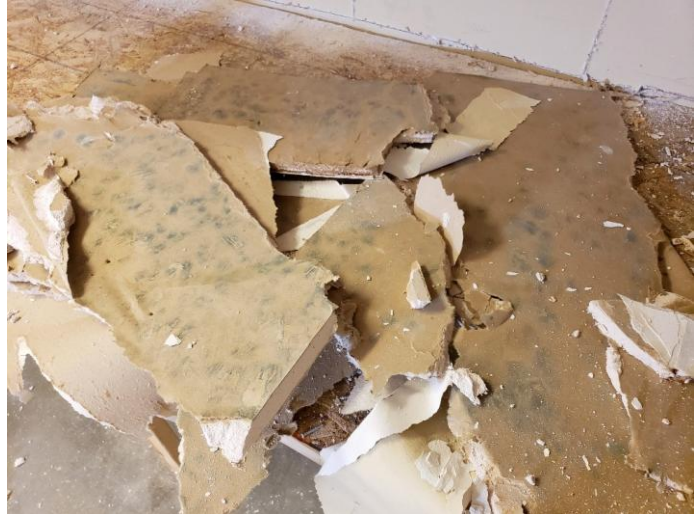
2. Mold Contaminated drywall

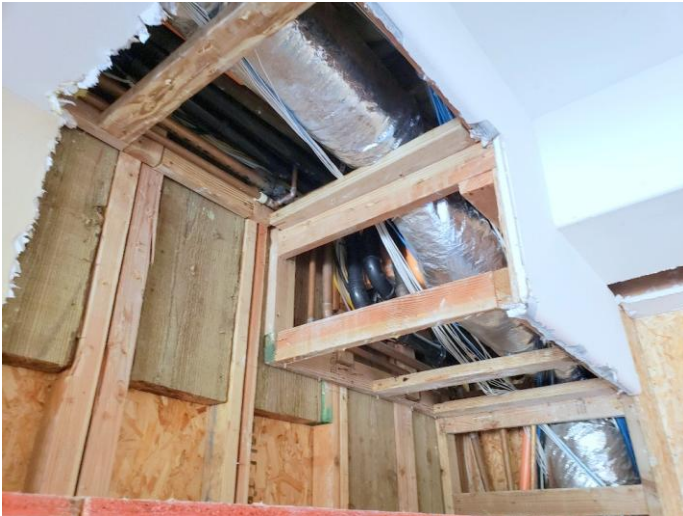
3. East wall and ceiling

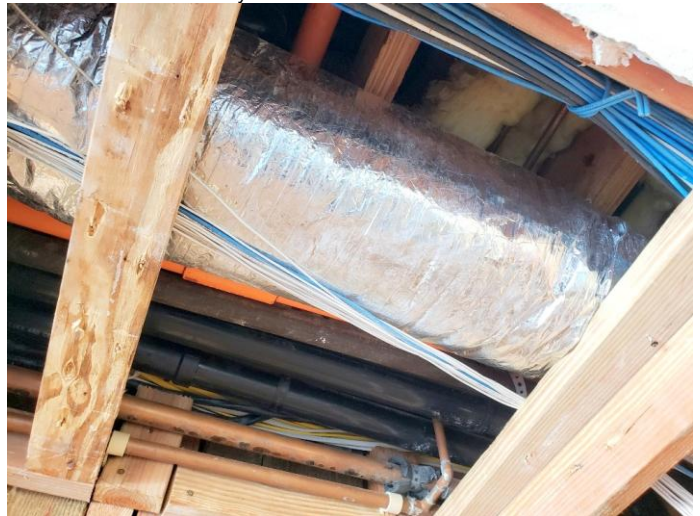
4. Portion of the in-ceiling lumber after cleaning

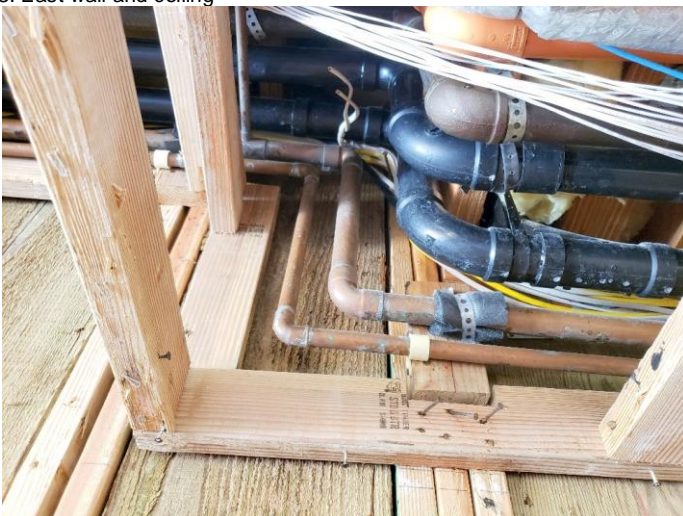
5. Portion of the in-wall and in-ceiling lumber after cleaning and chem. treatments.

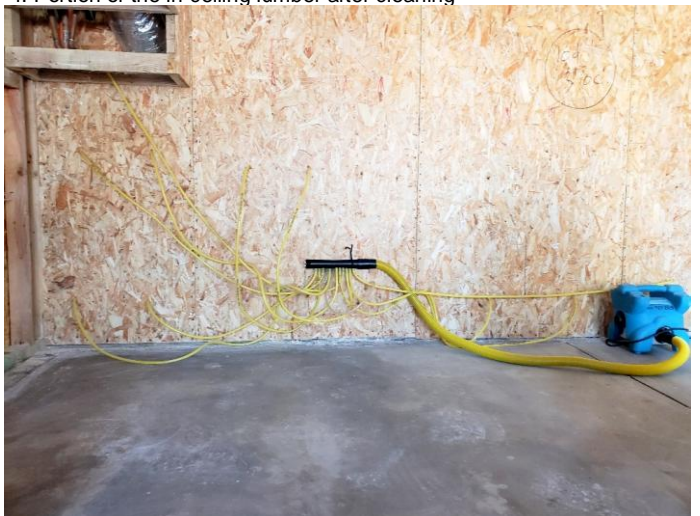
6. South wall after cleaning and chem. treatments. In-wall drying system installed

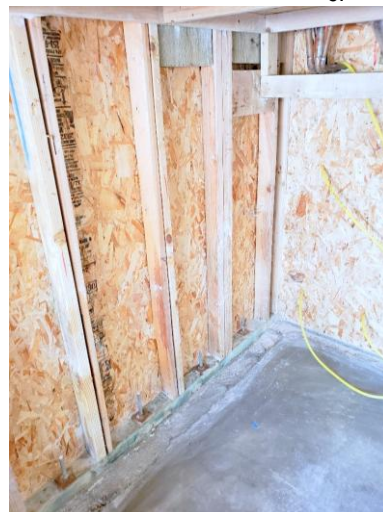
11. South-east corner

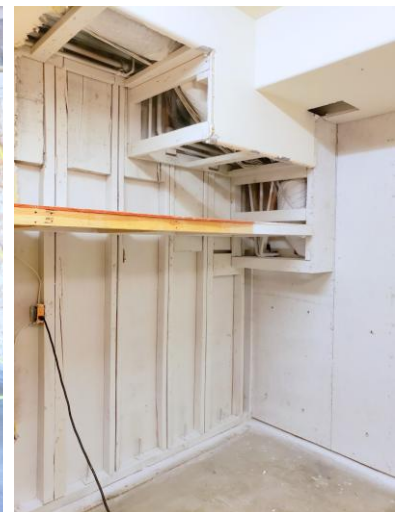
12. South-east corner after encapsulation

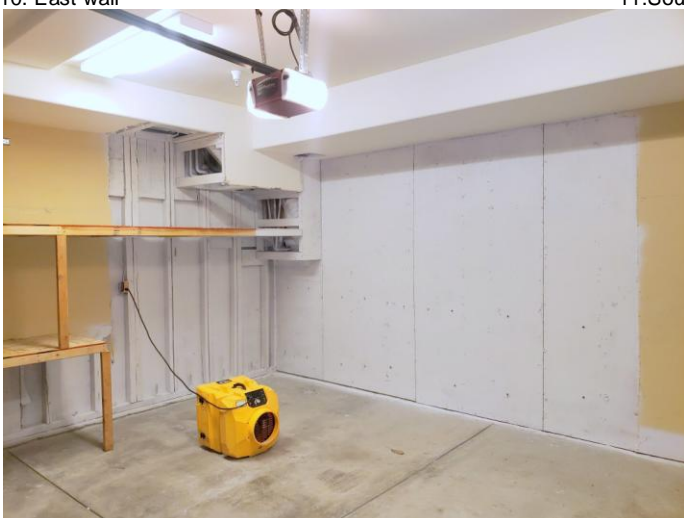
13. South and east walls after encapsulation

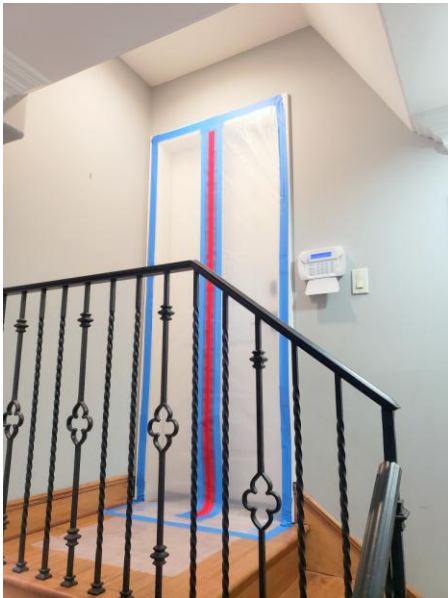
15. Sealed garage door

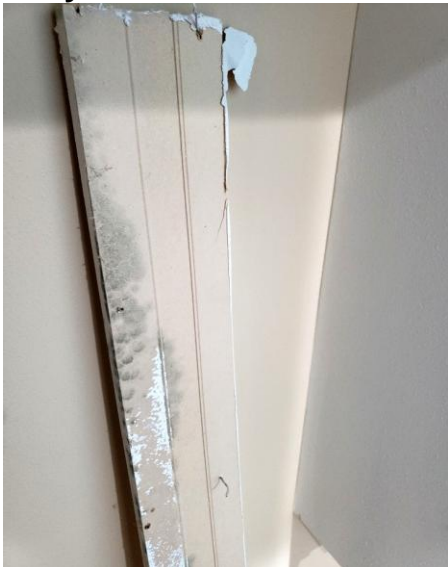
16. Mold contaminated baseboard

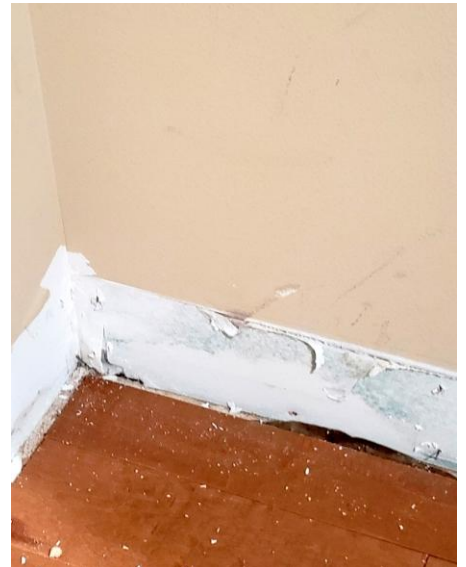
18. Fungal growth on the north wall

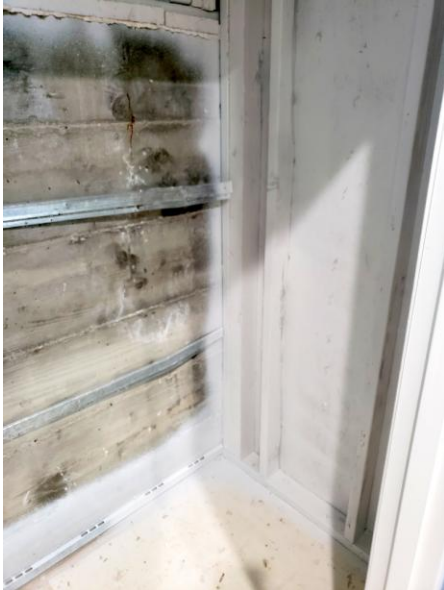
25. Closet after encapsulation

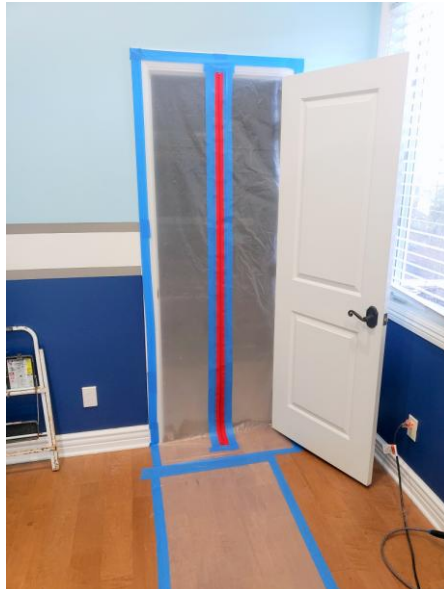
29. Sealed entrance

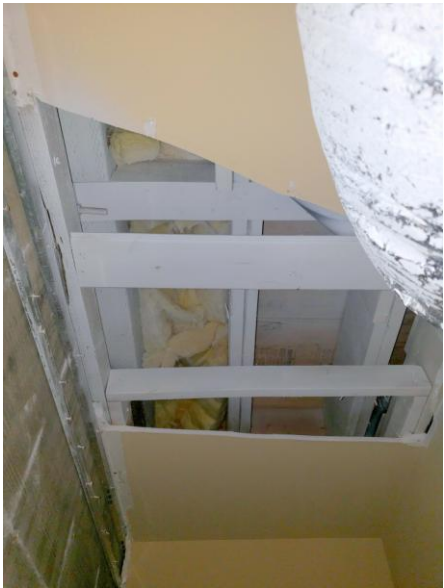
33. Ceiling after encapsulation

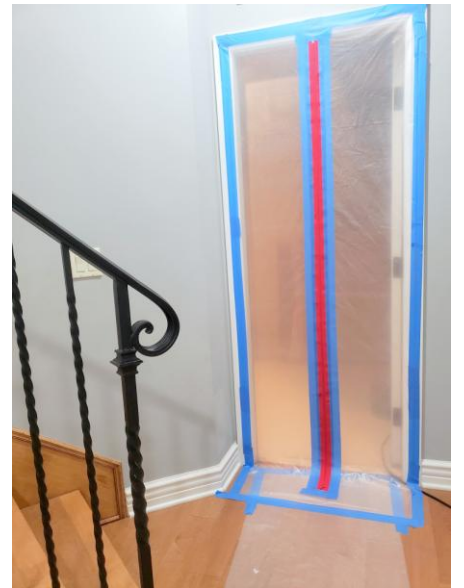
35. Closet's sealed door
