WOOD DESTROYING PESTS AND ORGANISMS INSPECTION REPORT

Building Address:				Date of Inspection	Number of Pages
2910 Burton Dr., Cambria, CA 93428				11/20/2025	9
805 Termite & Pest Control, Inc. P.O. Box 1818					Report # W15438
Nipomo, CA 93444 (805) 296-6058				Lic. Registration # PR 8447	
control, inc					Escrow#
Ordered by: Coldwell Banker Bill Mathes	Property	Owner and/or Party of Interest:		Sent to: Iwell Banker Mathes	
COMPLETE REPORT V LIMITED REPORT SUPPLEMENTAL REPORT REINSPECTION REPORT					т
General Description: Single family residence, detatched garage, comp roof, wood siding, vacant Inspection				on Tag Posted: G	Sarage
Other None				Tags Posted:	
An inspection has been made of the structure(s) shown on the diagram in accordance with the Structural Pest Control Act. Detached porches, detached steps, detached decks and any other structures not on the diagram were not inspected.					
Subterranean Termites 🗹 Drywood Termites 🗹 Fungus / Dryrot 🗹 Other Findings 🗹 Further Inspection 🗹 If any of the above boxes are checked, it indicates that there were visible problems in accessible areas. Read the report for the details on checked items.

Address 2910 Burton Dr., Cambria, C

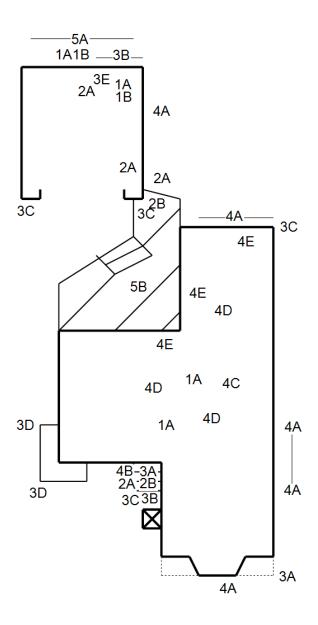
This Diagram is not to scale

FINDINGS: Evidence of subterranean termite infestation was noted at the siding and the cellulose debris. RECOMMENDATION: Chemically treat all soil adjacent perimeter of all exterior walls. Treatment will be made utilizing our trench and treat and/or slab injection. Holes may need to be drilled through the concrete to allow for the chemical to reach the soil below. 805 Termite Control will exercise reasonable caution when drilling but assumes no liability for damage to hidden plumbing, electrical, or other utilities below these areas. Our company will also knock down any accessible subterranean termite mud tubes. Treatment is Guaranteed for TEN YEARS from date of treatment.

FINDINGS: Subterranean termite damage was found at the siding.

FINDINGS: Evidence of drywood termite infestation at the fascia and the garage framing as indicated on the

diagram.

FINDINGS: Drywood termite damage was found at the fascia.

FINDINGS: Fungus damage was noted at the post.

FINDINGS: Fungus damage was noted at the siding.

FINDINGS: Fungus damage was noted at the fascia.

FINDINGS: Fungus damage was noted at the window shelf.

FINDINGS: Fungus damage was noted at the garage framing.

FINDINGS: Earth to wood contact was noted at the siding.
