# WOOD DESTROYING PESTS AND ORGANISMS INSPECTION REPORT

Building No. 1273	Street Arch Way	City Chico	ZIP 95973	Date of Inspection 04/25/2022	Number of Pages 4
<b>Stone Ridge Termite and Pest</b> <b>P.O. Box 6927</b> Chico CA 95927 (530) 228-1964 (530) 876-9271 stoneridge0790@sbcglobal.net Fax (530) 876-9273				Report # : 39853 Registration # : PR3779 Escrow # : <input type="checkbox"/> CORRECTED REPORT	
Ordered by: Alice Zeissler C-21 Select Real Estate 1101 El Monte Ave Chico CA 95928 atozchico@gmail.com		Property Owner and/or Party of Interest: C/O Alice Zeissler C-21 Select Real Estate 1101 El Monte Ave Chico CA 95928 atozchico@gmail.com		Report sent to: Alice Zeissler C-21 Select Real Estate 1101 El Monte Ave Chico CA 95928 atozchico@gmail.com	
COMPLETE REPORT <input checked="" type="checkbox"/> LIMITED REPORT <input type="checkbox"/> SUPPLEMENTAL REPORT <input type="checkbox"/> REINSPECTION REPORT <input type="checkbox"/>					
GENERAL DESCRIPTION: Single family residence; furnished, attached garage				Inspection Tag Posted: Garage Other Tags Posted: None noted

1273	Arch Way	Chico	CA	95973
Address of Property Inspected		City	State	ZIP
04/25/2022	39853			
Date of Inspection	Co

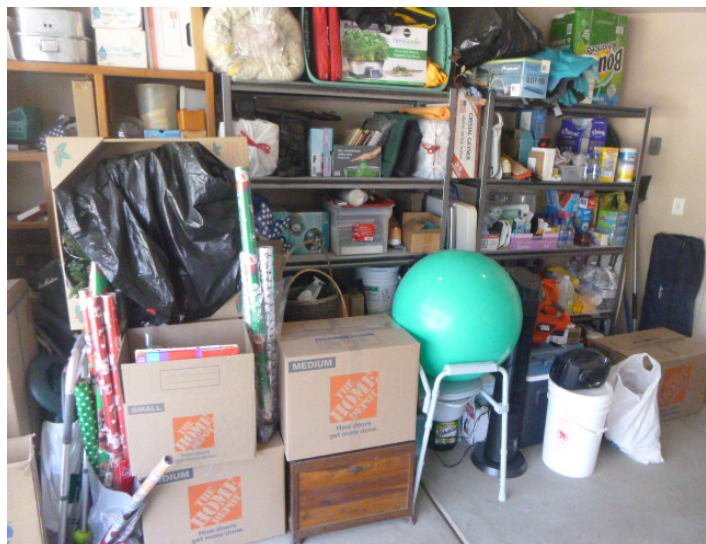
8A

FINDING: Portions of the garage are inaccessible for inspection due to occupant's storage along the perimeter walls.

RECOMMENDATION: The owner should remove the storage and call for further inspection of the garage. For an additional charge not to exceed the cost of the original inspection, the garage will be inspected and a supplemental report will be issued and any findings and recommendations will be listed.

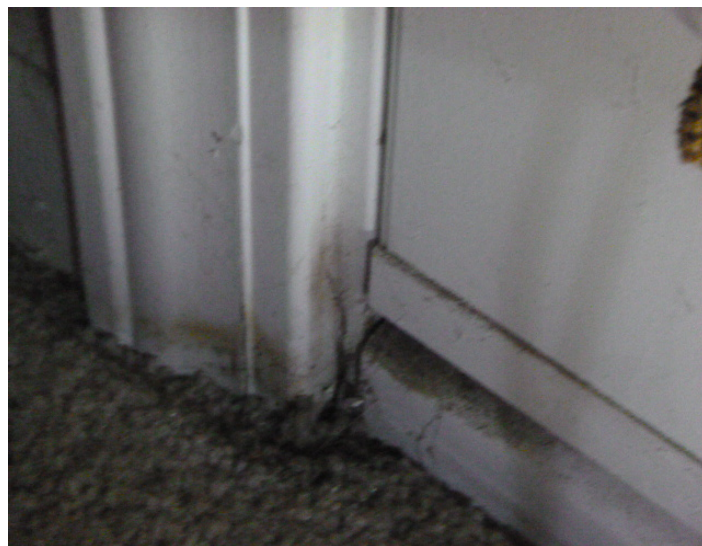
10A

FINDING: Stains were noted at the base of the master bedroom door and frames. Unable to determine if stains are active or passive.

RECOMMENDATION: Interested parties should engage the services of a licensed contractor to check for leaks and to perform any corrective work needed.

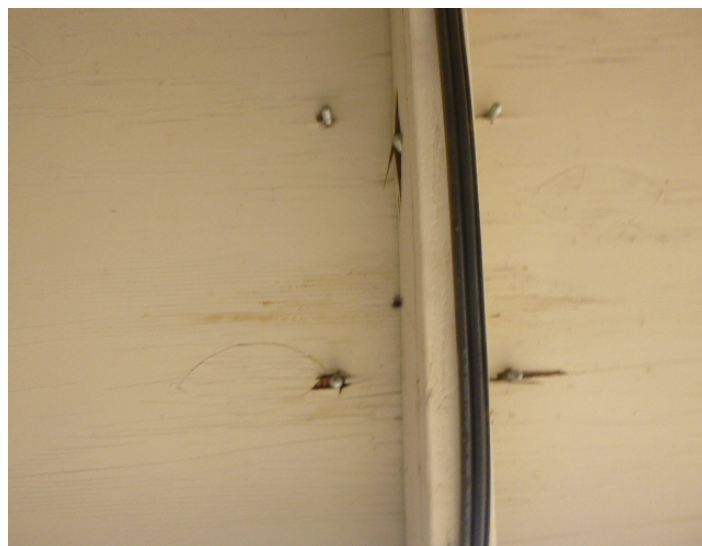
11A

FINDING: Stains were noted at the roof sheathing adjacent to the satellite dish mounting bolts.

RECOMMENDATION: Interested parties should engage the services of a licensed contractor to check for leaks and to perform any corrective work needed.
