Inspection Report

Property Address:
1102 7th Place
Hermosa Beach CA 90254

Ferguson Home Inspections

Date: 10/13/2022	Time: 02:00 PM	Report ID: 10132022Prospect
Property: 1102 7th Place Hermosa Beach CA 90254	Customer: Wendy & Scott Fletcher	Real Estate Professional: Amy Teitelbaum

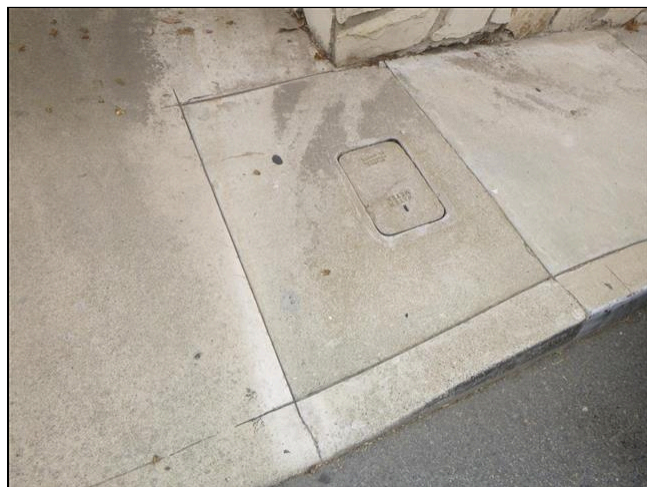
1.0 Item 1 (Picture)

1.0 Patched and repaired areas of the driveway was noted. Suggest review with the seller on the cause and any repairs needed. Suggest repair as needed.

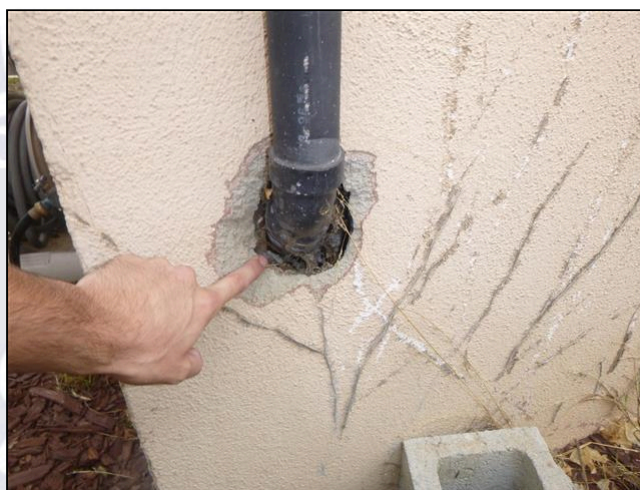
1.4 Item 1 (Picture)

1.4 (1) A large hole/gaps were noted at the stucco siding at the rear left near the plumbing vent. Suggest sealing around the siding penetration's to prevent future water/insect/rodent intrusion at these areas.

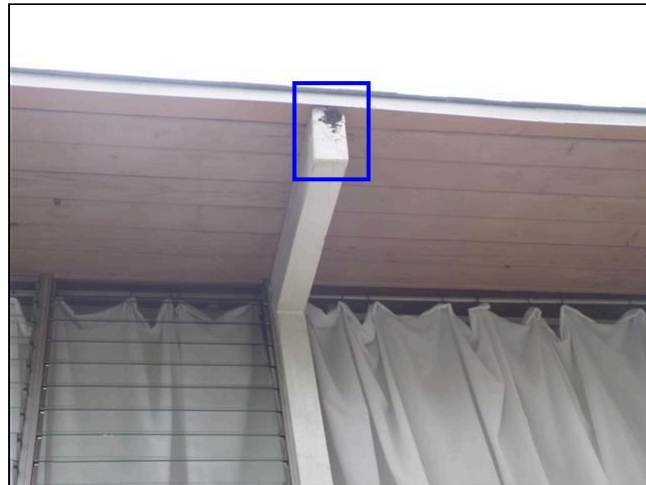
1.5 Item 1 (Picture)

1.5 Paint blistering, peeling and wood deterioration noted at various trim areas. Suggest review with a termite company and/or a licensed contractor and repair/replace as needed.

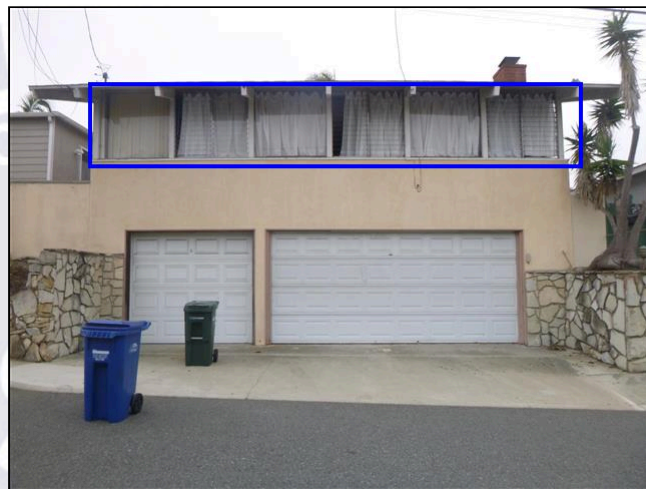
1.6 Item 1 (Picture)

1.6 (1) Aluminum louvered windows noted throughout the dwelling. These style windows, due to the style and construction, are susceptible to leak during heavy and direct rain. Due this issue and that the glass is also non-tempered, please review with a licensed contractor for replacement costs as needed.

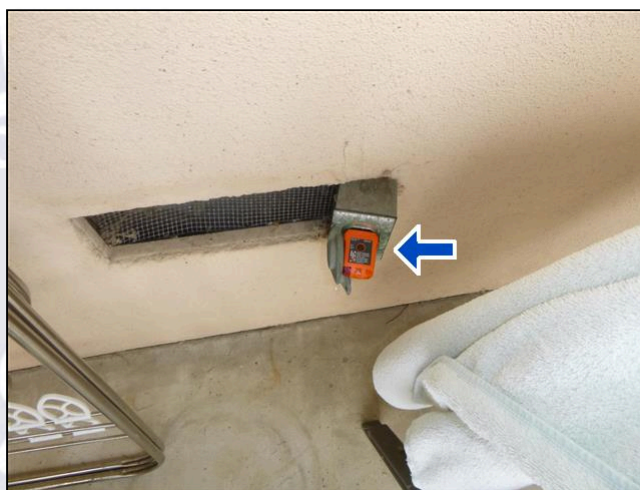
1.8 Item 1 (Picture)

1.8 (1) Unable to test the outlet at the rear exterior area as there was no power to the outlet. Suggest review with a licensed electrician for repair/ replacement cost and confirm correct operation as needed.

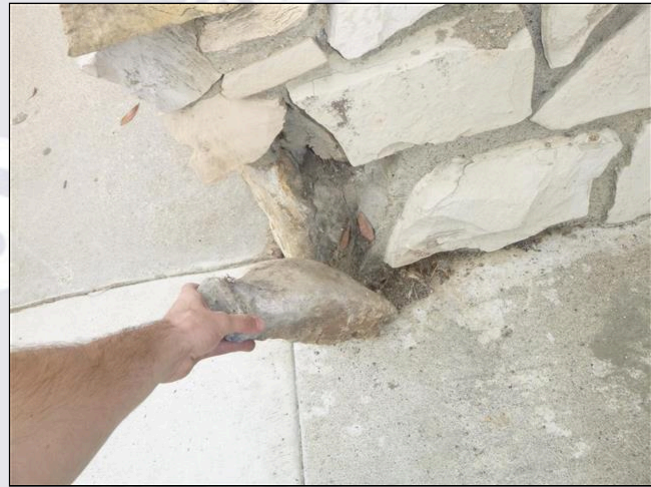
1.10 Item 2 (Picture)

1.10 A stone was loose at the front retaining wall, suggest repairs as needed.

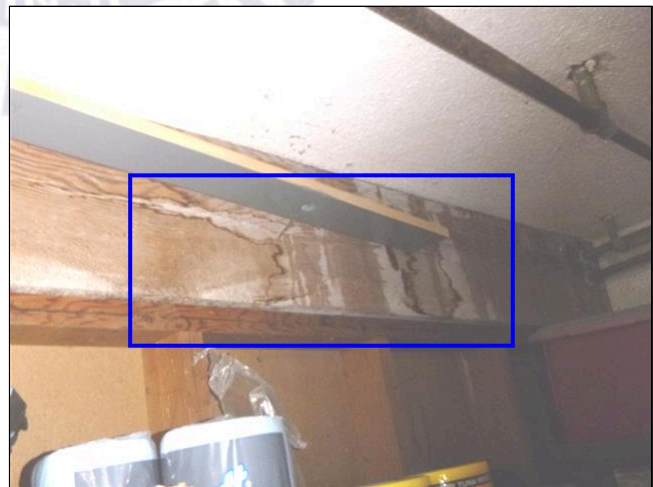
3.1 Item 2 (Picture)

3.1 (1) Water staining/deterioration noted at the interior floor support system at the garage area, suggest review with a licensed contractor and a licensed termite contractor as needed.

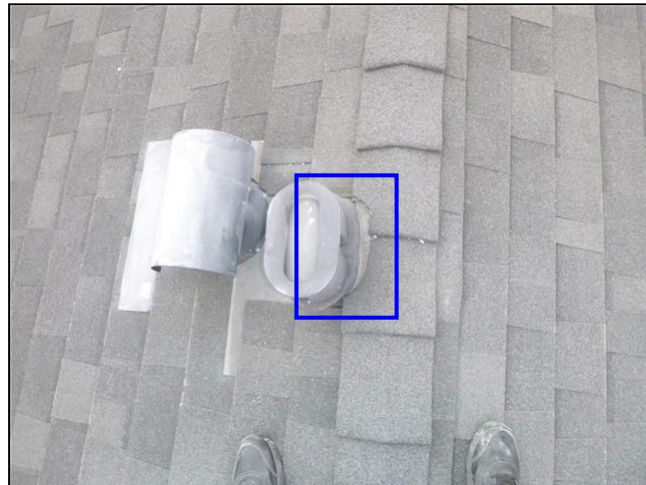
4.1 Item 1 (Picture)

4.1 A flashing is incorrectly installed on the ridge (penetrations should not be installed on a ridge). Suggest review with a licensed roofer for repair/ relocation costs as needed to prevent future leakage.

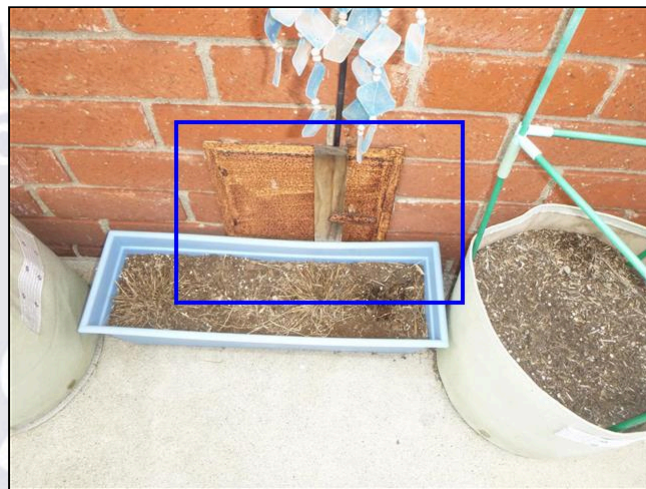
4.2 Item 1 (Picture)

4.2 (1) The chimney ash clean out port door was deteriorated/rusted/loose at the time of the inspection, this is a possible fire spread hazard. Suggest repair/ replace as needed.

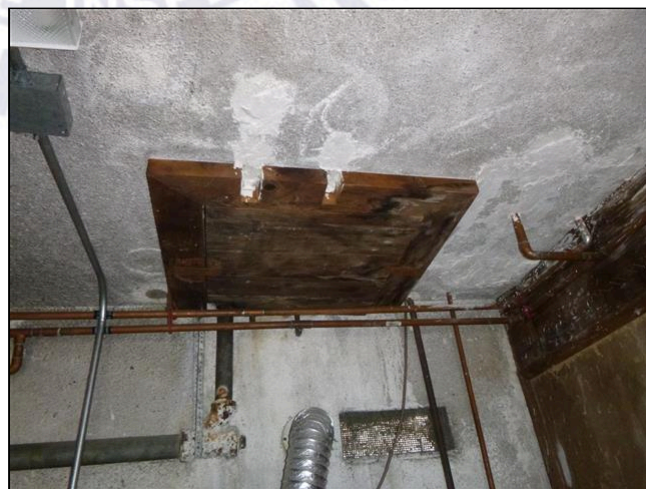
6.1 Item 1 (Picture)

6.1 (2) Water stains and deterioration noted at the ceiling, suggest repair/replace as needed.

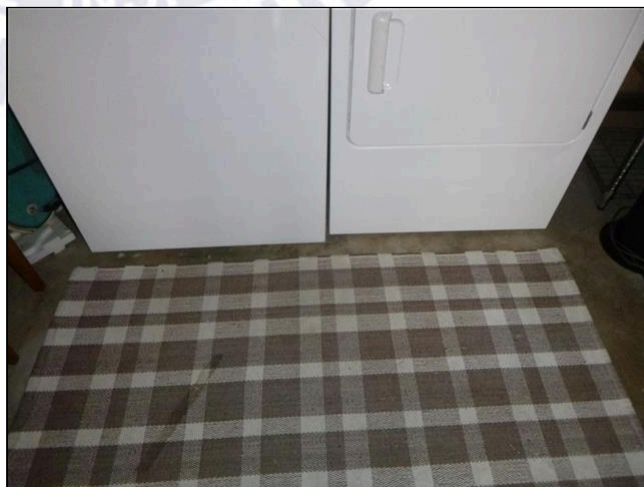
6.5 Item 2 (Picture)

6.5 (2) The dryer is not 18 inches above the garage floor level to ensure separation from combustibles as required. This is a potential safety hazard. Suggest review by a licensed plumber for repairs/relocation costs as required for safety.

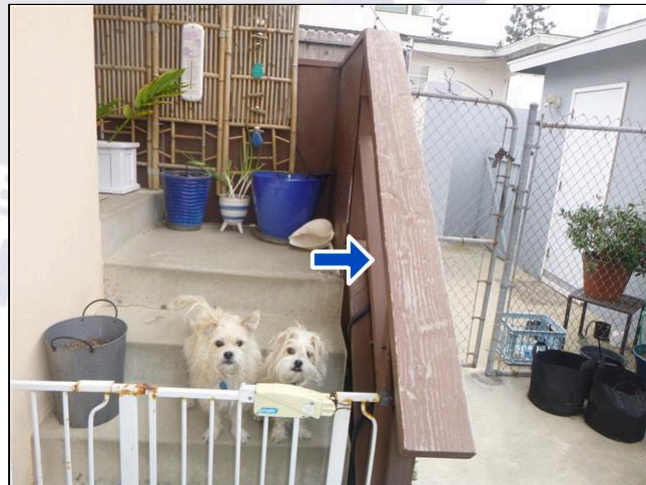
7.2 Item 1 (Picture)

7.2 (1) A non graspable handrail was noted at this area, this is a potential safety hazard. Suggest review with a licensed contractor for costs to upgrade to current standards for safety and/or as needed.

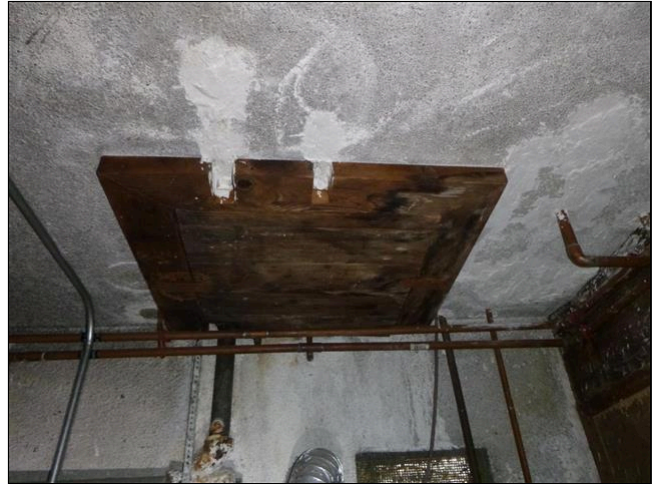
8.4 Item 2 (Picture)

8.4 (1) Patched and uneven areas of the ceiling noted (likely from past water damage), suggest review with the seller on the cause and any repairs needed. Suggest repair as needed.

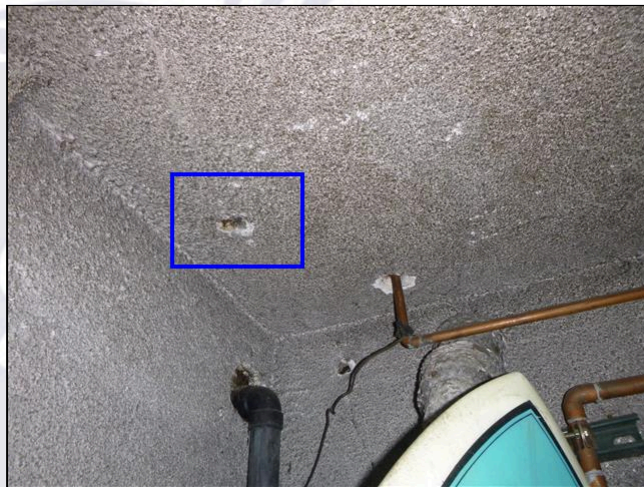
8.4 Item 3 (Picture)

8.4 (2) Holes and unfinished sections of firewall and ceiling were noted, this is a potential fire spread hazard. 5/8 inch sheetrock may be installed as a minimum standard material and as a requirement for a one hour burn through rating for firewall. Suggest review by licensed contractor for repair/installation costs as needed.

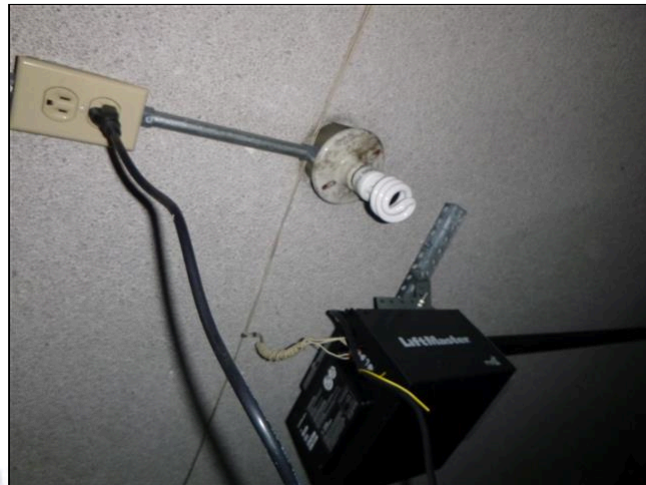
8.5 Item 1 (Picture)

8.5 (2) The cover globe(s) are missing at light fixture(s) at the time of the inspection. Suggest replacing the missing cover globe(s) for safety.

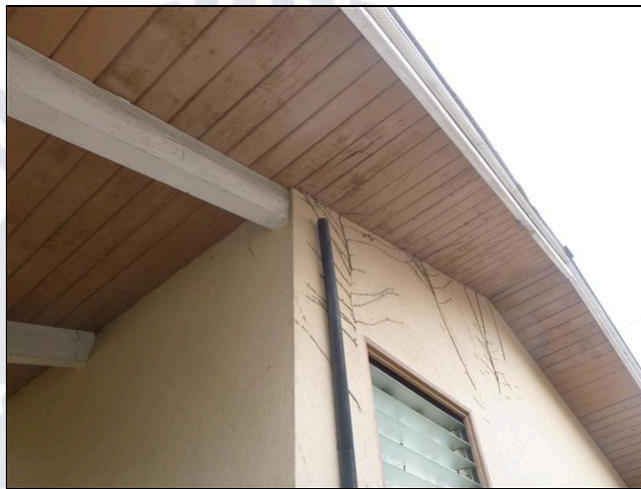
12.0 Item 2 (Picture)

12.0 (3) The plumbing vent at the rear left is installed incorrectly and does not extend 12 inches past the roof as required. Suggest review with a licensed plumber for repairs as needed.

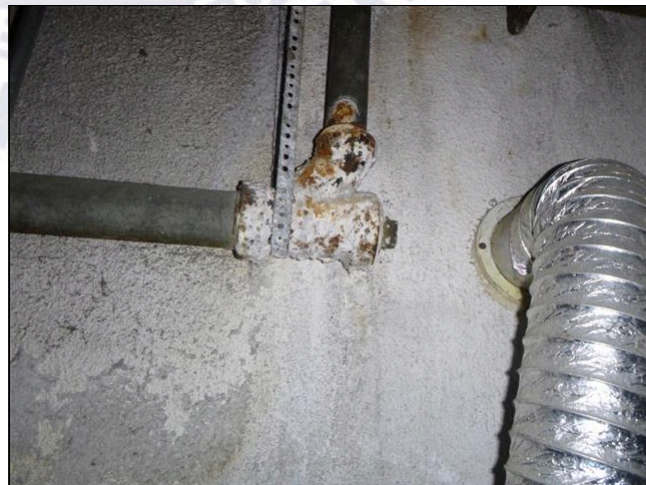
12.0 Item 3 (Picture)

12.0 (4) Excessive rust and corrosion noted at the drains within the garage. Suggest review by a licensed plumbing contractor for repair/replacement costs as needed.

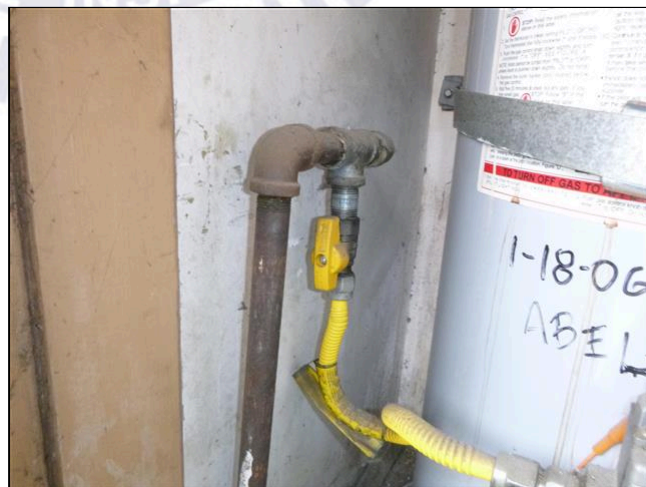
13.0 Item 6 (Picture)

13.0 (3) Currently no gas supply line drip leg/sediment trap is installed, please be aware that various cities do not enforce/require this installation. Suggest review with the local City Building Department and/or with a licensed plumbing contractor for installation costs as needed.

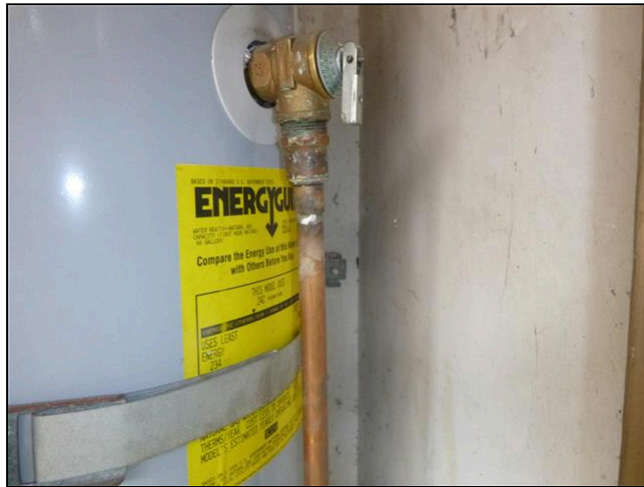
13.0 Item 7 (Picture)

13.0 (4) The pipe off the temperature pressure release valve is undersized, suggest review with a licensed plumber for replacement costs as required.

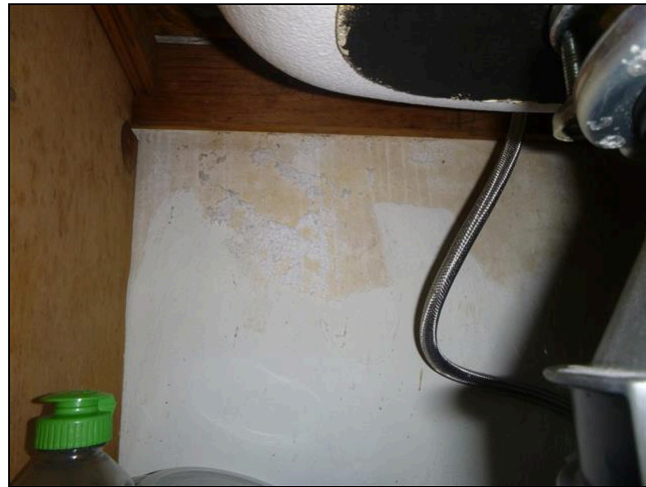
14.1 Item 1 (Picture)

14.1 Water damage/staining was noted under the sink, suggest review with a licensed contractor for removal/repair/ replacement costs as needed.

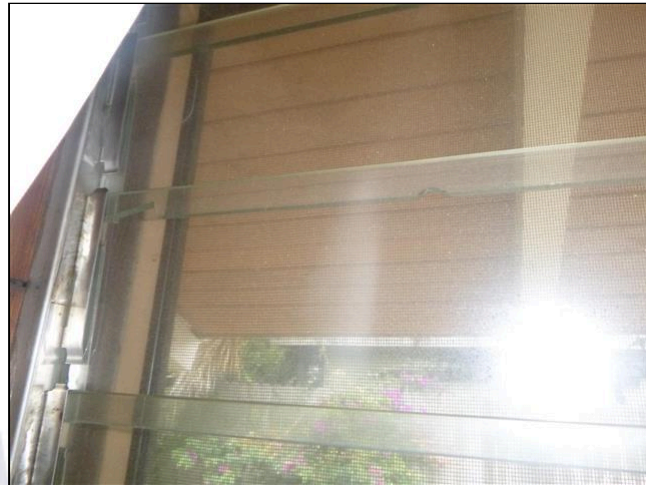
14.3 Item 1 (Picture)

14.3 (2) Chipped glass noted at the window(s), this is a potential safety hazard. Suggest review with a licensed contractor/glazing company for replacement costs as required for safety.

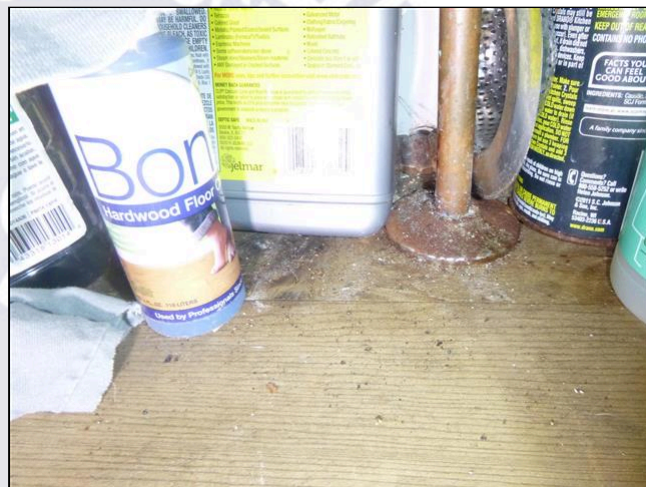
14.5 Item 1 (Picture)

14.5 The base cabinet under the sink is deteriorated/stained from previous leaks, suggest repair/replace as needed.

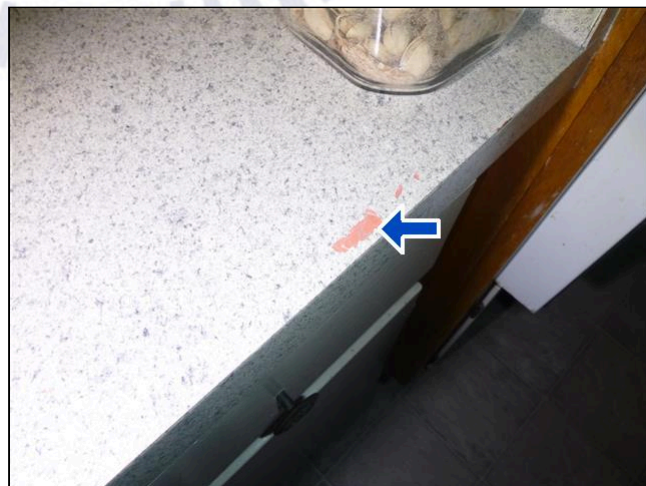
14.6 Item 1 (Picture)

14.6 Minor deterioration noted at the countertop, suggest repair/replace as needed.

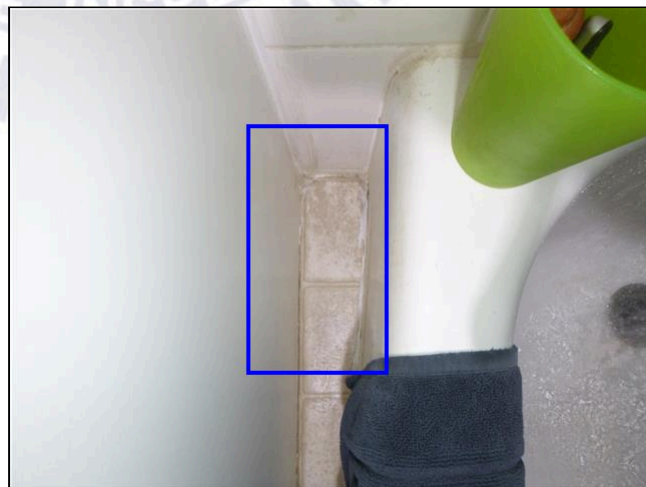
15.0 Item 1 (Picture)

15.0 The flooring is soft between the shower and the cabinet, this is likely due to water leaking from the shower area and damaging the subflooring. Suggest review with a licensed contractor for removal/repair/replacement costs as needed.

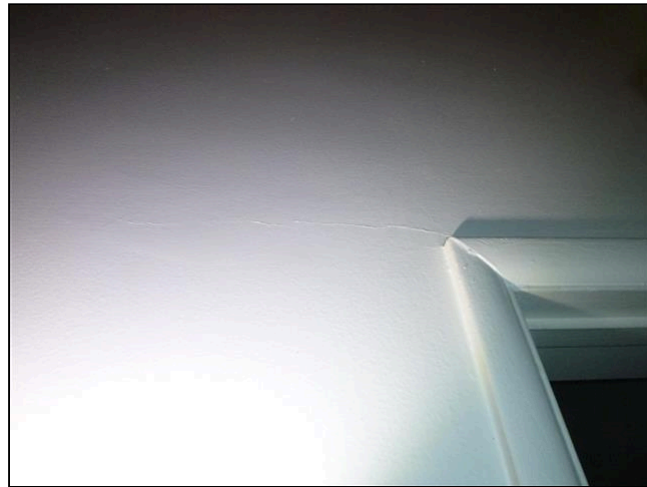
15.1 Item 1 (Picture)

15.1 (1) Settling cracks and patching was noted, suggest repair as needed.

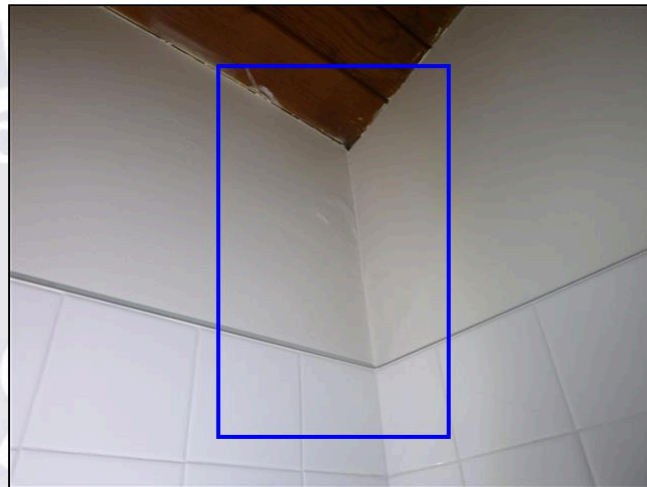
15.1 Item 2 (Picture)

15.1 (2) Old water damage was noted at the rear wall/corner, suggest review with a licensed contractor for repairs as needed.

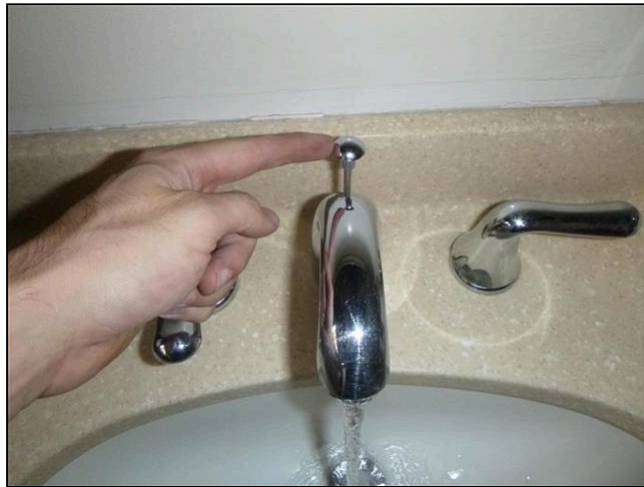
15.14 Item 1 (Picture)

15.14 The sink stopper is faulty/ inoperable, suggest repair/replace as needed.

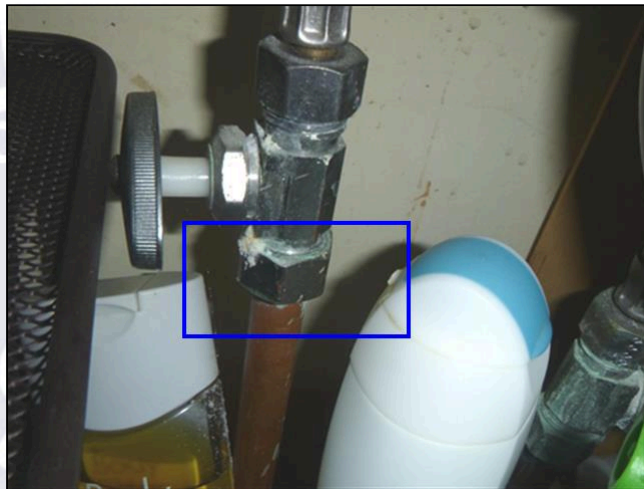
15.16 Item 1 (Picture)

15.16 Corrosion noted at the sink angle valve(s), no leaking noted at the time of the inspection. Suggest review with a licensed plumber and repair/replace as needed.

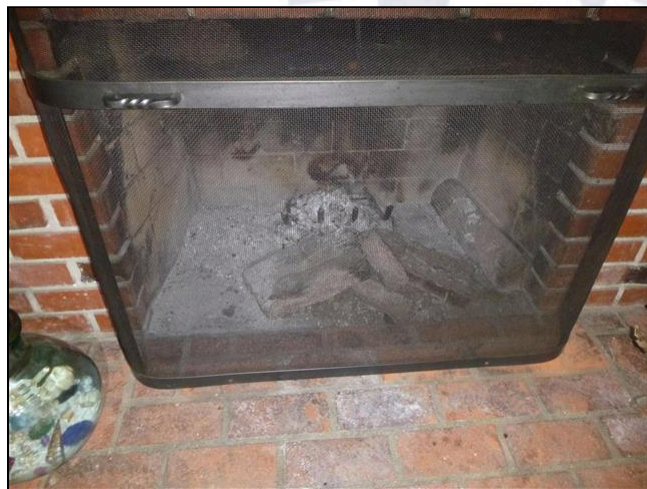
17.6 Item 3 (Picture)

17.6 (4) The tenant advised the inspector that the gas line was previously "Red Tagged" by the gas company which indicates a safety hazard. The tenant also advised that the tag was removed but no repairs were done/completed. Suggest review with the gas company as needed for safety.

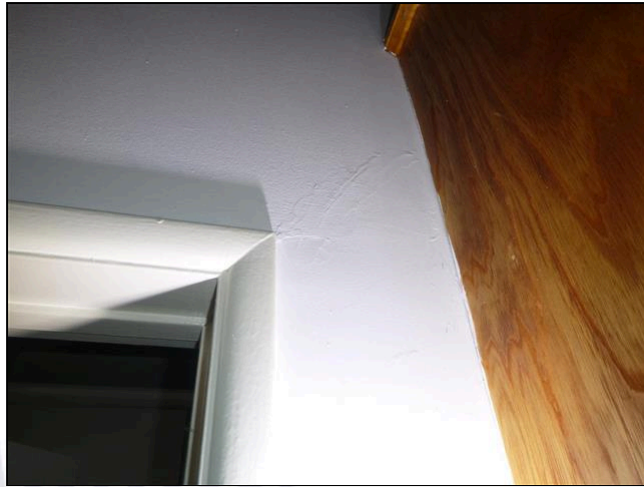
18.1 Item 1 (Picture)

18.1 Settling cracks and patching was noted, suggest repair as needed.

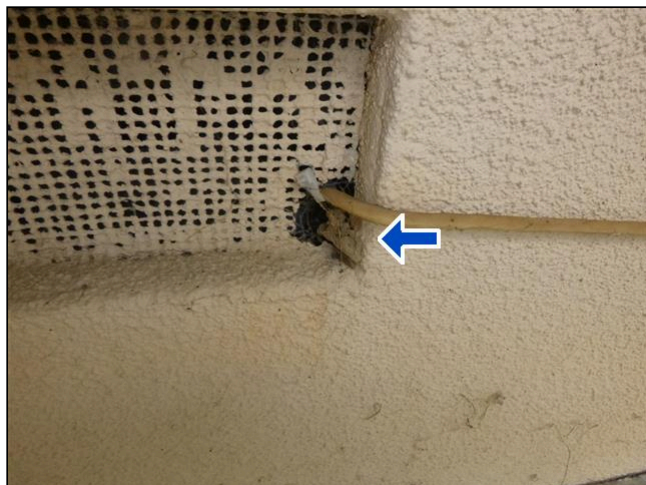
1.13 Item 1 (Picture)

- (1) Suggest review of trees and root structures to prevent future damage to the property, drainage systems and structures.
- (2) The vent to the garage area is deteriorated, suggest repairs/replacement as needed.

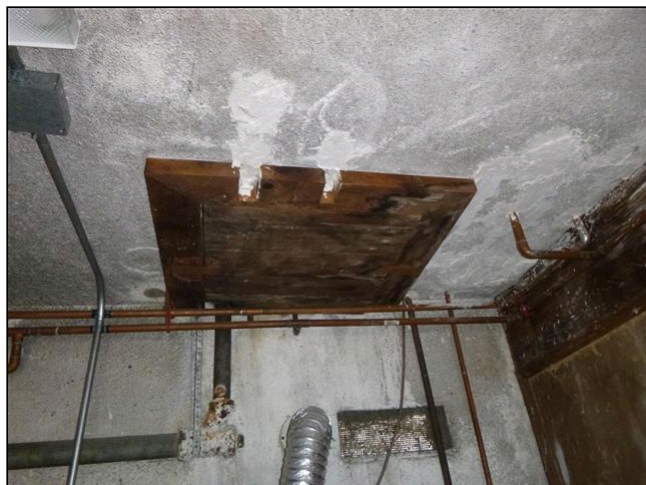
6.1 Item 1 (Picture)

(2) Water stains and deterioration noted at the ceiling, suggest repair/replace as needed.

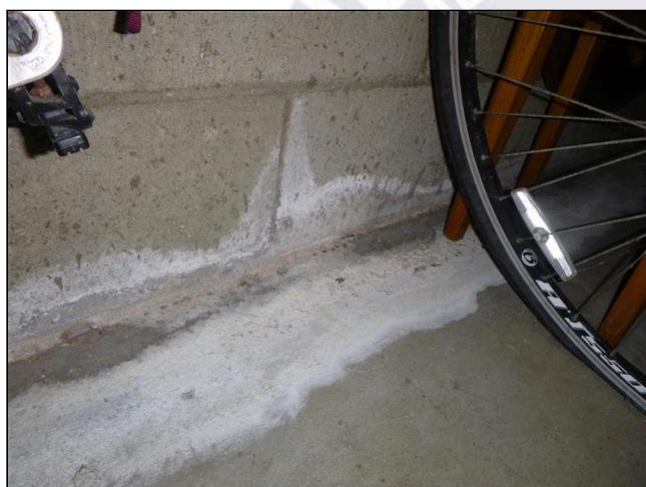
8.0 Item 3 (Picture)

(2) White efflorescence (powder substance) on foundation footings indicates prior, and possibly ongoing, excessive moisture build up at the exterior of the foundation. Ongoing water intrusion at the foundations can, in some cases, cause the steel in the foundations to rust, called spalling, which can lead to horizontal cracking of the foundation (currently there are no major horizontal cracks visible at the foundation). Any future horizontal cracking/damage can be an expensive repair as the foundation would be considered structurally weak and susceptible to horizontal movement. Suggest review of the Lot/Grade and drainage systems, including rain gutters, to reduce and prevent further and future water buildup at the exterior of the dwellings foundations.

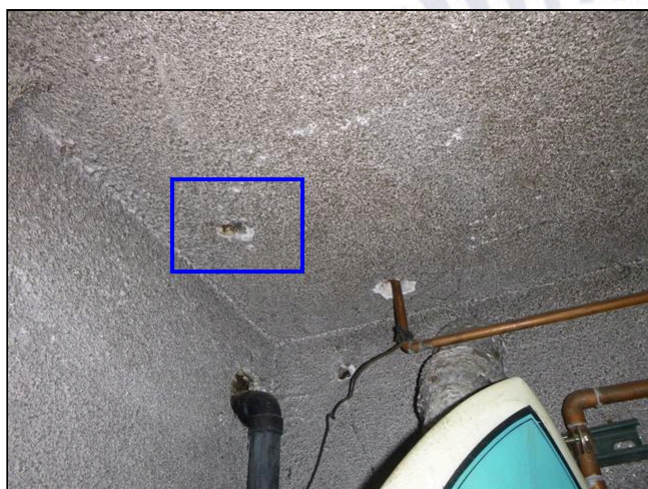
8.4 Item 3 (Picture)

(2) Holes and unfinished sections of firewall and ceiling were noted, this is a potential fire spread hazard. 5/8 inch sheetrock may be installed as a minimum standard material and as a requirement for a one hour burn through rating for firewall. Suggest review by licensed contractor for repair/installation costs as needed.

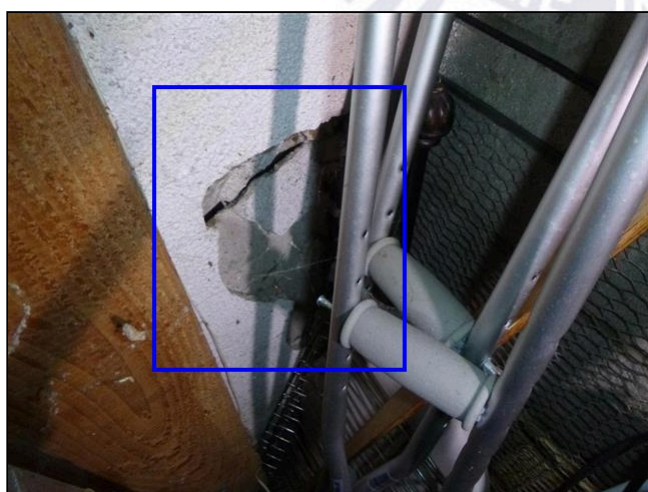
8.4 Item 4 (Picture)

(3) Holes and unfinished sections of the walls were noted, suggest review by licensed contractor for repair/ replacement costs as needed.

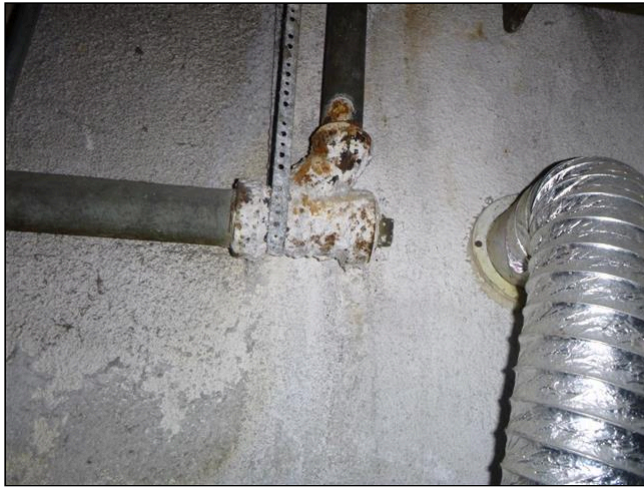
12.0 Item 3 (Picture)

(4) Excessive rust and corrosion noted at the drains within the garage. Suggest review by a licensed plumbing contractor for repair/replacement costs as needed.

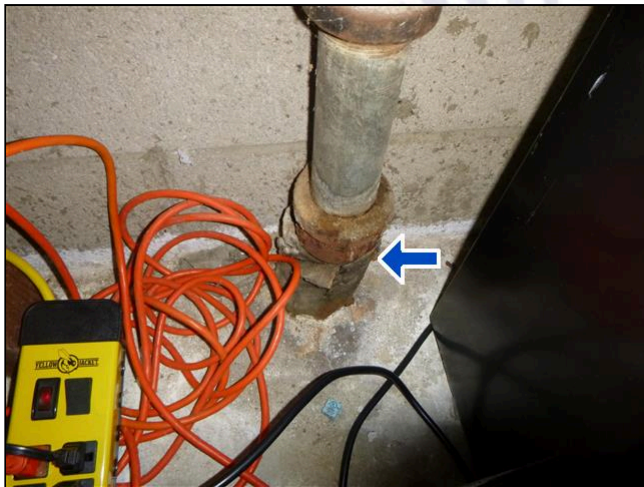
12.0 Item 4 (Picture)

(5) Rust and corrosion was noted at the various cast iron drain lines that are embedded/installed within the slab foundation. Suggest review by a licensed plumbing contractor to evaluate the condition of the cast iron drain lines and for removal/repair/replacement costs as needed.

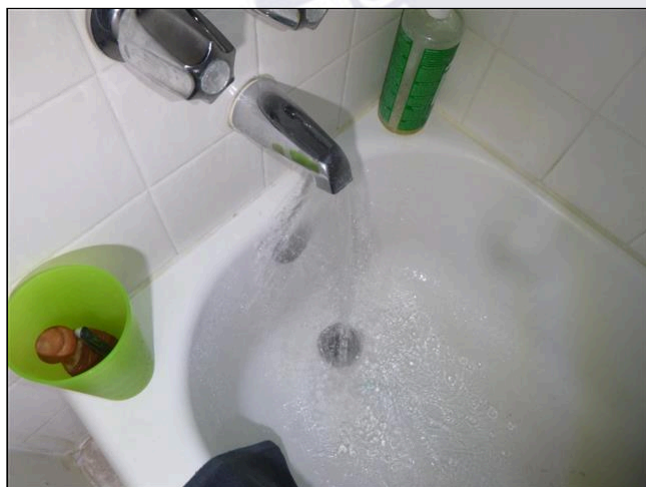
15.10 Item 1 (Picture)

The existing tub faucet is not a low-flow system as required. Suggest review with a licensed plumber for costs to replace the existing tub faucet with a low flow faucet (2.2 gallons per minute) as required by the State of California as of January 1st, 2017. See the plumbing system comments for further details and a link to the State of California plumbing ordinance.

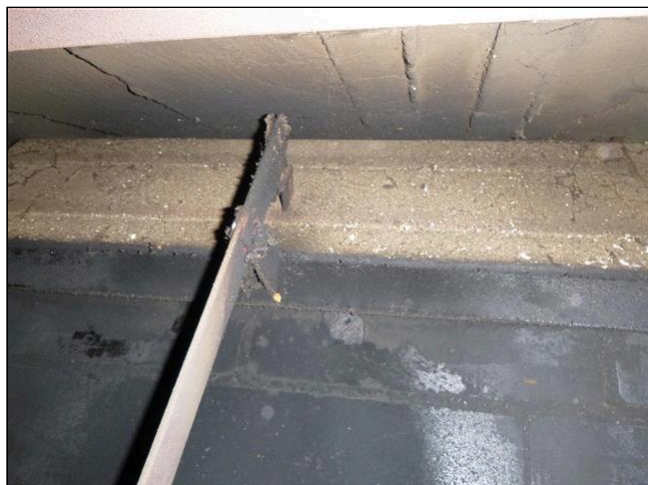
17.6 Item 1 (Picture)

(1) The fireplace damper was operational at the time of the inspection. Suggest securing the damper to a fixed open position due to the gas installation per current requirements.

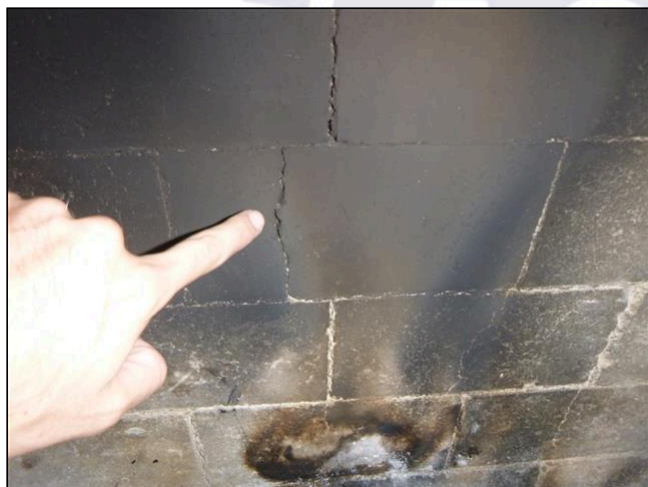
17.6 Item 2 (Picture)

(3) Surface cracks noted at the rear firebrick, suggest review with a licensed chimney sweep/contractor for repairs/ replacement as needed.

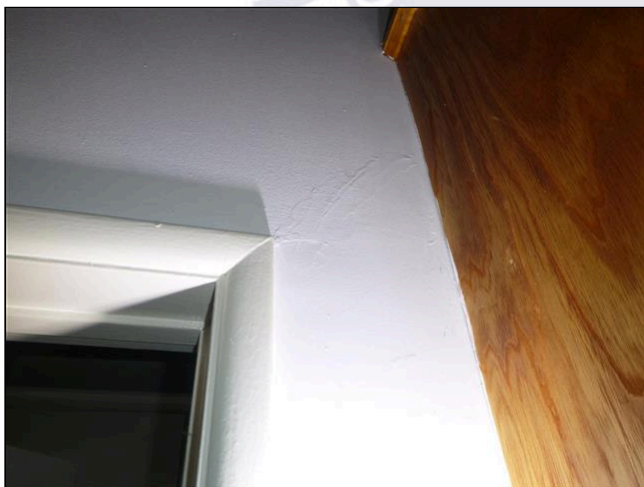
18.1 Item 1 (Picture)

Settling cracks and patching was noted, suggest repair as needed.
