**Ferguson Home Inspections**

**Customer**  
Dan Broese

**Address**  
1619 Armour Ln  
Redondo Beach CA 90278

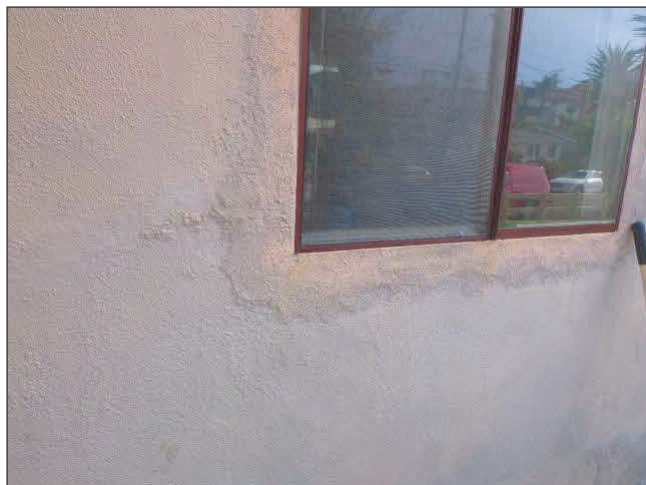
1.4 Item 1 (Picture)

(1) Various areas of the siding have been patched, suggest review with the seller on the cause and any repairs needed.

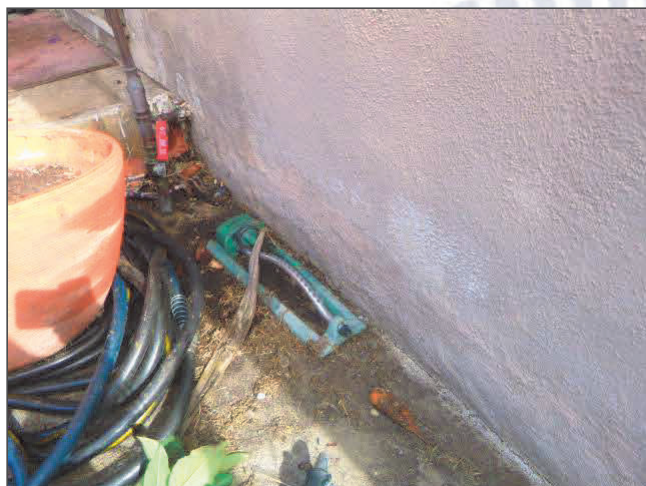
1.4 Item 3 (Picture)

(2) Deteriorated and blistering stucco noted at various areas. See the Lot/Drainage comments and review with a licensed contractor to repair as needed and divert water away from the foundation areas.

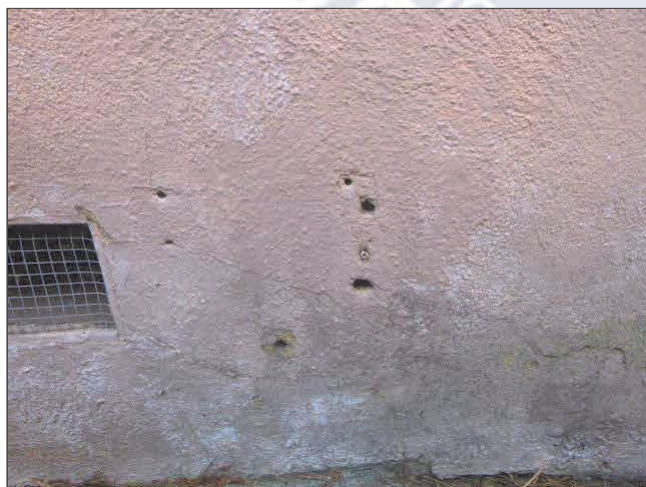
1.4 Item 5 (Picture)

(3) The holes in siding needs closing off with sealant, stucco or liquid foam at the right side.

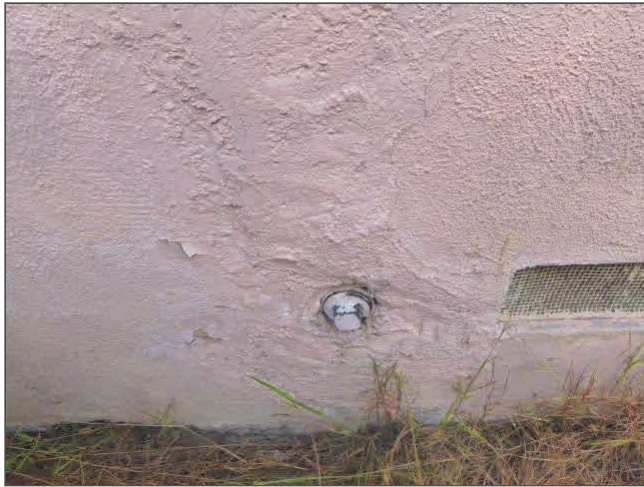
1.4 Item 6 (Picture)

(4) Excessive stucco deterioration/blistering and possible wood framing deterioration ( not visible due to the exterior stucco finish ) noted at the exterior of the kitchen, likely due from the leaking drain line(s). Suggest review with a licensed contractor for removal/repair/replacement costs as needed.

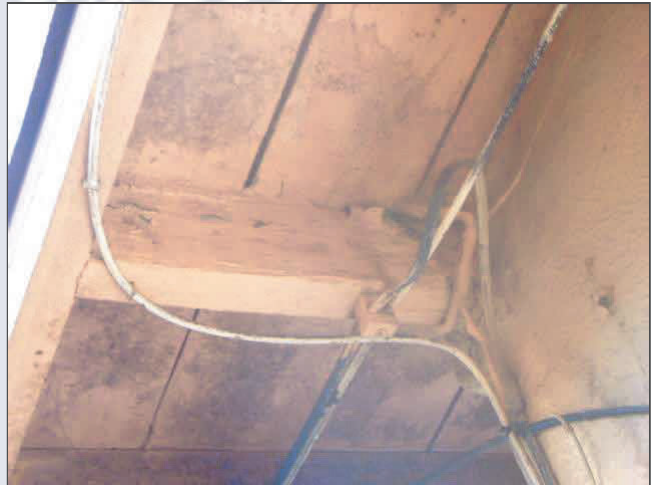
1.5 Item 2 (Picture)

(1) Paint blistering, peeling and wood deterioration noted at various trim areas. Suggest review with a termite company and/or a licensed contractor and repair/replace as needed.

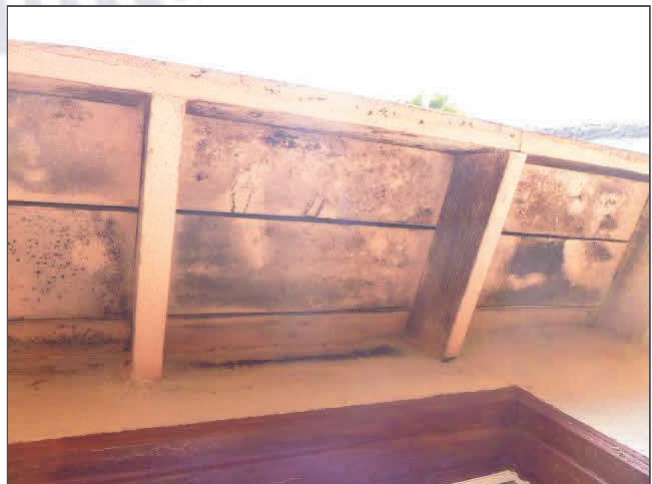
1.5 Item 4 (Picture)

(2) Excessive black staining noted at the roof line/eaves, suggest review with a licensed contractor for repairs as needed.

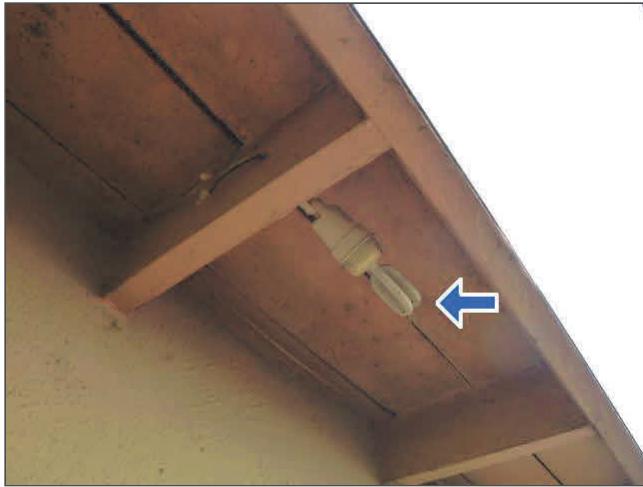
1.8 Item 1 (Picture)

(1) The cover globe was missing at the light fixture at the time of the inspection. Suggest replacing the missing cover globes for safety.

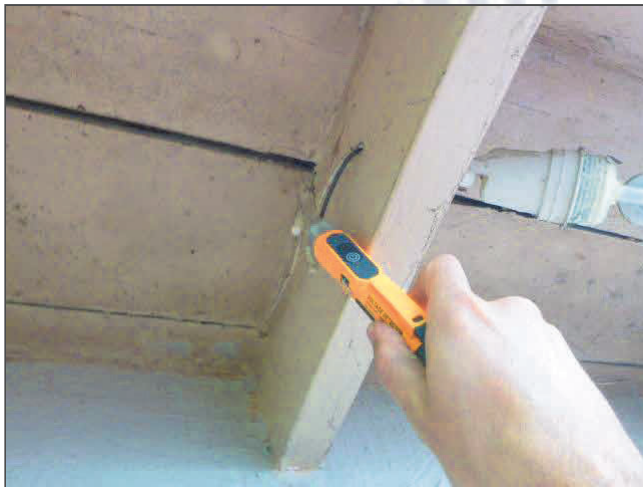
1.8 Item 2 (Picture)

(2) Open splices were noted, this is a safety concern. Whenever an electrical wire is cut and re-connected, the 'splice' should be encased in a covered junction box to prevent shocks and separation of the splice. Suggest review by licensed electrician and repair as needed.

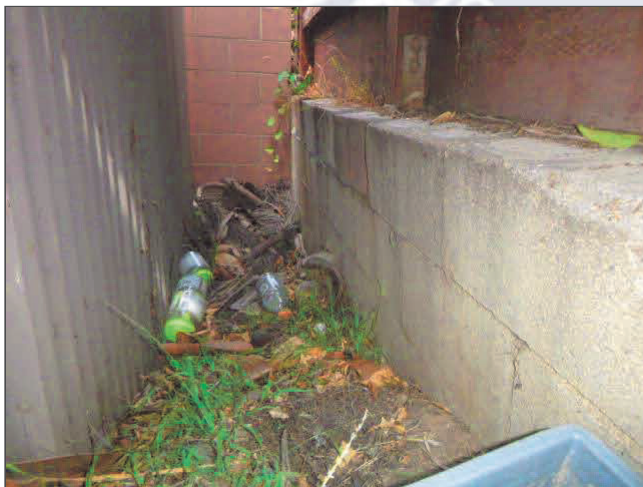
1.10 Item 3 (Picture)

(3) Minor leaning noted at the rear retaining wall, suggest review with a licensed contractor as needed.

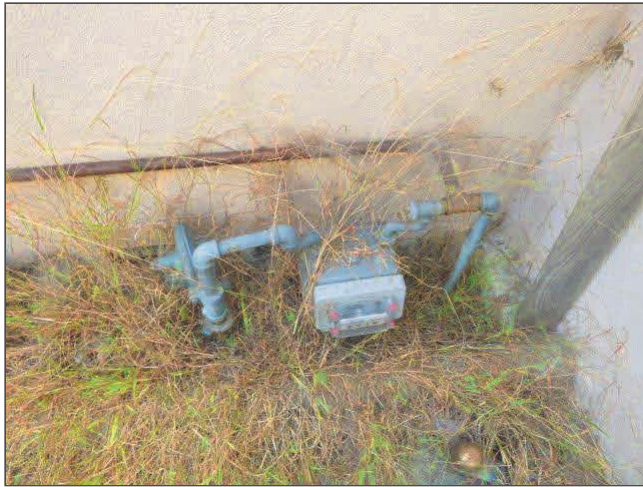
1.12 Item 1 (Picture)

Suggest removing/trimming the vegetation away from the gas meter to allow for correct accessed as required.

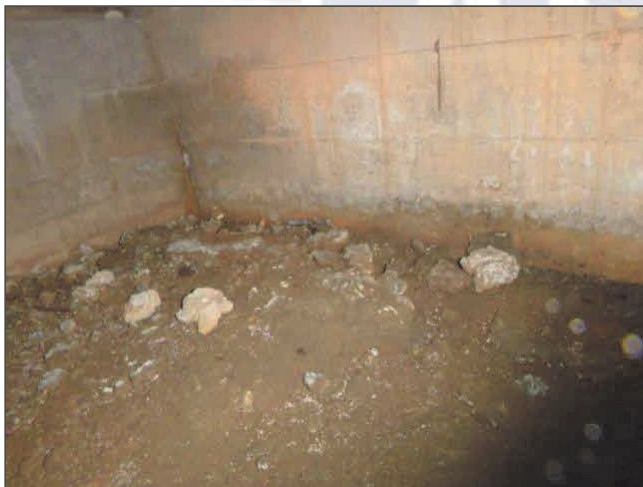
2.0 Item 1 (Picture)

(2) Re-grading where needed is recommended to assure all water drains away from the home's foundation. The inadequate drainage has caused the excessive moisture buildup at the foundation and intrusion into the crawl area, suggest review with a licensed contractor for foundation repairs and installation of rain gutters and an area drainage system to divert all the water away from the foundation.

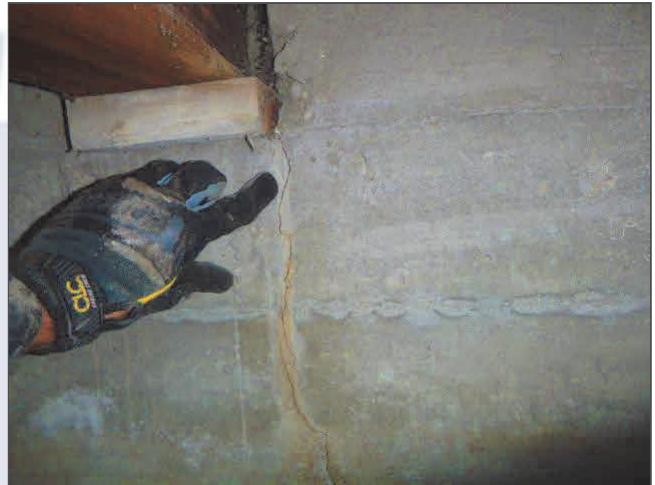
3.0 Item 8 (Picture)

(1) Re-grading where needed is recommended to assure all water drains away from the home's foundation. The inadequate drainage has caused minor settling/cracking/movement to the foundation, suggest review with a licensed contractor for installation of perimeter concrete walkways/barriers, rain gutters and an area drainage system to divert all the water away from the foundation.

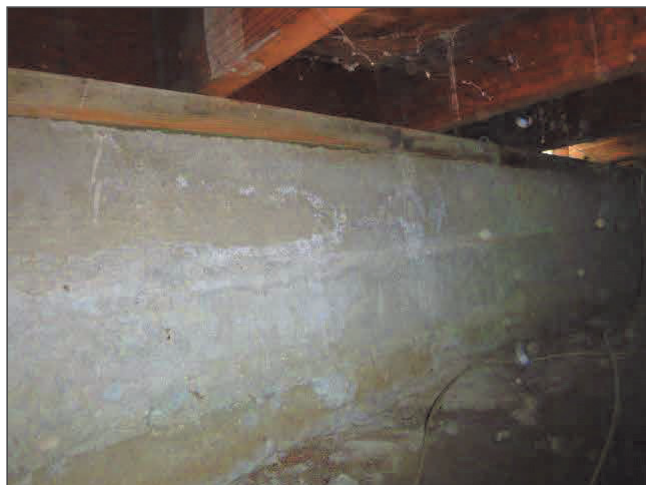
3.0 Item 9 (Picture)

(3) White efflorescence (powder substance) on foundation footings indicates prior, and possibly ongoing, excessive moisture build up at the exterior of the foundation. Ongoing water intrusion at the foundations can, in some cases, cause the steel in the foundations to rust, called spalling, which can lead to horizontal cracking of the foundation ( currently there are no major cracks visible at the foundation ). Any future cracking/damaged can be an expensive repair as the foundation is now structurally weak and susceptible to horizontal movement. Suggest review of the Lot/ Grade and drainage systems, including rain gutters, to reduce and prevent further and future water buildup at the exterior of the dwellings foundations.

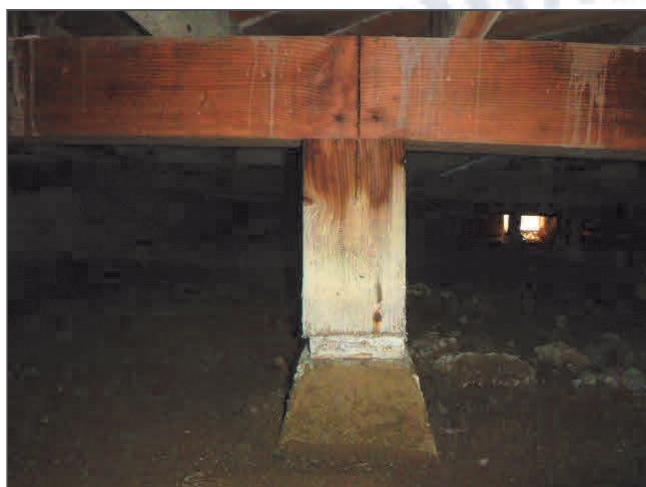
3.0 Item 10 (Picture)

(4) Excessive staining/saturation/deterioration of internal wood support members was noted due to excessive and ongoing water intrusion. Suggest review with a licensed foundation contractor for repair/replacement costs needed to prevent any future movement to the foundation and/or structure.

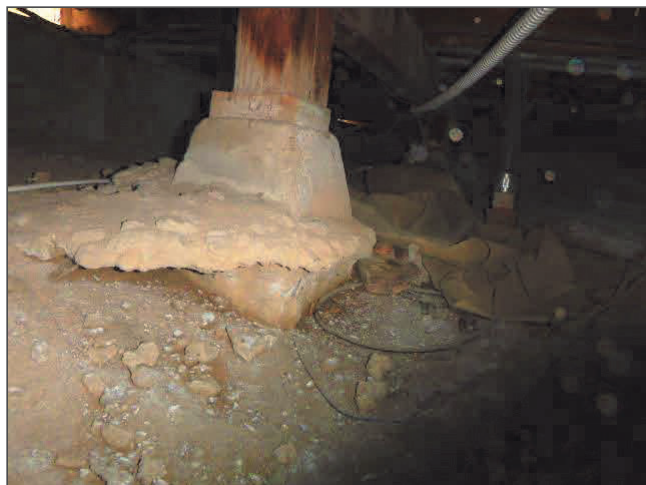
3.0 Item 12 (Picture)

(7) Undermining of the foundation/concrete piers noted at the front/right crawl areas. Suggest review by a licensed contractor for costs required to re-install the dirt or other means to prevent possible future movement of the foundation and/or structure.

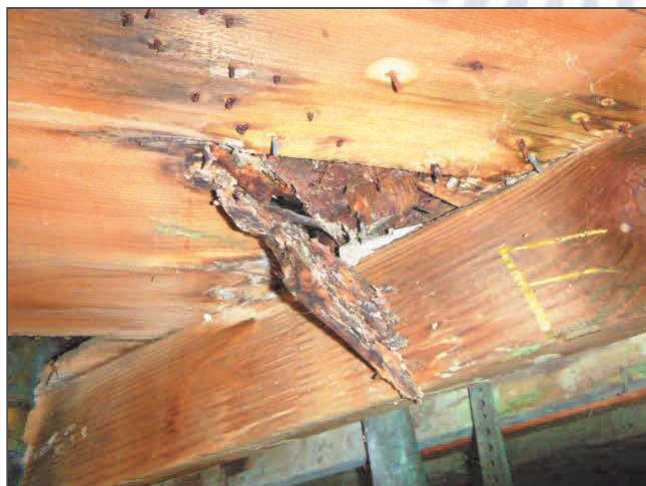
3.1 Item 2 (Picture)

(2) Stains and deterioration noted at various flooring and supports from prior and ongoing leaks. Suggest review with a termite company and/or a licensed contractor and repair/replace as needed.

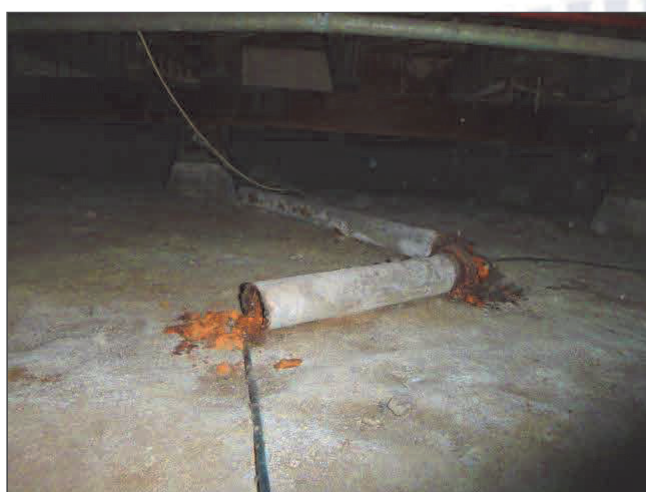
4.0 Item 5 (Picture)

(2) Suggest removal of debris and construction items from the crawl area.

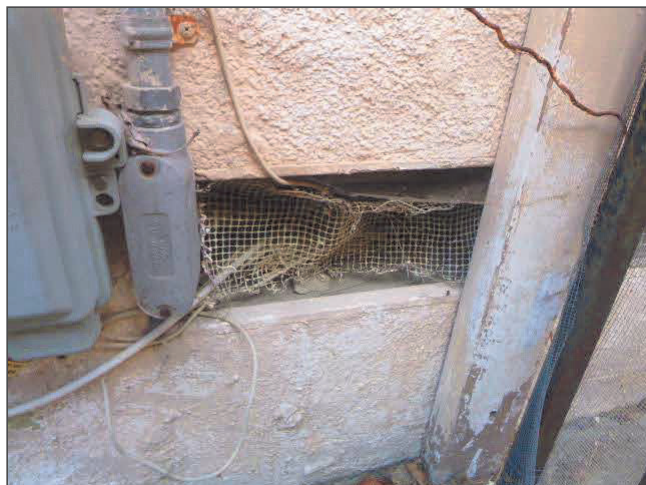
4.1 Item 1 (Picture)

Loose, missing or deteriorated vent screens noted. Suggest re-screening missing and/or deteriorated vent screens as needed to prevent rodent and insect intrusion.

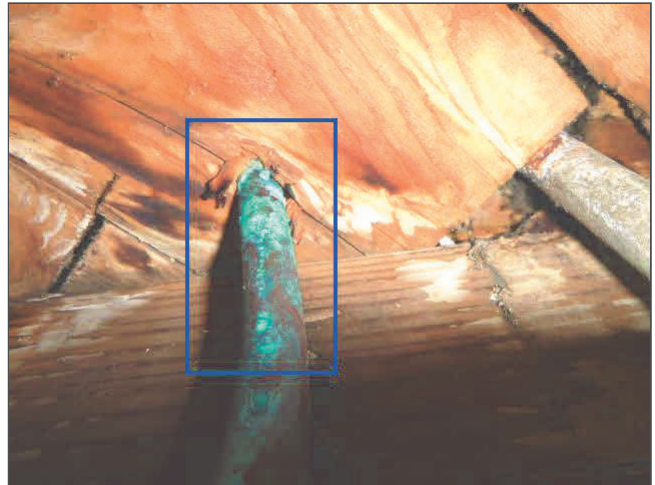
4.3 Item 2 (Picture)

(1) Corroded areas of the copper plumbing was noted throughout the crawl area, this can be a pre-cursor to 'pin hole' leaks. Suggest review with a licensed plumber for repair/replacement costs as needed.

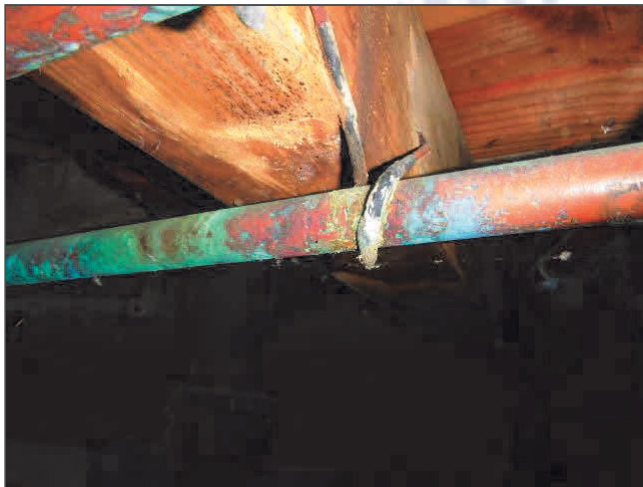
4.3 Item 3 (Picture)

(2) The copper plumbing lines are inadequately and improperly secured with straps that are causing excessive deterioration of the copper. Suggest replacing the deteriorated areas of the copper plumbing lines as well as replacing the straps with approved materials to prevent electrolysis and future leaks.

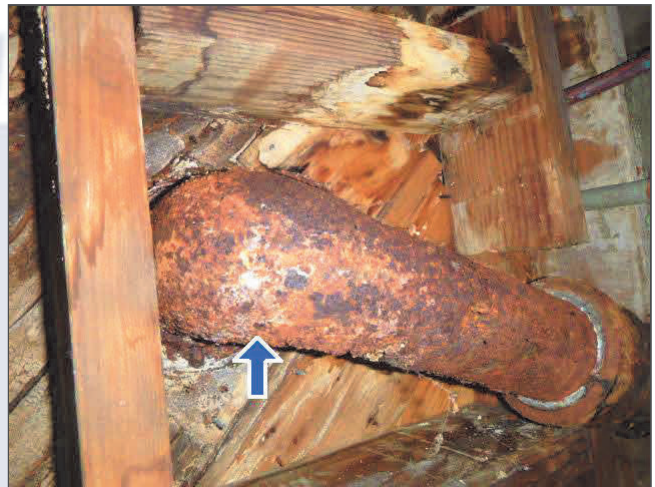
4.3 Item 10 (Picture)

(3) Excessive rust, leaking and seepage/deterioration noted at various cast iron/galvanized drain lines within the crawl space. The excessive deterioration of the drain lines have caused leaking and saturation of the soil in the crawl area. Suggest review by a licensed plumbing contractor for replacement costs as needed to prevent on-going leakage at the crawl area.

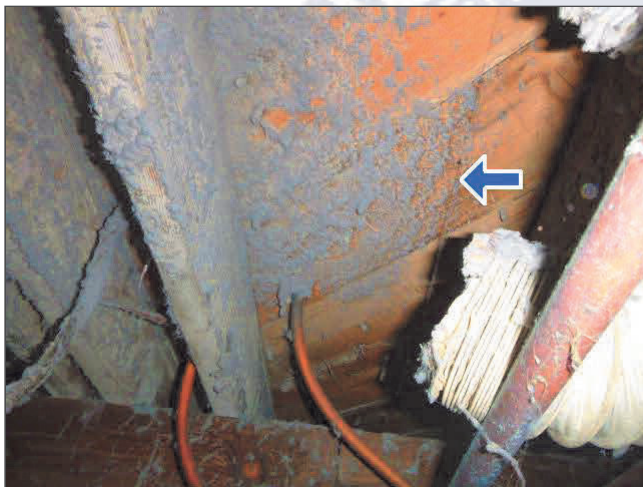
4.4 Item 1 (Picture)

Excessive lint was noted in the crawl area from the laundry dryer vent, this is a potential fire spread hazard. Suggest review with a licensed contractor for costs to repair and remove all of the lint from the crawl area as required for safety.

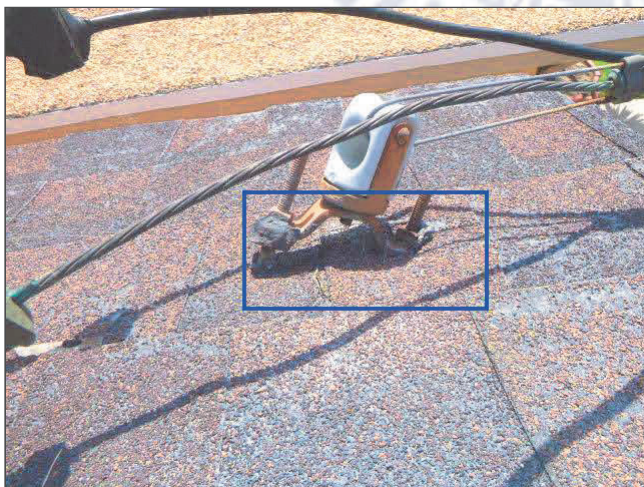
5.1 Item 1 (Picture)

(1) Loose/incorrect flashings/roof attachments were noted at various areas, suggest review with a licensed roofer for repairs as needed.

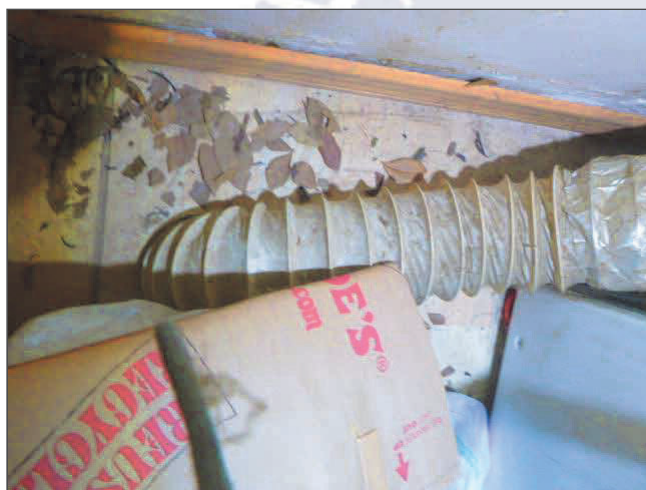
7.6 Item 1 (Picture)

(2) Improper vinyl flex vent installed to the crawl space ( not installed to the exterior as required ). Suggest removal of the existing material and install a rigid vent pipe to the exterior as required. Excessive lint noted was noted in the crawl area due to the incomplete installation, this is a potential fire hazard. Suggest review by licensed contractor for costs to remove the lint form the crawl area as required for safety.

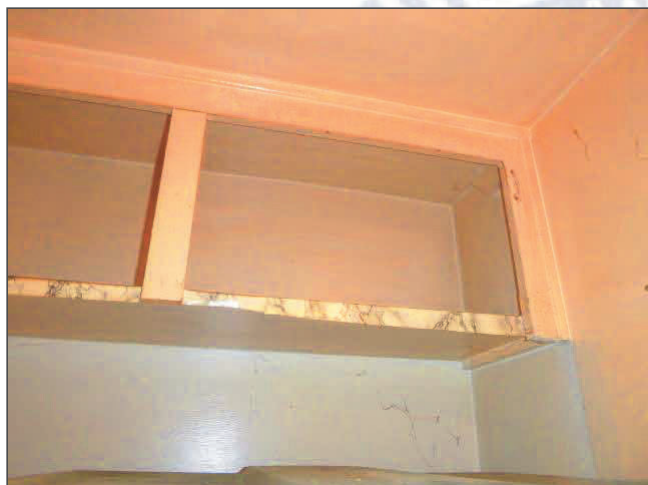
7.7 Item 1 (Picture)

Various cabinet doors are damaged, missing or loose on the hinges. Suggest repair/replace as needed.

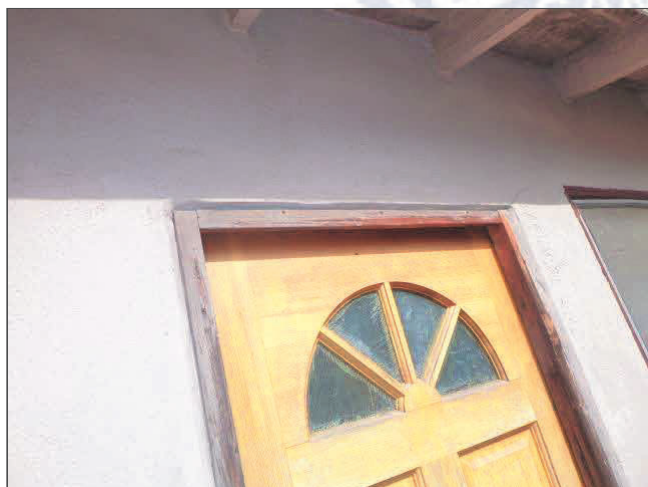
9.3 Item 1 (Picture)

No light fixture installed at this area as required, this is a possible safety hazard. Suggest review with a licensed electrician for installation costs for a light fixture to enhance safety.

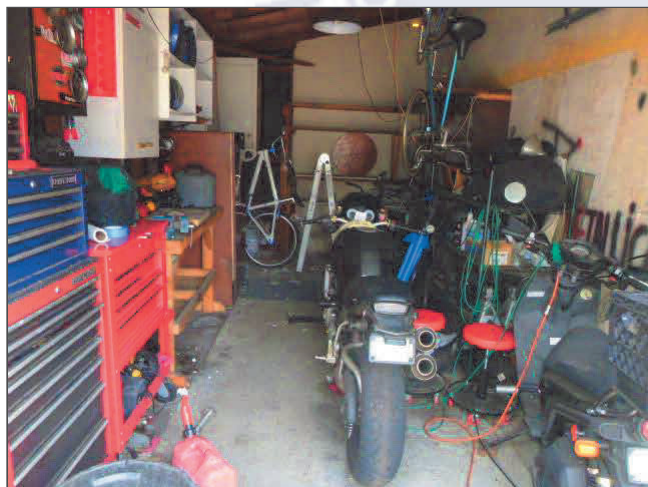
11.0 Item 1 (Picture)

(1) Access within this area was blocked or severely limited at the time of the inspection. An inspection of this area can be performed by appointment and at an additional cost when the area is made accessible.

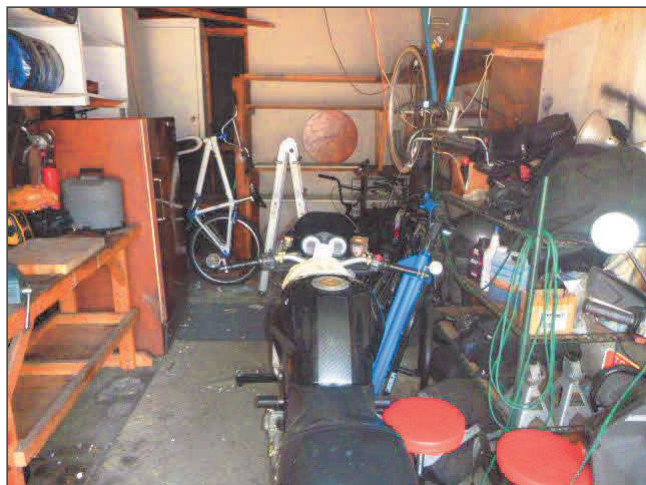
11.3 Item 1 (Picture)

(1) Unable to make a complete inspection of firewall due to a large concentration of personal effects. Suggest review of firewall once area has been cleared. If any breaches or damage to firewall is found, suggest patching and repair with 5/8 drywall as needed to complete firewall.

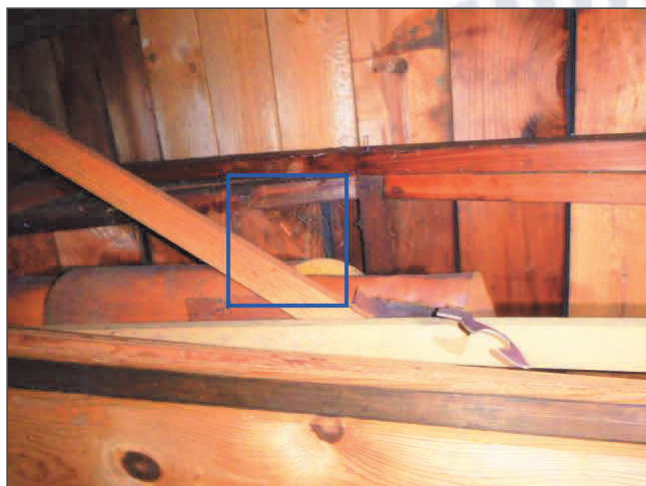
11.3 Item 2 (Picture)

(2) Wood deterioration noted at various areas of the garage framing, suggest review with a termite company and/or a licensed contractor for repairs as needed.

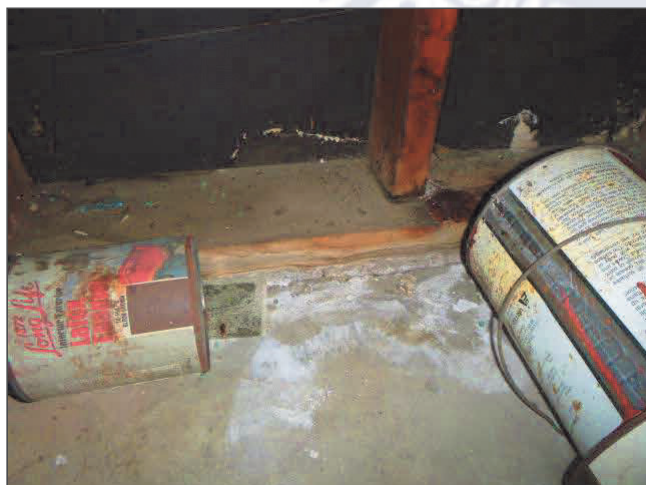
11.3 Item 3 (Picture)

(3) Water stains and deterioration noted at the lower section of the walls due to water intrusion. Suggest repair/replace as needed.

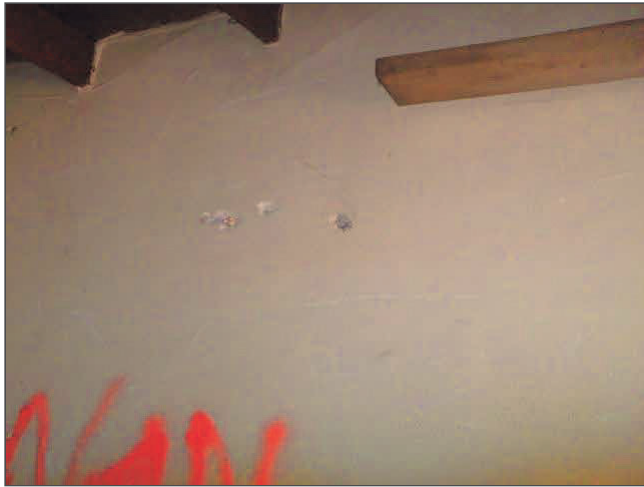
11.3 Item 5 (Picture)

(4) Holes and unfinished sections of firewall and ceiling were noted, this is a potential fire spread hazard. 5/8 inch sheetrock may be installed as a minimum standard material and as a requirement for a one hour burn through rating for firewall. Suggest review by licensed contractor for repair/installation costs as needed.

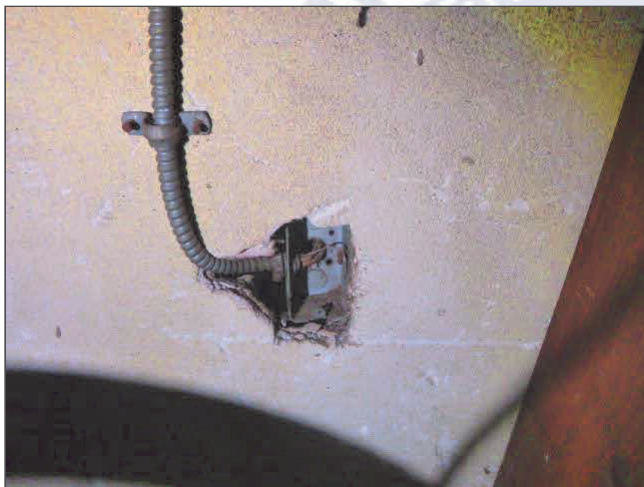
11.4 Item 1 (Picture)

(1) Open junction boxes were noted, this is a potential safety hazard. Whenever an electrical wire is cut and re-connected, the 'splice' should be encased in a covered junction box to prevent shocks and separation of the splice. Suggest review by a licensed electrician for repair/replacement costs as needed.

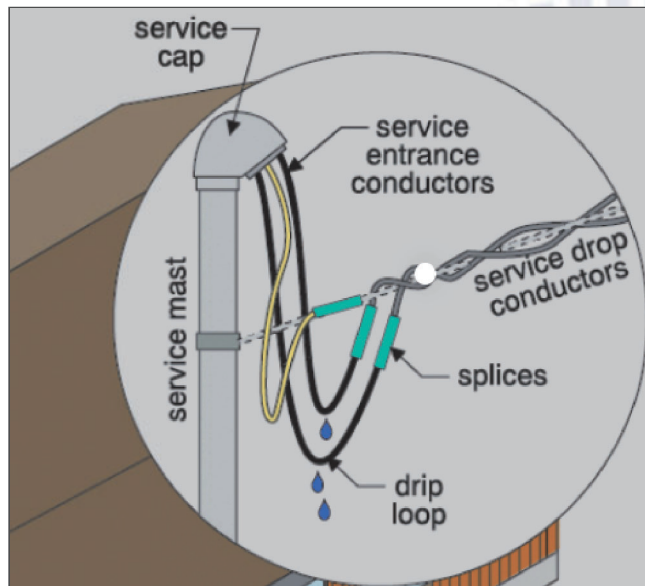
13.0 Item 2 (Picture)

(2) Inadequate drip loop was noted, suggest review with a licensed electrician for repairs as needed.

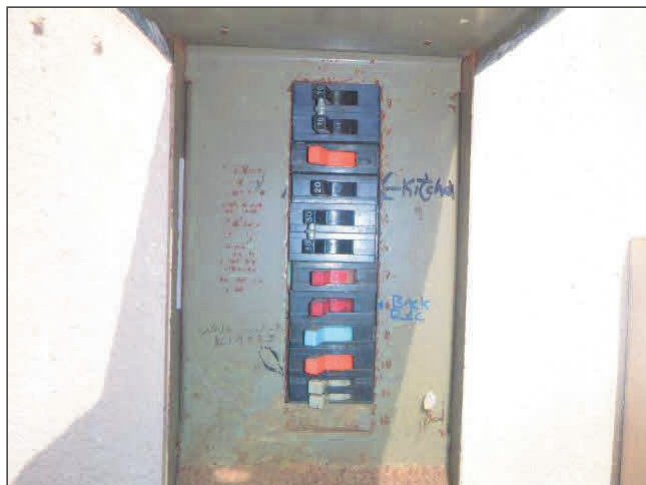
13.1 Item 1 (Picture)

(1) The main electrical panel is a Zinsco brand panel box, a product that hasn't been manufactured for many years. There are problems with these panels that can, in some cases, be serious. Some Zinsco panels have aluminum bus bars (the bars that run down the middle of the panel to which the breakers connect). Over a period of years, oxide forms on the aluminum causing a poor connection with the breakers and leading to arcing, overheating, and, eventually, breaker failure. Other problems with Zinsco panels include circuit breakers (depending on the vintage) with a dismal performance record and the possibility of unbalanced multi-wire circuits. Also, please be aware that various insurance companies will not insure homes with this style of electrical panel. Suggest review by a licensed electrician for replacement costs as needed.

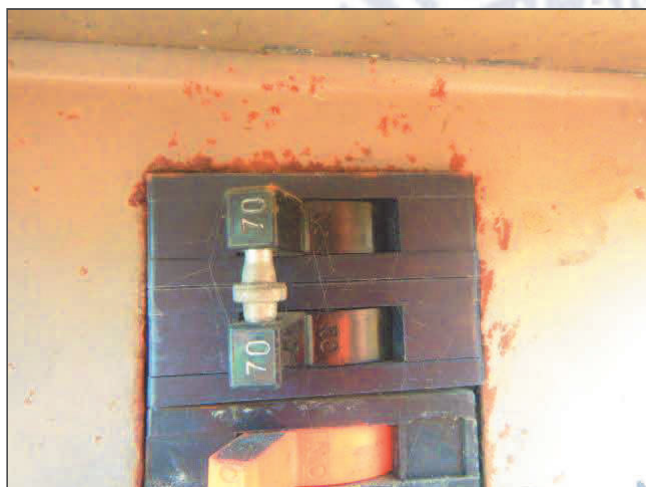
13.1 Item 3 (Picture)

(2) Due to the age and size/overall amperage of this system relative to the square footage of the dwelling, suggest review with a licensed electrician for replacement cost to upgrade the electrical panel, increase the overall amperage and install additional circuits to the interior of the dwelling as needed/desired.

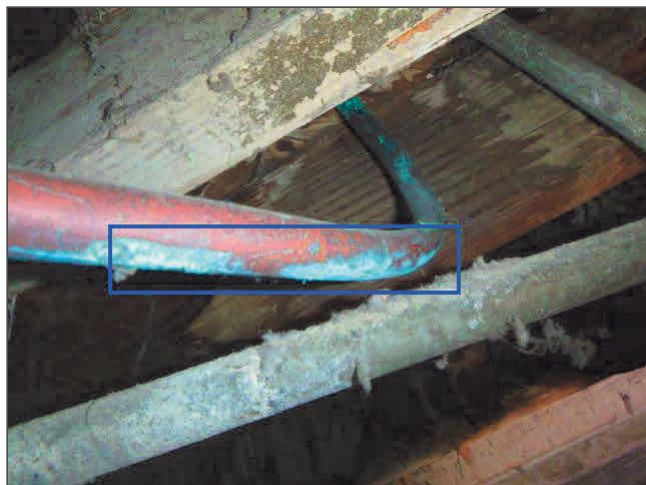
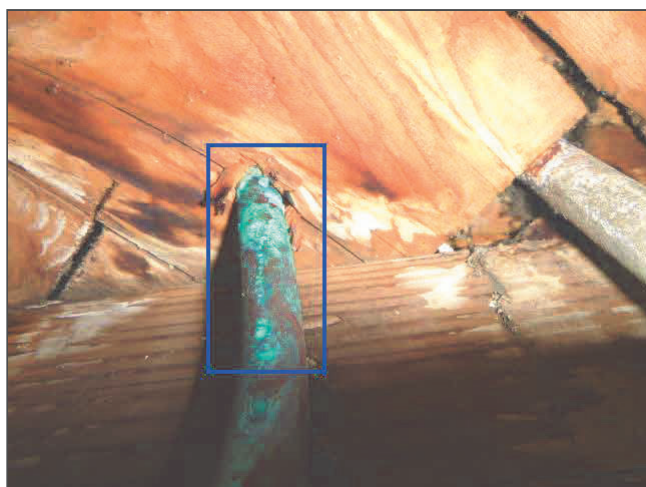
(2) See the crawl space comments and repair as needed.

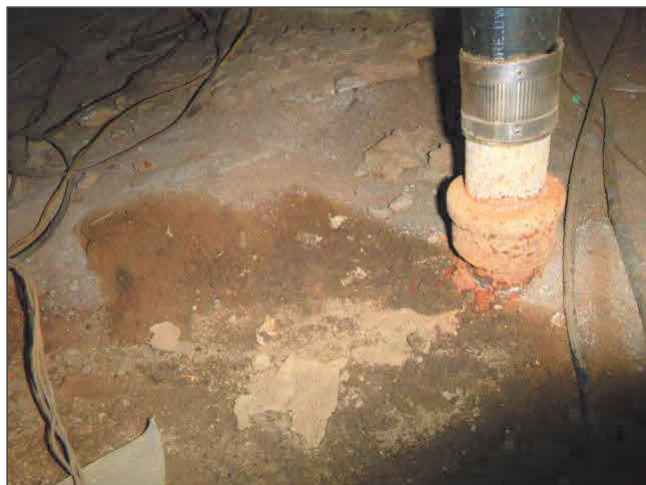
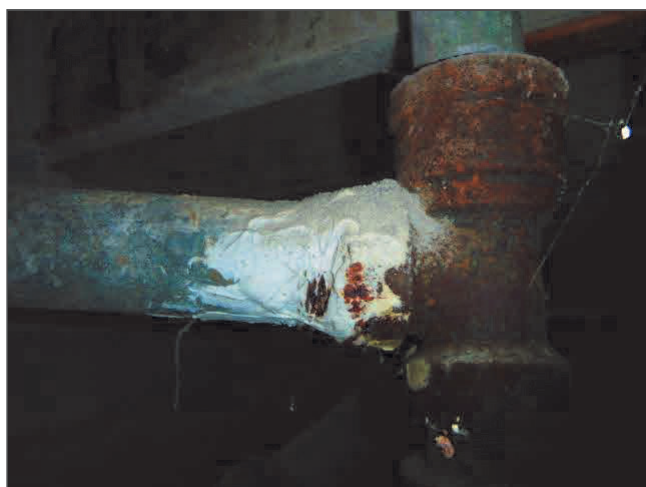
(1) See the crawl space comments due to multiple cracks and leaking drains. Suggest review by licensed plumber for repair/replacement costs.

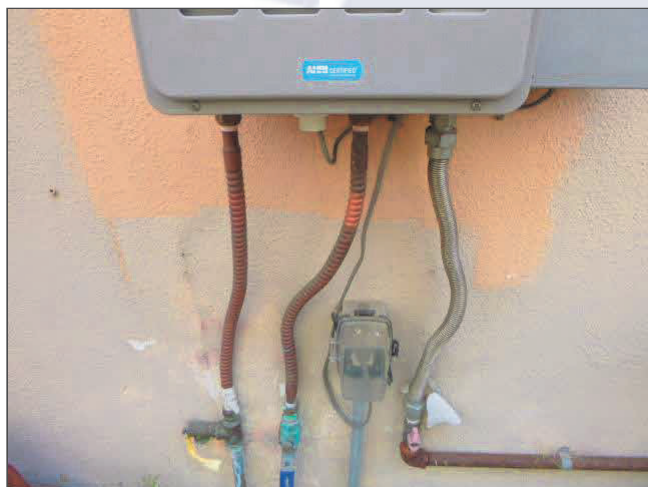
16.0 Item 5 (Picture)

(6) The current water heater does not have a "Thermal Expansion tank" which is generally installed to prevent a possible leak at the T&P or "pop-off" valve and/or excessive pressure build-up at the internal plumbing, fixtures and joints. Recent changes ( 2012 ) require one when a new water heater is installed, but various cities do not enforce this installation for multiple reasons ( the home is not on a closed system and various tankless units do not require it ). There were no leaks or drips at the T&P valve during inspection. If your water heater does begin to drip or leak, then a thermal expansion tank may be needed. Suggest review with the city and/or a licensed plumber to determine if this installation is required and install as needed.

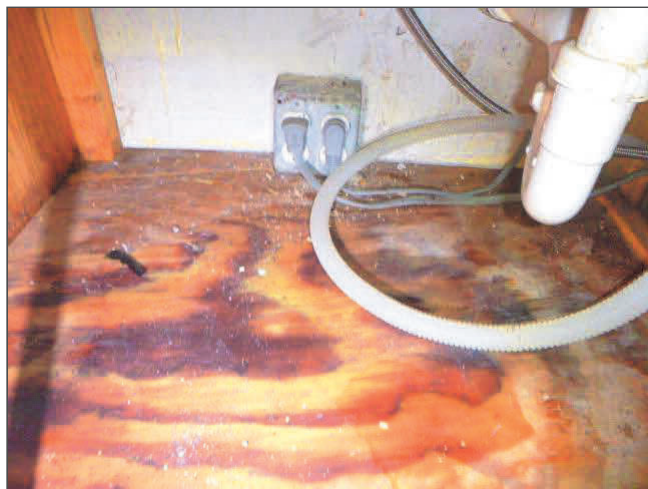
17.5 Item 1 (Picture)

- (1) The base cabinet under the sink is deteriorated/stained from previous leaks, suggest repair/replace as needed.

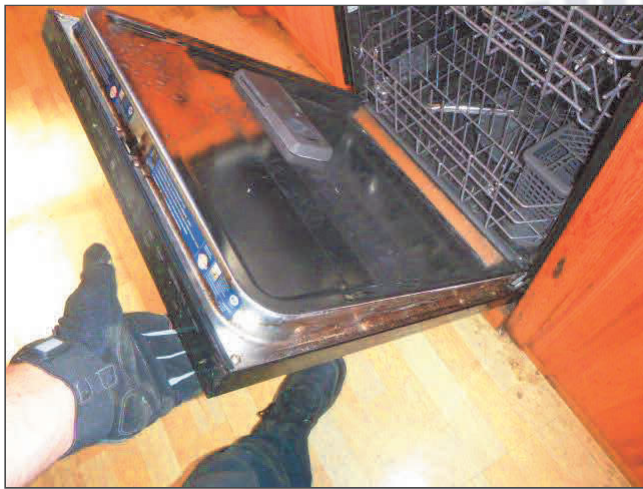
17.11 Item 2 (Picture)

(2) The dishwasher door spring is broken/disconnected, suggest repair or replace as needed.

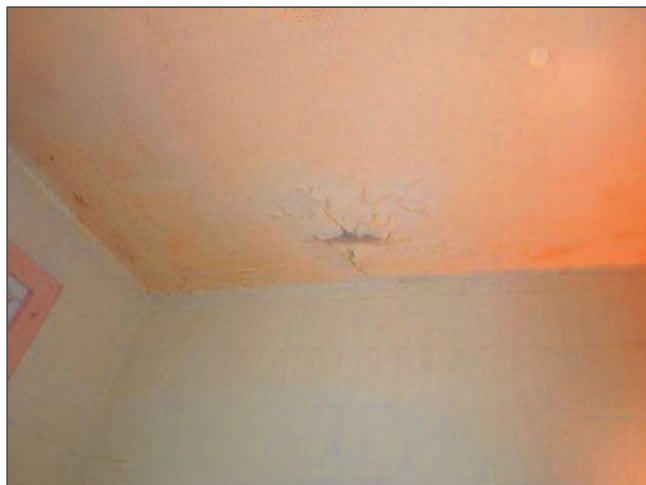
18.2 Item 1 (Picture)

(1) Blistering and excessive deterioration noted at the ceiling due to inadequate ventilation. See the exhaust fan comment and repair/install as needed.

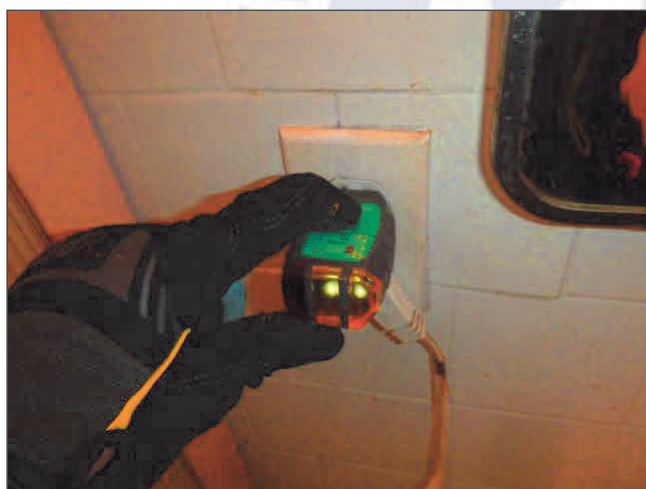
18.6 Item 1 (Picture)

No GFCI outlet or protection installed in this bathroom. GFCI protection has been required in bathrooms since 1975, suggest review by a licensed electrician for installation as required for safety.

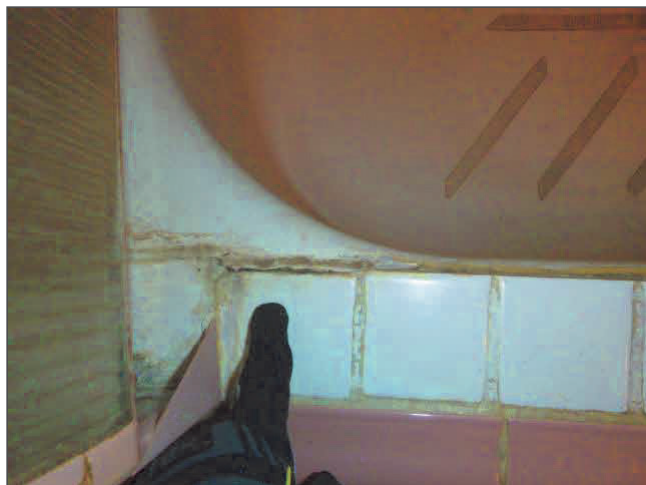
18.8 Item 1 (Picture)

Suggest caulking or re-grout as needed. The edges of the tub walls should be caulked to prevent moisture penetration. Failure to keep walls sealed can cause deterioration and extensive moisture damage to the interior walls, which is not always visible.

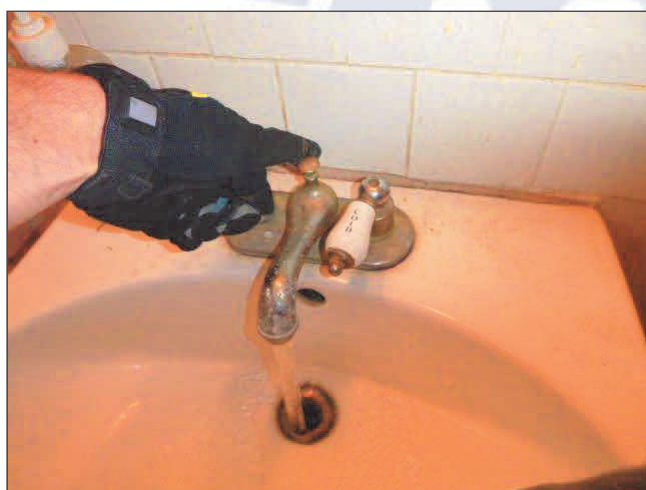
18.12 Item 1 (Picture)

The sink stopper is faulty/inoperable, suggest repair/replace as needed.

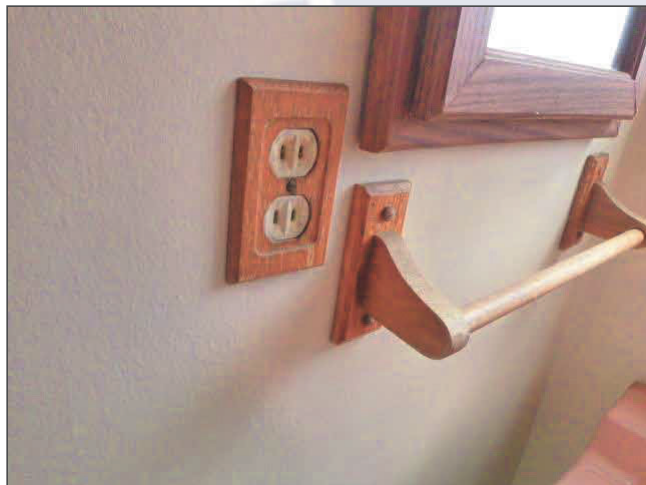
19.6 Item 1 (Picture)

(2) Two wire and two prong electrical receptacles noted. At the time of the original construction this type of system was the acceptable standard and appears to be intact. If three prong and GFCI receptacles are desired a ground source is required. Suggest review with a licensed electrician for costs to ground the outlets as needed as an upgrade and/or protected the outlet(s) on a GFCI circuit where recommended.

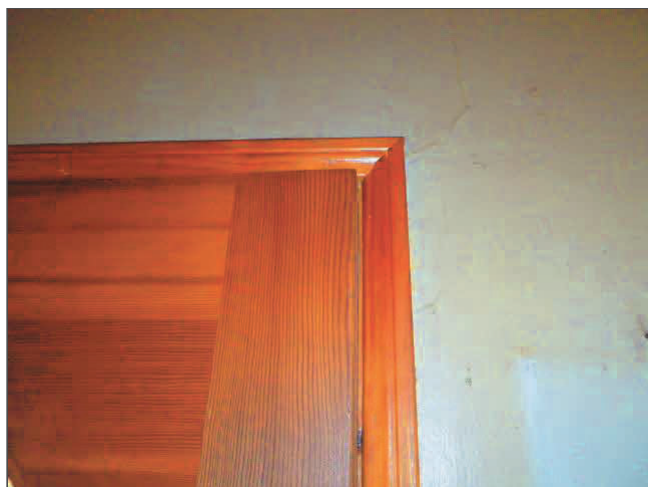
20.3 Item 2 (Picture)

(2) The door sticks/impacts on the jamb when operating due to settling, suggest repair as needed.

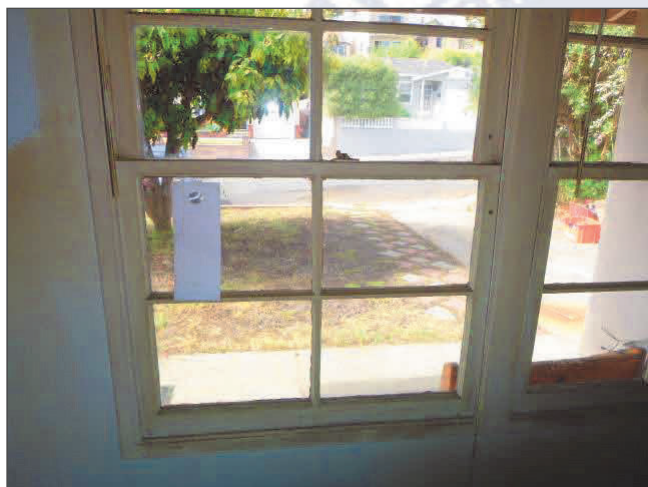
20.4 Item 1 (Picture)

(1) The window(s) are stuck/painted shut at the time of the inspection, maintenance or repair as needed is suggested to allow for emergency exit and ventilation.

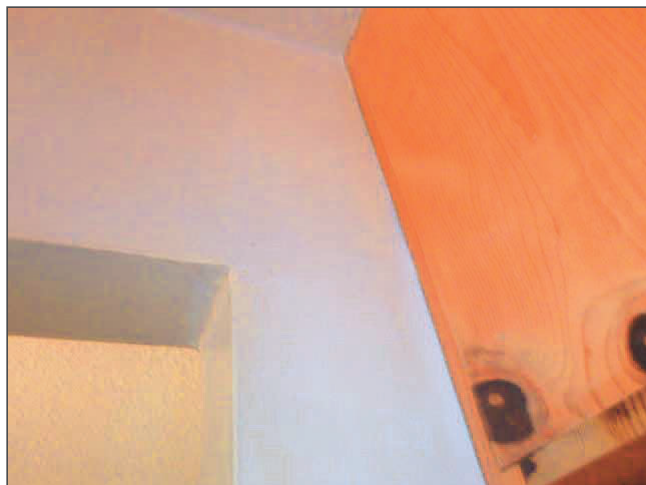
21.1 Item 1 (Picture)

(1) Settling cracks and patching was noted, suggest repair as needed.

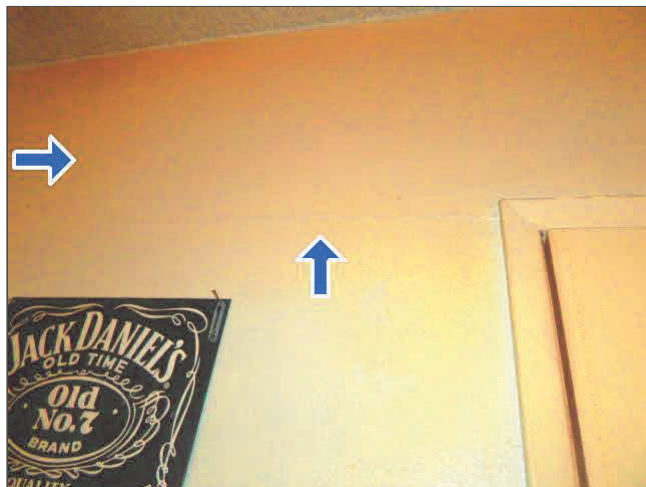
23.1 Item 1 (Picture)

(1) Excessive settling cracks noted, see the foundation and Lot/Drainage comments. Suggest review with a licensed contractor for repair/replacement costs as needed.

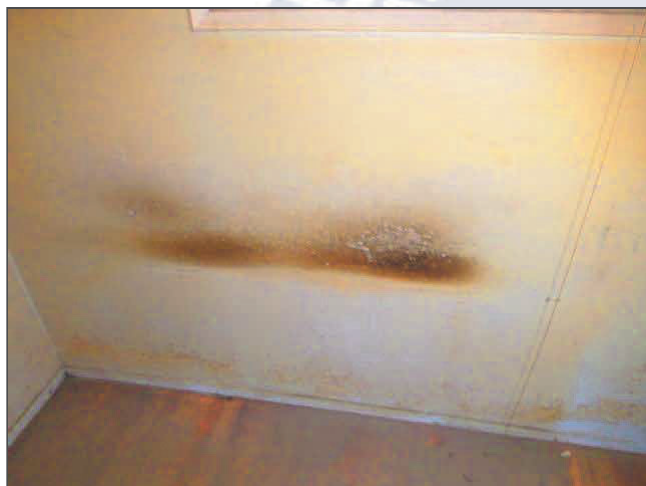
23.1 Item 3 (Picture)

(2) Excessive stains and smoke odor was noted due to potentially/likely excessive interior smoking, suggest review with the seller and a licensed contractor on this item as needed.

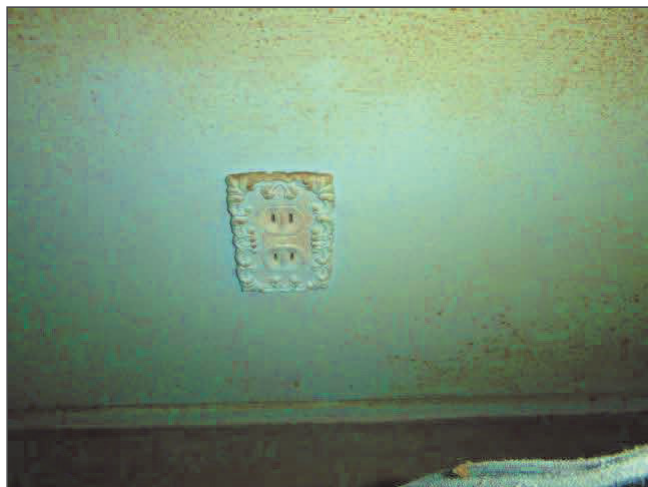
23.6 Item 1 (Picture)

(1) Two wire and two prong electrical receptacles noted. At the time of the original construction this type of system was the acceptable standard and appears to be intact. If three prong and GFCI receptacles are desired a ground source is required. Suggest review with a licensed electrician for costs to ground the outlets as needed as an upgrade and/or protected the outlet(s) on a GFCI circuit where recommended.

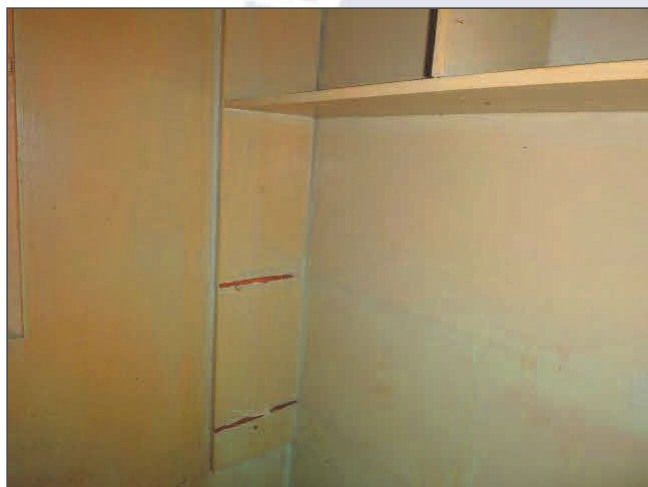
23.7 Item 1 (Picture)

Damaged/missing areas noted at the wall cabinetry, suggest repair/replace as needed.

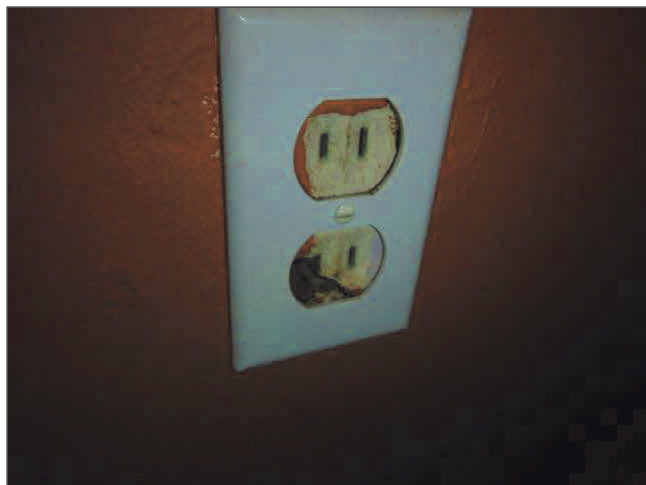
24.5 Item 1 (Picture)

(1) Two wire and two prong electrical receptacles noted. At the time of the original construction this type of system was the acceptable standard and appears to be intact. If three prong and GFCI receptacles are desired a ground source is required. Suggest review with a licensed electrician for costs to ground the outlets as needed as an upgrade and/or protected the outlet(s) on a GFCI circuit where recommended.

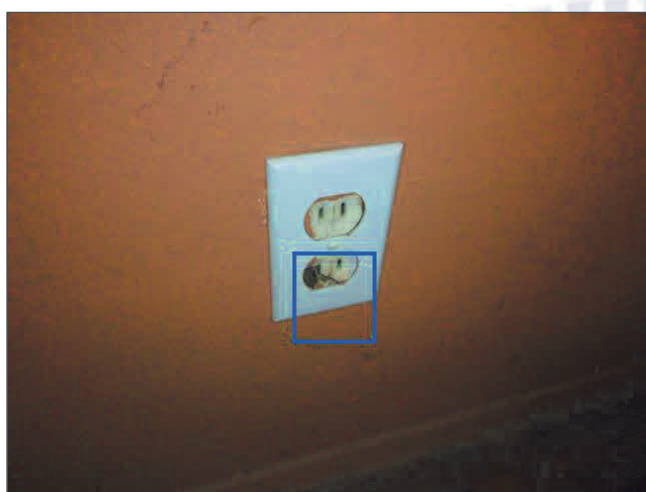
24.5 Item 2 (Picture)

(2) The outlets are deteriorated and loose. Suggest repair or replace as needed for safety.

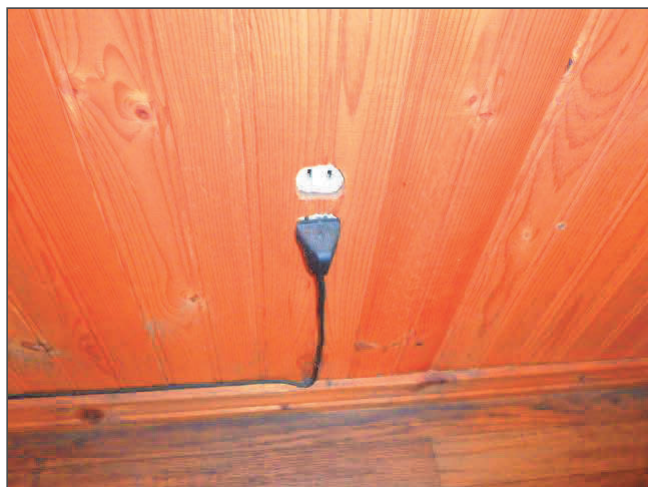
25.5 Item 1 (Picture)

(1) Two wire and two prong electrical receptacles noted. At the time of the original construction this type of system was the acceptable standard and appears to be intact. If three prong and GFCI receptacles are desired a ground source is required. Suggest review with a licensed electrician for costs to ground the outlets as needed as an upgrade and/or protected the outlet(s) on a GFCI circuit where recommended.

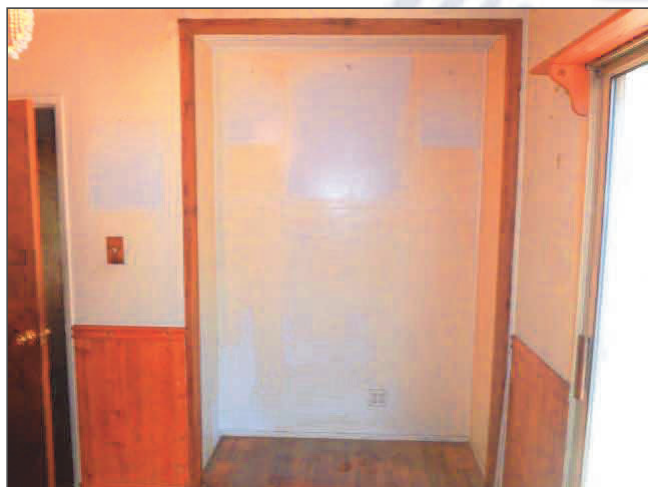
25.6 Item 1 (Picture)

(1) The closet doors were missing from this area at the time of the inspection, suggest replacing as needed.
