Fireplace Inspection Report

LOCATED AT:
548 N Hartley St
West Covina, California 91790

INSPECTED ON:
Wednesday, May 22, 2024

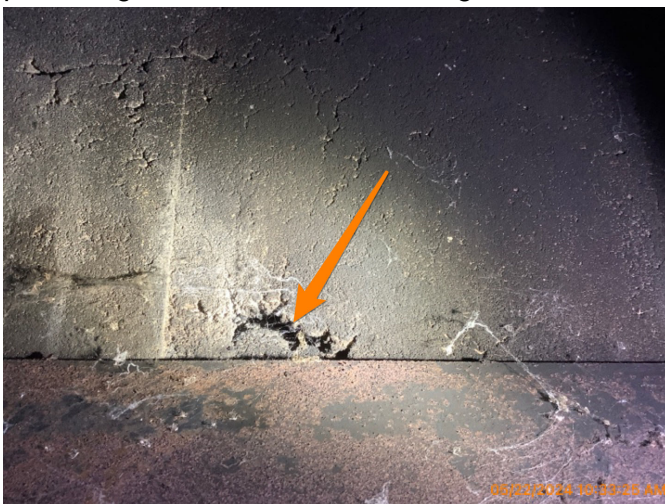
The breastplate surface is cracked and deteriorated; this should be repaired with a fire rated mortar. The breastplate is directly above the firebox opening and helps to direct smoke and gases, along with protecting the backside of the facing materials from high heat in the fireplace.

Breast deteriorated

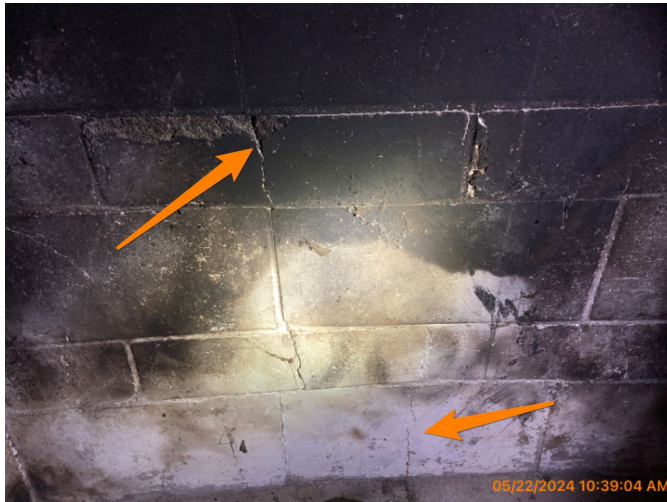
There is a crack along the back firebox wall - this should be repaired with a refractory (heat resistant) mortar.

Cracks in firebox back wall

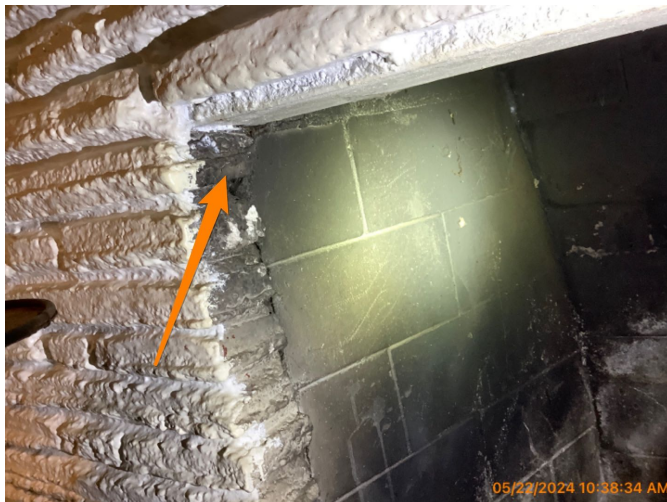
There are smoke stains noted outside the firebox surfaces. This is often an indication that the chimney flue is not drafting properly (smoke or gas is not going up the flue properly and may enter into the living space when the fireplace is in use). It is recommended to use the fireplace during different climate conditions to determine if the fireplace is drafting correctly and if not, an appropriate remedy could be to install a smoke guard at the top of the fireplace opening. There are other more extensive remedies as well, should they be needed.

Smoke stains near outside of firebox

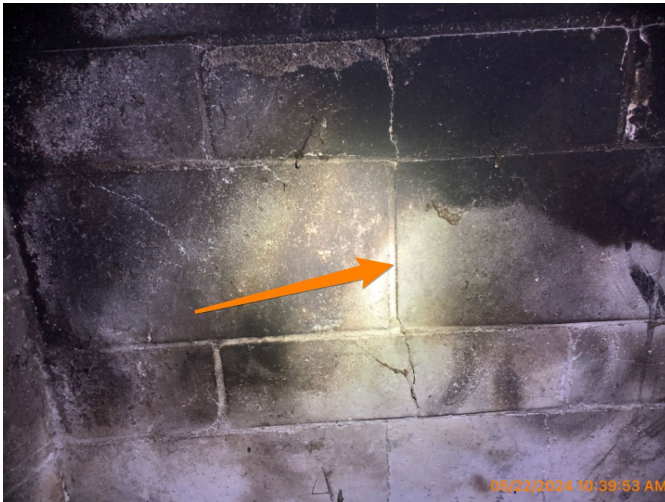
There were gaps noted between the bricks in the back wall. This should be repaired with a heat rated mortar.

Slight gap in back wall

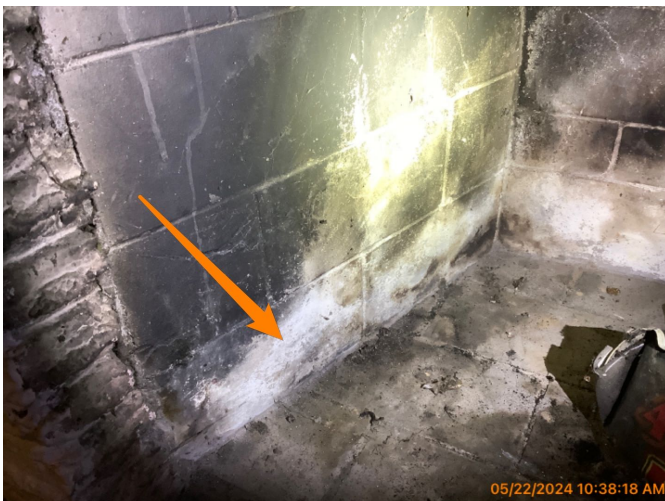
There is efflorescence (white mineral deposits typically caused by moisture) noted on the firebox walls- this is an indication of moisture intrusion into the firebox. The source of moisture should be isolated and then addressed.

Efflorescence in firebox

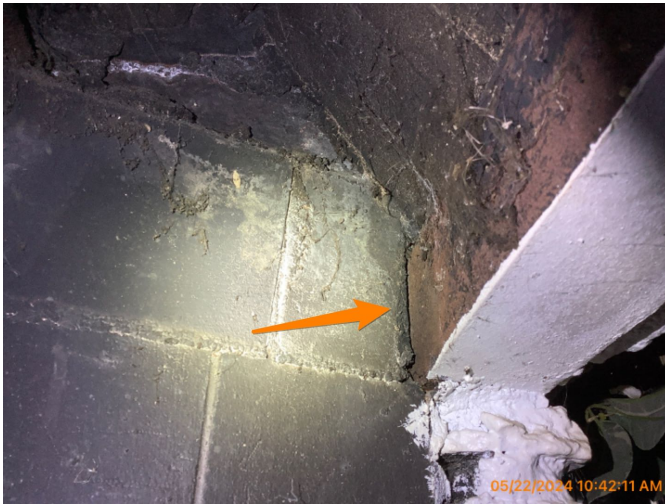
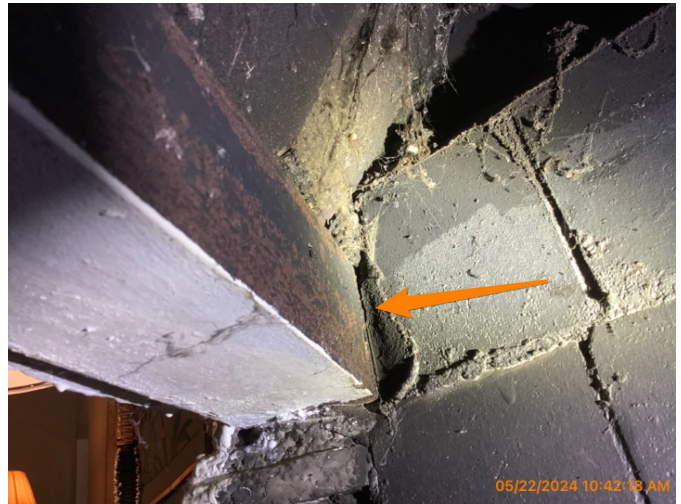
There are gaps in between the bricks noted next to the breastplate- these gaps should be sealed with a high temperature mortar.

Gap next to breast

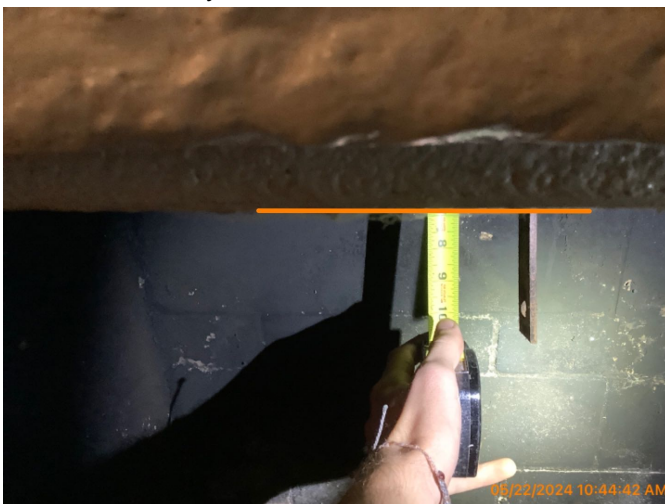
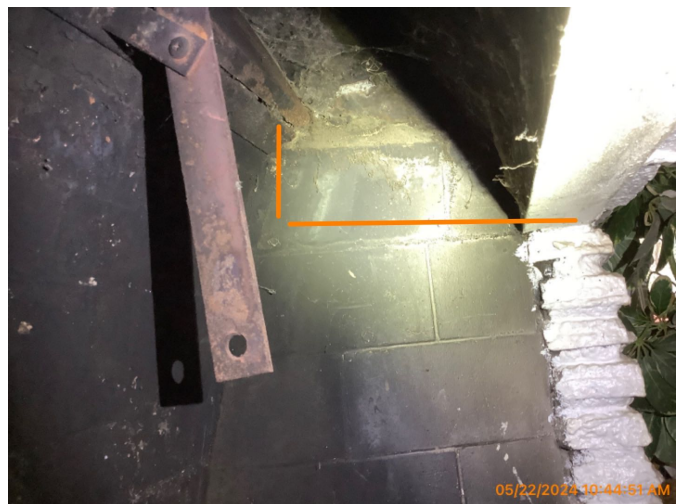
The back wall of the firebox is not 8 inches above the top of the fireplace opening. Ideally, the firebox wall would be higher, but raising the wall in this case would restrict the throat area and I would not recommend raising it as it could inhibit drafting. It is recommended to use the fireplace during different climate conditions to determine if the fireplace is drafting correctly and if not, an appropriate remedy could be to install a smoke guard at the top of the fireplace opening. There are other more extensive remedies as well, should they be needed.

Back wall not 8 inches high

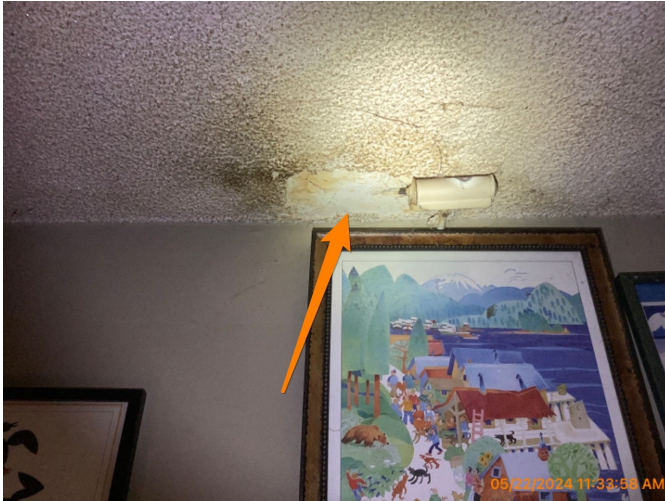
I was informed by the brother in law and sister of the previous owner that he was told not to use the fireplace due to a leak. The only indication of leaking or moisture entry other than efflorescence seen in the firebox and flue area was a moisture stain in the ceiling above the chimney in the living room. I was also informed that the roof was redone in 2016. It is possible that this problem has since been solved by the new roof installation. I did not see any other indication of moisture entry. Refer to a roof contractor regarding leaks in the roof.

Moisture stain above firebox

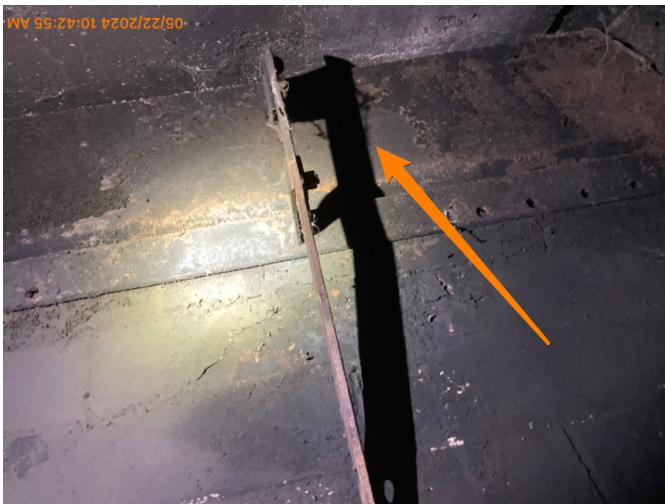
A damper is present and functioning correctly at this time.

Damper present

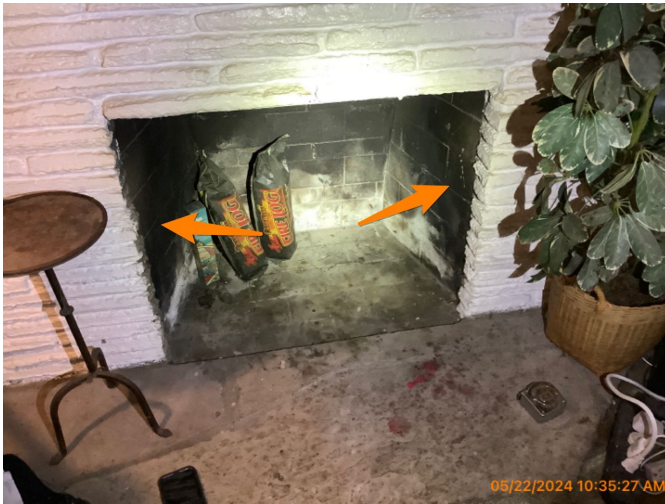
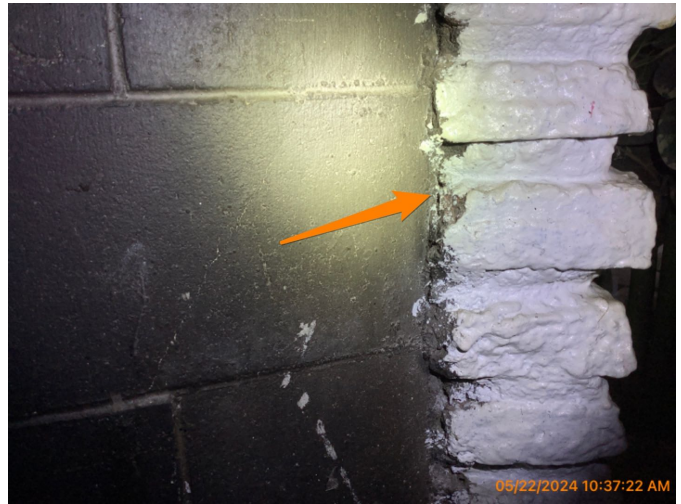
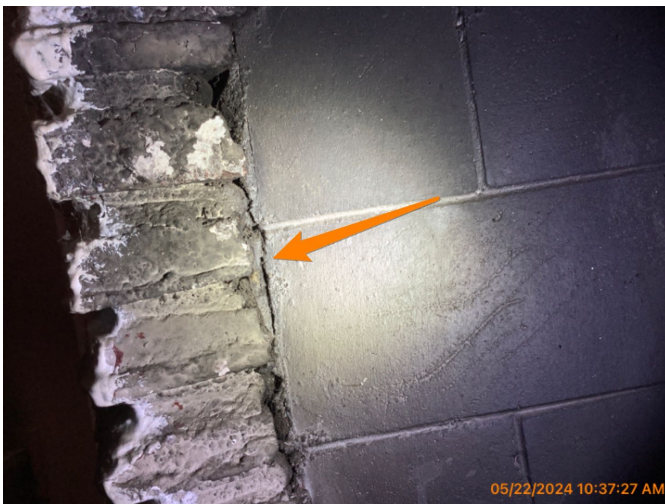
There are gaps where the surround meets the firebox at the opening- these gaps can allow heat to pass through it and behind the surround. The gaps around the fireplace opening should be sealed with a heat rated mortar or sealant.

Approximate location of surround gaps

Gap in surround

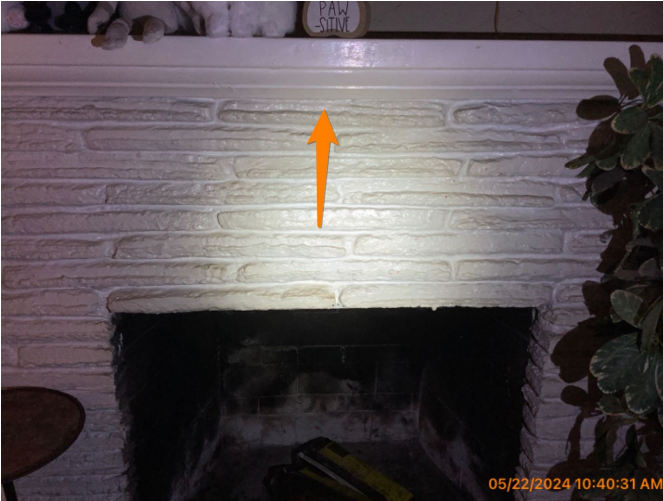
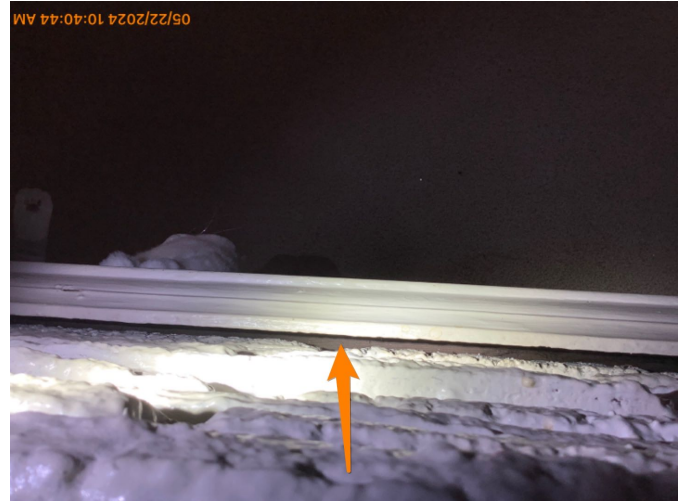
There is a gap behind the mantel materials- the gap can draw heat into this area and is called a second chimney effect. This area should be sealed fully.

Second chimney effect

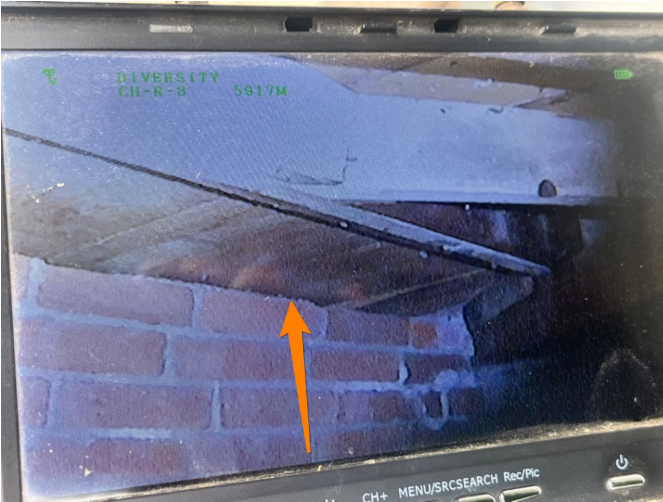
The temporary wood form boards are still below the hearth extension and this is not to code- these should be removed and replaced with non-combustible supports. Heat can transfer from the firebox floor to the wood and pose a fire risk.

Wood form boards under hearth extension

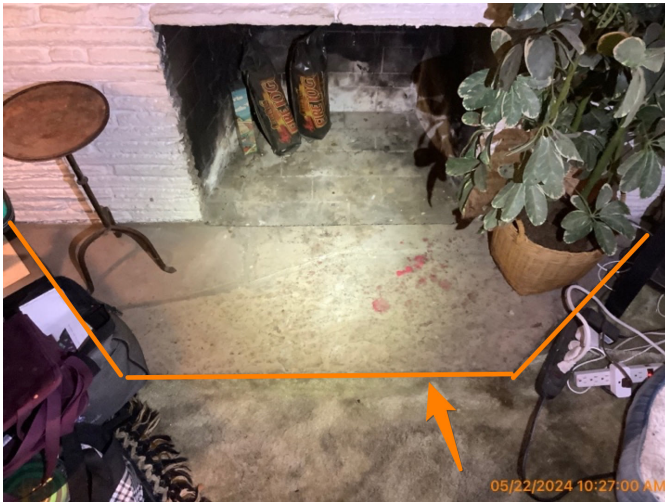
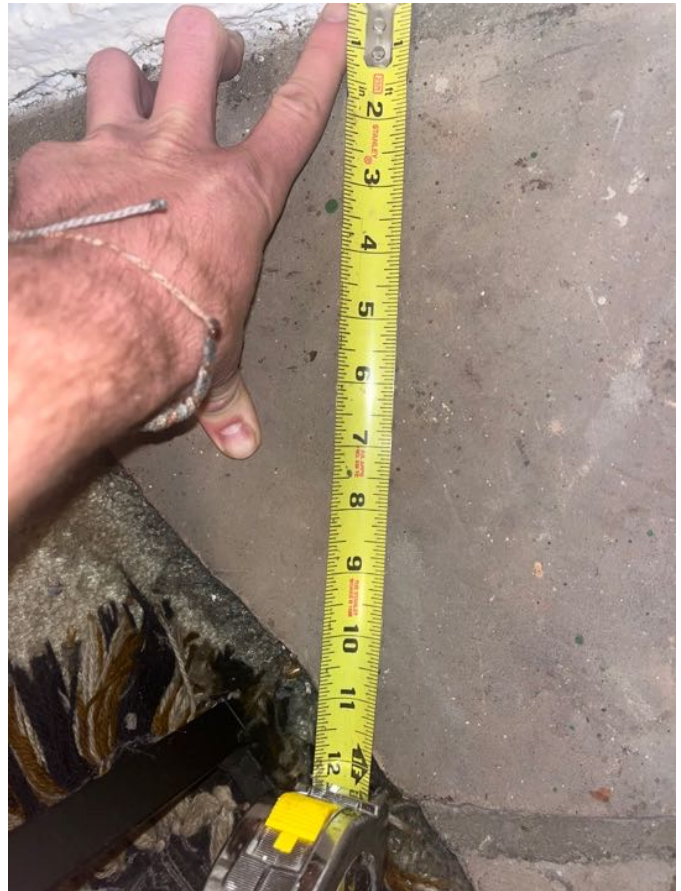
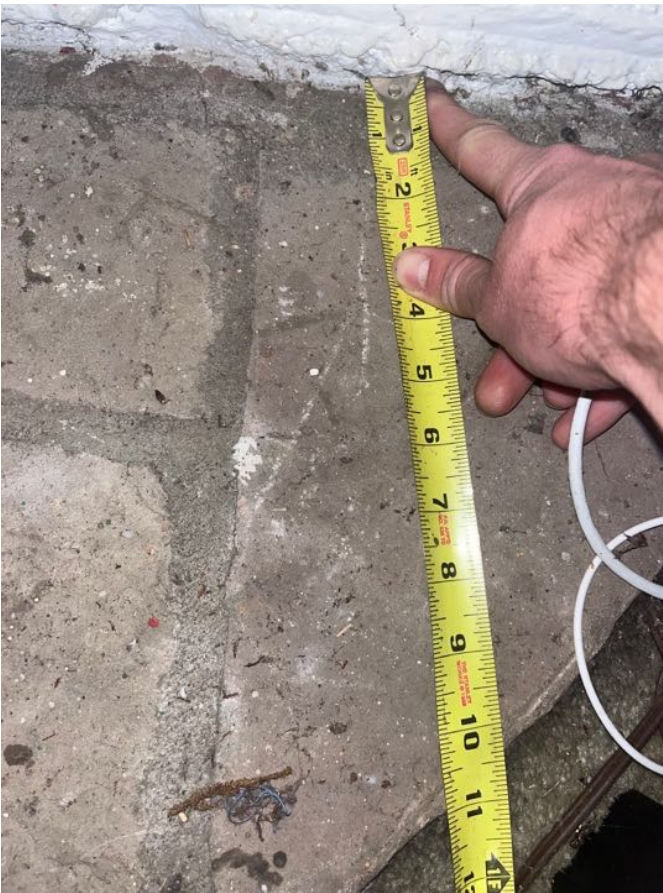
The hearth extension is deficient in depth, the sides of the hearth extension are angled and therefore not deep enough. This would be addressed by a finishing contractor. At the time of correction, the contractor should ensure that the proper clearances and insulating materials are provided for per the fireplace manufacturer requirements.

Hearth extension present

Hearth extension depth as measured 12 inches from the left of the firebox opening

Hearth extension depth as measured 12 inches from the right of the firebox opening

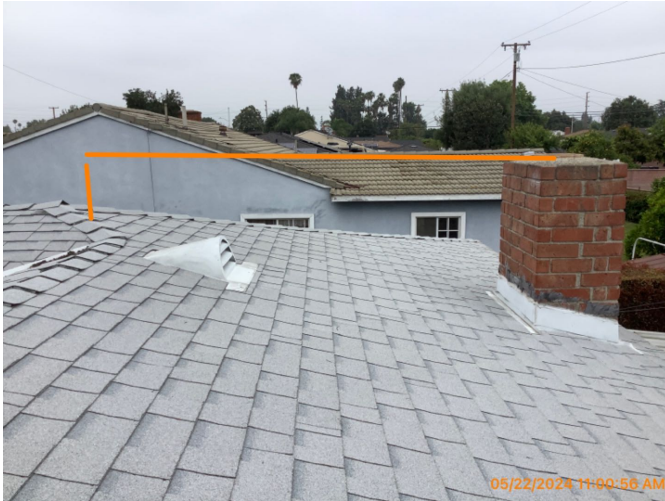
The chimney is approximately 1/2 a foot too short as it does not extend 2 feet higher than the any part of the structure within 10 feet of it, as required by code. The flue can be extended with a fabricated metal flue extension or by increasing the height of the chimney, with full permit and inspection.

Chimney slightly too short

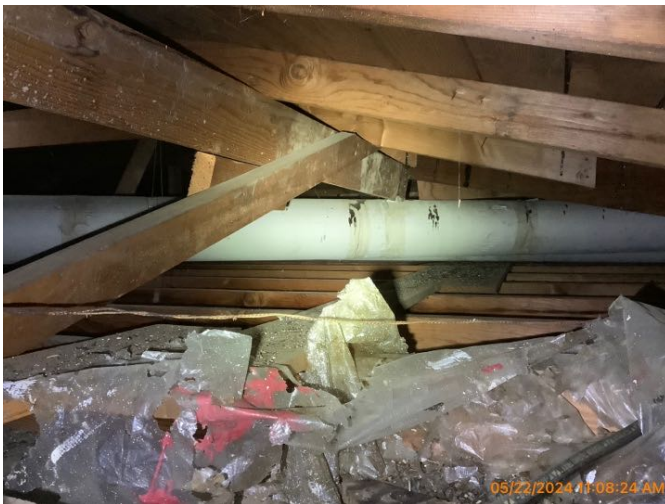
There isn't a catwalk platform in the attic to get to the chimney and there are low clearances, so the chimney was viewed in the attic from a distance and there may be undetected flaws in this area.

No catwalk and low clearances in attic space

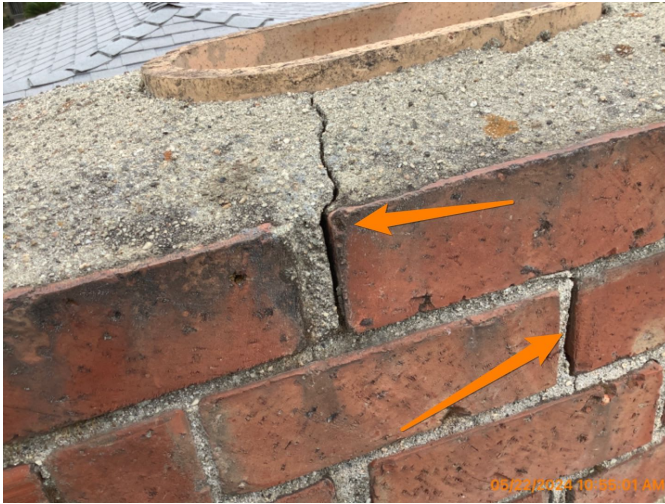
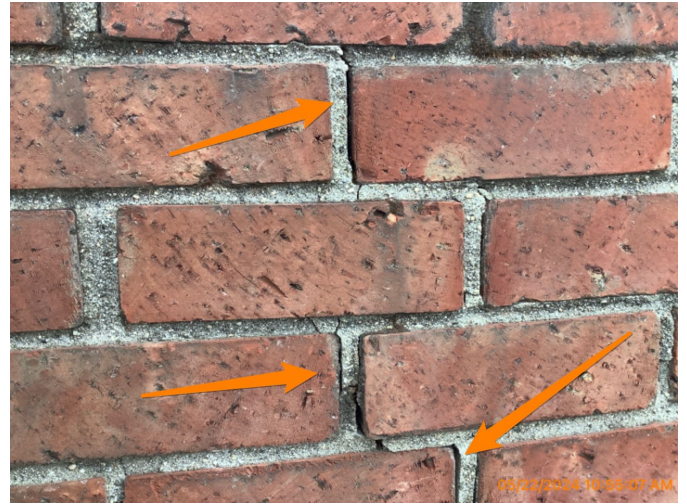
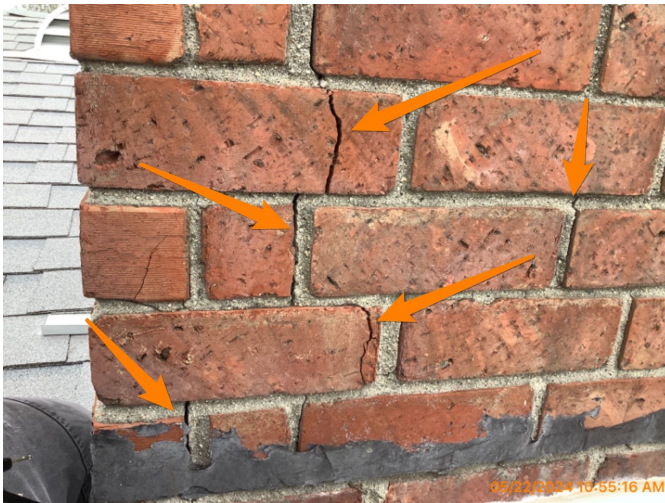
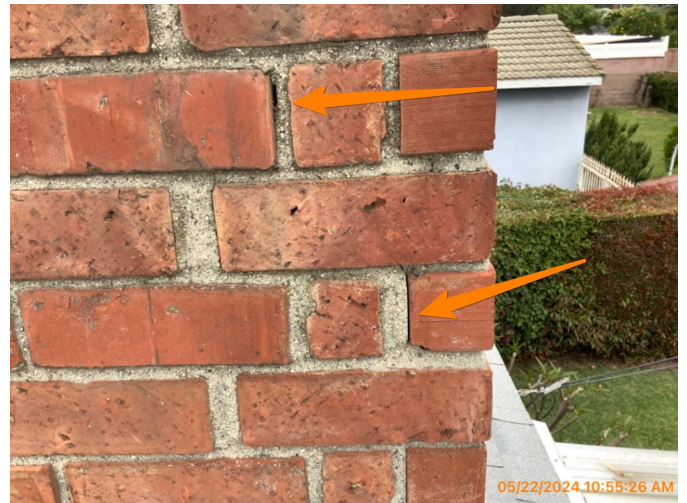
There is cracking in the masonry above the roof line that appears to be caused by rebar rust and expansion underneath the surface. This is an ongoing process and can continue even in spite of repairs being done. So at a minimum repairs should be done by repairing and sealing the cracks, including a water repellent to mitigate continued rusting and expansion cracks. And then monitor the condition of the masonry and repair/replace as needed.

Exterior cracks

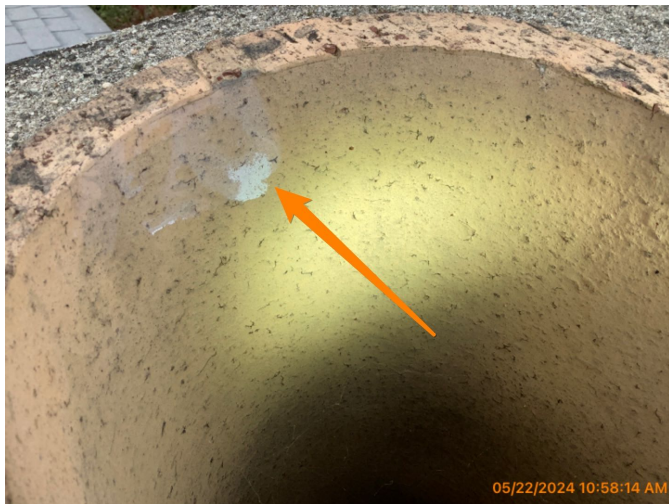
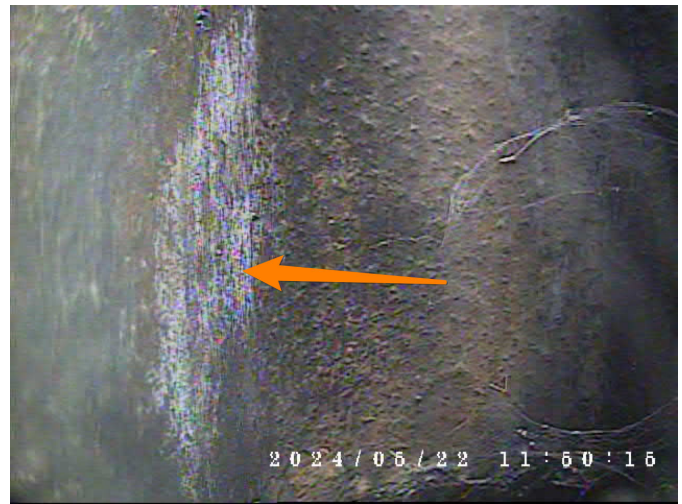
There is a lot of efflorescence (white mineral deposits typically caused by moisture) noted to the flue walls, this is an indication of moisture intrusion into the interior of the chimney. This is most likely caused by moisture entering the top of the flue.

Efflorescence in flue

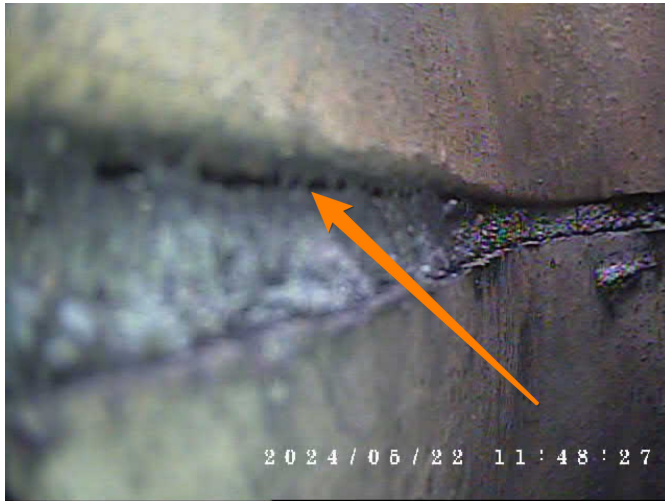
There is missing and deteriorated grout between the flue liners. This affects the integrity of the surfaces against heat transfer to adjacent materials and normally should be addressed with an approved recoating or relining procedure and materials.

Missing mortar between flue joints

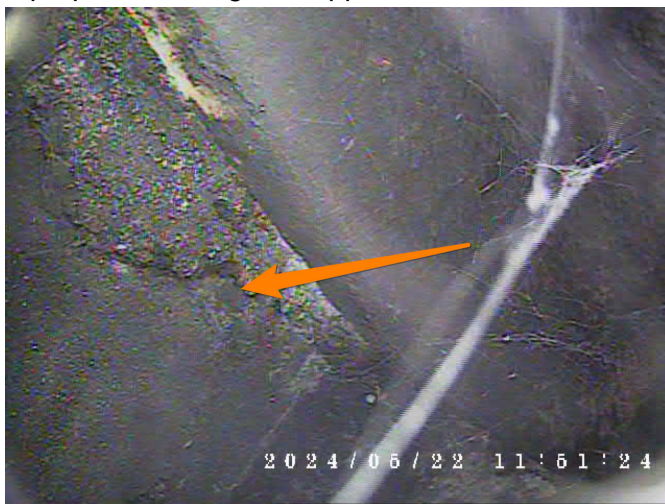
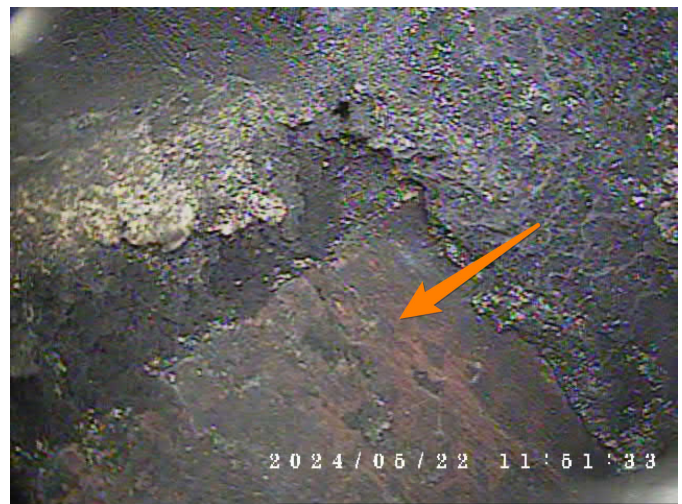
The mortar surfaces along the inner walls of the smoke chamber are missing in a few areas - a proper coating should be applied to the smoke chamber surfaces for smooth surfaces to help the fireplace draft correctly and to prevent heat transfer to adjacent materials to the chimney. It is recommended to perform a proper recoating with approved materials.

Smoke chamber surfaces worn

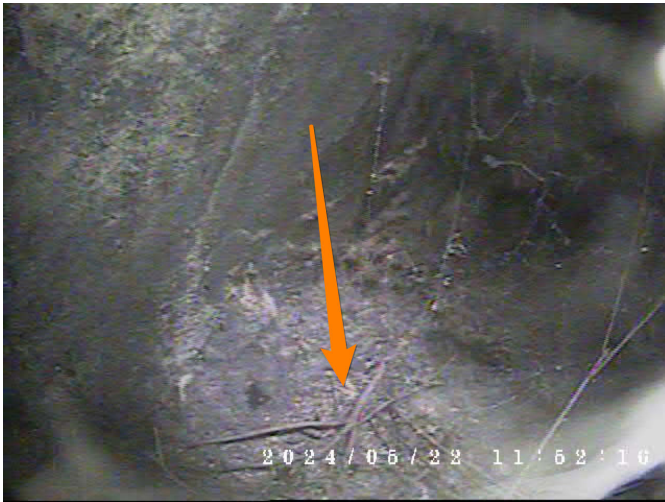
There is debris noted on the smoke shelf - it should be cleaned off as it can affect the proper ventilation of the fireplace or cause a chimney fire.

Derbis on smoke shelf

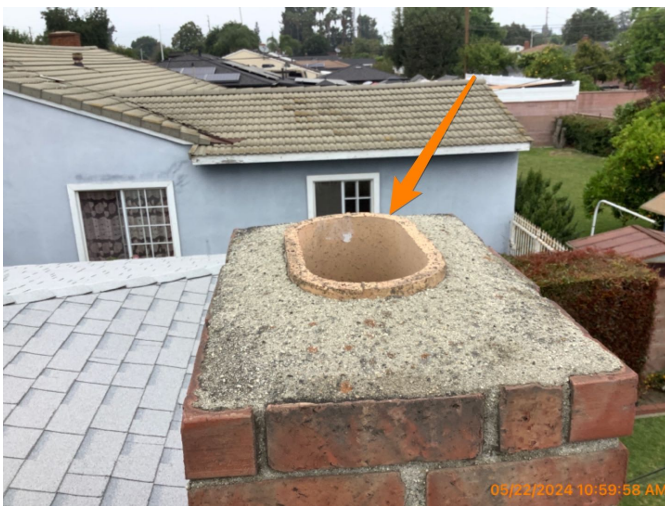
The chimney and flue don't have a rain cap and spark arrester, this is needed to prevent rain from entering the flue and sparks from escaping the chimney. A spark arrester and rain cap should be installed.

Spark arrester rain cap missing

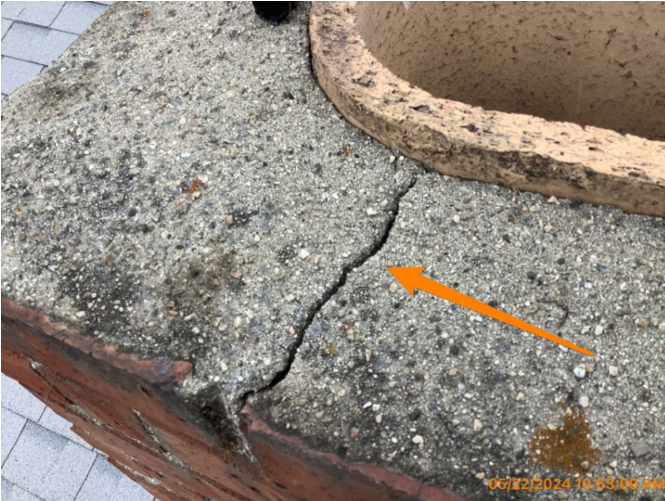
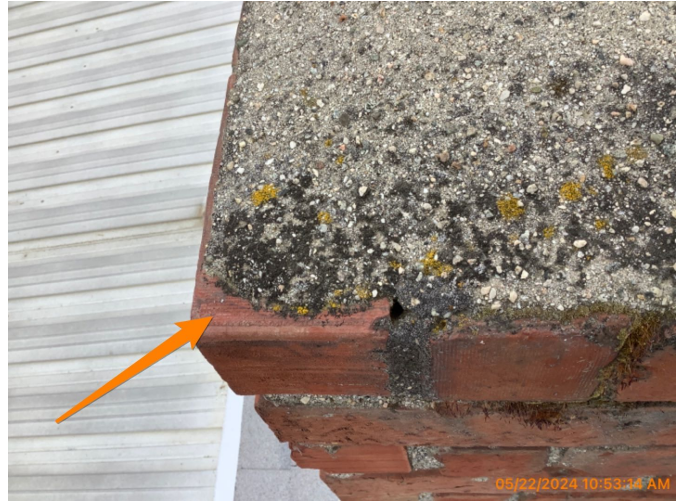
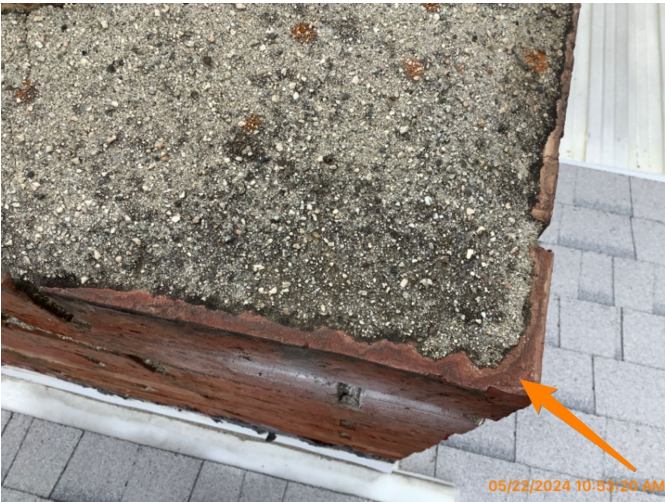
The concrete crown is cracked and worn and does not extend to the edges of the chimney. Proper repairs to the crown should be made to help prevent water saturation of the upper materials.

Crown cracked

Crown does not extend to the edges

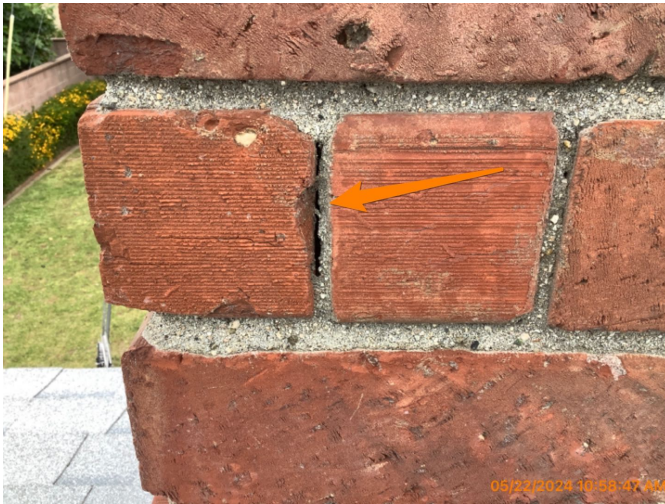
Some of the mortar between the exterior masonry is missing. It is recommended to point the deteriorated mortar joints.

Deteriorated grout above roof

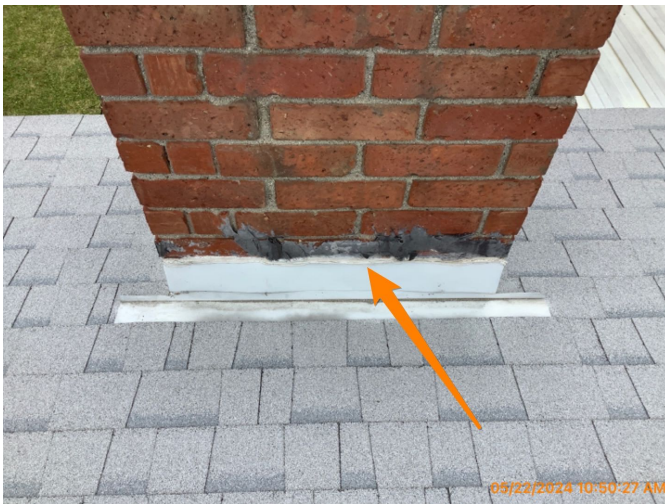
A cricket has not been installed at the roof flashing of the chimney - this is typically required to help divert water around the chimney. It is recommended to consult with a licensed roof contractor for further information and directions regarding the roof flashings.

No cricket

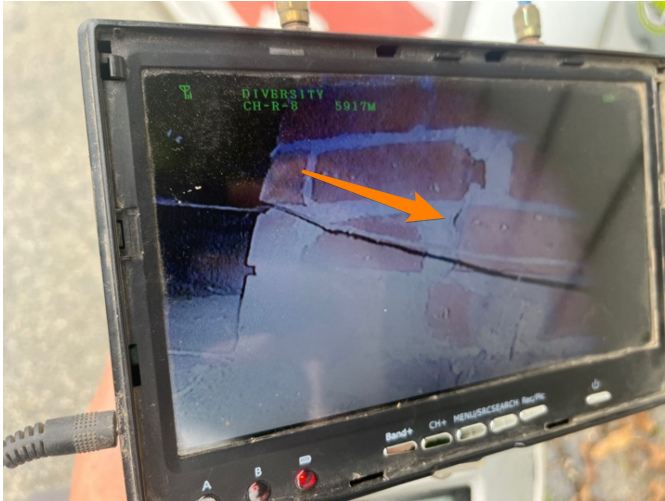
Some of the grout between the exterior masonry is deteriorated. It is recommended to point the deteriorated grout joints.

Deteriorated grout at base of chimney
