# Inspection Report

**Debra Trout**  
**649 Asilo Street**  
**Arroyo Grande, CA 93420**

*Inspected by:* **Gregory S. Terry**

Report Date: 10/22/2025

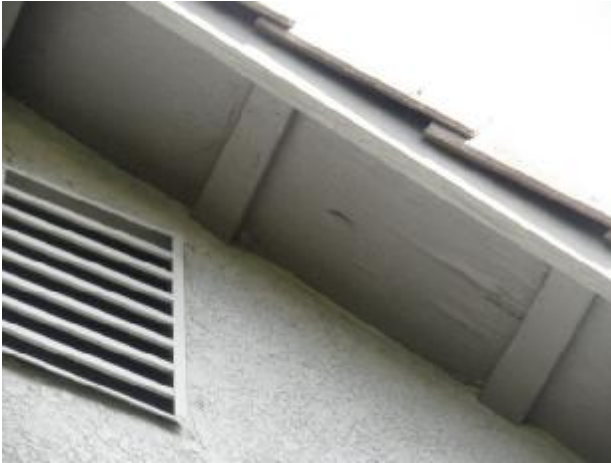
1.) There is evidence of roof leaks with moisture damage to the plywood sheathing at the top or the west facing gable and at the gable above the exterior door in the kitchen nook. Recommend further evaluation by a qualified and licensed Roofing Contractor prior to close of escrow.

Evidence of a leak with moisture damage to the plywood at the west facing gable.

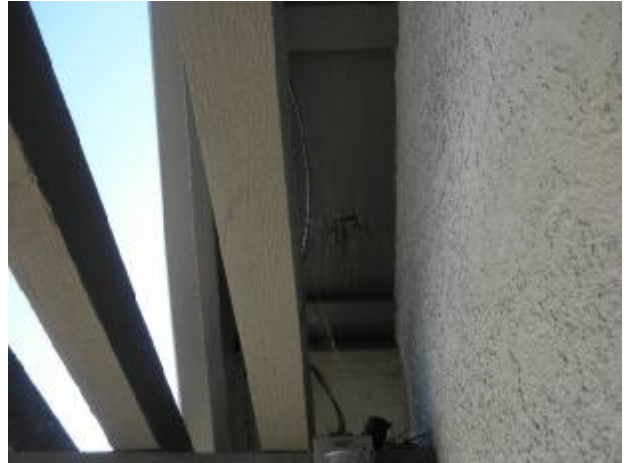
Evidence of a leak with moisture damage to the plywood at the gable above the exterior door.

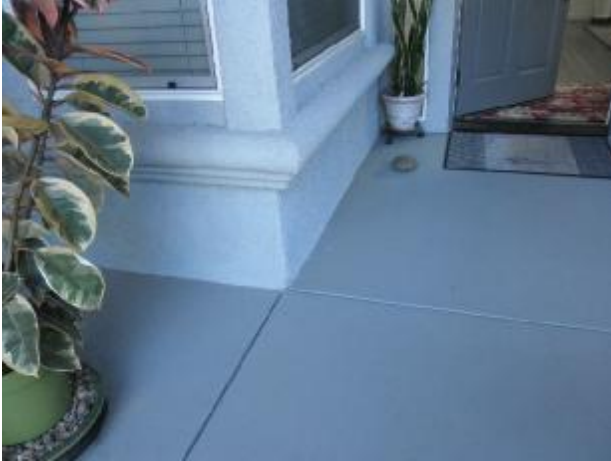
**Drainage Note:** The front entry concrete patio and part of the backyard concrete patio embeds the weep screed at the base of the stucco walls. This can be a moisture intrusion condition.

The front entry concrete patio embeds the weep screed at the base of the stucco wall.

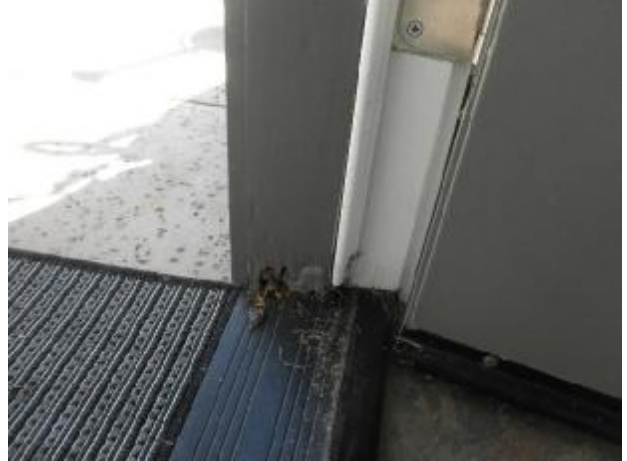
- 2.) There is moisture damage to the base of the jamb a the exterior door in the kitchen nook.

Moisture damage to the base of the jamb at the exterior door in the kitchen nook.

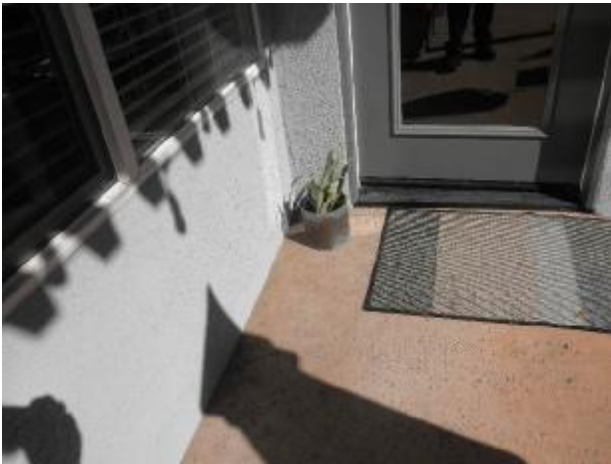
The backyard concrete patio embeds the weep screed at the base of the stucco wall.

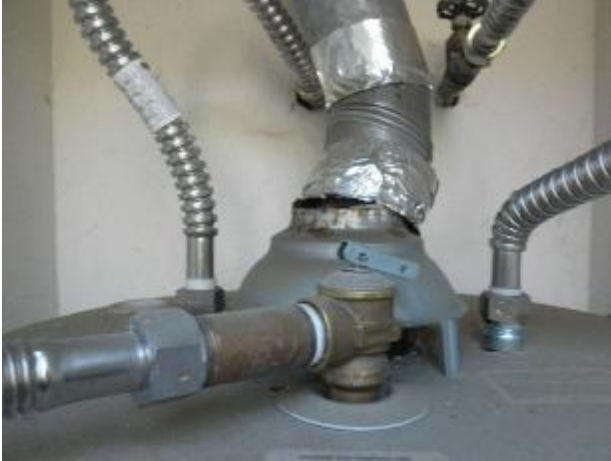
The exhaust vent has separated at the top of the water heater.

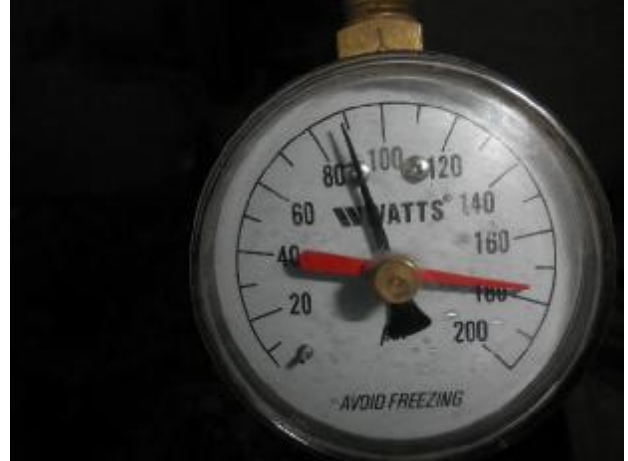
- 1.) The main water shut off valve is seized and inoperable. This valve will need to be replaced.
- 2.) The water pressure was measured at 90 psi. This exceeds the maximum allowable pressure of 80 psi. Recommend adjustment, rebuilding or replacement of the pressure regulator as needed to prevent a possible rupturing of a water line and flooding the home.
- 3.) The exhaust vent at the top of the water heater is separated. This will allow the products of combustion to vent into the closet posing a potential carbon monoxide hazard. Recommend corrective repairs by a qualified and licensed Plumbing Contractor prior to close of escrow.

The water pressure exceeds the maximum allowable of 80 psi.

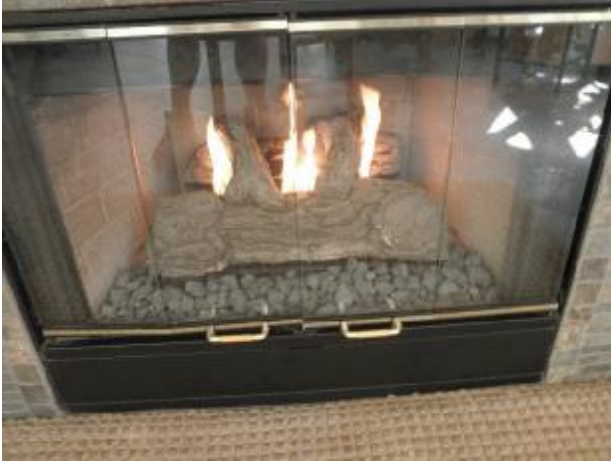
The gas fireplace was operable during the time of inspection.

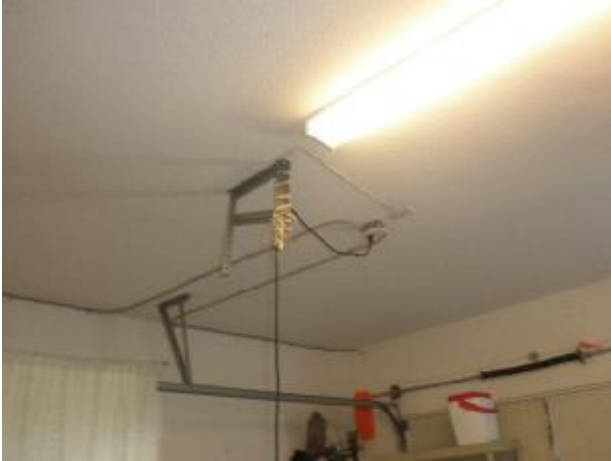
The garage vehicle door opener has been removed at the single overhead garage.
