**Exclusive Property Inspection Report Prepared For  
Edward Lee**

Property Address: 6919 Grovespring Dr. Rancho Palos Verdes CA.

Inspection Date: 5/23/2025

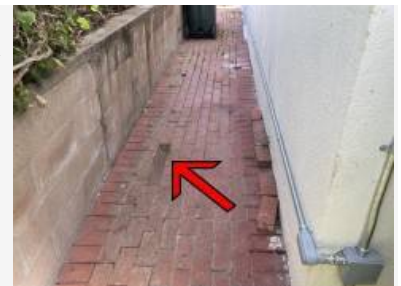
- Uneven surface joints are visible at multiple locations along the right side brick walkway. The condition poses a trip hazard. We recommend correction using appropriate methods by a qualified state licensed masonry contractor.

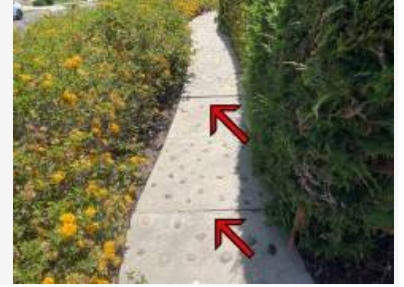
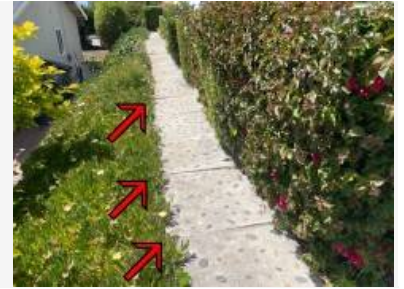
- Crack damage and uneven surface joints are visible at multiple locations along the front and left side concrete walkways. The condition poses a trip hazard. We recommend correction using appropriate methods by a qualified state licensed concrete contractor.

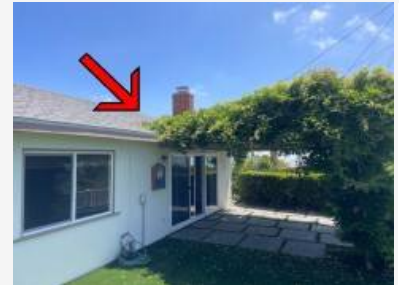
- Vegetation is growing onto the building. Damage to the building can occur as a result. The condition can also allow animal access onto the building. We recommend keeping the vegetation pruned back away from the building.

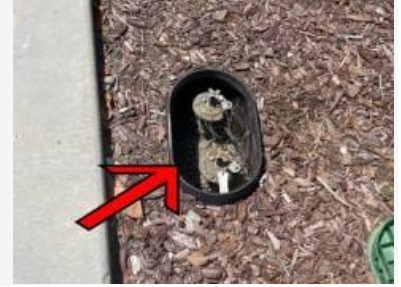
- Backflow prevention devices are not installed on the irrigation control valves adjacent the main entry walkway. The function of a backflow prevention device is to prevent contamination of the potable water system from a cross connection. We recommend correction using appropriate methods by a qualified irrigation specialist.

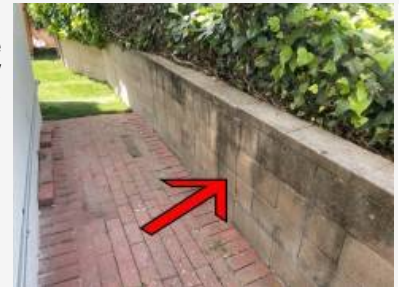
- Significant crack damage and leaning is visible to the entire length of the right side retaining wall. Replacement is likely needed. We recommend further evaluation / correction using appropriate methods by a qualified state licensed masonry contractor.

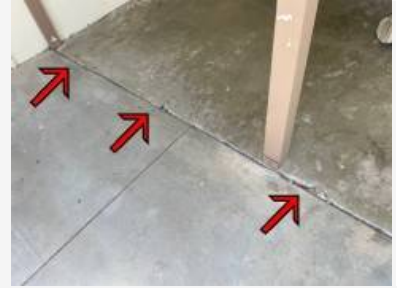
- Significant chip damage is visible along the interface joint to the main walkway. The damage is likely caused by exposed rebar along the joint. We recommend correction using appropriate methods by a qualified state licensed concrete contractor.

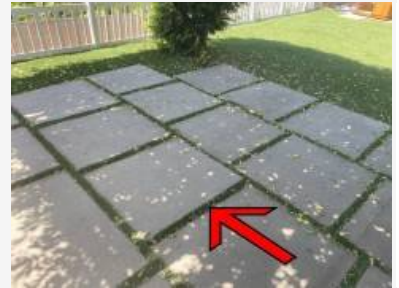
- Gaps and uneven surface joints are visible between the segments of concrete. The condition poses a trip hazard. We recommend correction using appropriate methods by a qualified state licensed concrete contractor.

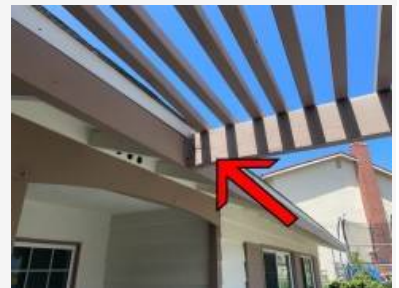
- Moisture related damage is visible to the wood at multiple locations. The condition can make the structure unstable. We recommend correction using appropriate methods. Replacement may be needed. We also recommend further evaluation by a qualified state licensed Structural Pest Control Operator to determine if any wood destroying organism conditions exist.

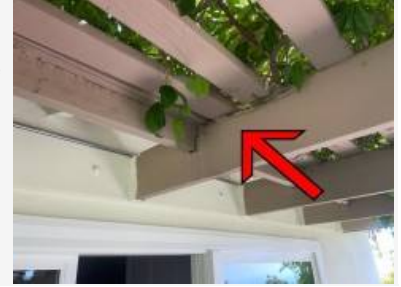
- Moisture related damage is visible to the wood at multiple locations. The condition can make the structure unstable. We recommend correction using appropriate methods. Replacement may be needed. We also recommend further evaluation by a qualified state licensed Structural Pest Control Operator to determine if any wood destroying organism conditions exist.

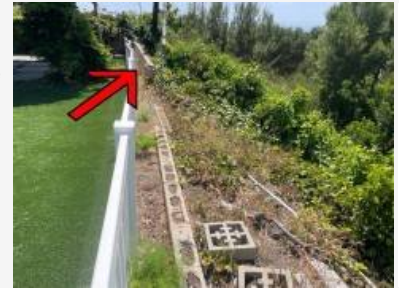
- Most of the blocks have been removed from the rear block fence. Significant leaning is visible to the remaining portion. We recommend correction using appropriate methods by a qualified state licensed masonry contractor.

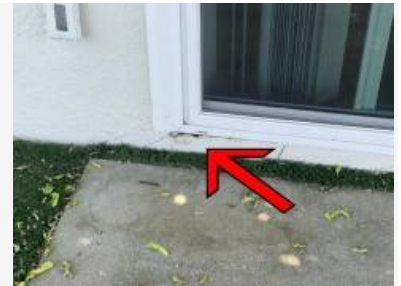
- Stucco is broken out below the sliding exterior door. The condition is conducive to moisture intrusion and subsequent damage. We recommend correction using appropriate methods by a qualified state licensed lathing & plastering contractor.

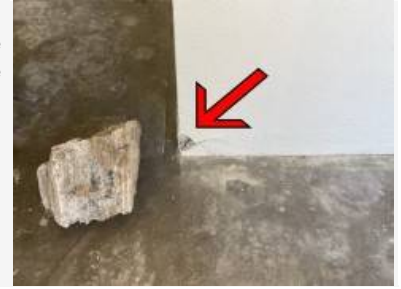
- Stucco is broken out of the front exterior wall adjacent the main entry porch. The condition is conducive to moisture intrusion and subsequent damage. We recommend correction using appropriate methods by a qualified state licensed lathing & plastering contractor.

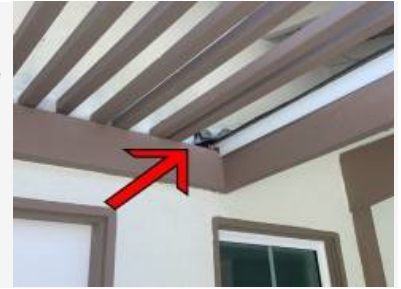
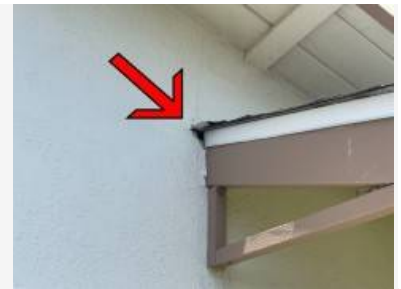
- Openings are visible through the stucco at the roof to exterior wall interfaces. The condition is conducive to moisture intrusion and subsequent damage. We recommend correction using appropriate methods by a qualified state licensed lathing & plastering contractor.

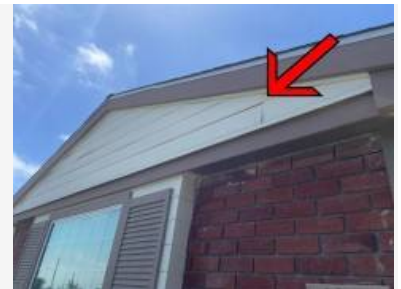
- Separated joints are visible on the siding at the garage exterior wall. The condition is conducive to moisture intrusion and subsequent damage. We recommend correction using appropriate methods by a qualified state licensed siding contractor.

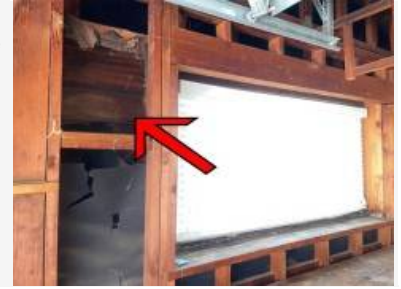
- Damage is visible to the moisture barrier wrap on the exposed walls at the garage interior. The condition is conducive to moisture intrusion from the exterior. Stains on the wall framing likely indicates a history of moisture intrusion. We recommend correction using appropriate methods by a qualified state licensed siding contractor.

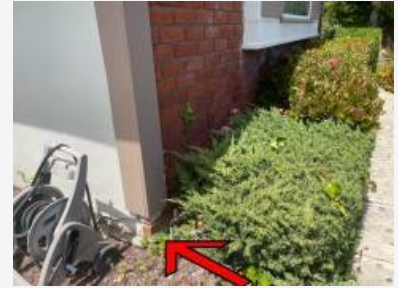
- A footing is absent at the base of the brick veneer. The condition can make the brick veneer wall unstable. The brick veneer also lacks flashings and weep openings to prevent moisture entrapment and subsequent damage between the veneer and its backing. We recommend correction using appropriate methods by a qualified state licensed masonry contractor. Determining if any damage exists behind the veneer as a result is beyond the scope of this inspection due to inaccessibility.

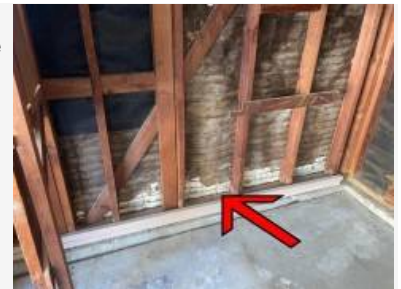
- Damage is visible to the moisture barrier wrap on the exposed walls within the garage. The condition is conducive to moisture intrusion from the exterior. Stains on the wall framing indicates a history of moisture intrusion. We recommend further evaluation / correction using appropriate methods by a qualified state licensed masonry contractor.

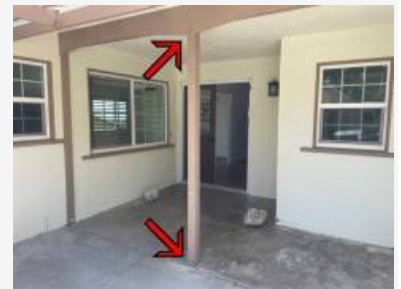
- The support post at the front of the building is unstable due to lack of post cap connection hardware and improper post base connection hardware. We recommend correction using appropriate methods by a qualified state licensed framing & rough carpentry contractor.

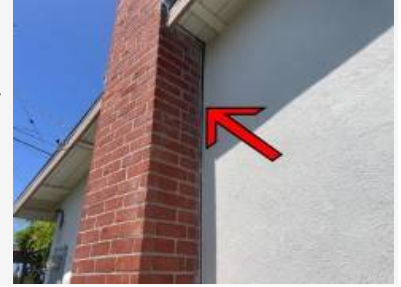
- A large gap is visible between the chimney and exterior wall flashing. The condition likely indicates movement of the chimney has occurred. The condition is also conducive to moisture intrusion and subsequent damage. We recommend further evaluation / correction using appropriate methods by a qualified chimney specialist.

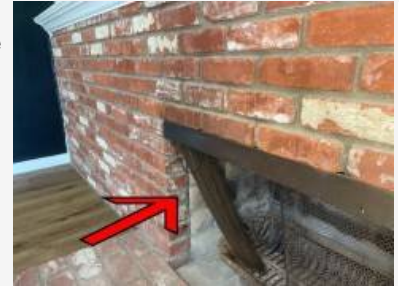
- A large gap is visible between the fireplace masonry and interior wall masonry. The condition likely indicates movement of the chimney has occurred. We recommend further evaluation / correction using appropriate methods by a qualified chimney specialist.

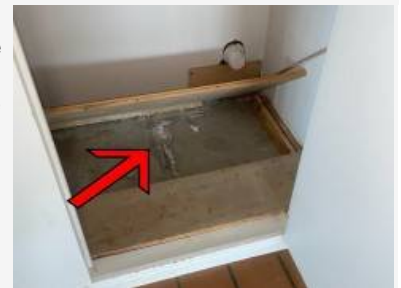
- Crack damage and efflorescence is visible on the exposed portion of slab within the main entry closet. We recommend further evaluation by a qualified state licensed geo-technical engineer to determine if the damage is a result of any adverse geological / foundation conditions.

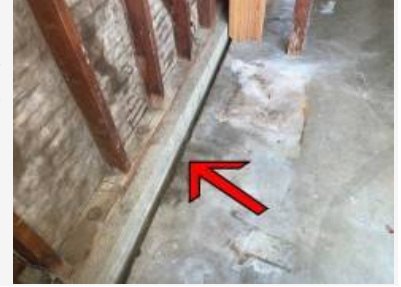
- A large gap is visible between the footing stem wall and garage slab. The condition likely indicates movement of the foundation has occurred. We recommend further evaluation by a qualified state licensed geo-technical engineer to determine if the damage is a result of any adverse geological / foundation conditions. We recommend further evaluation / cost estimate for corrections by a qualified state licensed concrete contractor.

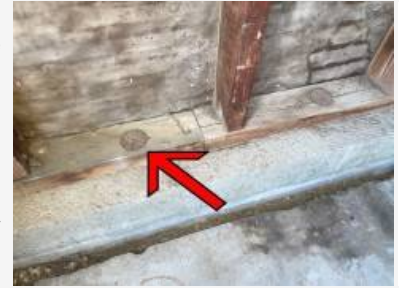
- Determining if the condition exists at the remainder of the building is beyond the scope of this inspection due to inaccessibility. We recommend further evaluation by a qualified state licensed geo-technical engineer.

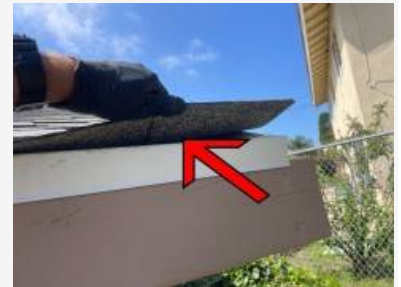
- The starter course shingles are installed with granules facing down which is improper. Damage to the shingles can occur as a result. We recommend correction using appropriate methods by a qualified state licensed roofing contractor.

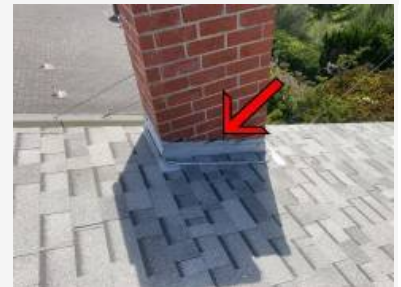
- Chimney flashing is improperly installed as it is face mounted with mastic seal instead of using reglet flashing. The condition is conducive to moisture intrusion and subsequent damage. We recommend correction using appropriate methods by a qualified state licensed roofing contractor.

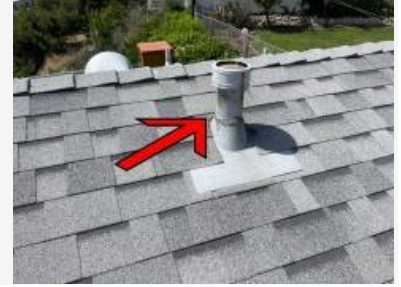
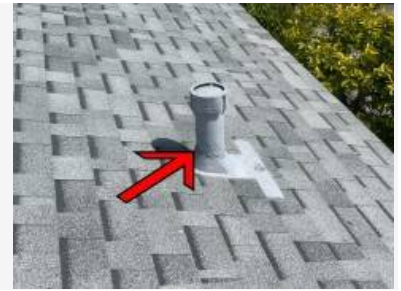
- Storm collars are absent where the furnace and water heater vent pipes transition through their flashings. The condition is conducive to moisture intrusion and subsequent damage. We recommend correction using appropriate methods by a qualified state licensed roofing contractor.

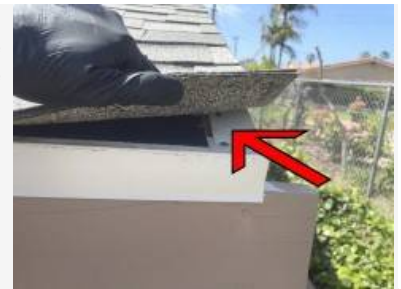
- The rake edge flashing is not properly lapped with the base sheet underlayment. The underlayment is cut short of the flashing. The condition could cause damage to the eaves from potential moisture entrapment. We recommend correction using appropriate methods by a qualified state licensed roofing contractor.

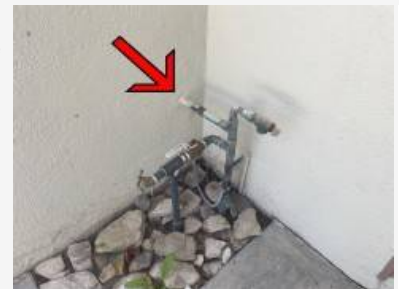
- A pressure regulator is not installed on the main line. Installation of an appropriate pressure regulator by a qualified state licensed plumbing contractor should be considered to prevent any adverse overpressure conditions.

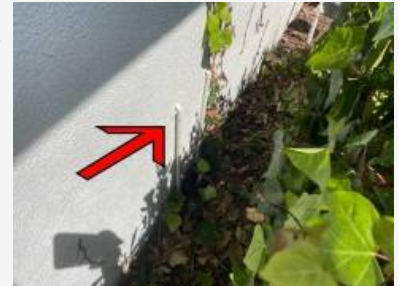
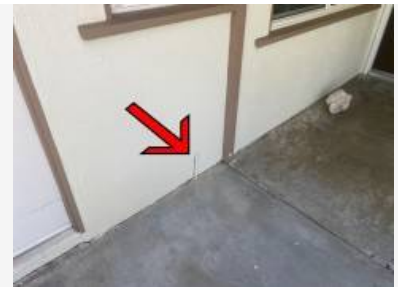
- Exposed piping subject to damage is visible at the left side exterior wall and exterior wall at the main entry porch. The pipes also lack insulation for protection against freezing. We recommend correction using appropriate methods by a qualified state licensed plumbing contractor.

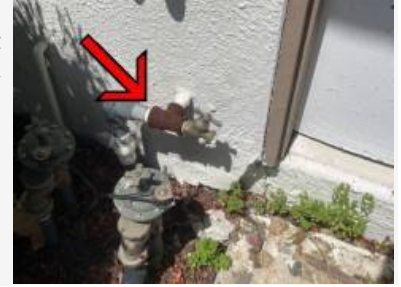
- Corrosion related damage caused leakage is visible on a hose faucet fitting at the left side exterior wall. We recommend correction using appropriate methods by a qualified state licensed plumbing contractor.

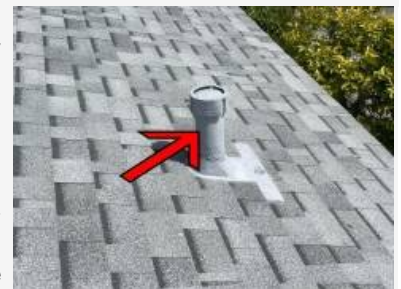
- Please be aware that the transite pipe may contain asbestos material. Any replacement and disposal should be performed by a qualified specialist using appropriate methods as asbestos is known to be a health hazard to people. To determine if asbestos is present, we recommend retaining a Cal/OSHA-Certified Asbestos Consultant. Only a Cal/OSHA-Certified Asbestos Consultant (CAC) can provide asbestos consulting (as defined by the Business and Professions Code, 7180-7189.7, and triggered by the same size and concentration triggers as for registered contractors). These services include building inspection, abatement project design, contract administration, supervision of site surveillance technicians, sample collection, preparation of asbestos management plans, and clearance air monitoring.

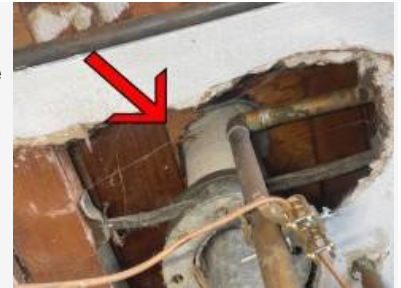
- Insufficient clearance (less than 1") is visible between the vent pipe and combustible wood roof sheathing. The condition poses a risk of fire hazard from heat transfer. We recommend correction using appropriate methods by a qualified state licensed plumbing contractor. Refer to the instructions stamped on the vent pipe for clearance requirements.

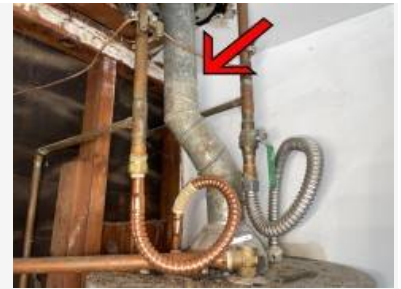
- The vent connector is not effectively joined to the draft hood and other joints with screws to prevent separation. A separated vent connector or pipe joint can cause spillage of hazardous exhaust gases resulting in a carbon monoxide poisoning hazard. We recommend correction using appropriate methods by a qualified state licensed plumbing contractor.

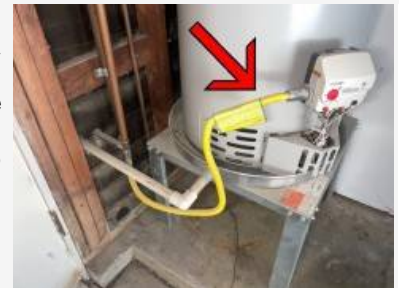
- There is no sediment trap at the gas line supplying the water heater. The purpose of a sediment trap is to catch potential debris that could clog and block an automatic gas valve in the open position, preventing the appliance from shutting off. A gas valve blocked in the open position poses a risk of fire hazard. We recommend correction using appropriate methods by a qualified state licensed plumbing contractor. Refer to the water heater manufacturers installation manual for gas piping installation instructions.

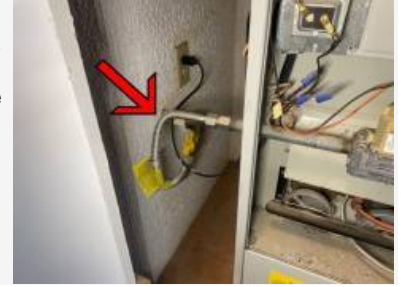
- There is no sediment trap at the gas line supplying the heater. The purpose of a sediment trap is to catch potential debris that could clog and block an automatic gas valve in the open position, preventing the appliance from shutting off. A gas valve blocked in the open position poses a risk of fire hazard. We recommend correction using appropriate methods by a qualified state licensed Warm-Air Heating, Ventilating and Air-Conditioning contractor. Refer to the heater manufacturers installation manual for gas piping installation instructions.

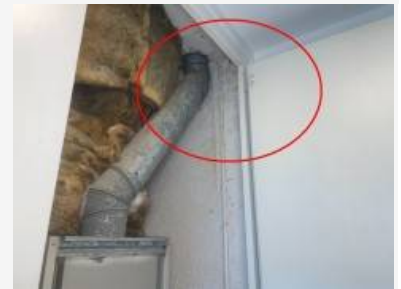
- Insufficient clearance (less than 6") is visible between the single wall vent connector and combustible wood closet door frame. The condition poses a risk of fire hazard from heat transfer. We recommend correction using appropriate methods.

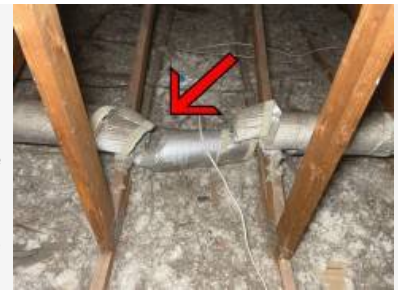
- Crushed ducting is visible in the attic. The ducting may contain asbestos. In certain conditions, asbestos is known to be a health hazard to people. We recommend retaining a Cal/OSHA-Certified Asbestos Consultant to determine if asbestos is present and if any safety hazards exist as a result. Only a Cal/OSHA-Certified Asbestos Consultant (CAC) can provide asbestos consulting (as defined by the Business and Professions Code, 7180-7189.7, and triggered by the same size and concentration triggers as for registered contractors). These services include building inspection, abatement project design, contract administration, supervision of site surveillance technicians, sample collection, preparation of asbestos management plans, and clearance air monitoring.

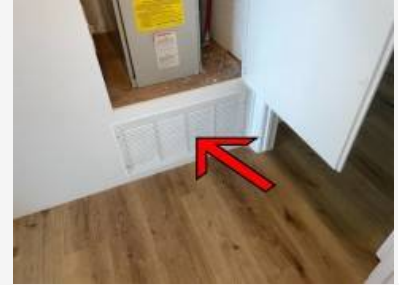
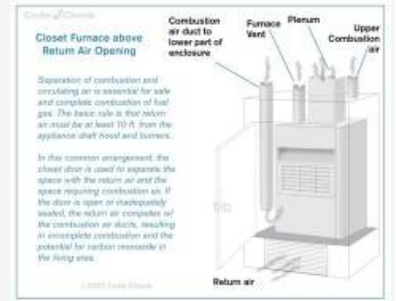
- The return air plenum is located below the closet door which is not acceptable by today's construction standards, although a common installation for this age building. Sealing gaskets are absent on the closet door. If the closet door does not seal, hazardous products of combustion air can be drawn into the air distribution return plenum located below the closet door, therefore a carbon monoxide poisoning hazard exists. We recommend further evaluation / correction by a qualified state licensed Warm-Air Heating, Ventilating and Air-Conditioning contractor.

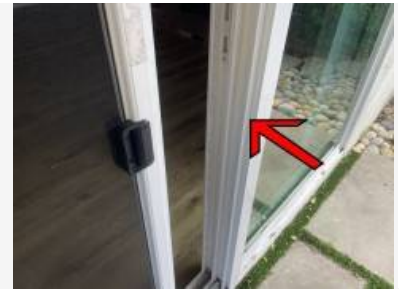
- The latch on the screen door is not functional as there is no receiver. We recommend correction using appropriate methods.
