INSPECTION REPORT  
146 Wylhorne Dr  
Crestline California 92325

INSPECTED BY  
Adan Mendoza,CPI  
Regal Maintenance  
& Inspections

INSPECTION DATE  
📅 9/17/2021  
🕒 09:00 AM

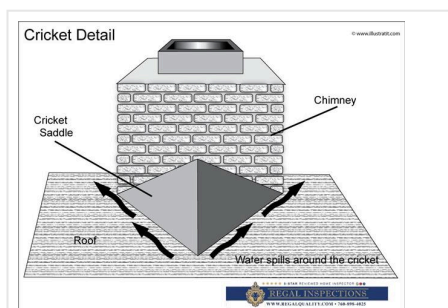
1.3 Item 2 (Picture)

(2) The inspector observed few deficiencies in the conditions of the roof penetrations. Extending of the penetration height to minimal of by today's building standards is recommended.

(3) Adding of a cricket to the chimney is recommended

A roof cricket is a sloped backing that diverts water away from the chimney and down the roof. A roofer builds a roof cricket out of wood and then adds metal flashing or asphalt shingles on top

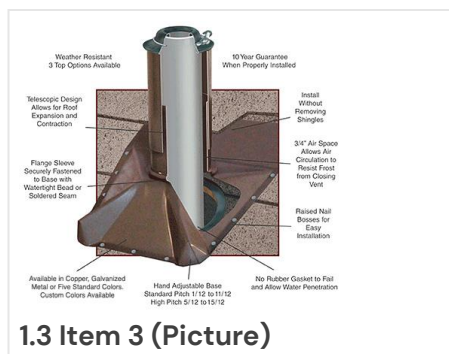
(4) The roof penetrations showed signs of cracking at the boot sealant.

These conditions can allow for moisture to enter advise with a licensed specialist for your options and cost of adding appropriate sealant.

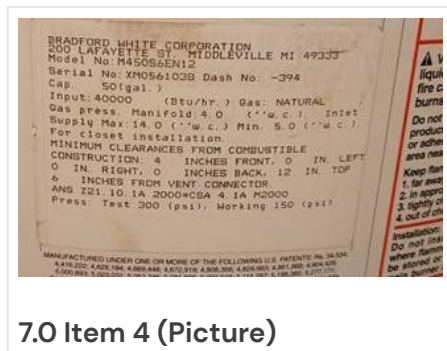
7.0 Item 4 (Picture)

(4) Gas water heater was not equipped with a flue at the time of the inspection.

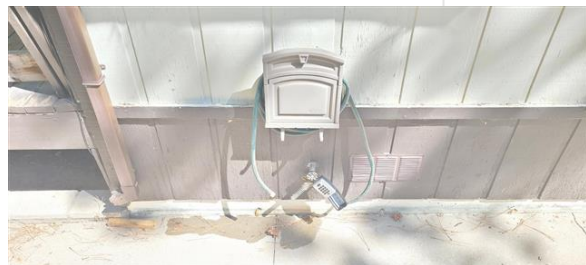
2.3 Item 1 (Picture)

(2) Exterior want to speak it to the left of the front entry door was leaking inside of the wall at the time of the inspection

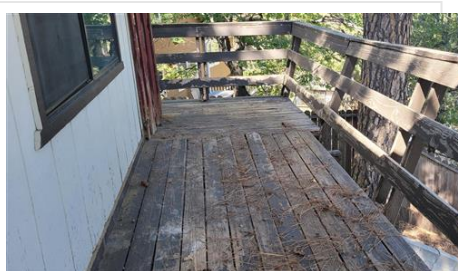
2.6 Item 6 (Picture)

Horizontal deck guardrail components made the guardrail assembly climbable. This condition may be hazardous to small children.

Posts supporting deck guardrail assemblies were placed too far apart. Although physical testing using specialized measurement devices lies beyond the scope of the General Home Inspection, the over-spanned guardrail assemblies appeared to be structurally inadequate as fall protection. Consider installation of additional support posts by a qualified contractor.

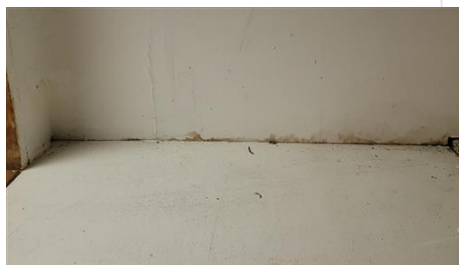
4.1 Item 3 (Picture)

(3) Materials in the laundry room closet had areas covered with a substance resembling mold. Mold can only be positively identified through sampling and analysis by qualified personnel. This condition indicates moisture intrusion. Expanding mold colonies can cause mold spore concentrations in indoor air to rise to unhealthy levels. Conditions that encourage mold growth can also cause structural damage from wood decay. The moisture meter indicated elevated levels of moisture present in these materials at the time of the inspection. The source of moisture intrusion should be located and corrected by a qualified contractor. Mold on dry materials will not produce spores and are not a health threat.

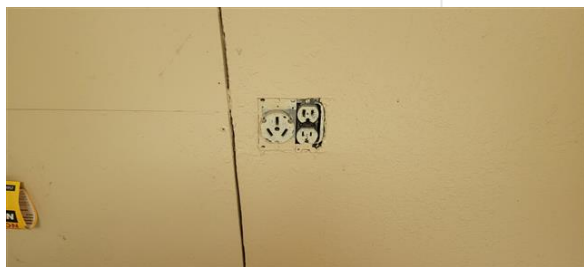
4.4 Item 2 (Picture)

(5) Outlet in the laundry room was missing a cover Outlets read and open ground when tested at the time of the inspection

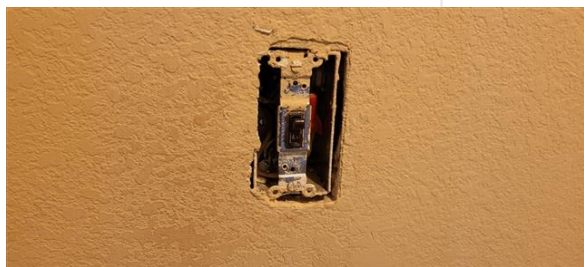
4.4 Item 3 (Picture)

(6) Hallway light switch was missing a cover

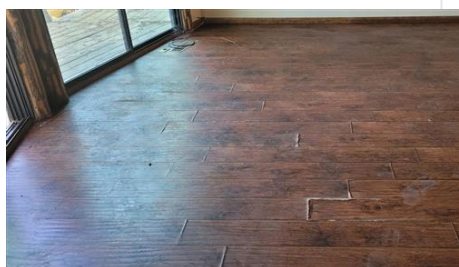
4.6 Item 1 (Picture)

The living room floor showed signs of pet damage.

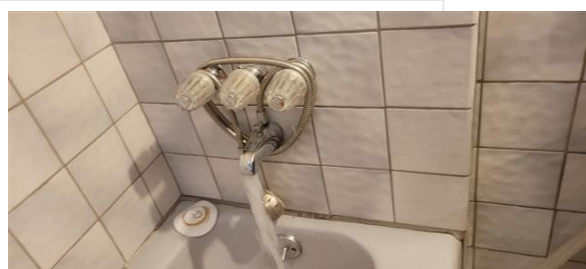
5.3 Item 6 (Picture)

(3) Down stair bathtub handles were leaking when operated

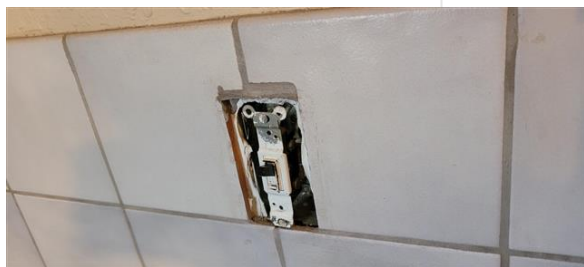
5.5 Item 4 (Picture)

(6) Down stair bathroom toilet light switch was missing a cover.

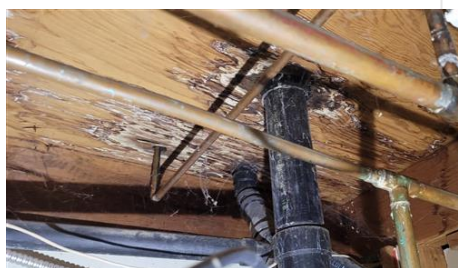
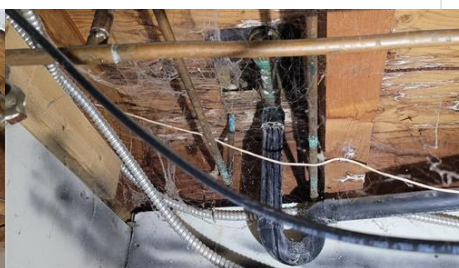
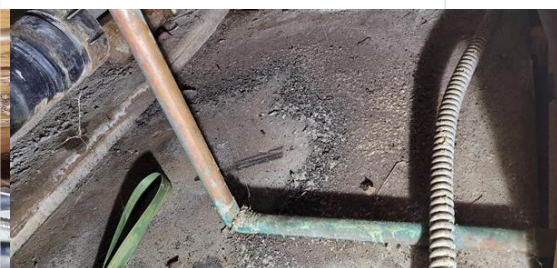
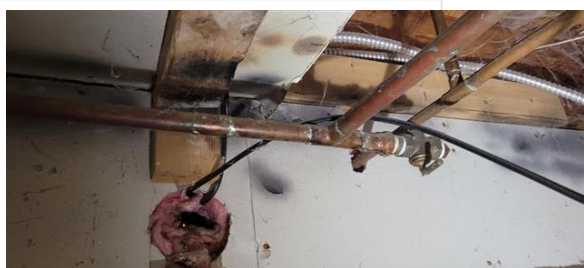
Upstair hallway bathroom supply lines showed signs of an active leak at the time of the inspection.

Further evaluation of the lines is recommended to help reduce the possibility of fungi growth.

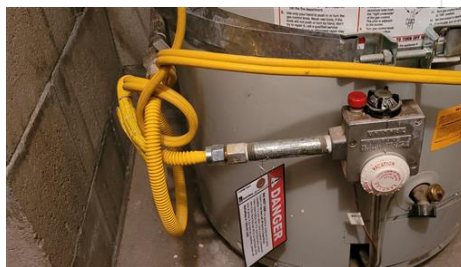
7.0 Item 2 (Picture)

(2) The photo identifies the location of the water heater gas shut off. The water heater had been red tagged and not operated at the time of the inspection.

Further evaluation by a licensed specialist is recommended.

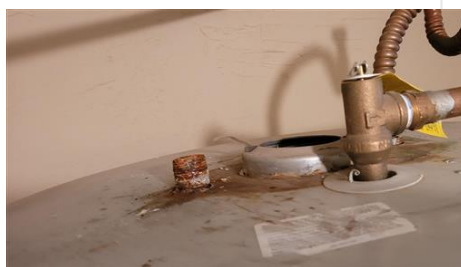
7.0 Item 5 (Picture)

(4) Gas water heater was not equipped with a flue at the time of the inspection.

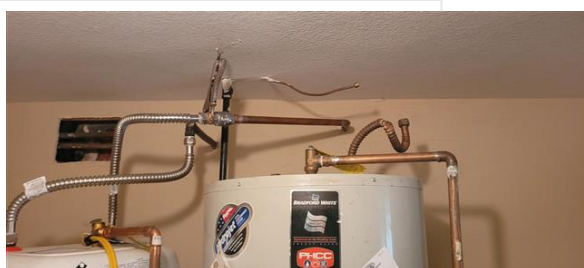
7.0 Item 7 (Picture)

(5) At the time of the inspection the inspector was unable to locate a water shut off for the water heater service lines.

Advise with a licensed specialist for your options and cost of adding a readily accessible shut off.

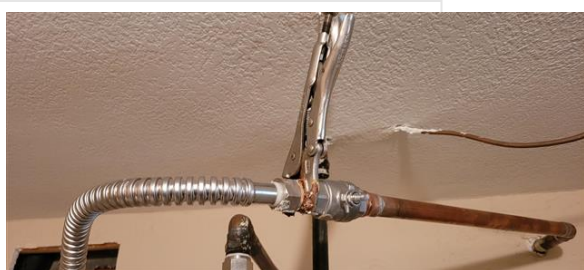
7.0 Item 8 (Picture)

(6) Corrosion on the water line was evident, a leak at the connection was evident. Further evaluation of the supply lines by a licensed specialist is recommended

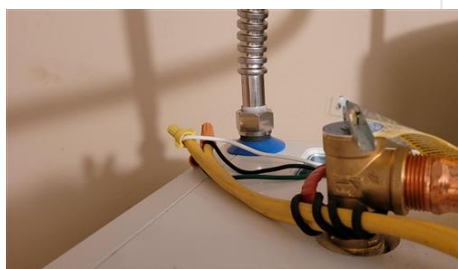
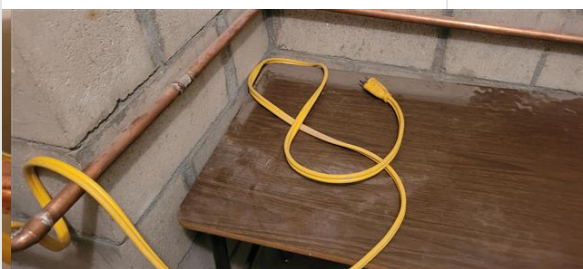
(7) Improperly wired electric tankless water heater.

Properly fastening and mounting of the tankless water heater is recommended.

Advise with a licensed plumber for your options and cost of repairs.

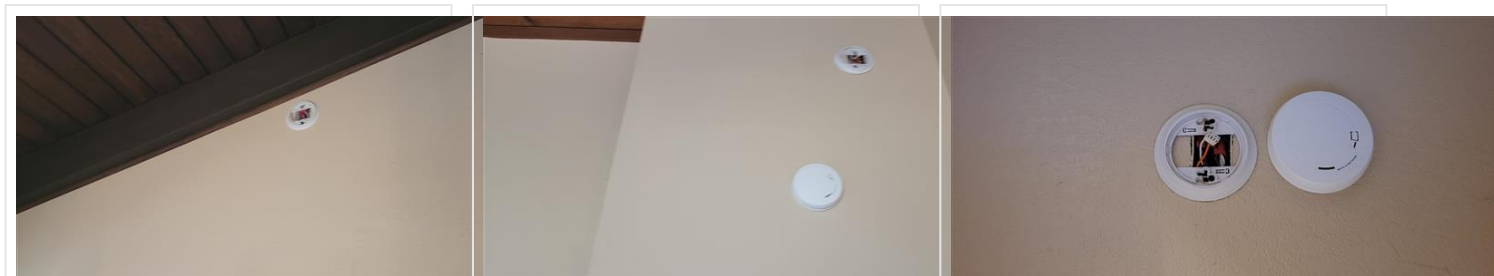
8.5 Item 1 (Picture)

(3) The home had smoke detectors that were interconnected through the home branch wiring. This means that when one detector is activated, all will be activated, and none will ever need batteries. Each detector should be checked occasionally to make sure it has power. If a detector has power, the indicator light will be illuminated. A number of types of smoke detectors exist and effective testing methods are not always obvious. The Inspector recommends that all detectors be checked for proper operation by a qualified contractor.

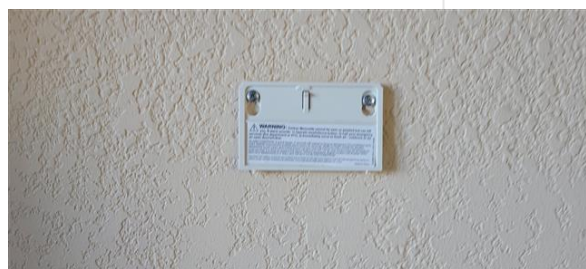
8.6 Item 1 (Picture)

(2) At the time of the inspection the inspector was unable to locate a carbon monoxide detector for the home, proper installation of a carbon monoxide detector per manufacture specifications is recommended.

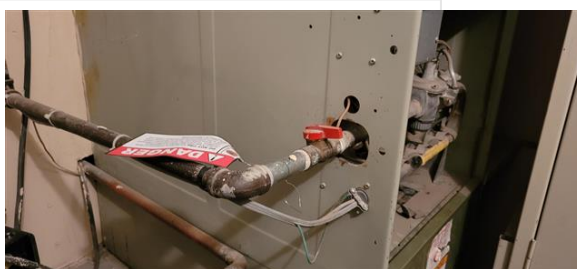
9.0 Item 2 (Picture)

(2) Furnace cover was missing at the time of the inspection.
