# **Property Inspection Report**

650 The Village, Unit 303, Redondo Beach, CA

Inspection date: 03/24/2026

## **Owner's Listing Inspection Report - Cover Page**

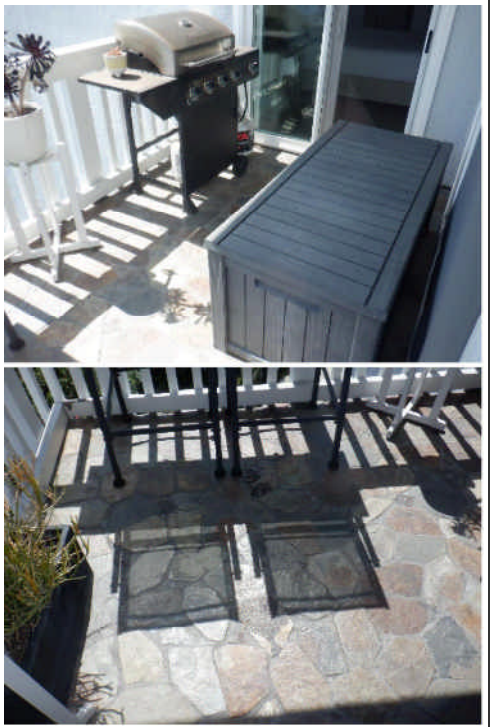
<b>ASSOCIATIONS</b>	Please read the residential dwelling unit statement in the "Introductory Notes" section on the "Inspection Information" page of the report.
<b>DOOR(S)</b>	The doors viewed from the exterior appeared functional.
<b>BALCONY(S)</b>	<p>The balcony/deck coating appeared functional, with exceptions noted.</p> <p>a. [FE] The balcony deck was tiled. The waterproofing material under the tile was not visible/accessible to examine. We recommend a full evaluation and/or corrections by a specialist in the appropriate trade.</p>

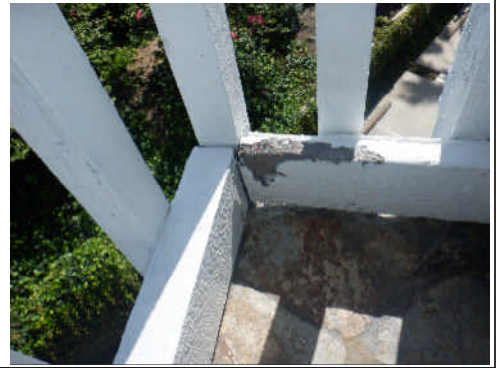
## GUARDRAIL(S)

The railings appeared functional, with exceptions noted.  
a. [SC] The guard railings were damaged and/or deteriorated in some areas. We recommend inquiries of the homeowners association for correcting the condition(s) noted.

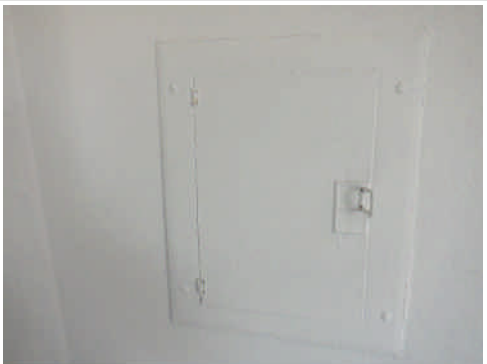
<b>LOCATION</b>	Located in the bedroom.

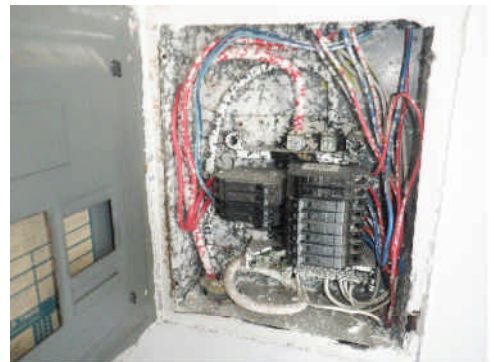
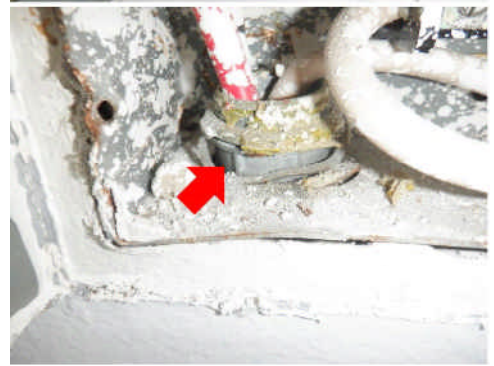
**WORKMANSHIP**

The wiring within the subpanel appeared functional, with exceptions noted.

- a. [FE] There was paint/texture overspray in the panel and on the electrical components. We recommend a full evaluation and/or corrections by a specialist in the appropriate trade.
- b. [SC] There was evidence of movement and the feeder conduit was loose where the wires enter the panel. We recommend correcting the condition(s) noted.

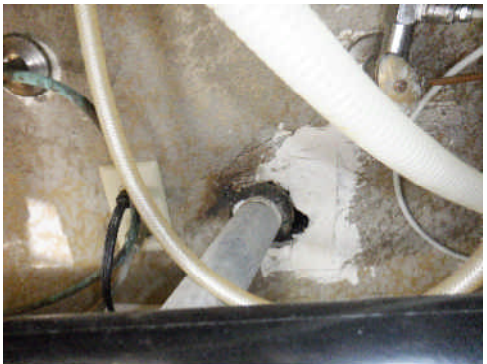
<b>RECEPTACLE(S)</b>	<p>The accessible receptacles were functional, with exceptions noted.</p> <p>a. [SC] Only the receptacle left of the sink was GFCI protected. The other countertop receptacle were not GFCI protected. This condition is a Safety Hazard. We recommend correcting the condition(s) noted.</p>	
<b>CABINET(S)</b>	<p>The cabinet(s)/ counter(s) were functional, with exceptions noted.</p> <p>a. [CR] There was a partially patched hole in the wall by the plumbing pipe in the sink cabinet. We recommend correcting the condition(s) noted.</p>

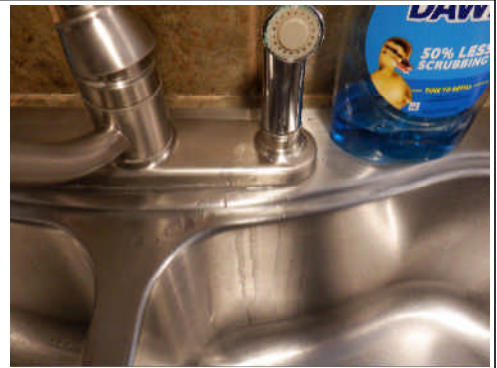
**SINK/PLUMBING**

The faucet(s), sink(s) and piping were functional with exceptions noted.  
a. [CR] The faucet hand sprayer was defective and/or leaking. We recommend correcting the condition(s) noted.

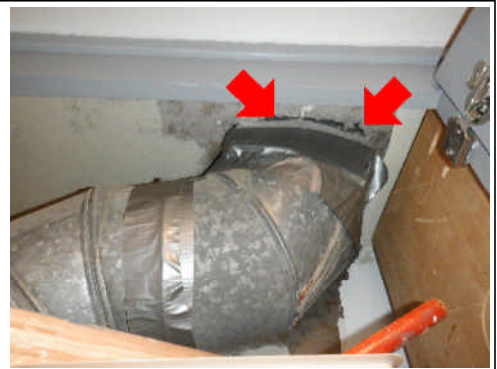
**EXHAUST VENT(S)**

The exhaust vent fan built into the microwave functioned, with exceptions noted.  
a. [CR] The duct tape was loose/missing at the exhaust vent connection(s). We recommend correcting the condition(s) noted.

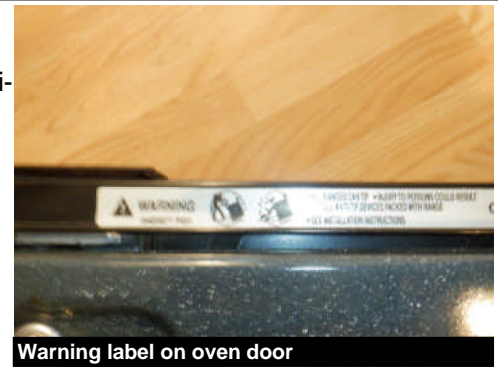
**OVEN(S)**

The oven functioned, with exceptions noted.  
a. **[SC]** The range/oven lacked an anti-tip device at the rear as required. This condition is a topple hazard. We recommend correcting the condition(s) noted.

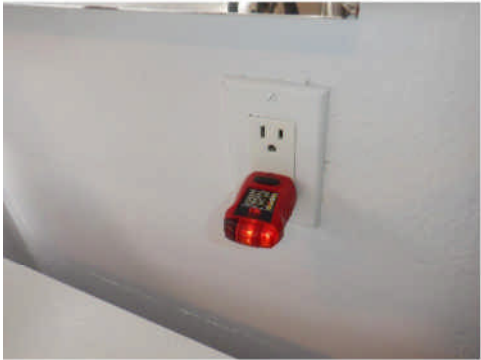
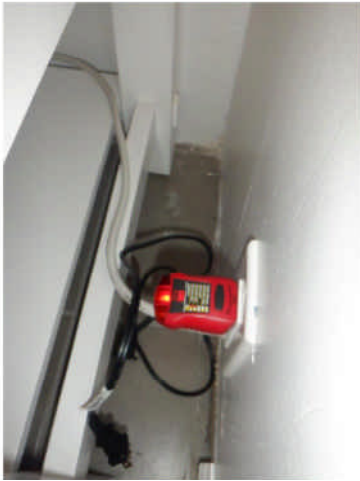
<b>BATHROOM #:</b>	1.
<b>RECEPTACLE(S)</b>	<p>The accessible receptacles were functional, with exceptions noted.</p> <p>a. [SC] Only the lower wall receptacle was GFCI protected and it was ungrounded. The other receptacle closest to the sink was not GFCI protected. This condition is a Safety Hazard. We recommend correcting the condition(s) noted.</p>

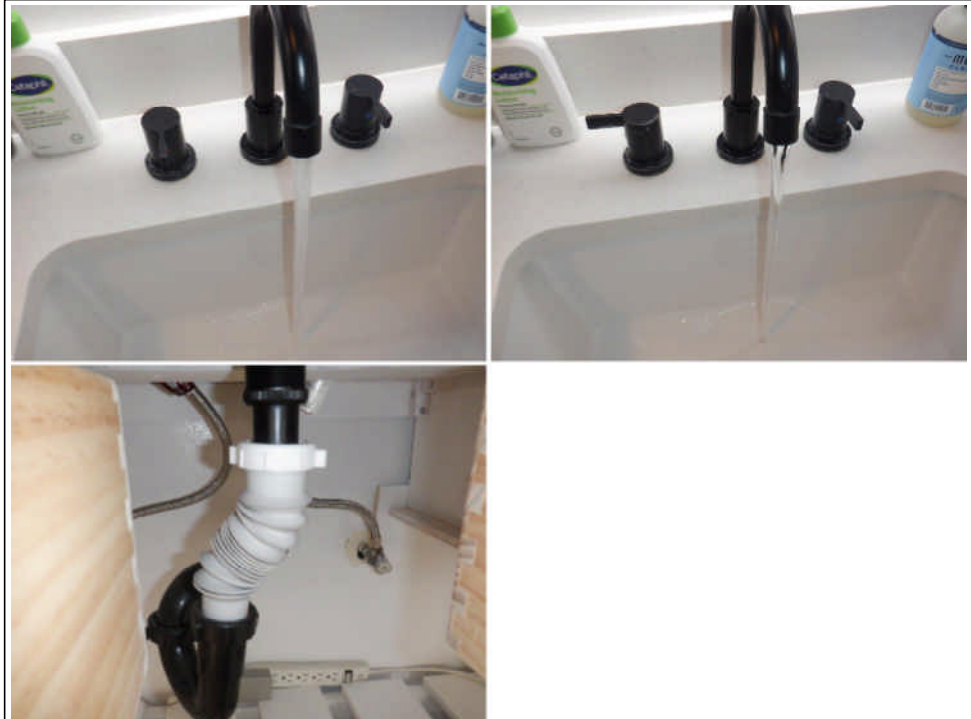
The faucets, sinks and piping were functional with exceptions noted.  
a. [CR] There was differing water flow from the faucet between hot and cold water. We recommend correcting the condition(s) noted.  
b. [SC] Corrugated plastic was used as drain piping. This material is not approved for this application. The corrugations trap bacteria. We recommend correcting the condition(s) noted.

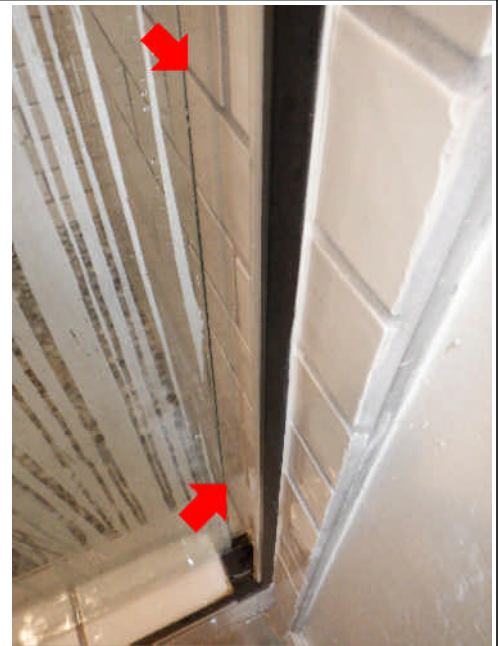
**ENCLOSURE(S)**

The enclosure(s) were functional, with safety glass, except as noted.  
a. [CR] The shower doors were not square and did not close tightly. We recommend correcting the condition(s) noted.

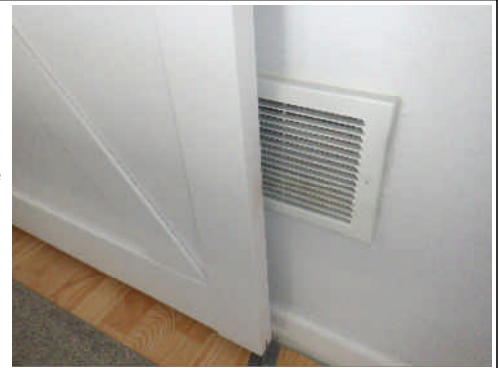
**HEAT & COOL**

The two electric wall heaters were functional, with exceptions noted.  
a. [SC] Bedroom; When the closet door was open, it was close to the heating unit. This condition is a safety hazard. We recommend correcting the condition(s) noted. Advise only using with closet door closed.

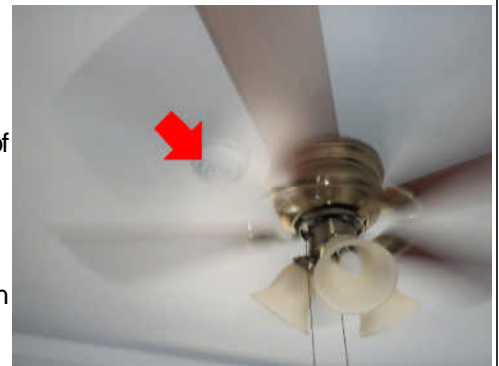
[SC] The location of the heat detector at the bedroom ceiling was obstructed by the ceiling fan. Generally, installation should be located away from ceiling fans for proper detection. We recommend correcting the condition noted.

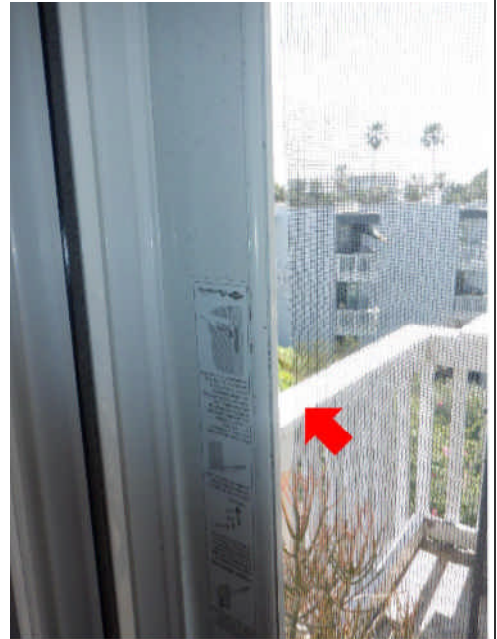
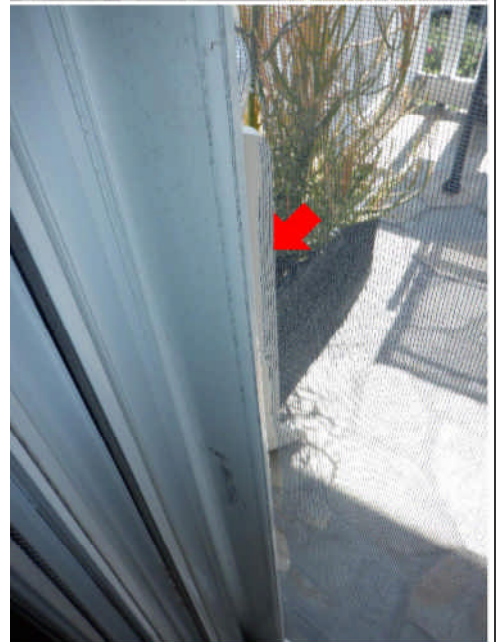
### EXTERIOR DOOR(S)

[CR] The screen door had damaged mesh. We recommend correcting the condition(s) noted.
