ELITE GROUP

RESIDENTIAL

PROPERTY LOCATION: 700 E 50th St Los Angeles, CA 90011

INSPECTION REPORT

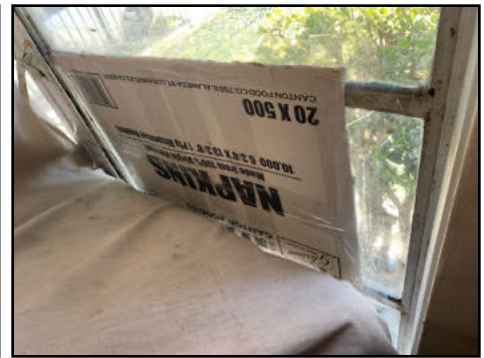
Hole in glass- needs to be serviced

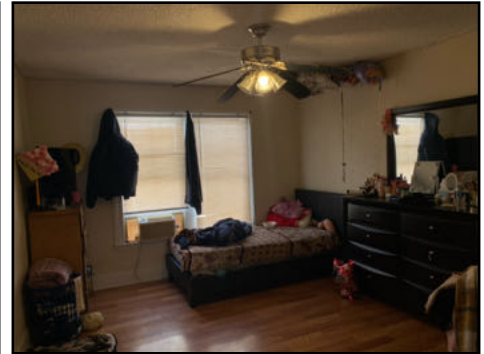
Patched/partial painted areas present - consult seller regarding patched areas

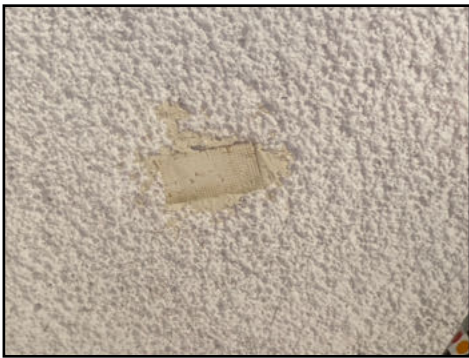
Patched/partial painted areas present - consult seller regarding patched areas

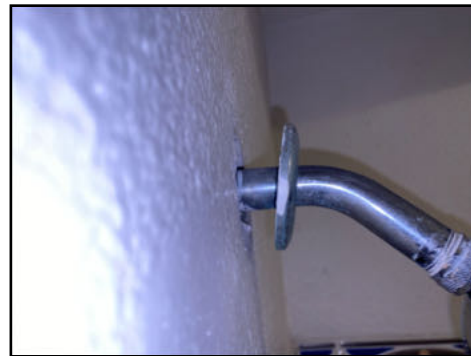
Diverter does not properly divert water to shower head - needs to be serviced (hall south)

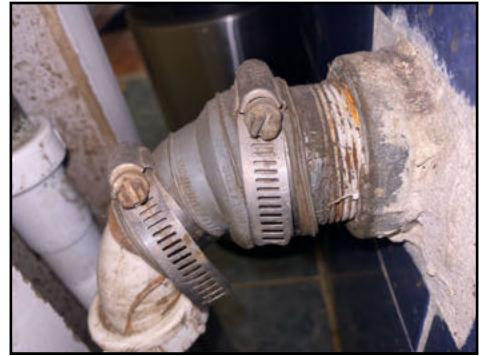
Rubber drain connections present - these are not for long term use - recommend upgrading connections

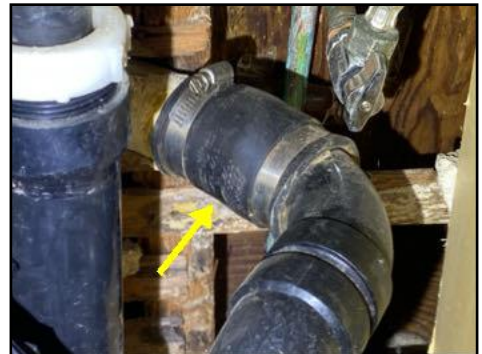
Rubber drain connections present - these are not for long term use - recommend upgrading connections

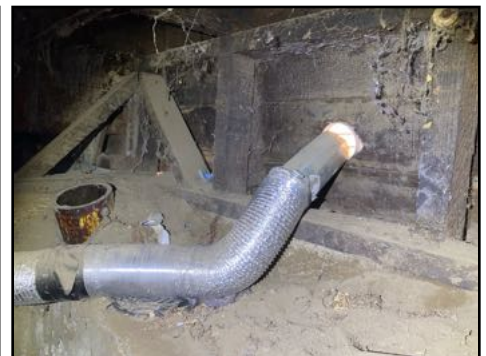
Flexible vent under structure - needs to be serviced

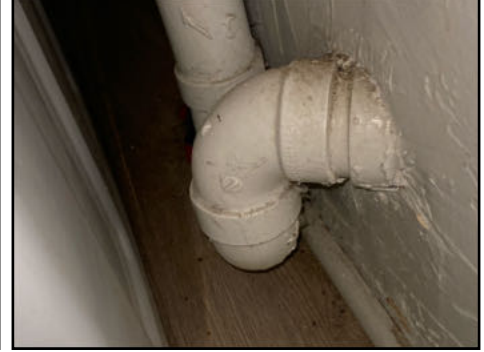
Flex drain present, these are subject to frequent clogging - recommend upgrading

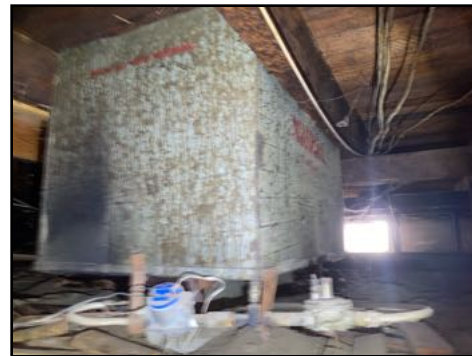
Older cement (AKA transite) flue pipe present - it is recommended to upgrade these areas

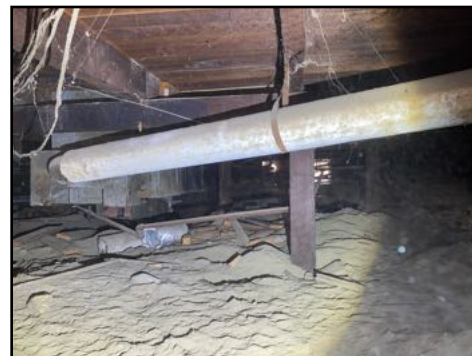
| INTERIOR | | |
|---|---|--|
| Page 30 Item: 2 | Venting | <ul style="list-style-type: none"> Older cement (AKA transite) flue pipe present - it is recommended to upgrade these areas |

Older cement (AKA transite) flue pipe present - it is recommended to upgrade these areas

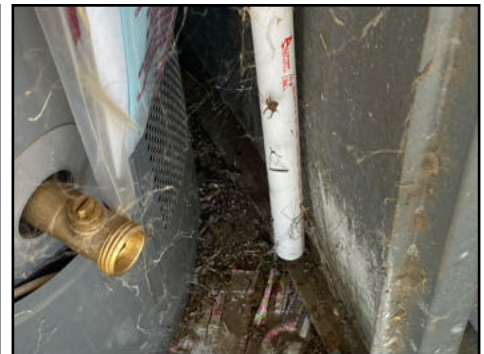
| INTERIOR | | |
|---|---|--|
| Page 33 Item: 5 | Overflow Line/s | <ul style="list-style-type: none"> PVC is an improper material for this overflow line due to it's potential for melting - needs to be serviced/upgraded to an approved material immediately |

PVC is an improper material for this overflow line due to it's potential for melting - needs to be serviced/upgraded to an approved material immediately

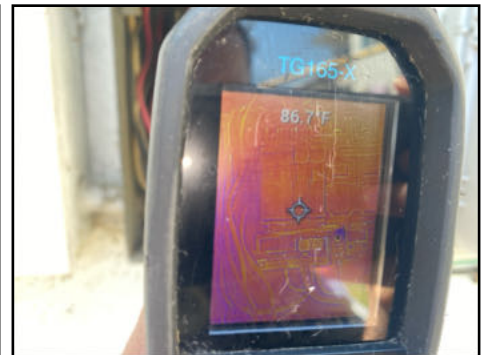
| Page 35 Item: 1 | Main Panel | <ul style="list-style-type: none"> • Manufacture of panel a brand (Federal Pacific) known for frequent issues - recommend further evaluation by a licensed electrician |

Manufacture of panel a brand (Federal Pacific) known for frequent issues - recommend further evaluation by a licensed electrician

Thermal Image View - Normal temperature readings with no visible signs of overheating at time of inspection

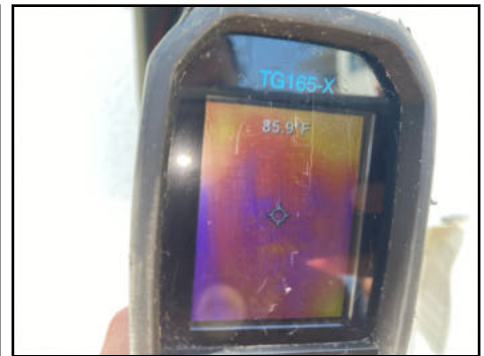
| Page 35 Item: 2 | Sub Panels | <ul style="list-style-type: none"> • Evidence of pests inside panel - needs to be serviced, cleaned and preventative measures taken to prevent pest entry • Manufacture of panel a brand (Federal Pacific) known for frequent issues - recommend further evaluation by a licensed electrician |

Manufacture of panel a brand (Federal Pacific) known for frequent issues - recommend further evaluation by a licensed electrician

Thermal Image View - Normal temperature readings with no visible signs of overheating at time of inspection

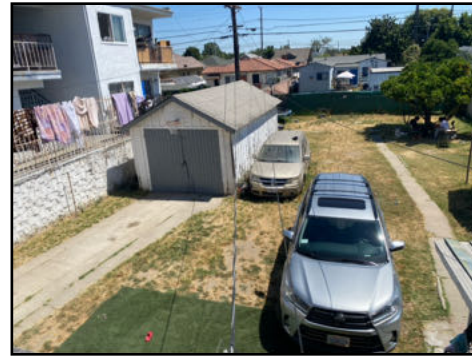
Older style wiring connections to the structure - it is recommended that you upgrade these areas

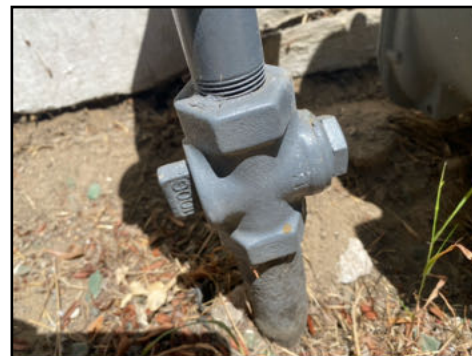
| Page 38 Item: 7 | Main Gas Valve | <ul style="list-style-type: none"> • No seismic safety valve present - recommend installation for increased safety |

No seismic safety valve present - recommend installation for increased safety

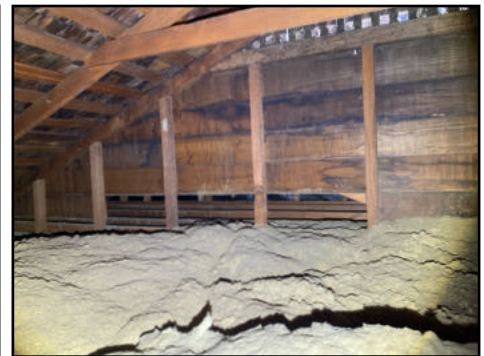
No visible roof sheathing at rafters - this is an irregular roofing installation and needs further evaluation by a roofer

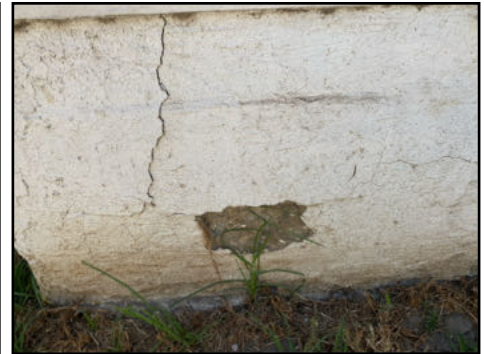
**Blistered due to unknown reason -
needs to be serviced**

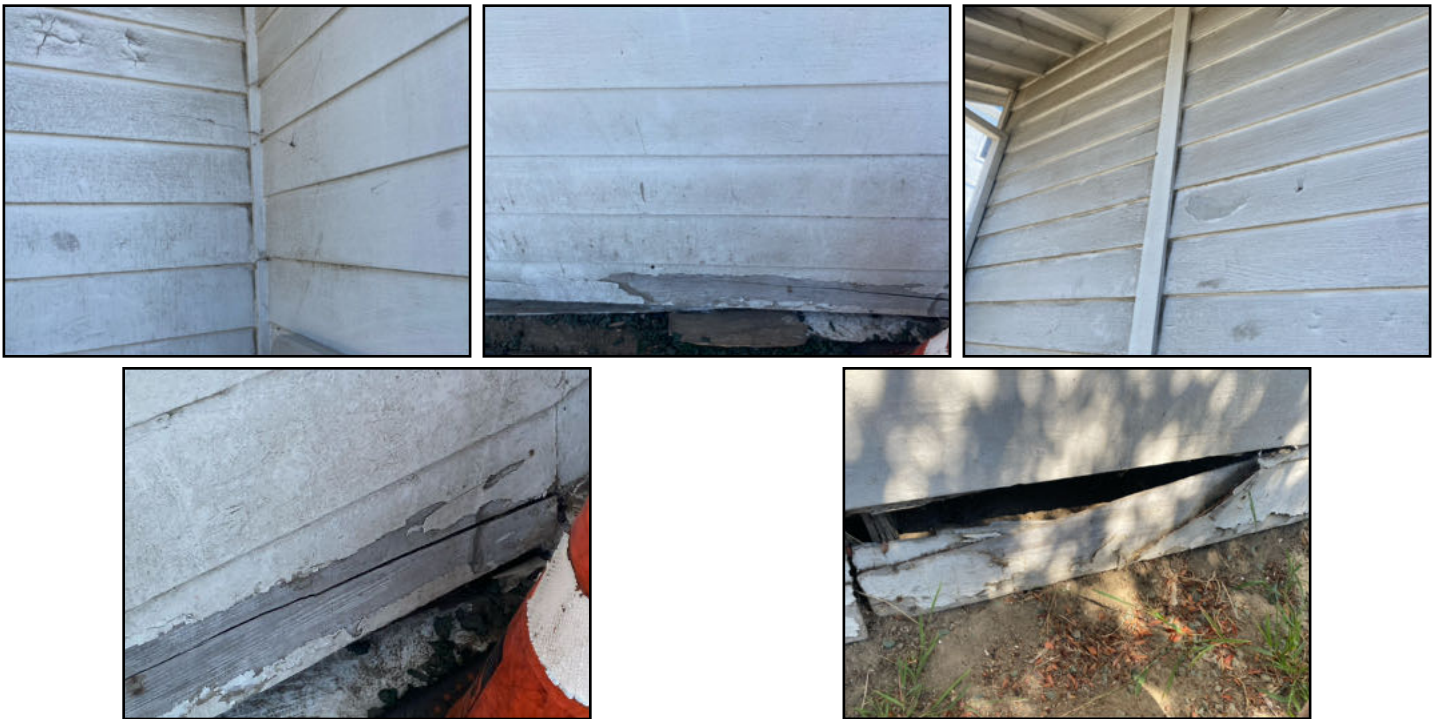
| Page 44 Item: 2 | Siding | <ul style="list-style-type: none"> • Cracking/chipping/holes more than typical - needs to be serviced |

Cracking/chipping/holes more than typical - needs to be serviced

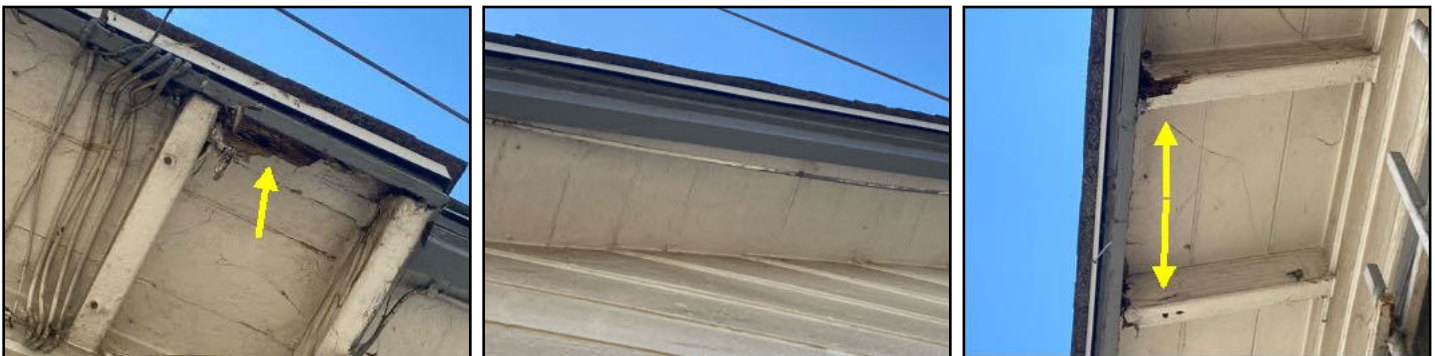
| Page 45 Item: 4 | Eaves & Fascia | <ul style="list-style-type: none"> • Cracking/deterioration - more than normal - needs to be serviced • Heavily damaged - needs to be replaced |

Cracking/deterioration - more than normal - needs to be serviced

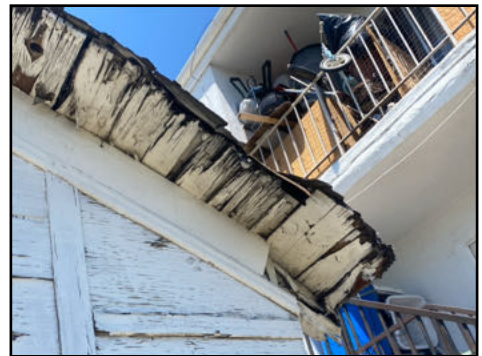
Heavily damaged - needs to be replaced

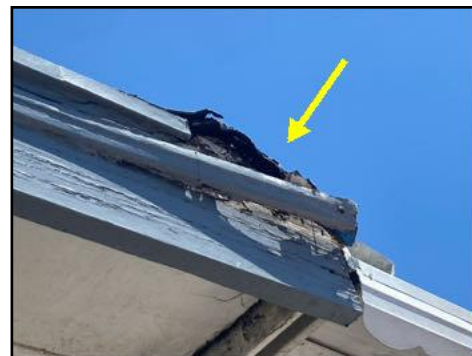
Cracking/deterioration - more than normal - needs to be serviced

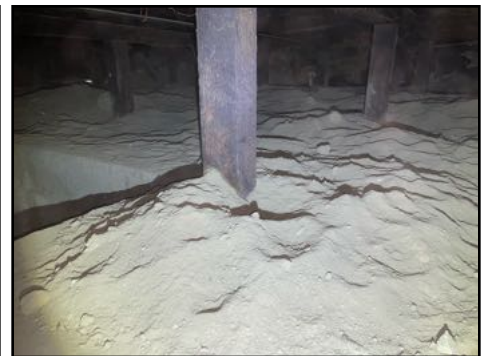
Posts in contact with soil - needs to be serviced - consult the termite report

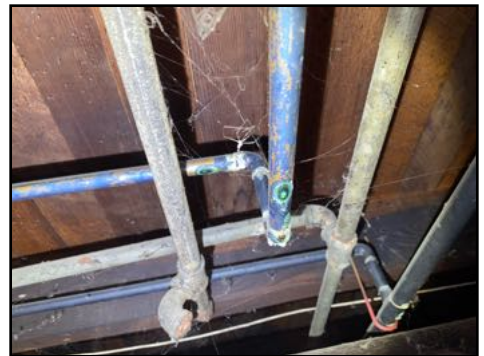
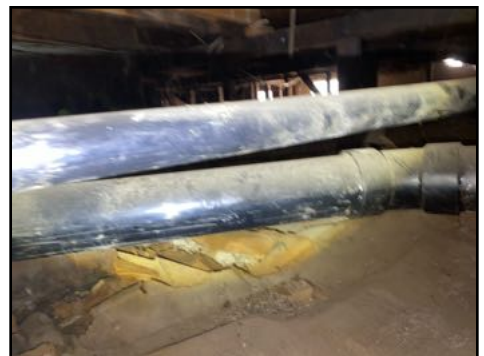
| Page 52 Item: 12 | Plumbing | <ul style="list-style-type: none"> • Leak found under toilet - needs to be serviced • Corrosion/cysts at one or more locations of the metal drain lines or distribution piping - recommended further evaluation by a licensed plumber |

Leak found under toilet - needs to be serviced

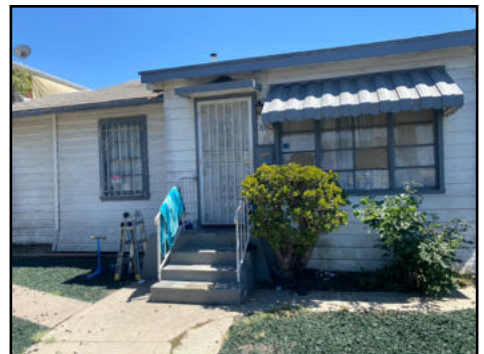
| GROUNDS | | |
|---|---|--|
| Page 55 Item: 2 | Patio and Porch Roofs | <ul style="list-style-type: none">• Structure attached to fascia board – irregular installation – recommend licensed contractor to evaluate• Post base dented/buckling - needs to be serviced• Recommend evaluation and costs of repair from a licensed roofer/contractor |

Structure attached to fascia board – irregular installation – recommend licensed contractor to evaluate

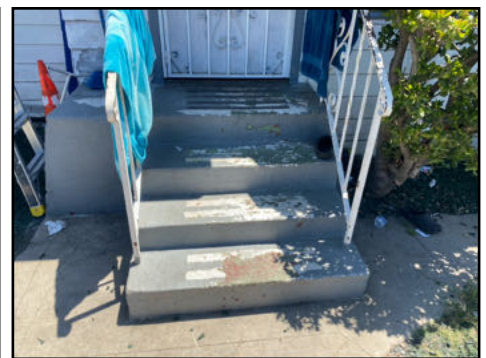
| GROUNDS | | |
|---|---|--|
| Page 56 Item: 4 | Stairs & Handrails | <ul style="list-style-type: none">• Loose rails - unsafe - needs to be serviced |

Loose rails - unsafe - needs to be serviced

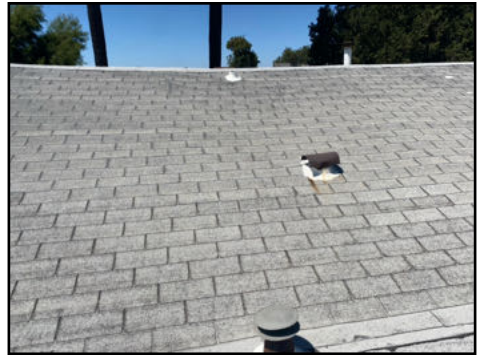
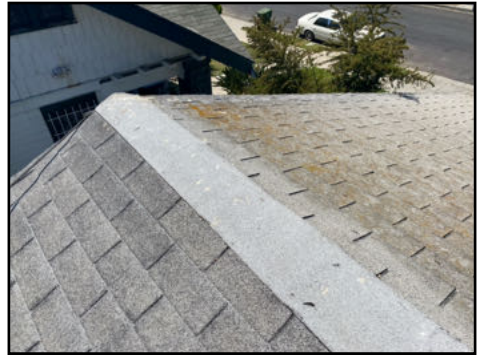
| GROUNDS | | |
|---|---|--|
| Page 61 Item: 1 | Condition | <ul style="list-style-type: none">• Materials appear to be nearing end of useful life - needs to be further evaluated by a licensed roofer• Missing/damaged shingles/tiles in areas - needs to be serviced |

Missing/damaged shingles/tiles in areas - needs to be serviced

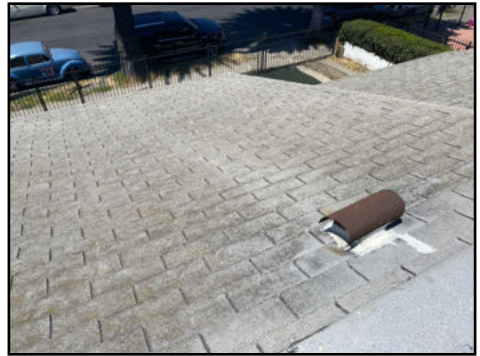
Moss growth present in areas - sign of moisture accumulation and lack of sunlight for drying - recommend servicing as part of seasonal maintenance

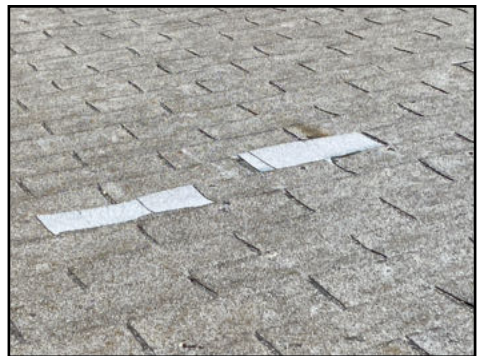
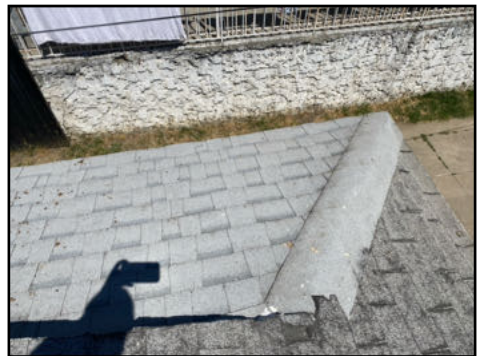
Exposed nails/staples/screws on roofing material - recommend sealing all fastener heads

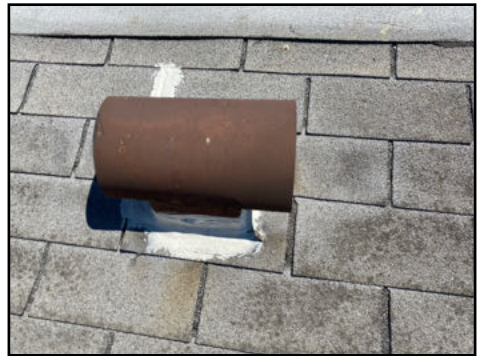
Re-roof covers flashings - irregular installation - needs further evaluation by a licensed roofer
