Property Inspection Report

Property address: **32311 Scandia Dr, Running Springs, CA 92382**

Inspection date: **Thursday, September 7, 2023**

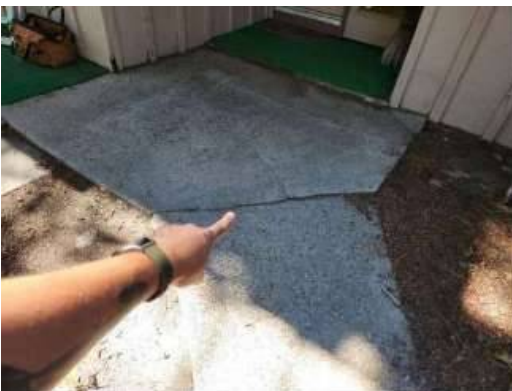
Photo 6-1

6) 🚧 Cracks, holes, settlement, heaving and/or deterioration resulting in trip hazards were found in the sidewalks or patios. For safety reasons, recommend that a qualified contractor repair as necessary to eliminate trip hazards.

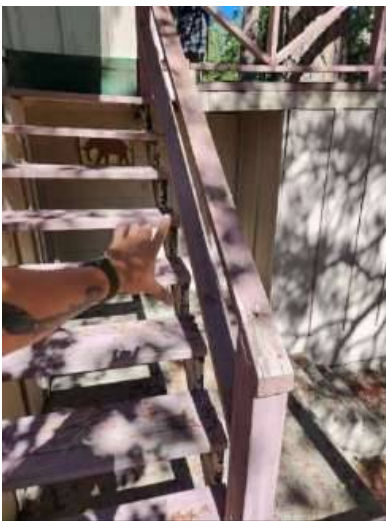
Photo 8-1

Handrails at one or more flights of stairs were loose and/or wobbly. This is a safety hazard. Recommend that a qualified person repair as necessary.

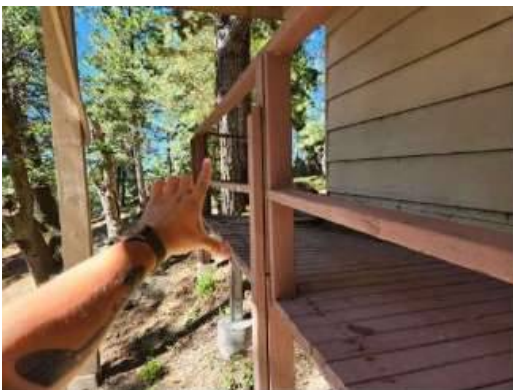
Photo 9-1

Guardrails at one or more locations with drop-offs higher than 30 inches were loose, wobbly, damaged and/or deteriorated, and pose a fall hazard. Recommend that a qualified person repair guardrails as necessary.

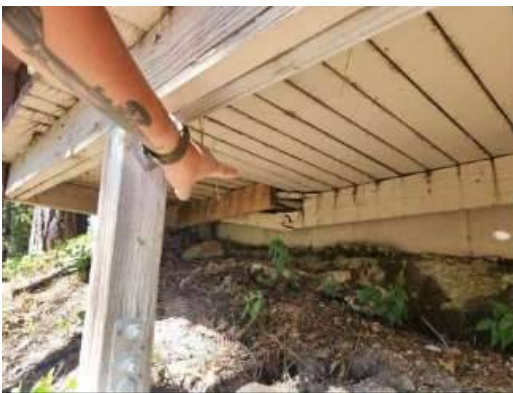
Photo 10-1

Fungal rot was found in decking boards and/or beams at one or more decks or porches. Recommend that a qualified contractor evaluate and repair as necessary. All rotten wood should be replaced.

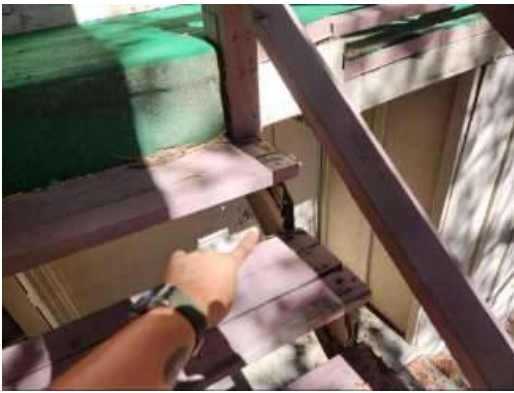
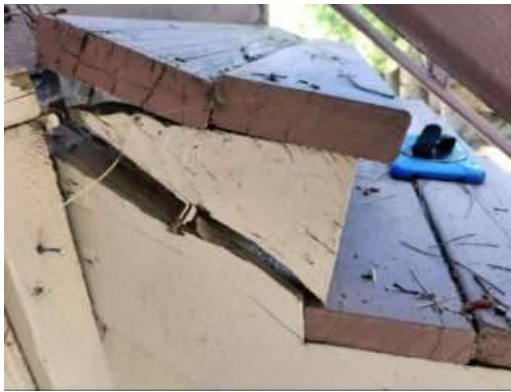
Photo 11-1

Fungal rot was found in stringers at one or more sets of exterior stairs. Fungal rot in some stair components may pose a safety hazard. Recommend that a qualified person evaluate and repair as necessary. All rotten wood should be replaced.

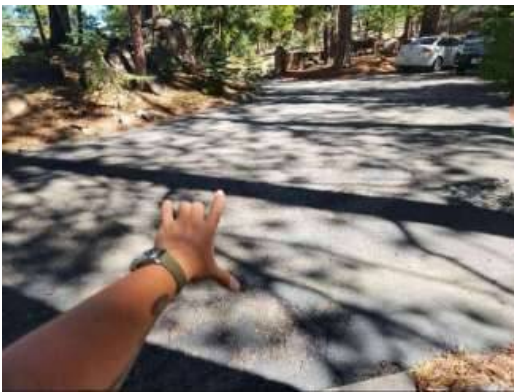
Photo 12-1

12) 🗑️ ⓘ Minor deterioration (e.g. cracks, holes, settlement, heaving) was found in the driveway, but no trip hazards were found. The client may wish to have repairs made for cosmetic reasons.

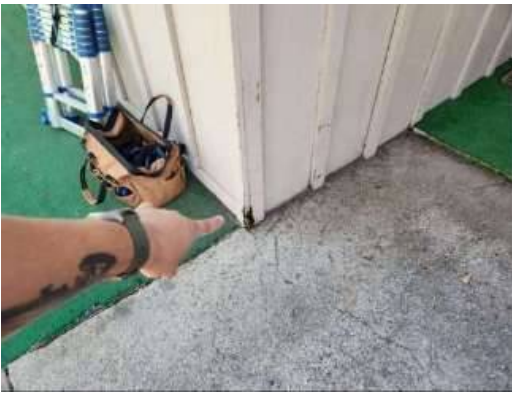
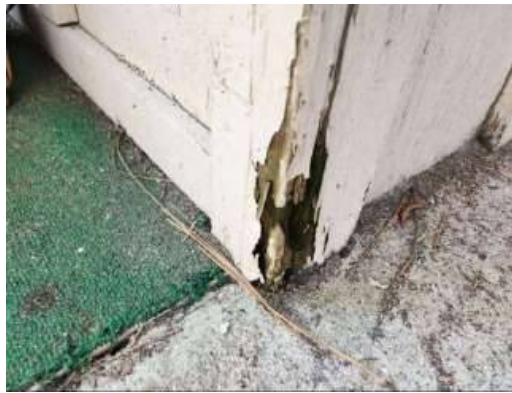
Photo 16-1

16) 🛠️ Fungal rot was found at one or more sections of siding or trim. Conductive conditions for rot should be corrected (e.g. wood-soil contact, reverse perimeter slope). Recommend that a qualified contractor repair as necessary. All rotten wood should be replaced.

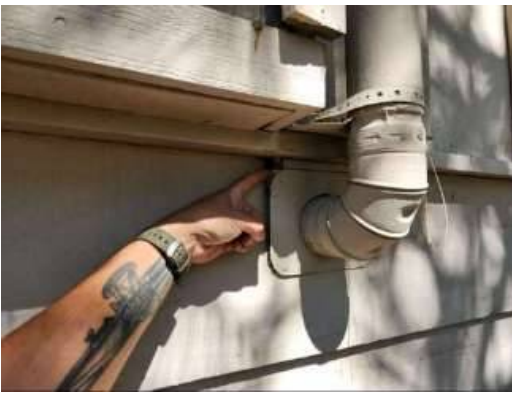
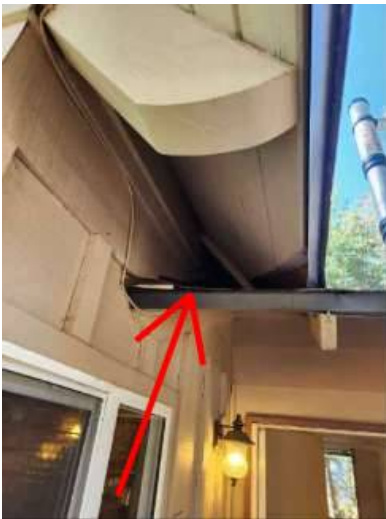
Photo 17-1

17) 🛠️ One or more holes or gaps were found in siding or trim. Vermin, insects or water may enter the structure. Recommend that a qualified person repair as necessary.

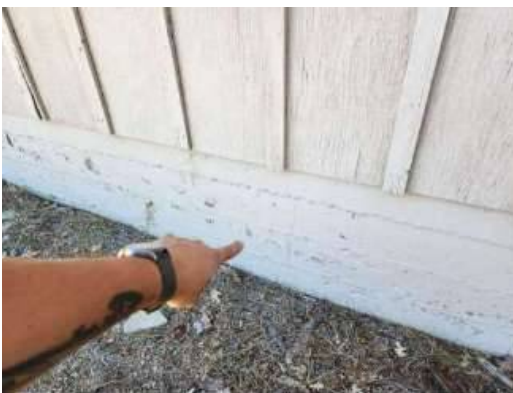
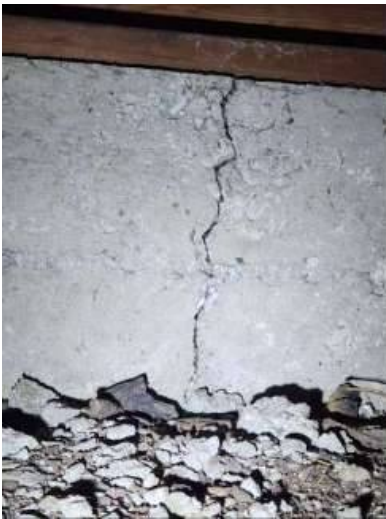
Photo 18-1

18) 🛠️ One or more minor cracks were found in the foundation. Recommend having a qualified person repair as necessary by sealing them to prevent water infiltration and monitor them in the future. Numerous products exist to seal such cracks including hydraulic cement, non-shrinking grout, resilient caulks and epoxy sealants.

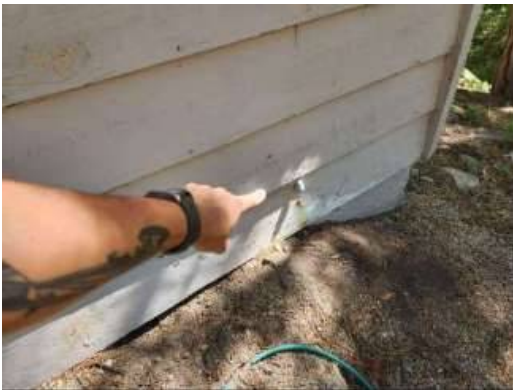
Photo 19-1

19) 🛠️ A condensate line that terminated at the exterior was damaged, or came in contact with building exterior, therefore allowing water to come in contact with the stucco and damaging it. Recommend a qualified person make repairs as necessary, so the water doesn't come in contact with the building

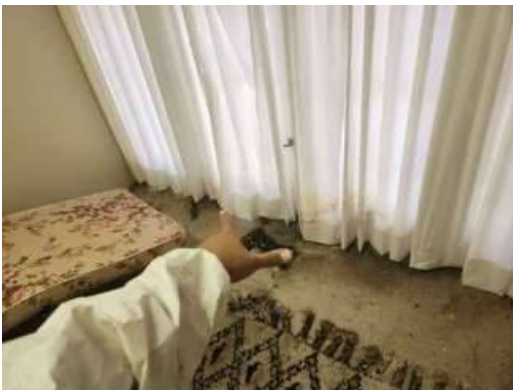
Photo 24-1

Fungal rot was found at one or more exterior doors or windows. Recommend that a qualified person repair as necessary. All rotten wood should be replaced.

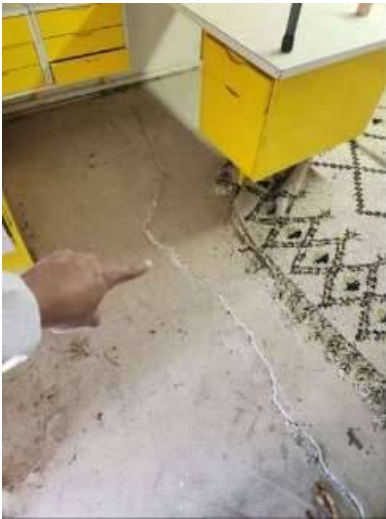
Photo 25-1

Minor cracks were found in the concrete slab floor. These are common and appeared to be only a cosmetic issue.

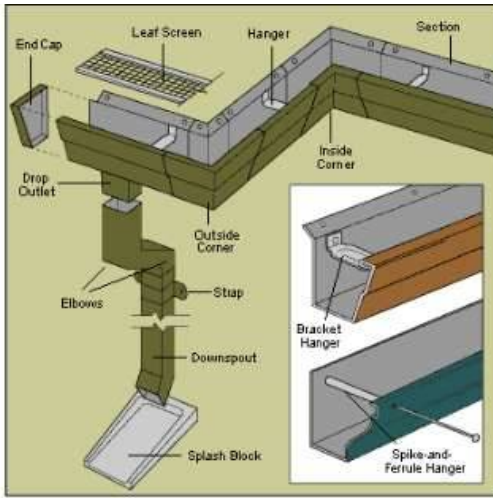
Photo 27-1

27) ⚠ No roof drainage system was installed. Rainwater may come in contact with the building exterior or accumulate around the building foundation as a result. This can be a conducive condition for wood-destroying organisms. Recommend that a qualified contractor install roof drainage components where missing per standard building practices.

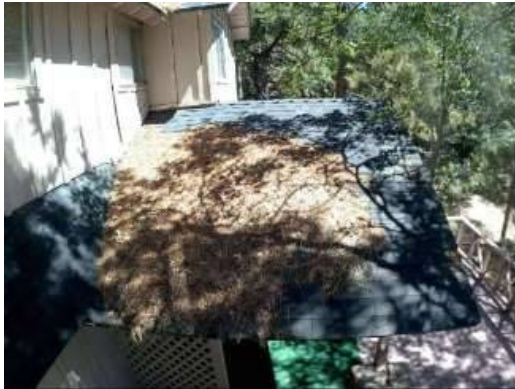
Photo 28-1

28) Significant amounts of debris such as leaves, needles, seeds, etc. have accumulated on the roof surface. Water may not flow easily off the roof, and can enter gaps in the roof surface. Leaks can occur as a result. This is a conducive condition for wood-destroying organisms. Recommend cleaning debris from the roof surface now and as necessary in the future.

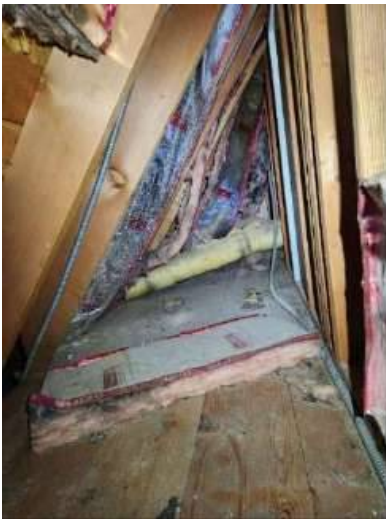
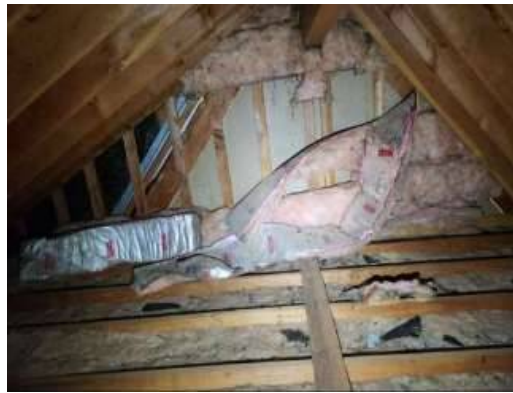
Photo 31-1

31) 🛠️ Attic insulation at one or more attic walls was falling down. Heating and cooling costs will likely be higher due to reduced energy efficiency. Recommend that a qualified person repair, replace or install insulation as necessary and per standard building practices.

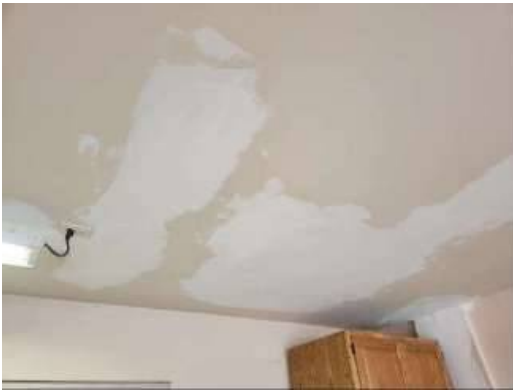
Photo 36-1

36) 🛠️ One or more walls or ceilings had evidence of repairs. The client may wish to consult with the property owner regarding these findings.

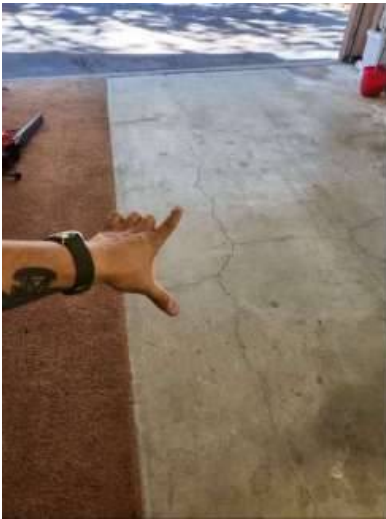
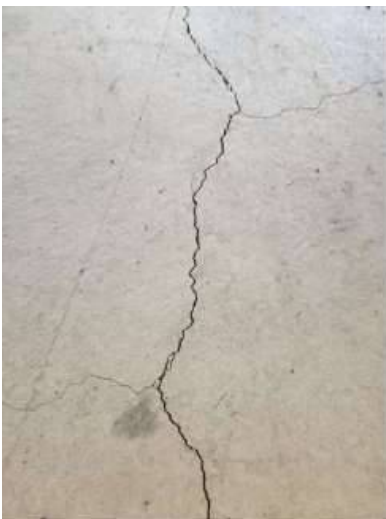
Photo 39-1

Minor cracks were found in the concrete slab floor. These are common and appeared to be only a cosmetic issue.

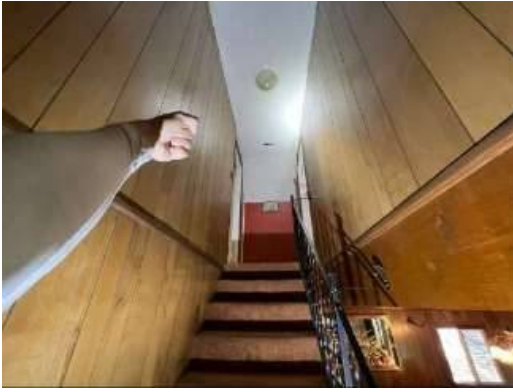
Photo 43-1

Smoke alarms were missing from one or more hallways leading to bedrooms and/or on one or more levels. Smoke alarms should be installed as necessary so a functioning alarm exists in each hallway leading to bedrooms, in each bedroom, on each level and in any attached garage. For more information, visit: <https://www.reporthost.com/?SMKALRM>

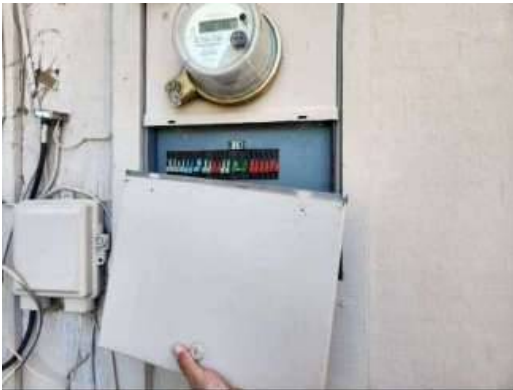
Photo 44-1

The cover plate at Panels #A was loose, damaged or deteriorated. Recommend having a qualified person repair or replace as necessary.

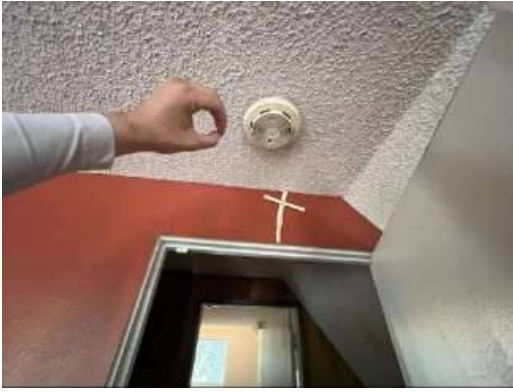
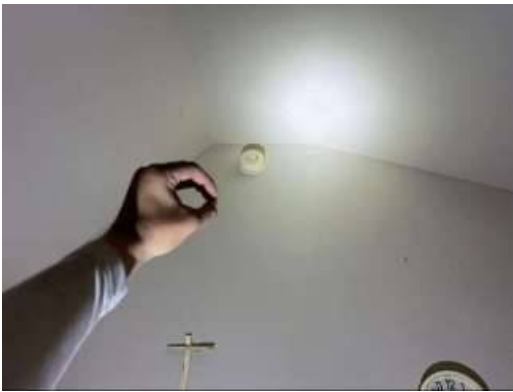
Photo 45-1

Based on the age of this structure and the appearance of existing smoke alarms, the alarms may have been installed more than 10 years ago. According to [National Fire Protection Association](https://www.nfpa.org), aging smoke alarms don't operate as efficiently and often are the source for nuisance alarms. Older smoke alarms are estimated to have a 30% probability of failure within the first 10 years. Newer smoke alarms do better, but should be replaced after 10 years. Unless you know that the smoke alarms are new, replacing them when moving into a new residence is also recommended by NFPA. For more information, visit: <https://www.reporthost.com/?SMKALRMLS>

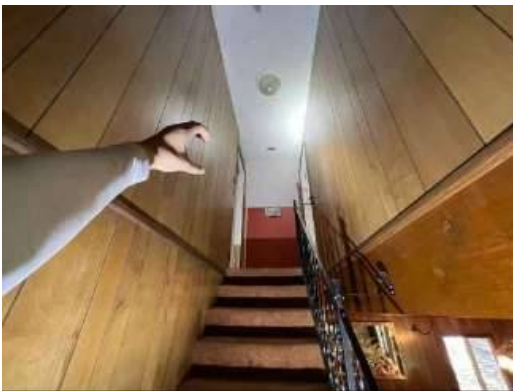
Photo 46-1

46) 🚨 No permanently installed carbon monoxide alarms were found. This is a potential safety hazard. Some states and/or municipalities require CO alarms to be installed for new construction and/or for homes being sold. Recommend installing approved CO alarms outside of each separate sleeping area in the immediate vicinity of the bedrooms on each level and in accordance with the manufacturer's recommendations. For more information, visit: <https://www.reporthost.com/?COALRM>

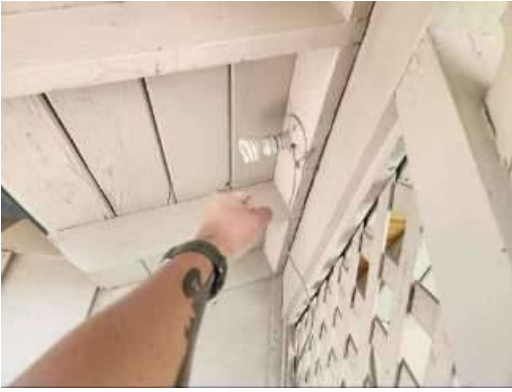
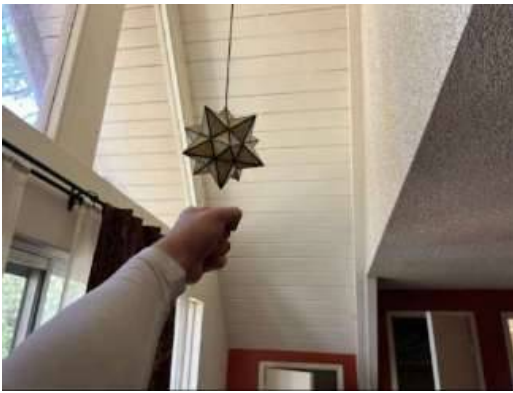
Photo 49-1

One or more light fixtures were inoperable (didn't turn on when nearby switches were operated). Recommend further evaluation by replacing bulbs and/or consulting with the property owner. If replacing bulbs doesn't work and/or no other switch(es) can be found, then recommend that a qualified electrician evaluate and repair or replace light fixtures as necessary.

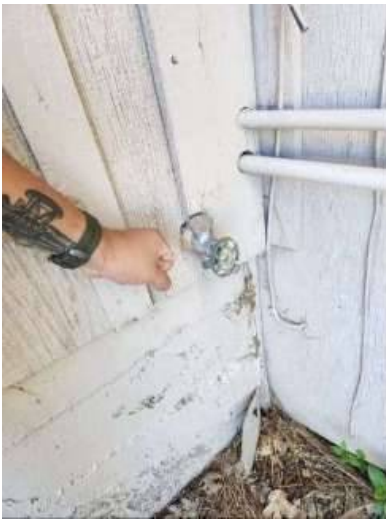
Photo 55-1

One or more hose bibs appeared to be inoperable. No water flowed from the bib(s) when turned on. This may be due to a shut-off valve being turned off. Note that the inspector does not operate shut-off valves. Recommend consulting with the property owner about inoperable hose bibs, and if necessary have a qualified plumber make repairs.

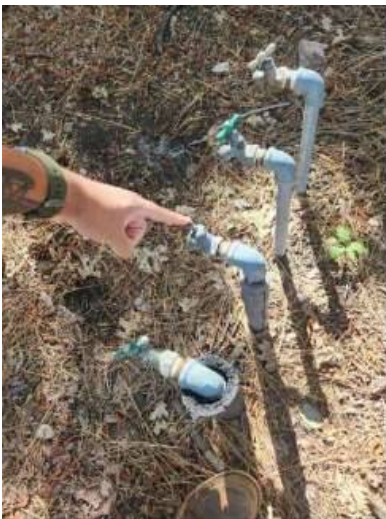
Photo 56-1

One or more hose bib handles were missing. Recommend that a qualified person replace handles or make repairs as necessary.

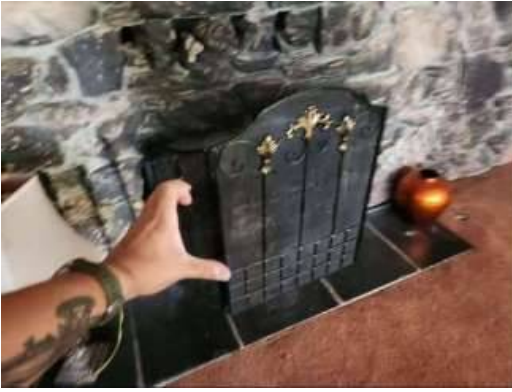
Photo 73-1

A wood burning fireplace has been converted to use gas logs, and no glass doors were installed on the fireplace. For gas conversions like this, the fireplace damper should be modified so it is permanently open to prevent combustion gases from the pilot light and main burners accumulating in living spaces. Since the damper is always open, unconditioned air from outside can enter living spaces through the chimney, and conditioned air from inside can exit through the chimney. This can result in higher heating and cooling costs. Recommend that a qualified person install glass doors on the fireplace per standard building practices.

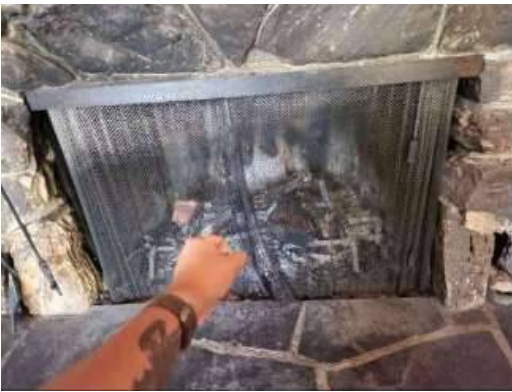
Photo 74-1

74) One or more gas fireplaces or stoves did not respond to normal controls (e.g. on/off switch, thermostat, remote control) and were not fully evaluated as a result. The pilot light or gas supply may have been turned off, or some other condition may have prevented operation. The inspector only operates normal controls and does not light pilot lights or operate gas shut-off valves. Consult with the property owner, review all documentation for such gas appliances, and become familiar with the lighting procedure. If necessary, a qualified specialist should assist in lighting such appliances, and make any needed repairs.

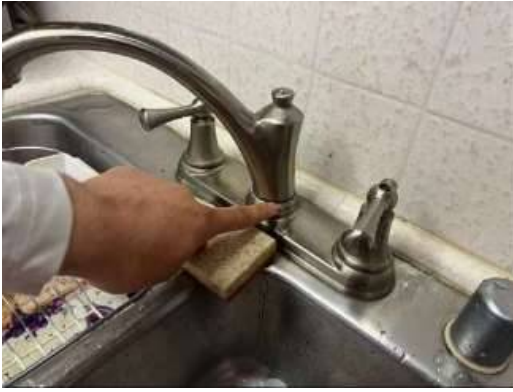
Photo 77-1

77) 🛠️👉 Water was leaking at the sink faucet base or handles. Recommend that a qualified plumber repair as necessary.

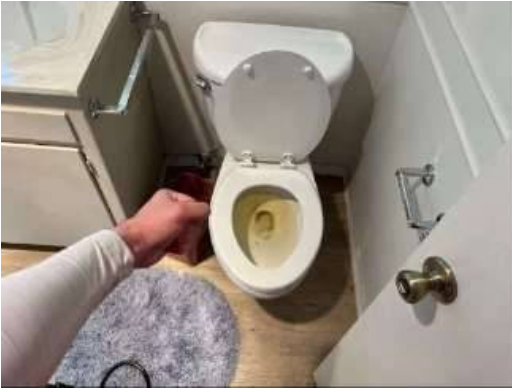
Photo 79-1

The toilet at location(s) #A didn't flush or had a weak flush. Recommend that a qualified plumber evaluate and repair or replace the toilet as necessary.

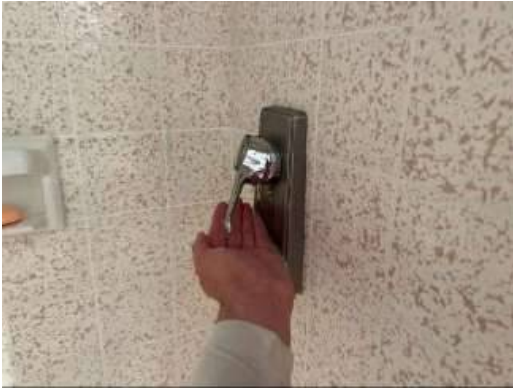
Photo 82-1

One or more handles controlling water flow to the shower at location(s) #A were leaking when tested. Recommend that a qualified person repair or replace handles as necessary.

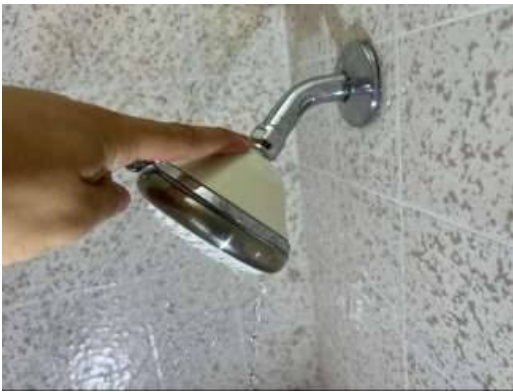
Photo 83-1

The shower head at location(s) #A and D was leaking when tested. Recommend that a qualified person repair as necessary.

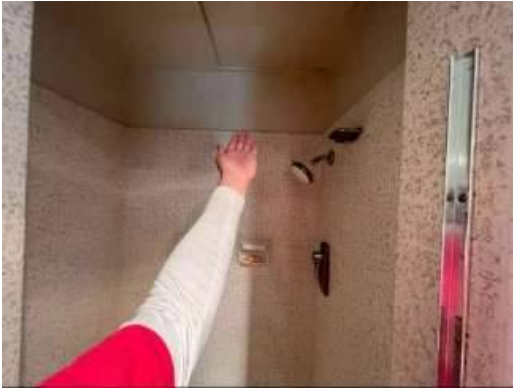
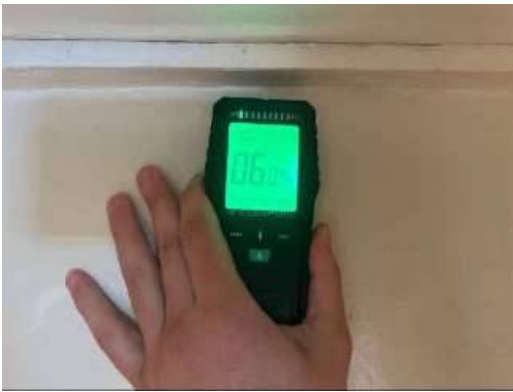
Photo 87-1

The wall by the shower at location(s) #A was water-damaged. Recommend that a qualified person repair as necessary.

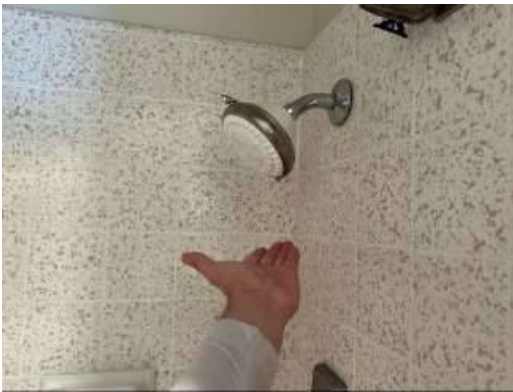
Photo 88-1

88) 🛠️ The shower head at location(s) #A was dripping when the shower was turned off. Recommend that a qualified person repair as necessary.

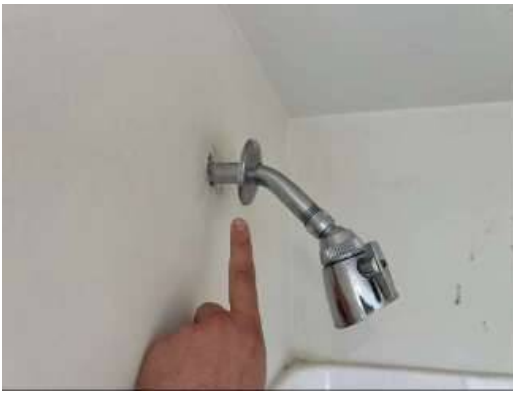
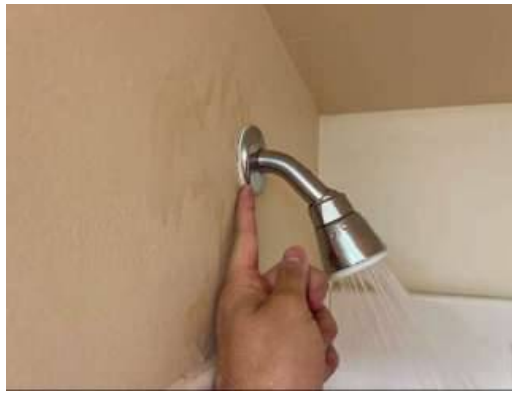
Photo 89-1

89) 🛠️ Caulk was missing around the base of the shower head plate, or there was a gap behind it, at location(s) #B and #D. Water may enter the wall structure behind the enclosure. Recommend that a qualified person repair as necessary to eliminate the gap. For example, by installing or replacing caulk if the gap is small enough. For larger gaps, a shorter spout nipple or an escutcheon plate can be installed.

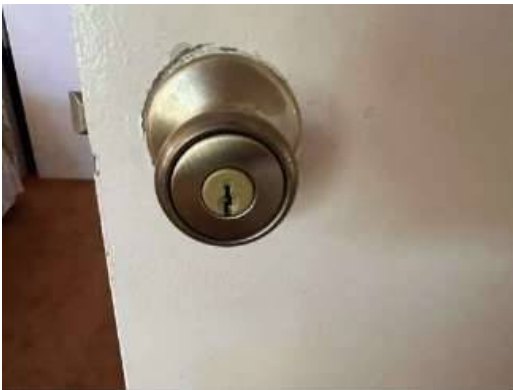
Photo 94-1

94) 🚪🔑 One or more interior doors had a keyed lockset or deadbolt installed. This is a safety hazard for small children in the event that they lock themselves in the room, do not know how to unlock the door, and the key is not available. Recommend that a qualified person replace keyed locksets and/or deadbolts with "privacy" locksets (no key required) as necessary.

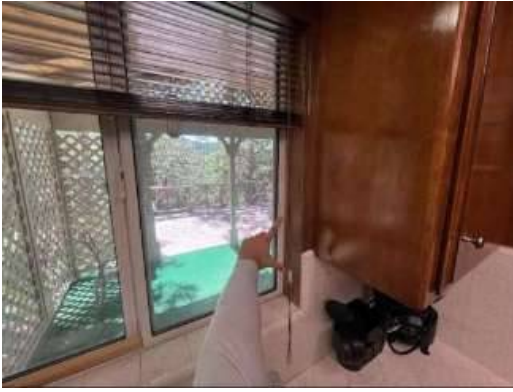
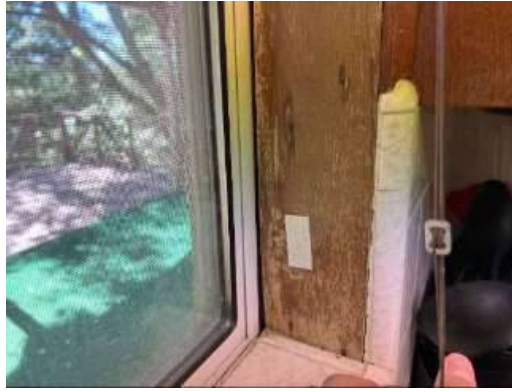
Photo 96-1

96) 🛠️🔍 Water stains or damaged wood was found at one or more windows. Recommend that a qualified contractor evaluate and repair as necessary.

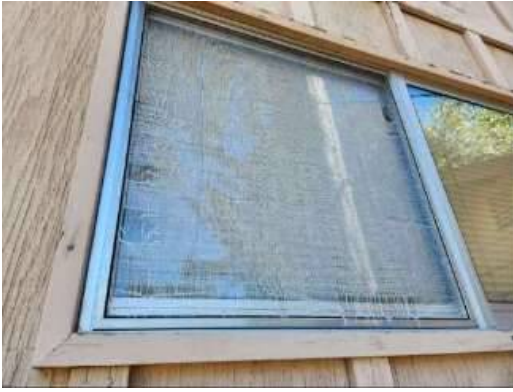
Photo 104-1

One or more window screens were damaged or deteriorated. These window(s) may not provide ventilation during months when insects are active. Recommend replacing window screens as necessary.

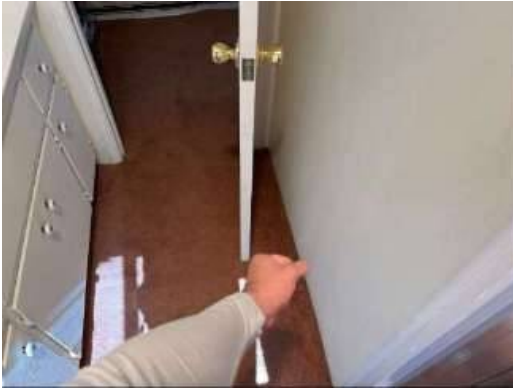
Photo 105-1

Fixtures such as door stops were missing in one or more areas. Recommend that a qualified person install missing fixtures per standard building practices.

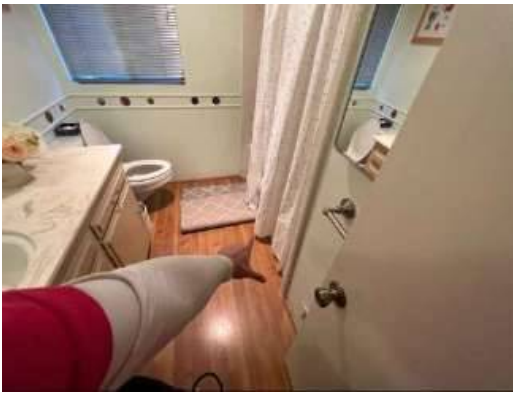
Photo 106-1

Vinyl, linoleum or marmoleum flooring in one or more areas was deteriorated and/or loose. If in a wet area, water can damage the sub-floor as a result. Recommend that a qualified contractor replace or repair flooring as necessary.

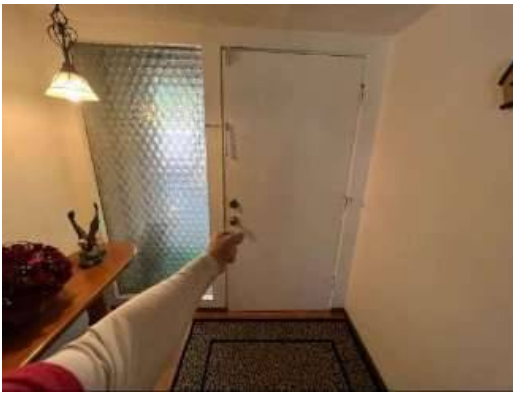
Photo 107-1

One or more entry doors wouldn't latch when closed. This is a security concern if no deadbolt is installed. A qualified person should repair as necessary.

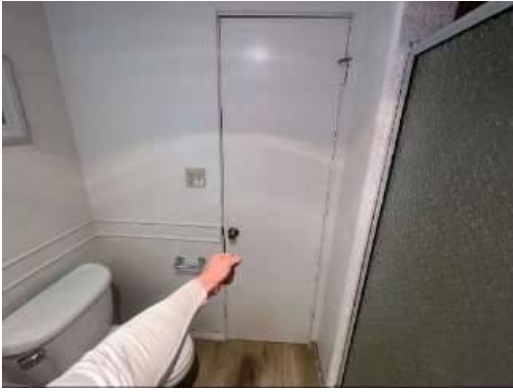
Photo 109-1

One or more interior doors wouldn't latch or were difficult to latch. Recommend that a qualified person repair as necessary. For example, by adjusting latch plates or locksets.

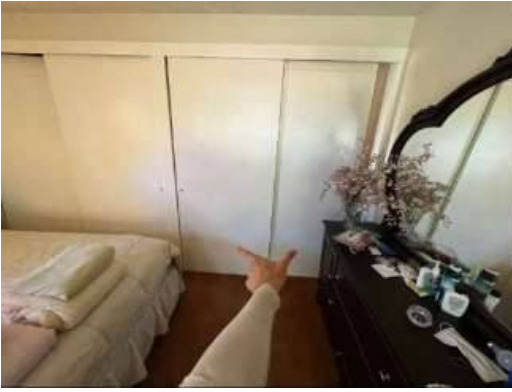
Photo 111-1

111) 🛠️ One or more sliding closet doors were off the track, stuck or difficult to slide. Recommend that a qualified person adjust or repair as necessary.

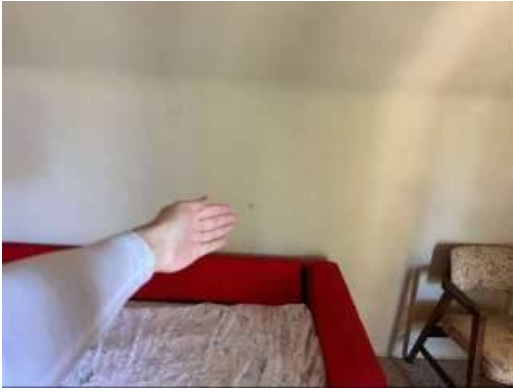
Photo 113-1

113) 🛠️ Minor cracks, nail pops and/or blemishes were found in walls and/or ceilings in one or more areas. Cracks and nail pops are common, are often caused by lumber shrinkage or minor settlement, and can be more or less noticeable depending on changes in humidity. They did not appear to be a structural concern, but the client may wish to repair these for aesthetic reasons. For recurring cracks, consider using an elastic crack covering product: <https://www.reporthost.com/?ECC>

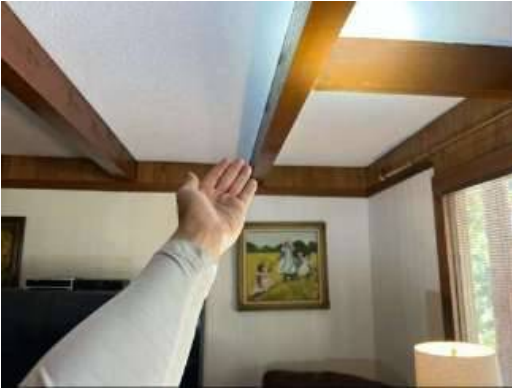
Photo 115-1

Stains were found in on or more walls or ceiling areas. However, no elevated levels of moisture were found. The stain(s) may be due to past roof and/or plumbing leaks. Consult with the property owner and monitor the stained area(s) in the future, especially after heavy or prolonged rain. If elevated moisture is found in the future, then recommend that a qualified contractor evaluate and repair as necessary.
