T.I.N. ENGINEERING COMPANY

File No.: 240002

November 4, 2024

SUBJECT: Site Geologic Reconnaissance Report for Existing Residential Property at # 20
Cinchring Road, Rolling Hills, California

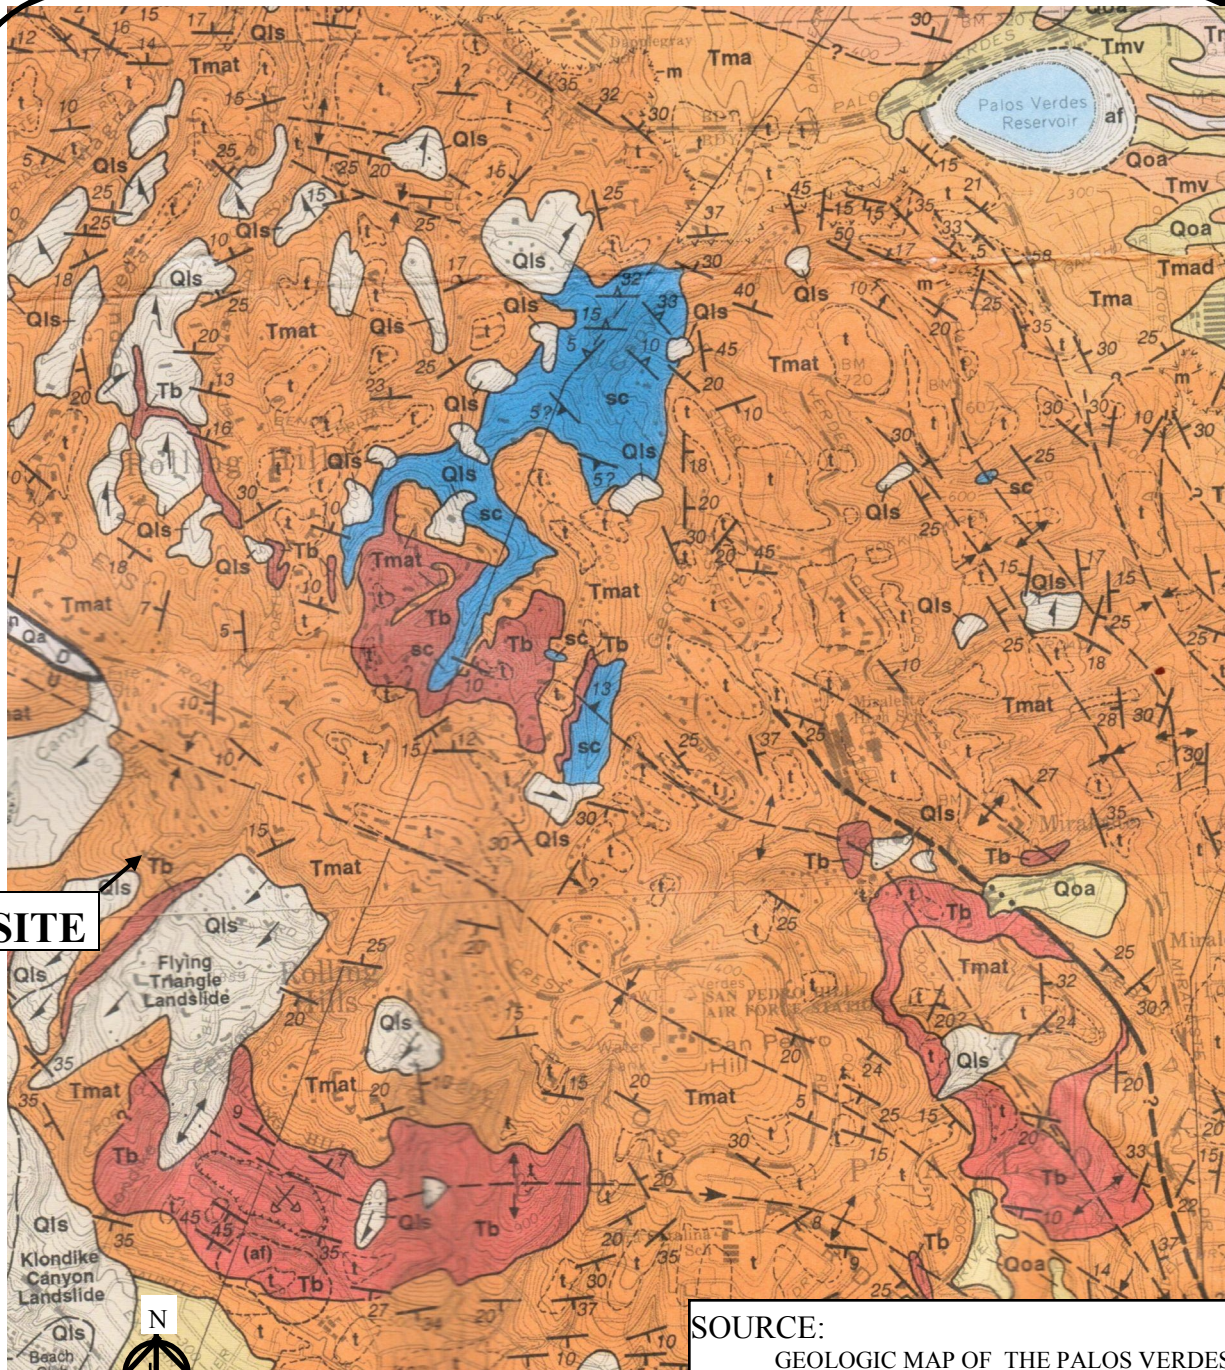
PLATE 1

The subject site is located approximately 500 feet northwesterly of the active Flying Triangle landslide. Two unnamed landslides are located on the southerly and northerly sides of the subject site, respectively. The southern unnamed landslide appears associated with Flying Triangle Landslide. The south portion of the subject site appears located within the northern boundary of the southern unnamed landslide as shown on the regional geology map, Plate 3. It is no indication that the southern unnamed landslide is reactive. The northern unnamed landslide appears associated with Portuguese Bend Landslide. The north portion of the subject site appears located within the southern boundary of the northern unnamed landslide as shown on the regional geology map, Plate 3, as well. New road cracks/separations, located approximately 800 feet northeasterly of the subject site, were observed on Cinchring Road near the 12 Cinchring Road site. The northern unnamed landslide appears to be reactive after the past two-year rains. The north boundary of the northern unnamed landslide appears to have been expanded northerly approximately 60 feet. Locations of the Flying Triangle landslide, unnamed landslides, and new road cracks/separations on Cinchring Road near the 12 Cinchring Road site are shown on Regional Geologic Map by Slosson and Associates, Plate 3.

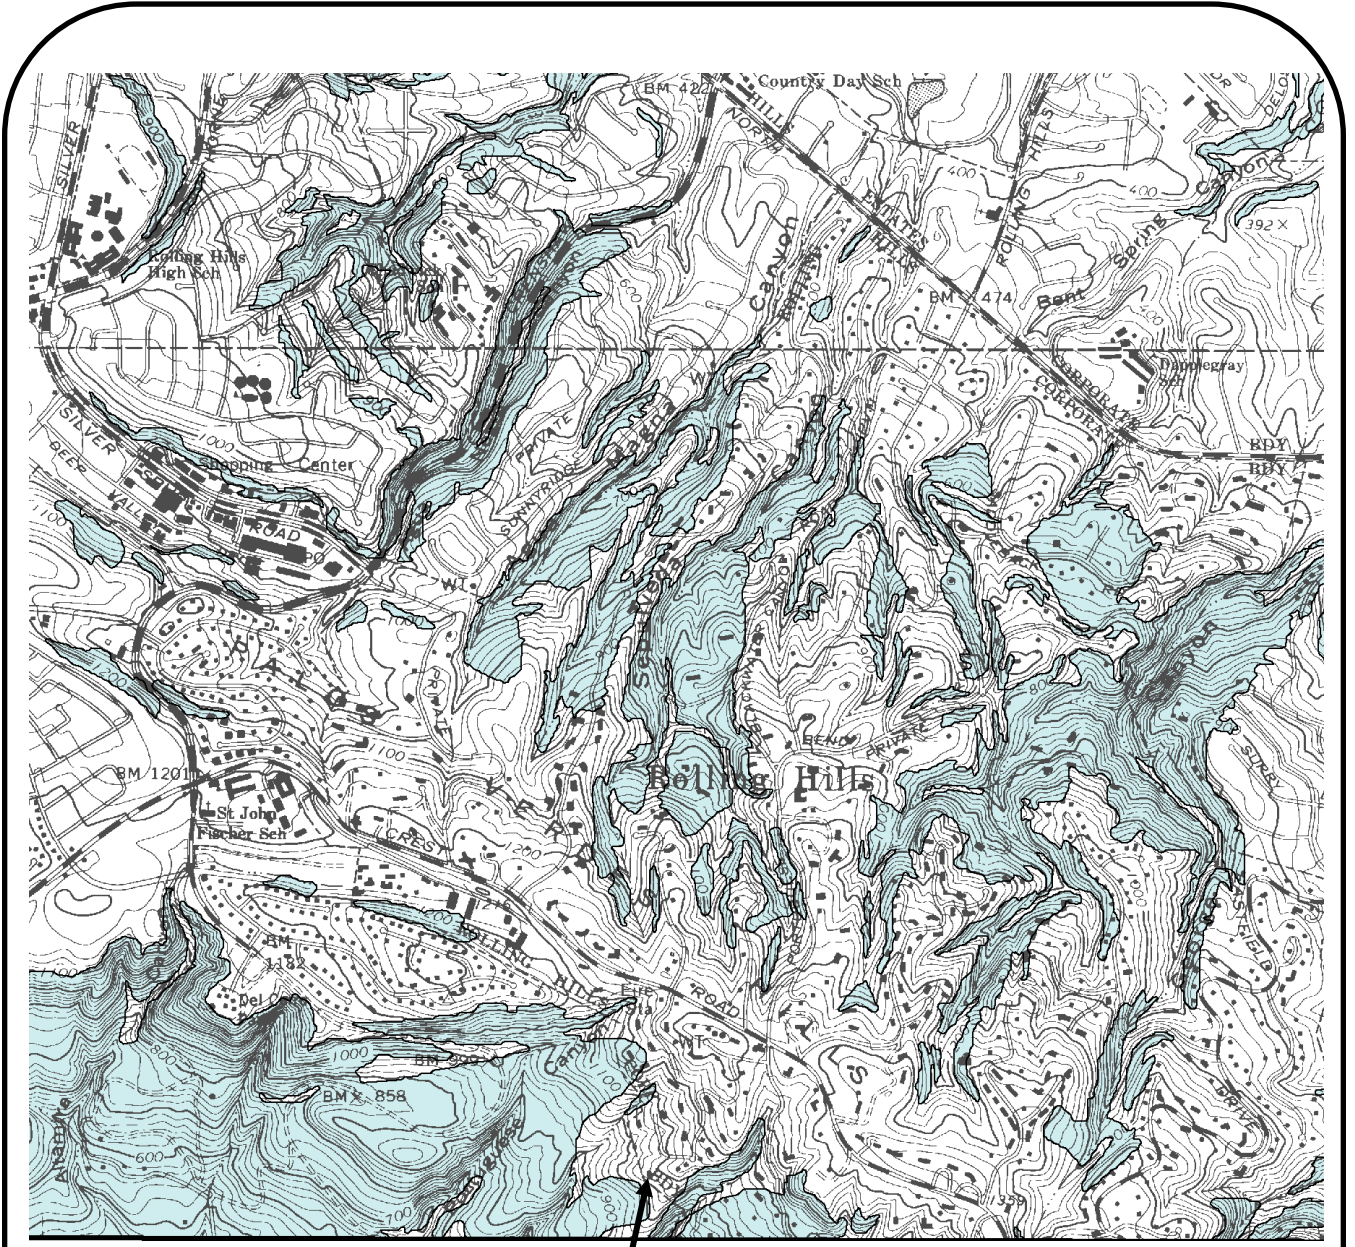
PLATE 2

10. The subject site is not located within the potential seismic hazard zones (liquefaction zones) mapped by the State as shown on Plate 2. The subject site is not located within a seismically-induced landslide hazard zone. The potential of the seismically-induced landslide at the subject site is to be minimal.
