WOOD DESTROYING PESTS AND ORGANISMS INSPECTION REPORT

Building No. 2734	Street W. Caldwell St	City Compton	ZIP 90220	Date of Inspection 09/16/2024	Number of Pages 10
----------------------	--------------------------	-----------------	--------------	----------------------------------	-----------------------

Report # : 15205
 Registration # : PR-7397
 Escrow # :
 CORRECTED REPORT

GENERAL DESCRIPTION: ONE STORY HOUSE, COMPOSITION ROOF, DETACHED GARAGE, STUCCO, RAISED, OCCUPIED/FURNISHED	Inspection Tag Posted: Other
	Other Tags Posted: N/A

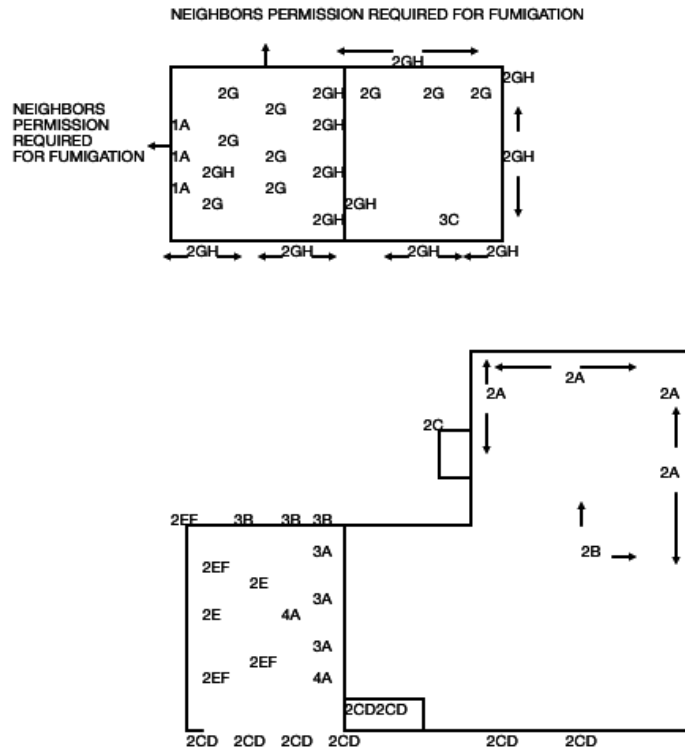
Diagram Not To Scale

FINDING: We observe evidence of subterranean termites at/in the **garage** in the approximate area as shown on the diagram.

FINDINGS: We observed evidence of drywood termites at/in **subarea** in the approximate area as shown on the diagram.

FINDINGS: We observed evidence of drywood termites at/in **attic** in the approximate area as shown on the diagram.

FINDINGS: We observed evidence of drywood termites at/in **front door jamb, stucco molding, rafter tails/fascia board** in the approximate area as shown on the diagram.

FINDING: We observed evidence of dry wood termite damage at/in the **front door jamb, stucco molding, rafter tails/fascia board** in the approximate area as shown on the diagram.

FINDINGS: We observed evidence of drywood termites at/in **carport door jamb, studs, rafters, rafter tails, fascia board** in the approximate area as shown on the diagram.

FINDING: We observed evidence of dry wood termite damage at/in the **door jambs, rafter tails** in the approximate area as shown on the diagram.

FINDINGS: We observed evidence of drywood termites at/in **garage rafters, shiplaps, studs, door jambs, extended rafter tails, fascia boards, attached garage, ceiling plywood** in the approximate area as shown on the diagram.

FINDING: We observed evidence of dry wood termite damage at/in the **garage rafters, shiplaps, studs, door jambs, extended rafter tails, fascia boards, attached garage, ceiling plywood** in the approximate area as shown on the diagram.

FINDING: We observed evidence of dry rot at/in the **carport roof plywood** in the approximate area as shown on the diagram.

FINDING: We observed evidence of dry rot at/in the **fascia board** in the approximate area as shown on the diagram.

FINDING: We observed evidence of dry rot at/in the **door** in the approximate area as shown on the diagram.

FINDING: We observed evidence of a water stains at/in the **carport roof plywood** in the approximate area as shown on the diagram.

FINDING: We observed evidence of cellulose debris at/in **subarea** in the approximate area as shown on the diagram.

RECOMMENDATION: Chemically treat the subarea for subterranean termites as stated in the above finding for control of subterranean termites. (NOTE: Superior Care Termite Inc. will not be liable for possible damage to pipes embedded in or below the concrete slab. We also assume no responsibility for damage for the floor coverings).

RECOMMENDATION: Fumigate the structure as a primary method of control using (VIKANE FUMIGANT) NATURAL GAS SERVICE MUST BE DISCONNECTED (TURNED OFF) AND RECONNECTED (TURNED ON) BY YOUR LOCAL GAS COMPANY. THESE ARRANGEMENTS MUS BE MADE BY OCCUPANT(S) OR YOUR AGENT PRIOR TO THE FUMIGATION. IF GAS SERVICE IS NOT OFF THE FUMIGATION WILL POSTPONE. FOLLOWING ARE THE PHONE NUMBERS FOR YOUR LOCAL GAS COMPANIES.

RECOMMENDATION: Re-Brace, Patch, Replace and or repair damaged wood members as required to eliminate the deficiency.

RECOMMENDATION: Replace, Re-brace, Patch and/or repair the damaged wood member to eliminate this deficiency.

RECOMMENDATION: OWNER/AGENT should engage the services of a licensed contractor in that field to inspect the area as described in the above finding.

RECOMMENDATION: Remove cellulose debris of a size that can be raked or larger.
