# Insight Home Inspections

## Home Inspection Report

**27413 Fawnskin Dr**

Inspected on Tue, Aug 7 2018 at 11:20 AM

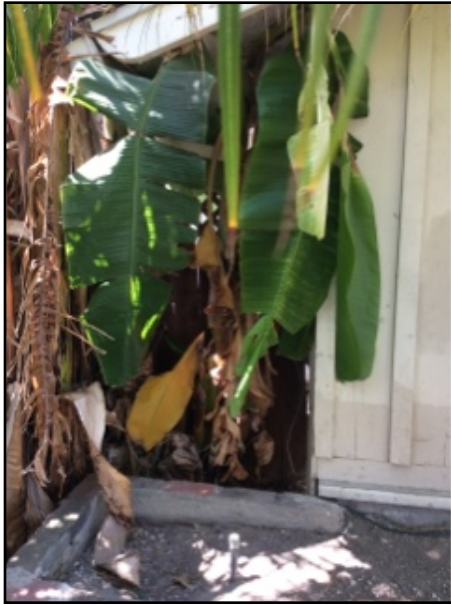
Figure 1-1

Multiple trees are growing against structure. Recommend removing any tree within 6' of Home to prevent structural damage.

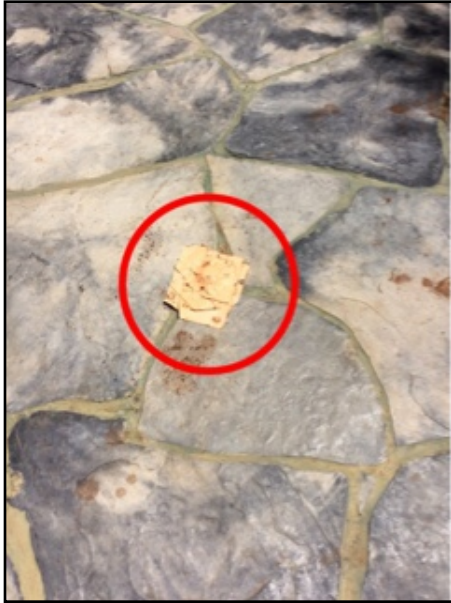
Figure 2-1

Comment 2:  
Recommend cutting pipe flush with ground. Potential trip hazard.

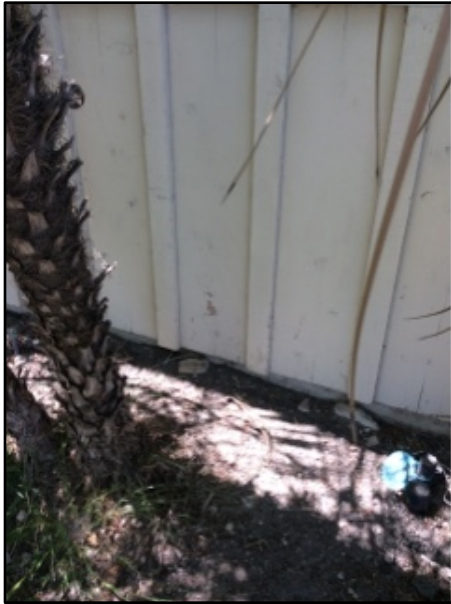
Figure 5-1

Present dry rot. Possible termite damage. Recommend termite inspection.

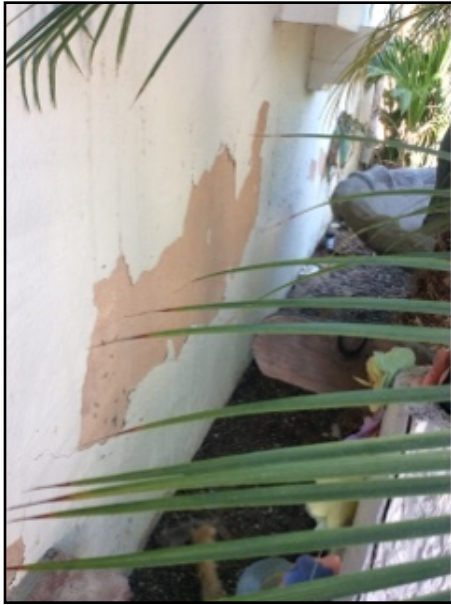
Figure 6-1

Multiple areas of failing and delaminating paint. Along with open holes and incomplete patch work. Recommend repair to prevent water intrusion.

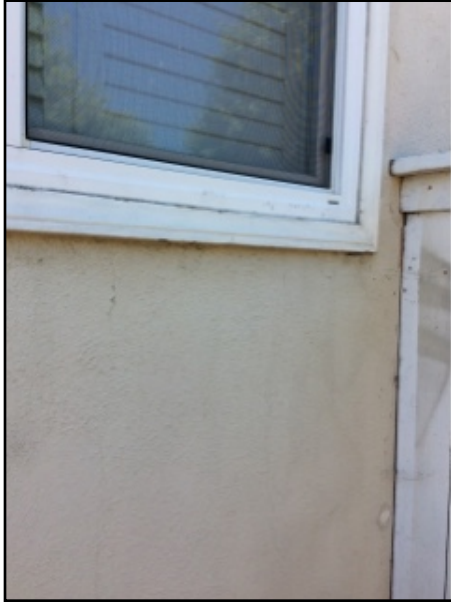
Figure 7-1

Multiple cracks in stucco. Caused by normal wear, also by potential foundation settling. Recommend further evaluation.

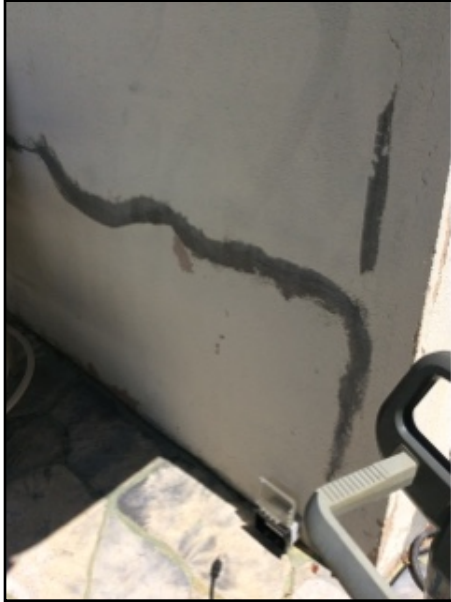
Figure 8-1

Patches appear to be from repair from settlement cracks. Recommend further evaluation by a structural engineer.

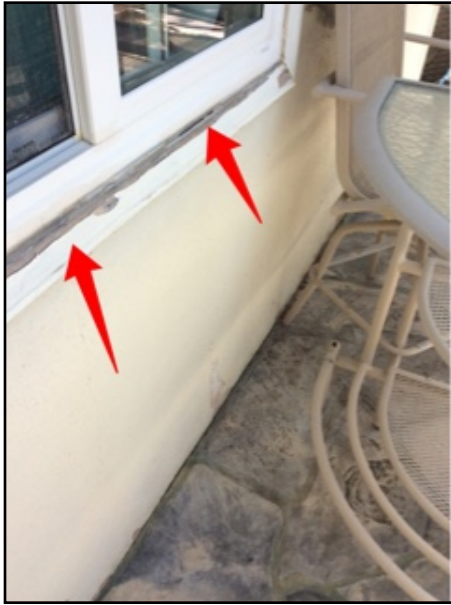
Figure 9-1

Wood trim needs to be painted and sealed to prevent water intrusion and structural damage.

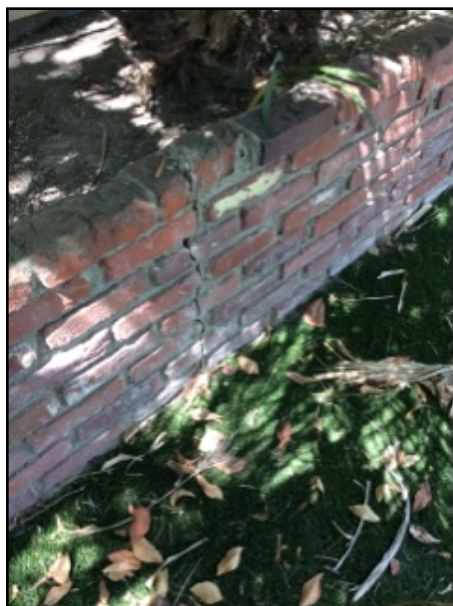
Figure 10-1

Broken planter box from over growing tree roots.

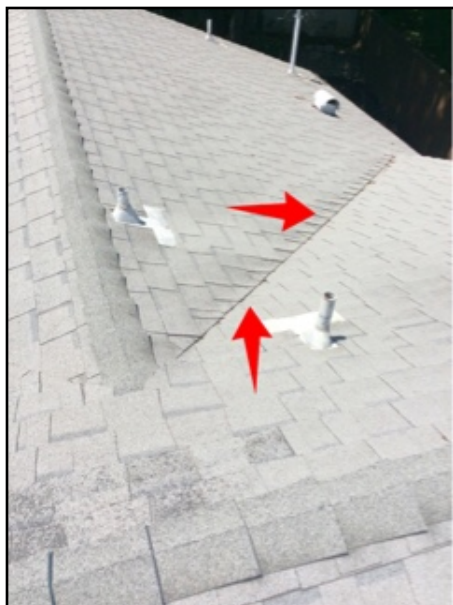
Figure 11-1

Recommend installing valley flashing to aid in proper rain drainage.

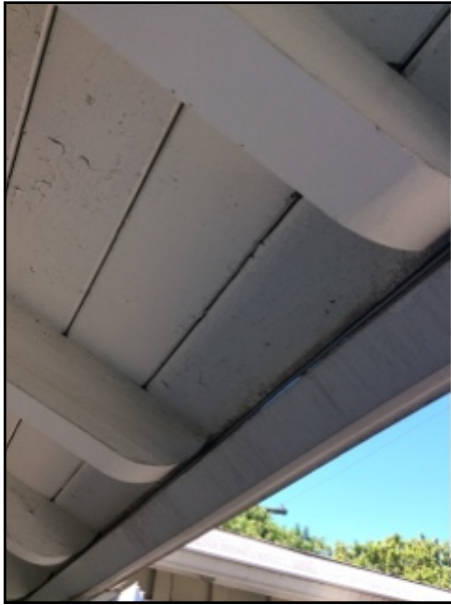
Figure 12-1

Multiple areas of failing paint and delaminating wood along fascia boards and eaves. Recommend further inspection by termite company.

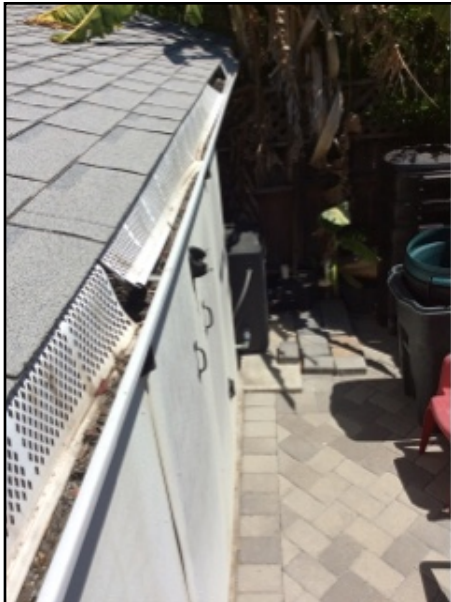
Figure 13-1

Recommend cleaning out rain gutters for optimal drainage. Backed up gutters can lead to water intrusion.

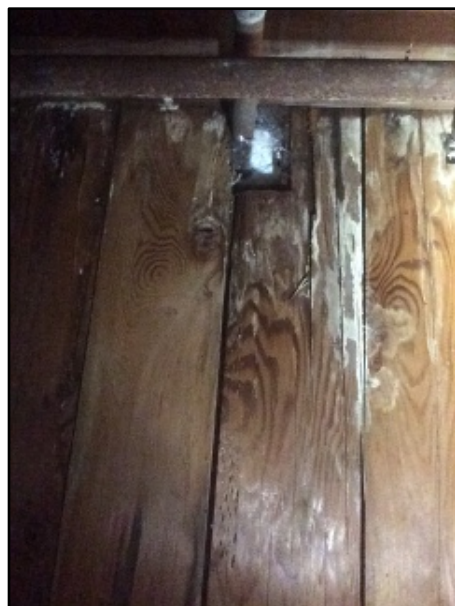
Figure 14-1

Dry rot and wood damage underneath bathroom fixtures from water intrusion.

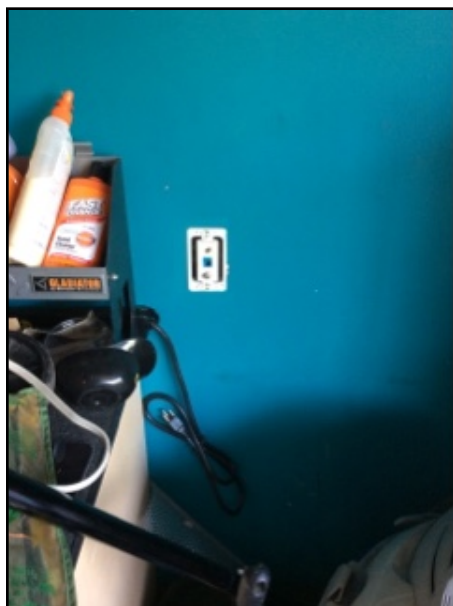
Figure 16-1

Comment 16:  
Missing plate cover.

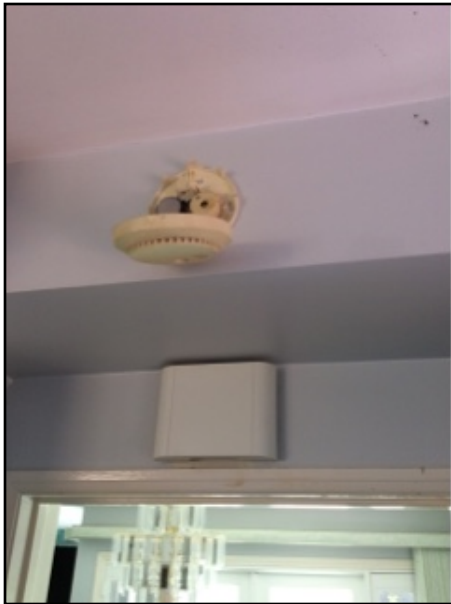
Figure 17-1

All smoke detectors are not functioning and need to be replaced.

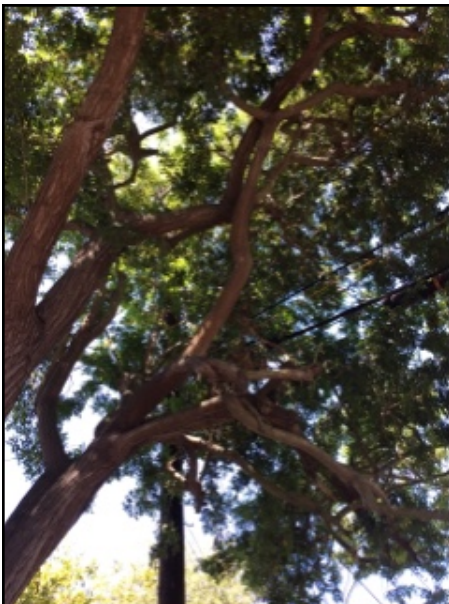
Figure 19-1

Tree is posing potential damage to electrical service.

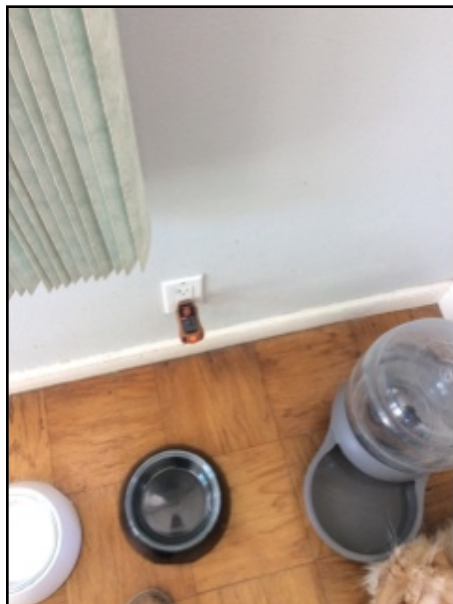
Figure 20-1

Majority of outlets are not grounded. Recommend further evaluation by a licensed electrician.

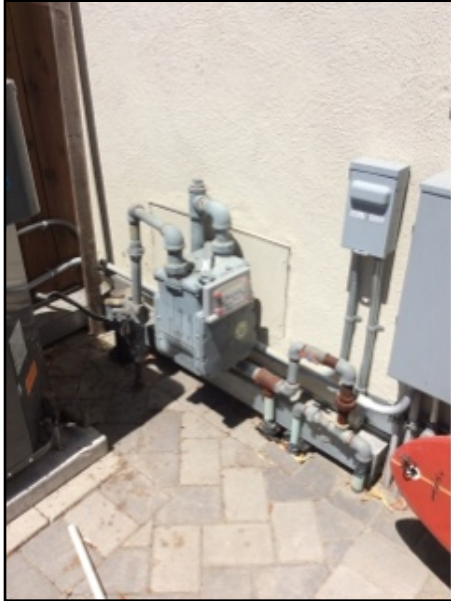
Figure 21-1

Appears added valves and plumbing has been installed from gas meter. Recommend further evaluation by gas company to ensure gas plumbing is up to city code.

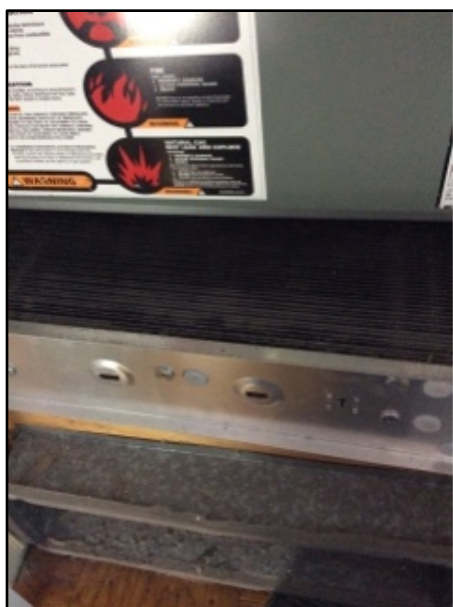
Figure 23-1

Comment 23:  
Recommend cleaning air filter every 3-6 months.

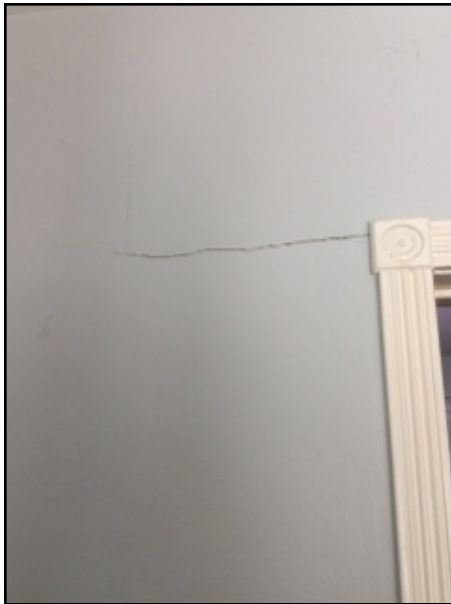
Figure 26-1

**Comment 26:**  
Multiple settlement cracks through interior at weak points of structure.

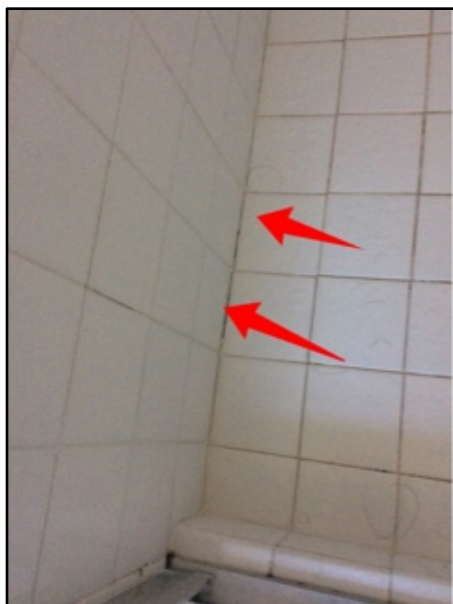
Figure 27-1

Comment 27:  
Recommend repairing cracks in grout to prevent water intrusion.

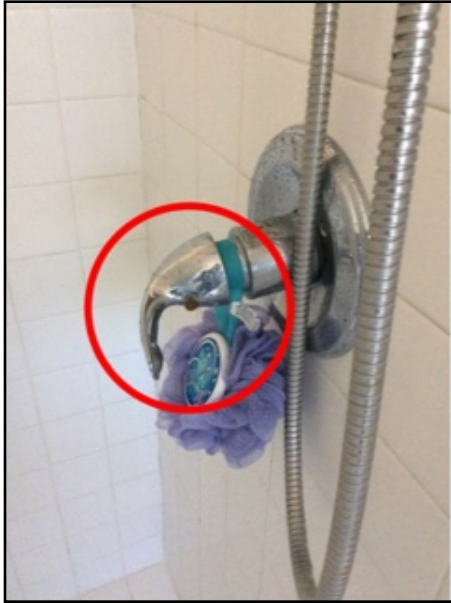
Figure 28-1

Comment 28:  
Loose shower valve handle.

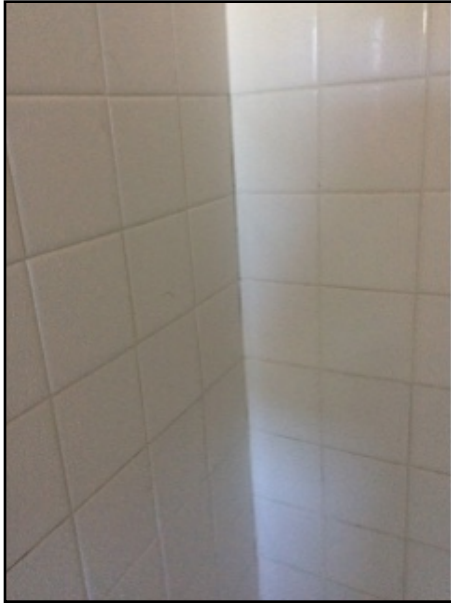
Figure 29-1

Comment 29:  
Recommend sealing cracked grout.

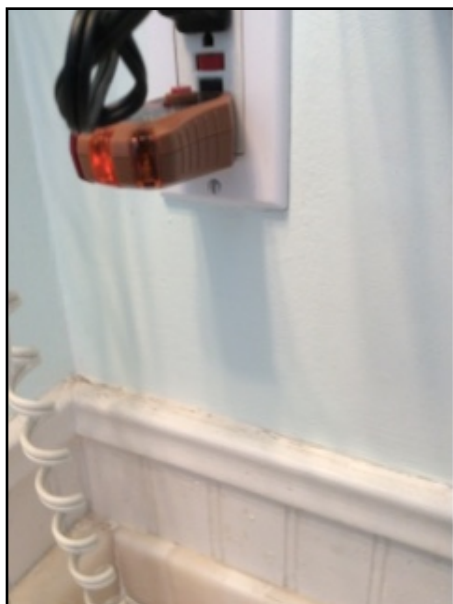
Figure 30-1

GFCI outlet is not grounded. This is a safety issue. Recommend repair.

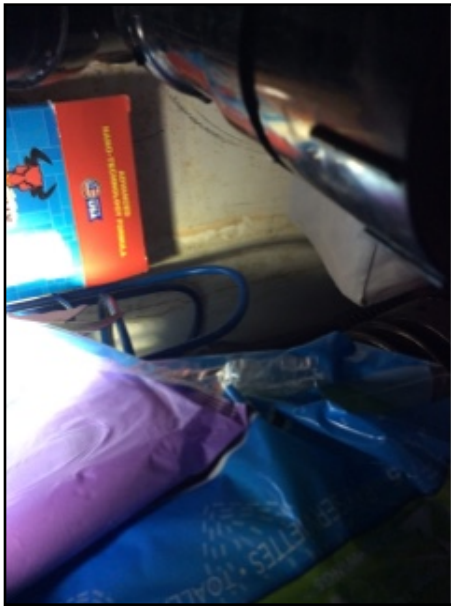
Figure 31-1

Comment 31:  
Obvious water damage. Moisture not present at time of inspection.

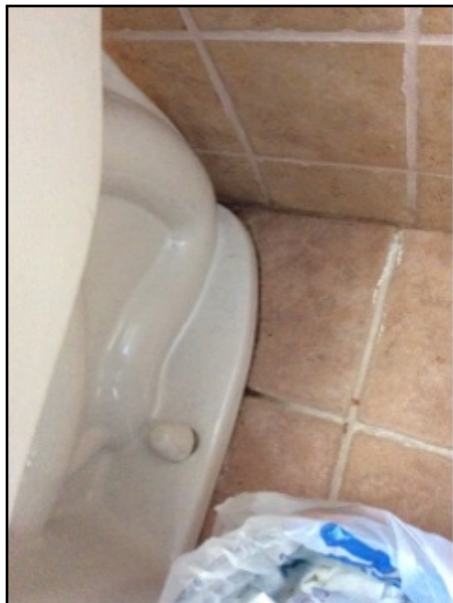
Figure 33-1

Water pooling around toilet base. Recommend further evaluation.

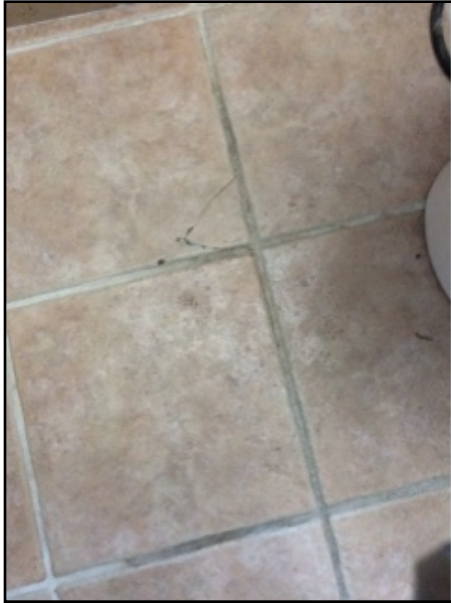
Figure 34-1

Comment 34:  
Single cracked tile in front of toilet.

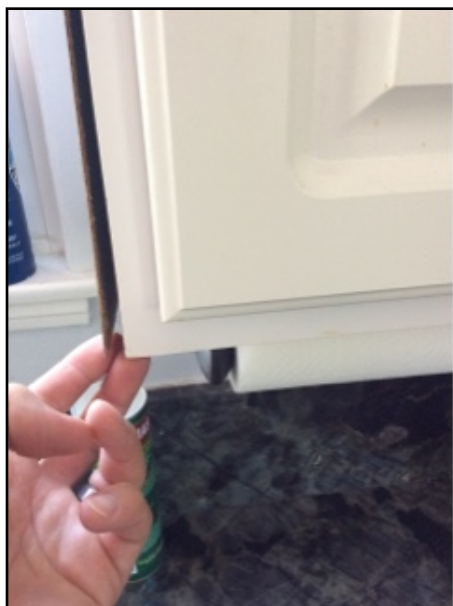
Figure 35-1

Delaminating portions of cabinets. Recommend repair or replace.

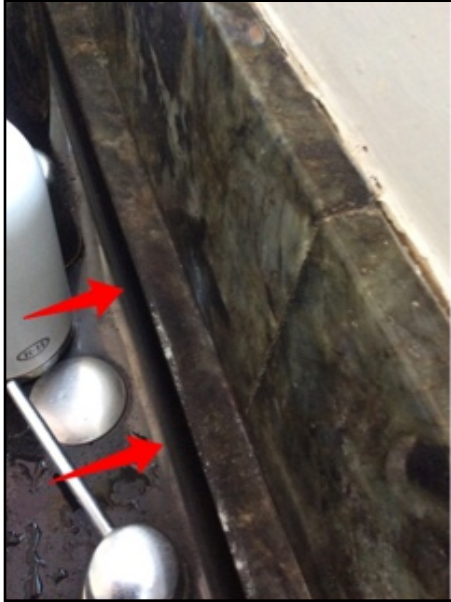
Figure 37-1

Gap behind sink and counter top needs to be sealed. There may possibly be mold growth due to water intrusion. Recommend further evaluation.

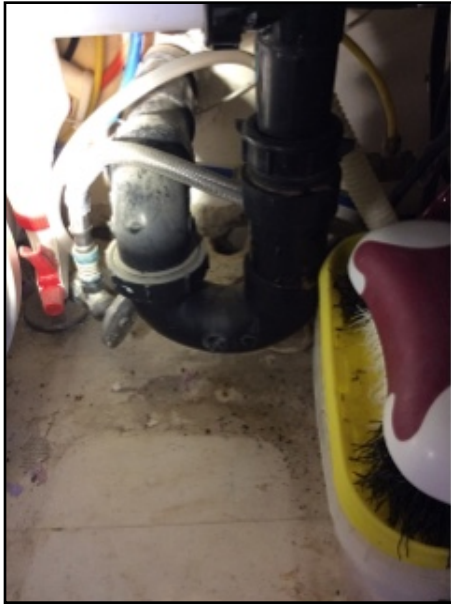
Figure 38-1

Water damage under sink. Recommend further evaluation and testing for mold growth.

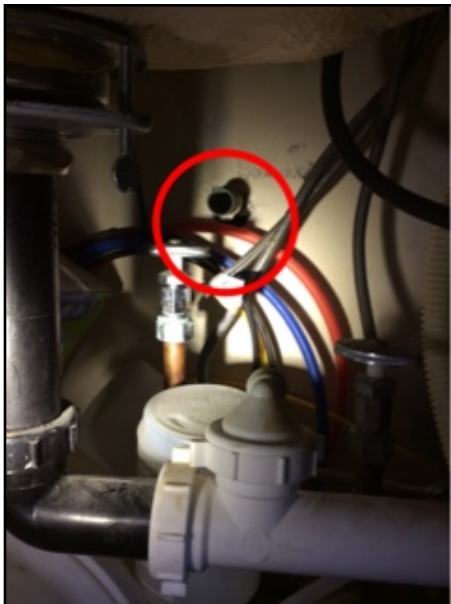
Figure 39-1

Comment 39:  
Recommend capping open plumbing lines.

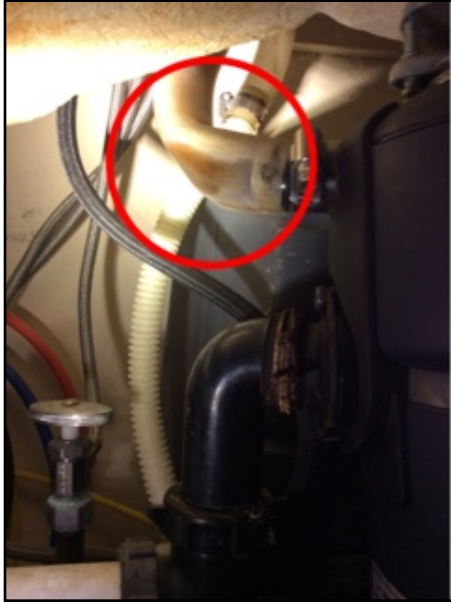
Figure 40-1

Air gap drain line is kinked and clogged. This causing water to exit through the air gap creating flooding over the counter top to the floor. Recommend repair.

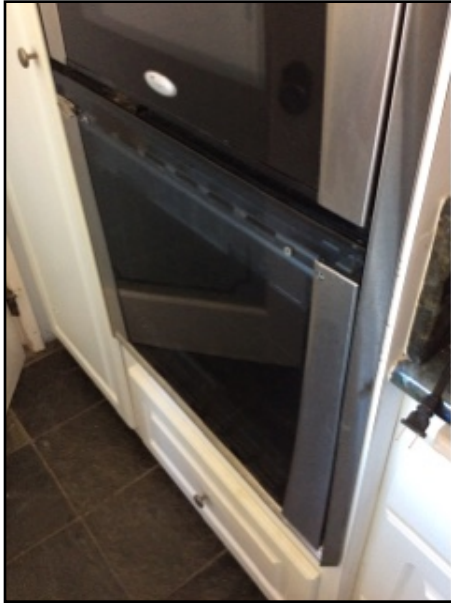
Figure 42-1

Comment 42:  
Missing handle to oven door.

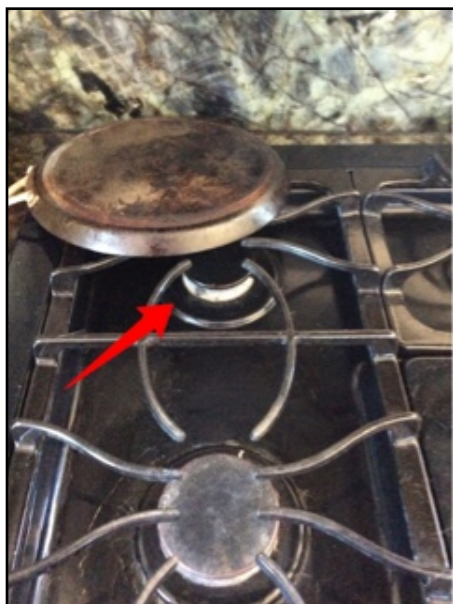
Figure 43-1

Comment 43:  
Bake left burner is not functioning.

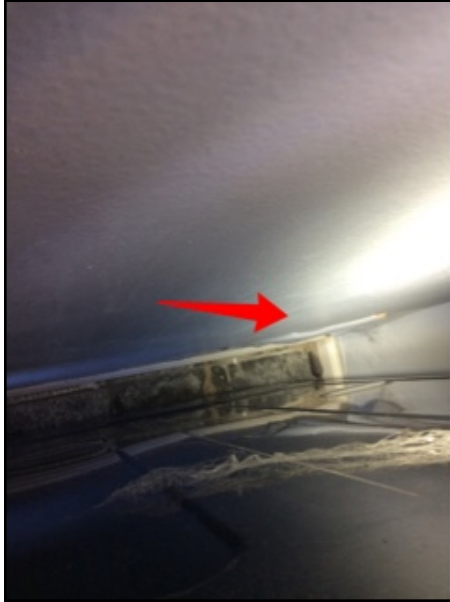
Figure 44-1

Delaminating paint. Possible cause by moisture intrusion. Recommend further evaluation.

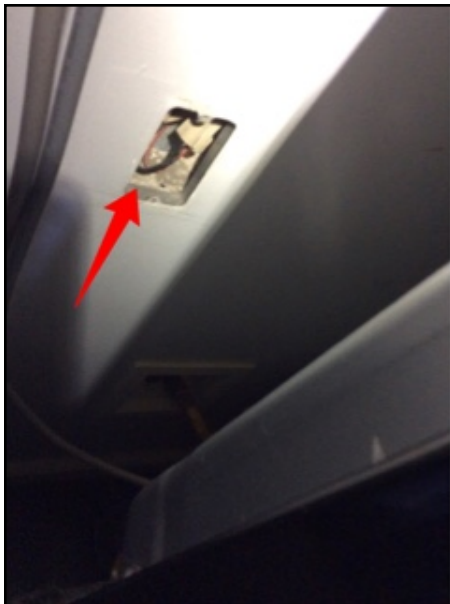
Figure 45-1

Open electrical box. Recommend adding cover plate.

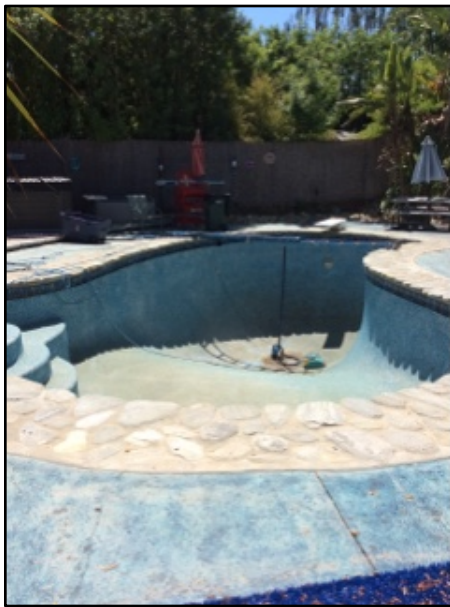
Figure 46-1

Unable to test pool equipment, due to pools current conditions.

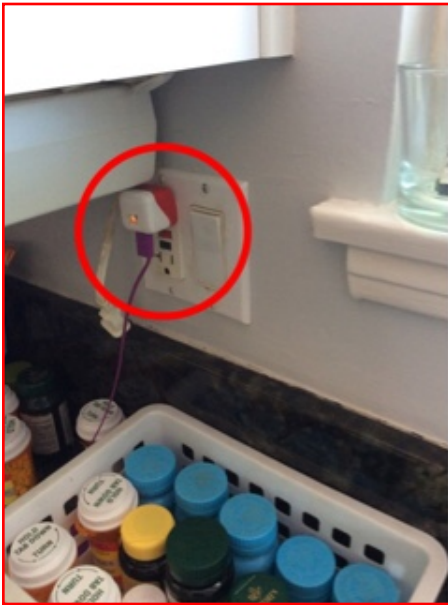
Figure 41-1

**Comment 41:**  
GFCI outlet is not grounded. Recommend repair by a licensed electrician.
