WOOD DESTROYING PESTS AND ORGANISMS INSPECTION REPORT

Address 2015 Calle Pattito, Templeton, CA 93465

09/22/2025

W15290

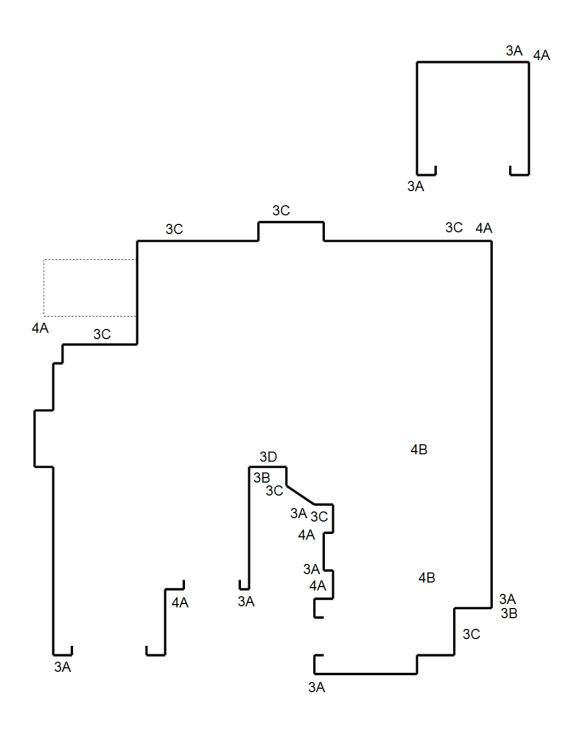
This Diagram is not to scale

FINDINGS: Fungus damage was noted at the fascia.

FINDINGS: Fungus damage was noted at the raftertail.

FINDINGS: Fungus damage was noted at the door jamb and the door trim.

FINDINGS: Fungus damage was noted at the door molding.

FINDINGS: The rain gutters were noted to be leaking.

FINDINGS: Missing or deteriorated caulking/grout was noted at the bathroom floor and the bath tub.

RECOMMENDATION: Remove and replace damaged wood members with new material. Painting is included,

RECOMMENDATION: Re-seal gutters at area of water leakage with an approved water tight sealer.

RECOMMENDATION: Re-caulk or re-grout the area to prevent future problems.
