# Confidential Inspection Report

626 Lake St #49 in Huntington Beach

Prepared by: Peak Inspections Inc.

At your request we have performed an inspection of the property at 626 Lake St #49 , Huntington Beach CA . on 09/29/2021

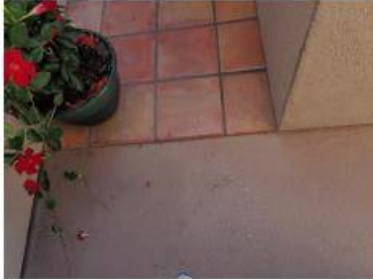
### 2.1 Walkway Conditions

**Safety Concern:** Uneven surfaces (not flush) on the walkway at the front area. This condition is a trip hazard. Repair as needed for safety.

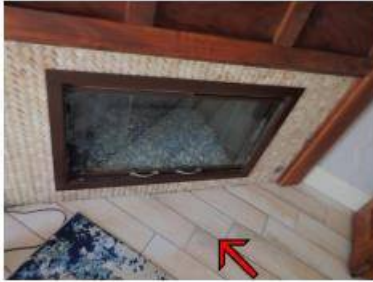
### 3.2 Fireplace(s) Condition

**Safety Concern:** The height of fireplace hearth extension was not distinguishable from the surrounding flooring. The hearth extension is a designated space where combustible materials should not be located. Repair as needed for safety.

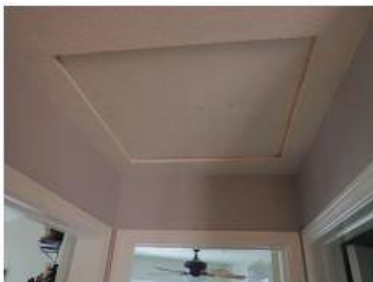
### 6.1 Access(s) Location

The inspector entered the attic.  
Location: Upper hall

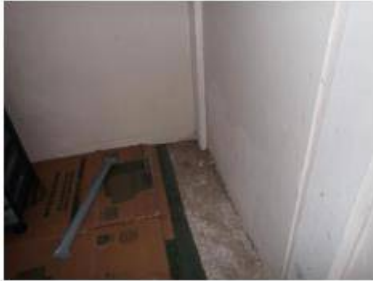
### 7.2 Wall Conditions

**Corrections Recommended:** Moisture stains were noted on the garage interior wall(s). The area appeared dry during the inspection. Repair as needed.

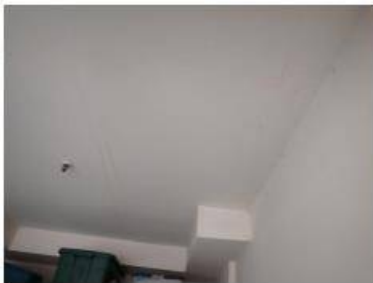
### 7.3 Ceilings Conditions

**Corrections Recommended:** Moisture stains were noted on the garage interior ceiling. The area appeared dry during the inspection. Repair as needed.

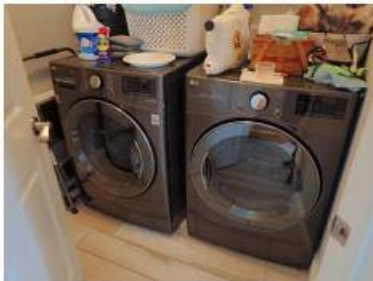
#### 8.2 Laundry Conditions

A visual inspection of the laundry room and it's components appear to be in operational condition. Those components determined to have material defects and or disclaimed are itemized below or in other sections of this report.

**Maintenance:** Clean dryer vents often. A build up of lint will reduce the efficiency of the dryer and reduce the chance of a lint fire.

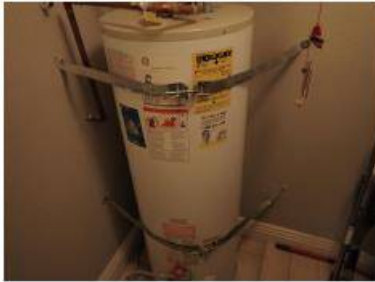
### 9.1 Water Heater Location

Water heating unit #1 was located at the laundry room.

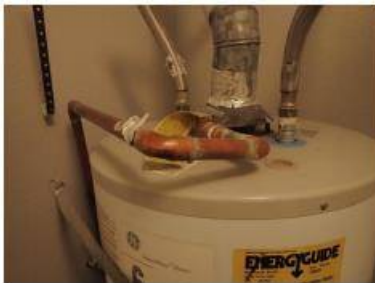
### 9.5 T-P Relief Valve

**Safety Concern:** The water heater pressure temperature relief (TPR) valve discharge piping was observed to run improperly up-hill. This can result in possible failure of the valve to operate properly when needed due to the corrosion caused by condensate moisture trapped in the discharge line. This configuration may have been allowed when the water heater was installed but is currently classified as a safety hazard. We recommend further review for a better understanding of replacement/repair costs and present condition.

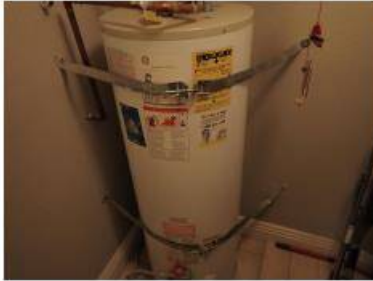
### 9.7 Strapping

**Corrections Recommended:** The water heater strapping was installed in a manner that did not meet the states architects or water heater strapping kits manufactures installation instructions. We recommend repairing the condition noted.

**Corrections Recommended:** The water heater was double strapped, it was not stabilized/blocked at the back to resist movement required by the states architects. We recommend repairing the condition noted.

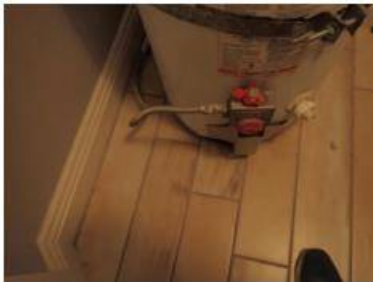
### 9.8 Water Heater Platform Conditions

**Corrections Recommended:** A pan was not provided at the bottom of the water heater to prevent water damage in the event of a leak. Repair as needed.

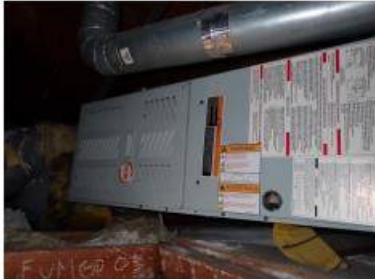
### 10.1 Location And Number Of Units

Heating unit/system #1 was located, in the attic.

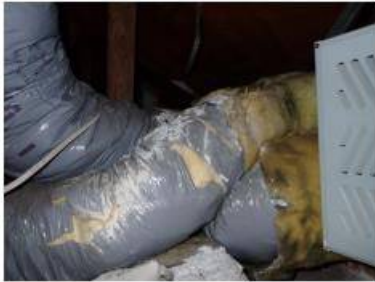
### 10.5 Ducts

**Corrections Recommended:** There were air ducts with damaged/deteriorated outer plastic covering. This condition can effect the energy efficiency.

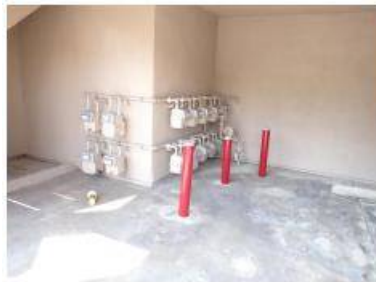
### 11.9 Location

The gas meter and or shut off was located at the rear of the building. The main gas supply shut-off valve was located on the riser pipe between the ground and the meter. Recommend having a gas shut off key available at or near the gas shut off in case of an emergency.

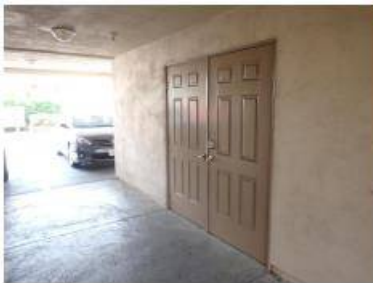
### 12.1 Service Panel Conditions

**Further Evaluation:** The closet access to the main panel was locked and not accessible to inspect.

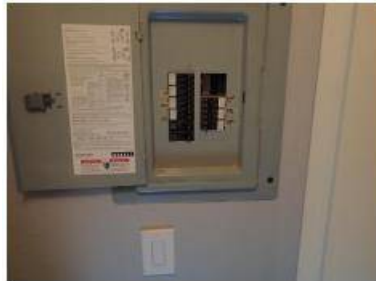
#### 12.4 Sub Panel Location(s)

The location of sub panel #1 is located in the laundry room.

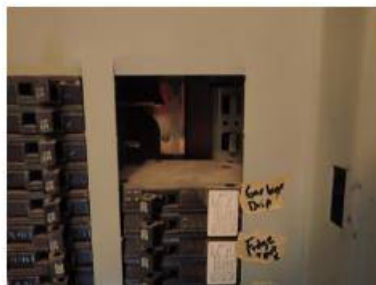
#### 12.5 Sub Panel Conditions

**Safety Concern:** The dead-front cover to electric sub panel in the laundry room was missing twist-outs/knock-outs at unused breaker slots. All openings in the cover should be filled/closed to minimize access by insects, rodents or unauthorized personnel.

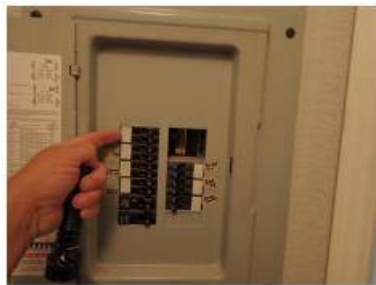
**Corrections Recommended:** A number of breakers/fuses in electric sub panel in the laundry room were not labeled to identify their use. All circuit disconnecting devices should be accurately labeled to allow the appropriate circuit to be shut off for maintenance or emergencies.

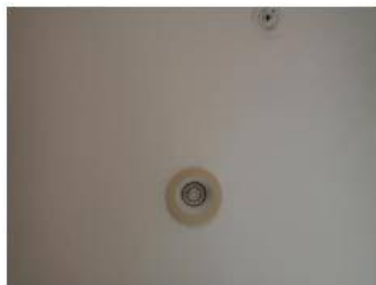
#### 12.6 Light(s) Fixture(s) Conditions

**Corrections Recommended:** The light fixture(s) at the entry area failed to function using the normal operating controls (unusual nose when switch is on). The bulb(s) in this fixture may be burned out. If the bulbs are not burned out, the condition of the fixture and wiring should be verified. We recommend repair as necessary to restore the function of this fixture.

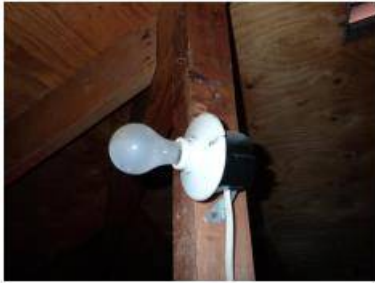
**Corrections Recommended:** The light fixture(s) in the attic failed to function using the normal operating controls. The bulb(s) in this fixture may be burned out. If the bulbs are not burned out, the condition of the fixture and wiring should be verified. We recommend repair as necessary to restore the function of this fixture.

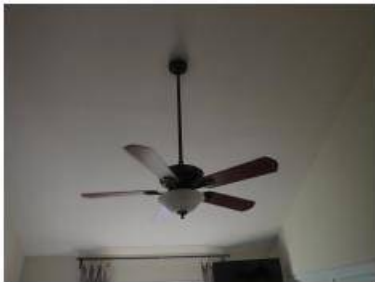
### 12.7 Ceiling Fans

The ceiling fans were operated and appear to be in generally acceptable condition.

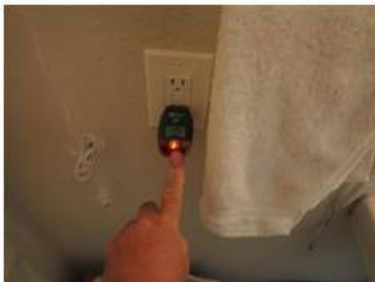
### 12.8 Receptacle(s)

**Corrections Recommended:** An ungrounded three-prong receptacle was observed at master bathroom. We recommend that any ungrounded three-prong receptacle be grounded.

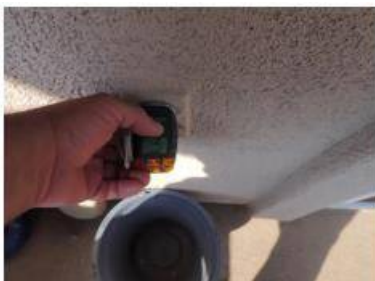
### 12.9 GFCI Conditions

**Recommended Upgrade: Safety Concern:** GFCI (Ground Fault Circuit Interrupter) protection was not installed at the both back decks. We recommend that GFCI protection be installed according to current applicable standard as a safety enhancement.

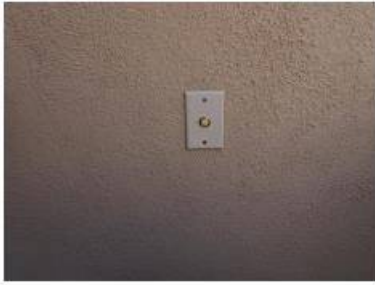
### 12.10 Door Bell

The door bell was operational at the time of the inspection.

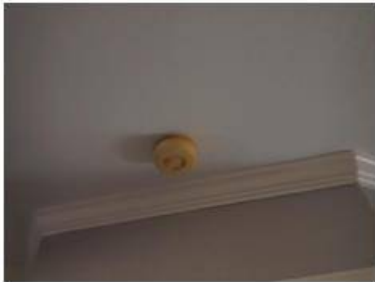
### 12.11 Smoke Alarms

**Further Evaluation:** The smoke alarms appear to be older than 10 years. Aging smoke alarms don't operate as efficiently and often are the source for nuisance alarms. The industry standards recommend replacing older smoke alarms. Repair as needed.

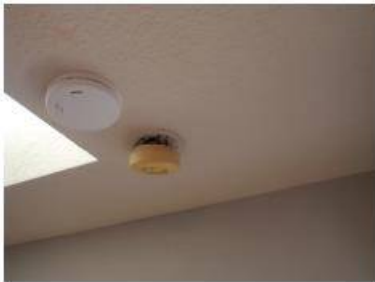
**Corrections Recommended:** The smoke alarm is hanging from its wiring in the upper hallway. Smoke alarms should be installed in their proper place and tested at regular intervals per the manufacturer's instructions.

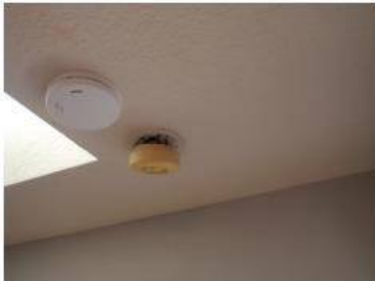
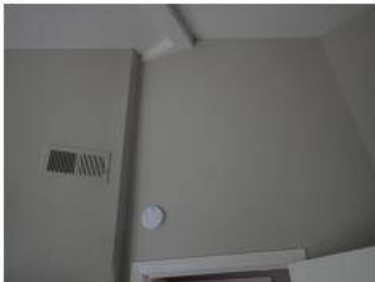
**Safety Concern:** Smoke alarm was installed too low in the upper back left bedroom. Smoke alarms should be installed in their proper place and tested at regular intervals per the manufacturer's instructions.

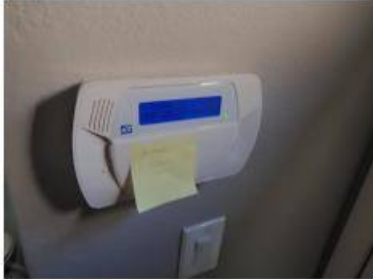
### 12.13 Alarm System

**Consult Seller:** A security system for the property was observed and is outside the scope of this inspection and was not tested. We recommend consulting the seller for more information as to the condition, service provider and functions of the system.

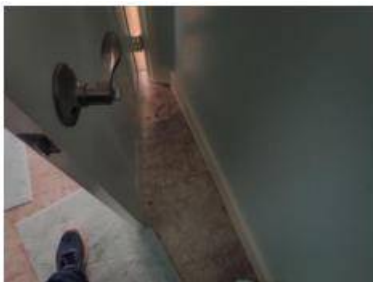
### 13.2 Interior Door Conditions

**Corrections Recommended:** One or more door stops were missing. This condition will likely lead to damage to the wall surfaces. Repair as needed.

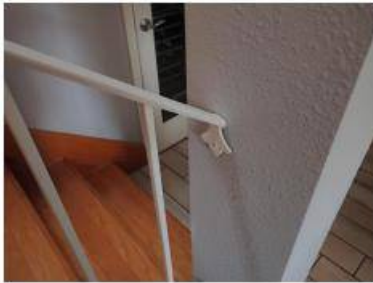
### 13.9 Handrails(s)

**Safety Concern:** The handrail was loose (not properly secured). This condition is a safety hazard.

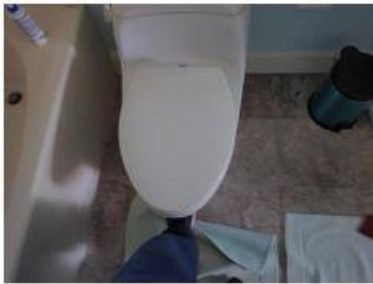
### 14.3 Toilet Conditions

**Corrections Recommended:** The toilet is loose at the floor at the at the upper back left bedrooms bathroom. This condition can cause leakage and moisture damage. Repair as needed.

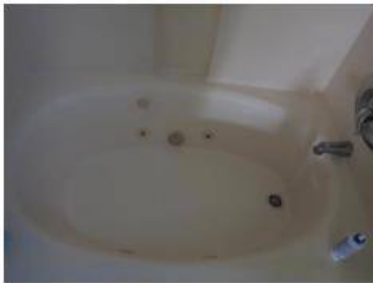
### 14.5 Tub Spa

The tub spa was filled and activated using the supplied controls. A visual inspection of the tub and all related components were operational.

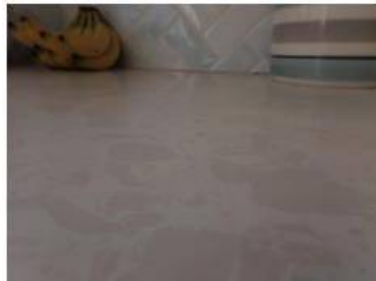
#### Counters/Cabinets Conditions

**Corrections Recommended:** The grout was cracked or missing at the countertop. Repair as needed.

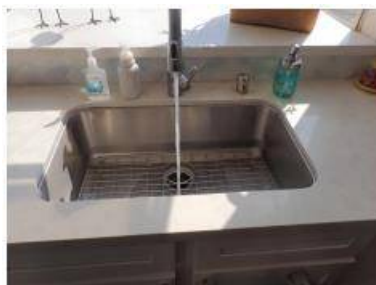
#### 15.3 Kitchen Sink

Inspection of the accessible areas of the kitchen sink(s) and it's components appear to be in operational condition.

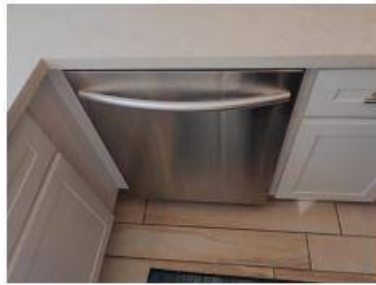
#### 15.5 Dishwasher

Inspection of the accessible areas of the dishwasher and it's components appear to be in operational condition.

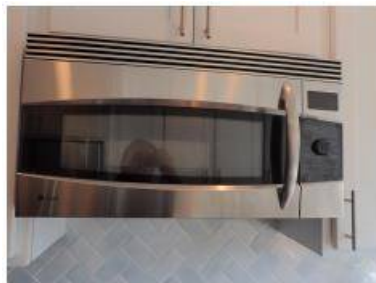
### 15.6 Microwave

Inspection of the accessible areas of the microwave oven and it's components appear to be in operational condition.

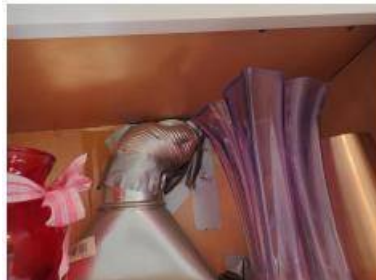
### 15.8 Exhaust Vent Conditions

**Corrections Recommended:** The exhaust vent pipe was reduced to a smaller diameter. Repair as needed for proper operation.

**Corrections Recommended:** The exhaust vent pipe was a corrugated flexible material. Corrugated ducting is not approved for kitchen exhaust vents as grease gets trapped in the corrugations creating health concerns.
