## Sprinkler System Inspection

11/04/2022  
Client File # 17459-2176  
FICS File # 3048792

Tony Accardo  
507 Sapphire street  
Redondo Beach, ca 90277

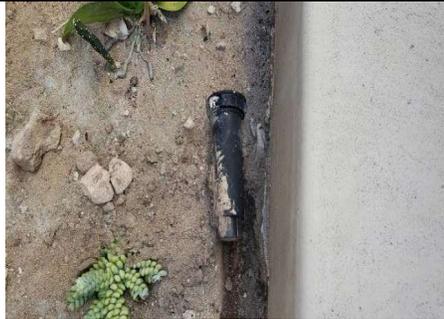
CONDITION OF COMPONENTS	
<b>Automatic Timer</b>	Acceptable
<b>Manual Controls</b>	Acceptable
<b>Shut Off/Draining Valves</b>	Acceptable
<b>Individual Zones/Pop up Heads</b>	The sprinkler head in Zone 1 is broken.
Corrective Action	Contractor to replace the broken sprinkler head
<div style="display: flex; border: 1px solid black; padding: 5px;"> <div style="width: 30%; text-align: center;">

<p>Broken head</p> </div> <div style="width: 70%;"></div> </div>	
<b>Water Pressure Flow</b>	The head at the front/left planter in Zone 1 had low flow.
Corrective Action	Contractor to head at the front left paltner.

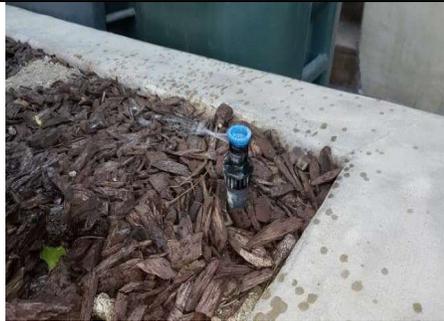
Low flow at head			
<b>Additional Comments</b>
