# WOOD DESTROYING PESTS AND ORGANISMS INSPECTION REPORT

| Building No.<br>1721 | Street<br>Sunset Ave. | City<br>Chico | ZIP<br>95926 | Date of Inspection<br>10/02/2026 | Number of Pages<br>4 | | |
| | | <b>HOUSE DETECTIVE TERMITE CONTROL INC</b><br>302 Bellamy Terrace<br>CHICO CA 95973<br>(530) 591-7079<br>hdetective@att.net | | Report # : 16859<br>Registration # : PR5960<br>Escrow # :<br><input type="checkbox"/> CORRECTED REPORT | | | |
| GENERAL DESCRIPTION:<br>One story wood frame single family dwelling. | | | | Inspection Tag Posted:<br>At the water heater | | | |

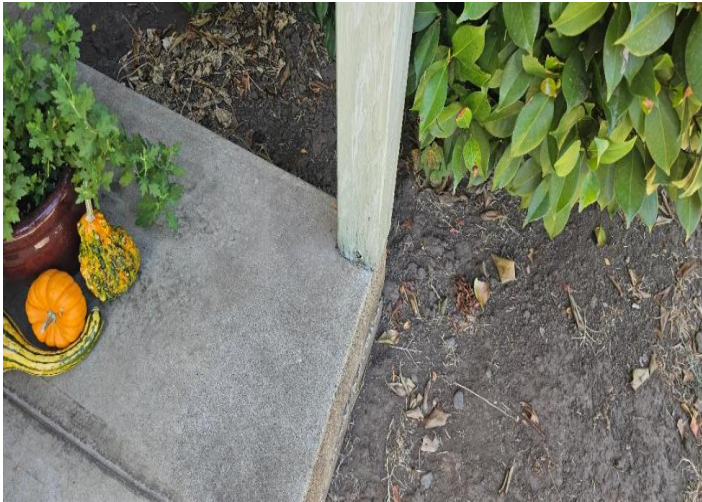
**FINDING:** Fungus damage was found to the front porch support post.

3A - Damaged post.

**RECOMMENDATION:** Remove the damaged wood members and replace with new material. Prime paint only.

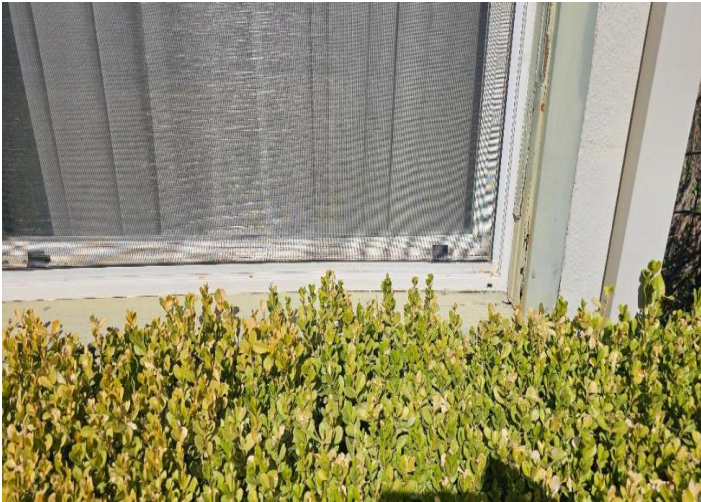
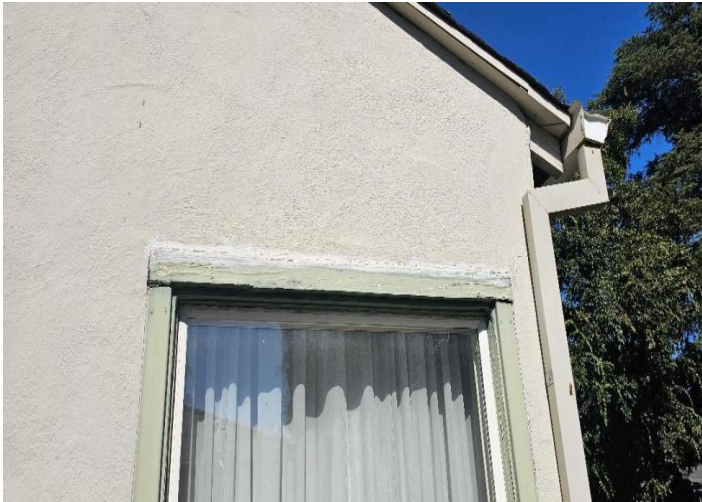
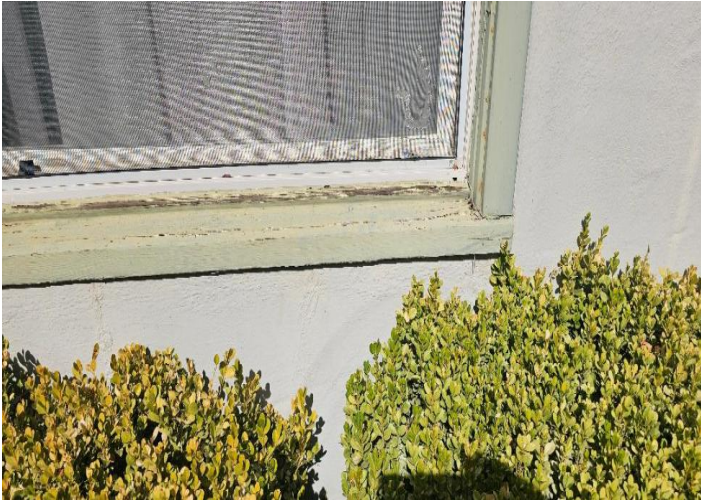
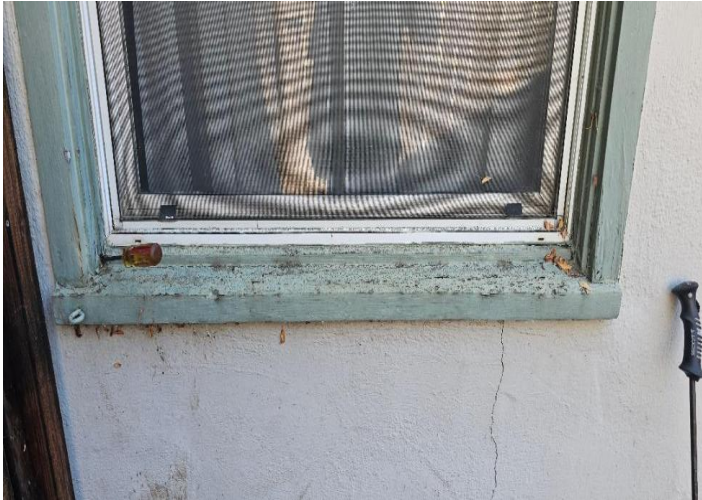
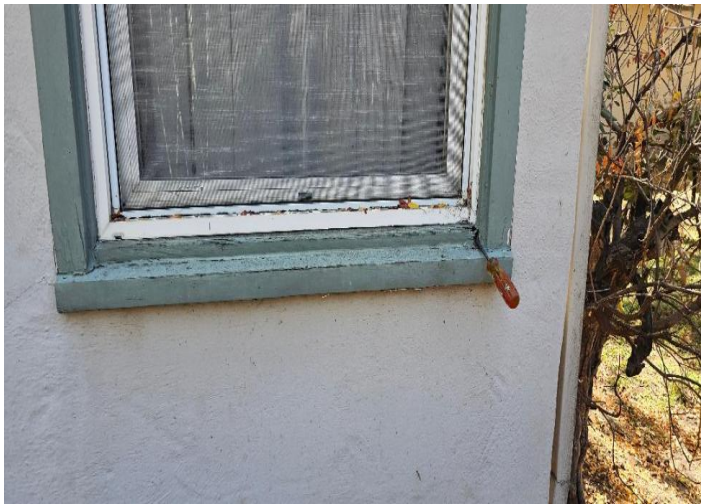
**FINDING:** Fungus damage was found to wood members at the windows where indicted with possible hidden damage to enclosed framing.

3B - Damaged window members.

**RECOMMENDATION:** Remove the damaged wood members and replace with new material. Prime paint only. Check for hidden damage. The bid outlined is an estimate only.

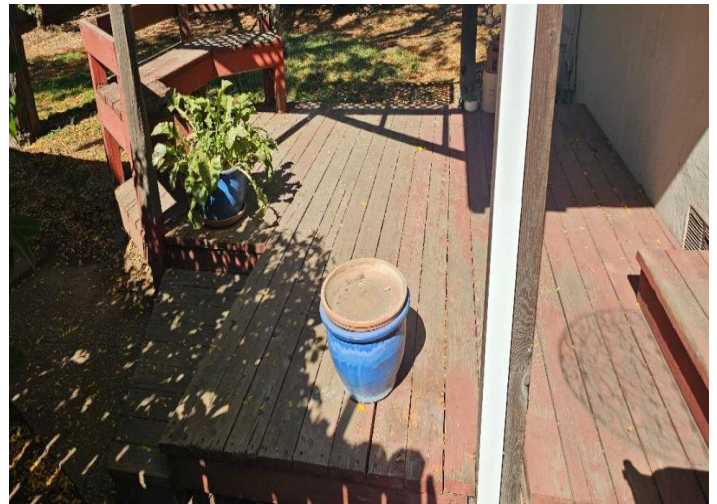
**FINDING:** Fungus damage was found to the rear wood deck and arbor assembly.

3C - Damaged wood deck.

**RECOMMENDATION:** We recommend the owner/agent engage the services of a licensed contractor to remove all damaged members and to replace with new appropriate material.

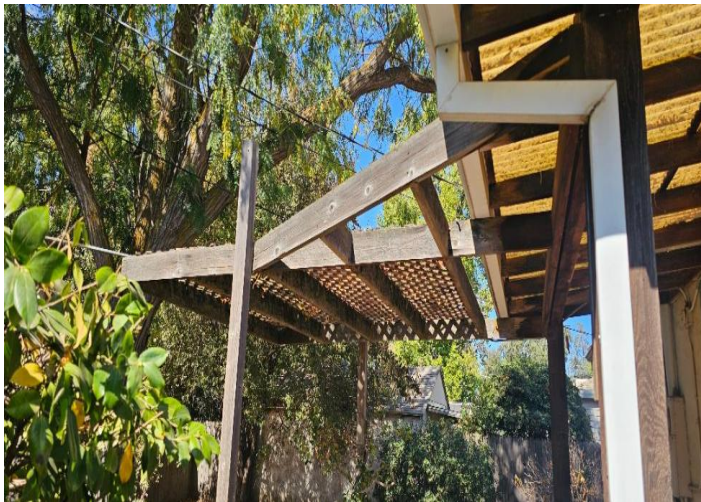
3C - Damaged arbor assembly.

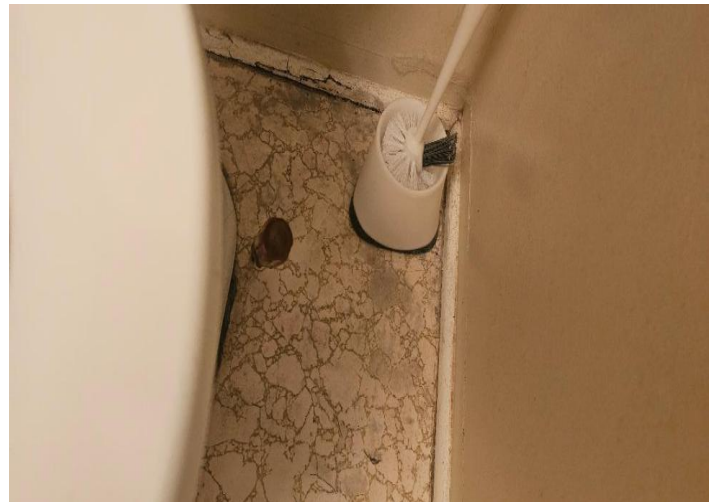
**FINDING:** The floor adjacent to the toilet in the bathroom is swollen and/or discolored indicating possible damage to the subflooring.

3D - Damaged bathroom floor.

**RECOMMENDATION:** Remove the toilet. Remove the floor covering and underlayment for further inspection. If no further damage is exposed, install new underlayment and floor covering. Reset the toilet on a new wax ring.
