Duration Plumbing

Sewer Inspection Report

1608 Cataluna Place
Palos Verdes Estates, California 90274

Friday, January 28, 2022 at 2:00 PM

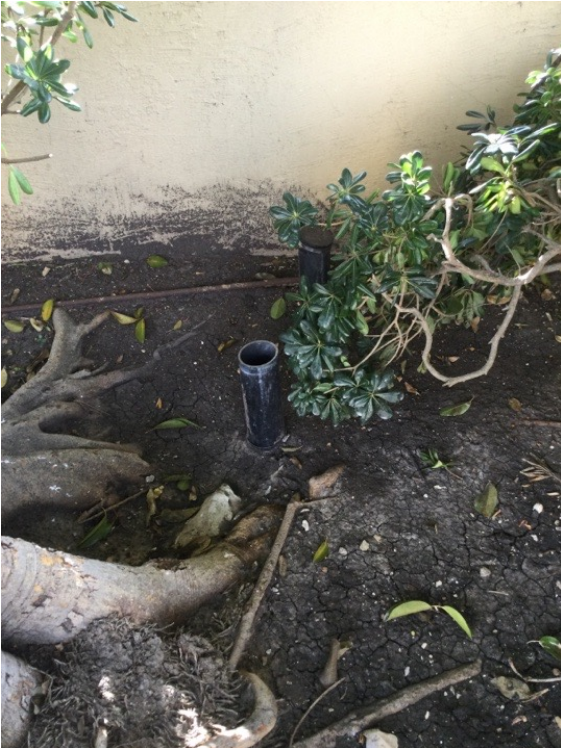
Four inch abs plastic clean outs.

Planter behind the front wall.

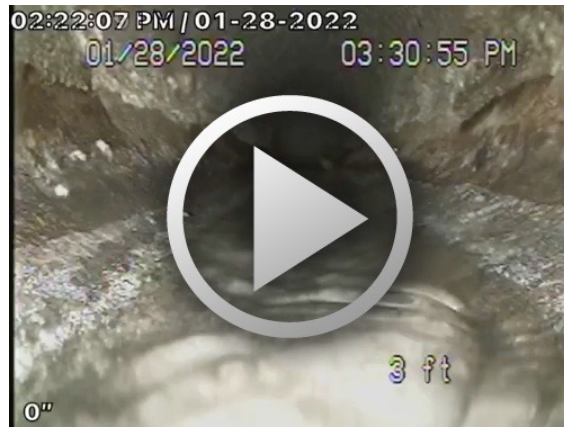
Downstream towards the street.

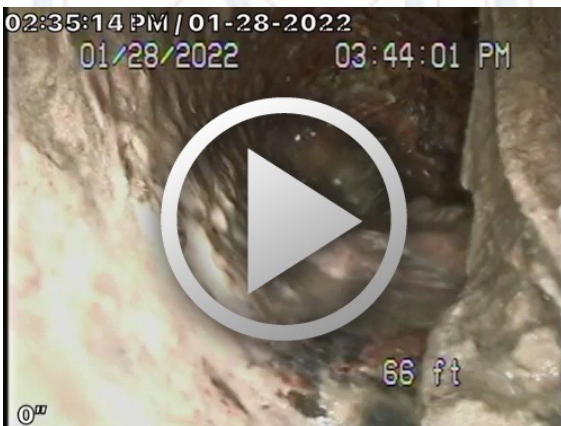
Upstream towards the house.

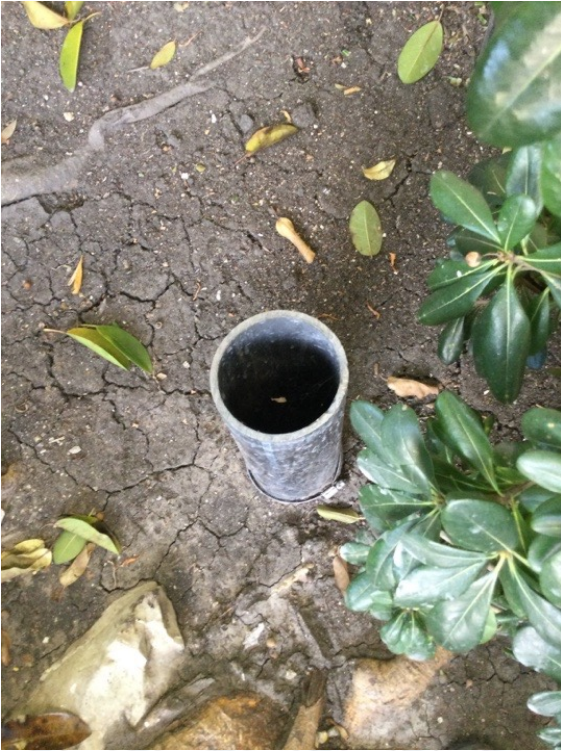
The clean out cap was missing. We recommend correcting the condition noted.
