# WOOD DESTROYING PESTS AND ORGANISMS INSPECTION REPORT

#: 20137599

| BUILDING NO<br>11456 | STREET<br>MCLAREN ST | CITY<br>NORWALK | ZIP<br>90650 | Date of Inspection<br>07/31/2025 | NUMBER OF PAGES<br>1 of 5 |

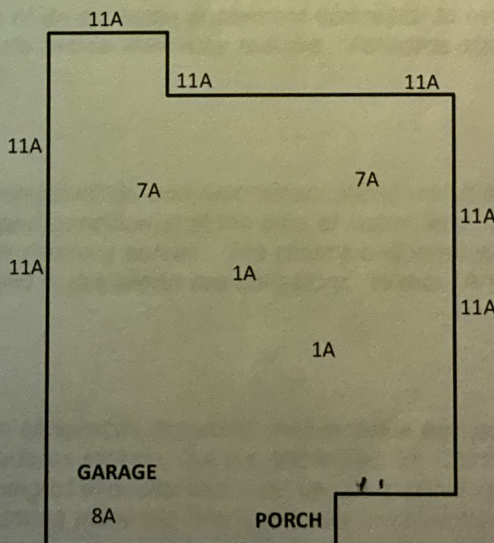
Evidence of SUBTERRANEAN TERMITES in as indicated by 1A on the diagram.  
The evidence was located in or near: SUBAREA.

Evidence of DRYWOOD TERMITES as indicated by 7A on the diagram.  
Evidence noted in or near: ATTIC.

Evidence of DRYWOOD TERMITES as indicated by 8A on the diagram.  
Evidence noted in or near: GARAGE.

Evidence of DRYWOOD TERMITES as indicated by 11A on the diagram.  
Evidence noted in or near: EXTERIOR.

We recommend treating infestation for the control of SUBTERRANEAN TERMITES. Remove or cover subterranean termite fecal pellets in accessible areas. This treatment has a warranty of one (1) year.

Fumigate (tent) the structure with vikane lethal to DRYWOOD TERMITES. Remove or cover drywood termite fecal pellets in accessible areas. See the occupants fumigation notice for further details. This company is not responsible for delays or schedule changes due to inclement weather or other agencies, nor is it responsible for damage to roof or plants as a result of the fumigation. Refer to the occupant's fumigation notice/preparation sheet (sent separately) for additional information. The fumigation has a warranty of two (2) years.
