Preliminary Inspection Report

Client: Daniel & Melanie Cherry
Inspection Address: 1303 Harkness Lane
Redondo Beach, CA 90278
Date of Inspection: May 22, 2023

Inspection performed by David Puccio
1130 South Flower Street #221
Los Angeles, CA 90015
Office: 310-773-9936
Hygienist Mobile: 310-422-6934

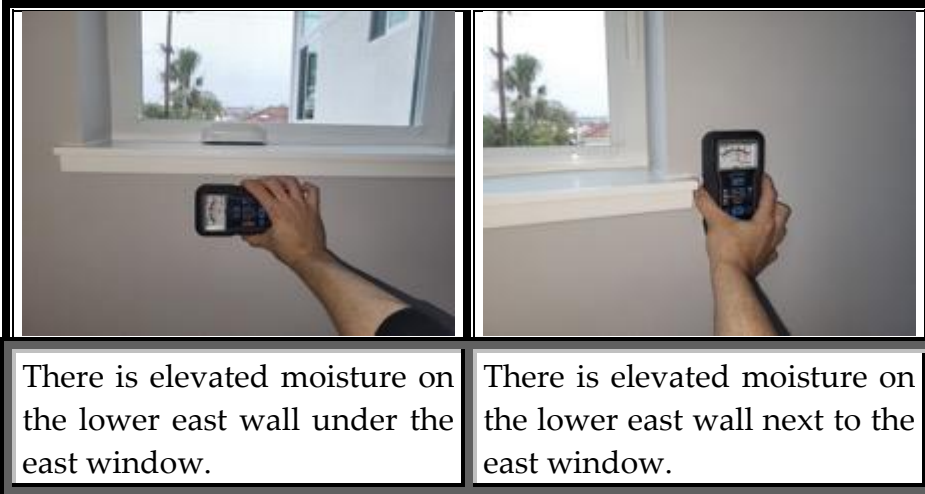
Concern #1: 2F North Bedroom

Overview image of the east window.	There is elevated moisture on the wood base of the east window.	There is elevated moisture on the wood base of the east window.

- **Remove the lower 3-4 feet of the east wall under and next to the east window.**
 - **Remove the base of the east window.**
 - **Remove the lower portion of the drywall window frame of the east window to investigate.**

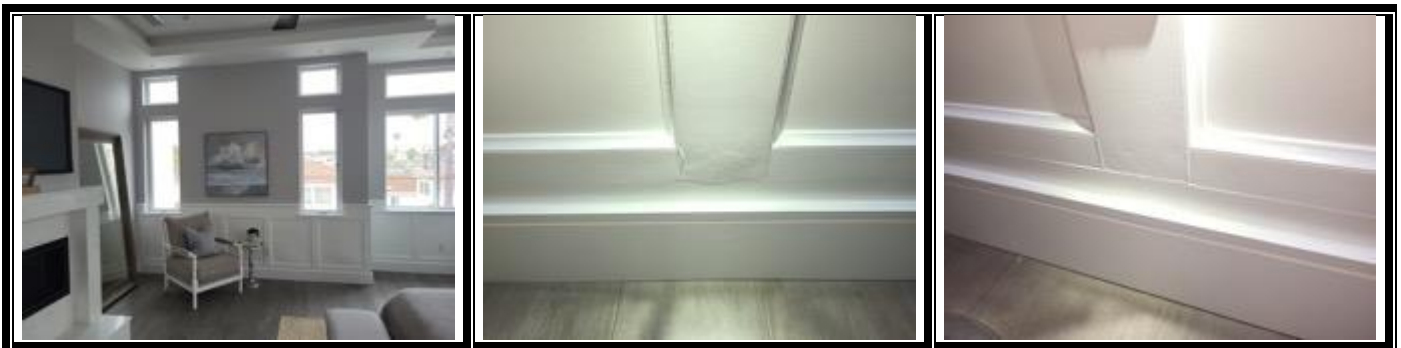
Concern #3: 2F Primary Bedroom

<p>Overview image of the east windows.</p>	<p>There is damage and bubbling on the east wood panel wall below the east middle window.</p>	<p>There is damage/bubbling on the lower east wood panel wall between the two small east windows.</p>
--	---	---

- **Remove the lower 3-4 feet of the entire east wood panel wall where the two thin east windows are present.**

- Remove the east drywall next to the east thin windows above the wood panel wall. The lower portion of the drywall window frames of the two east thin windows should be investigated.

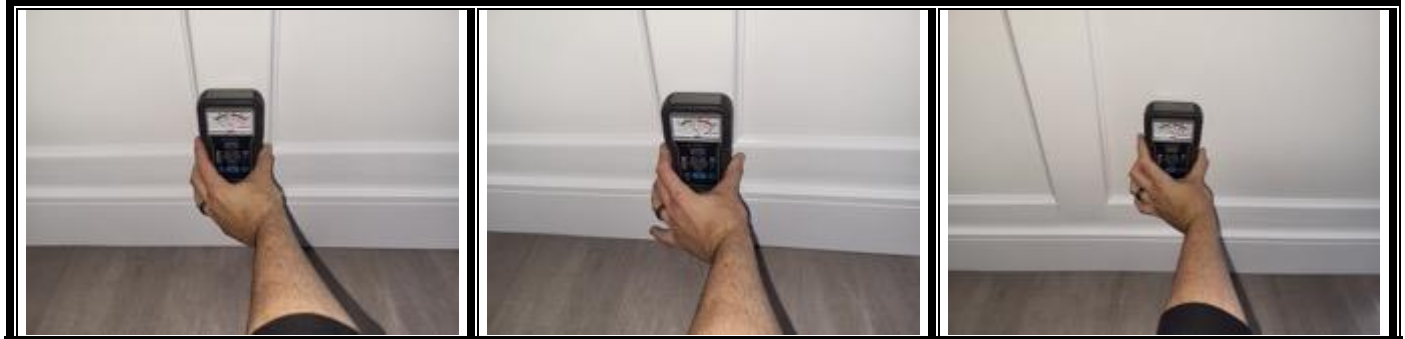
<p>There is damage and bubbling on the east wood panel wall below the east middle window. Elevated moisture is present.</p>	<p>There is damage/bubbling on the lower east wood panel wall between the two small east windows. Elevated moisture is present.</p>	<p>There is elevated moisture on the east wood panel wall under the east windows.</p>
---	---	---

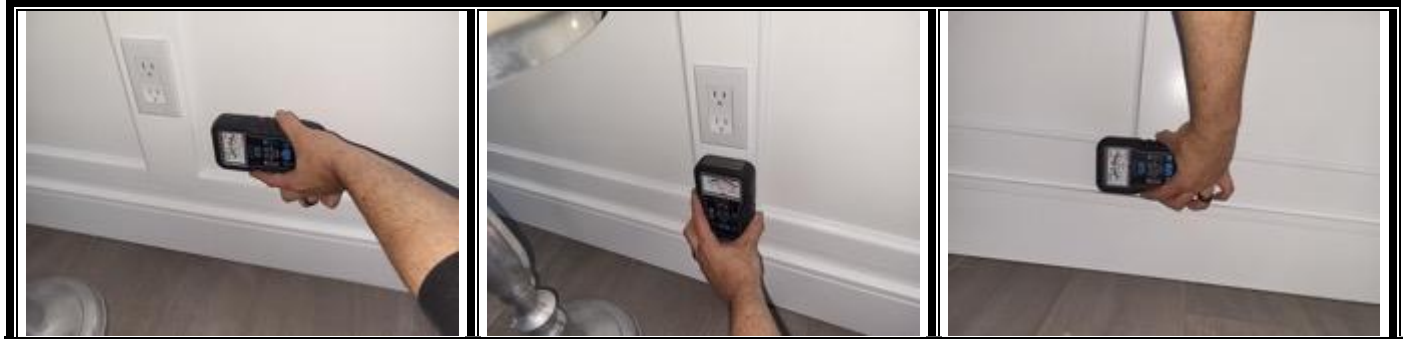
<p>There is elevated moisture on the east wood panel wall between the east windows.</p>	<p>There is elevated moisture on the east wood panel wall between the east windows.</p>	<p>There is elevated moisture on the east wood panel wall between the east windows.</p>
---	---	---

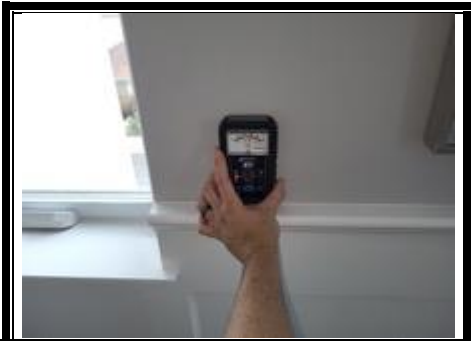
There is a spot of elevated moisture on the east drywall next to the NE window.

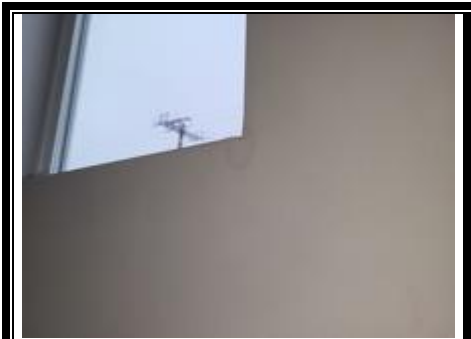
Concern #4: Bottom of the Stairs

At the bottom of the stairs, there are stains on the upper east drywall below the high east windows. The stains are present on drywall framing of the windows.

- The following areas of concern should be addressed:
 - At the bottom of the stairs- remove the stained portions of the upper east window drywall to investigate. Remove the drywall base of the stained east window.
 - In the entry- remove the stained portions of the upper east window drywall. Remove the drywall base of the stained east window.
 - Upon removal, further investigate to determine if more removal is necessary due to damage/mold growth.
 - Place full containment if mold growth is found.
 - If no mold is found, no need for further remediation or follow up testing unless specifically requested.
 - If concerned- intrusive wall cavity samples can be taken with the permission of the seller by drilling a dime-sized hole on the area/areas of concern.

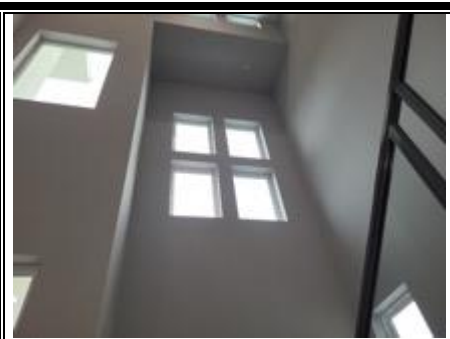
Overview image of the east high windows at the bottom of the stairs.

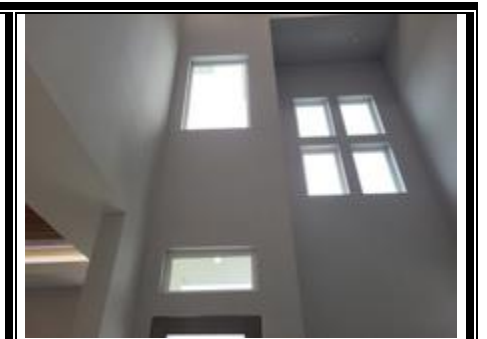
Overview image of the east high windows above the main entry door.

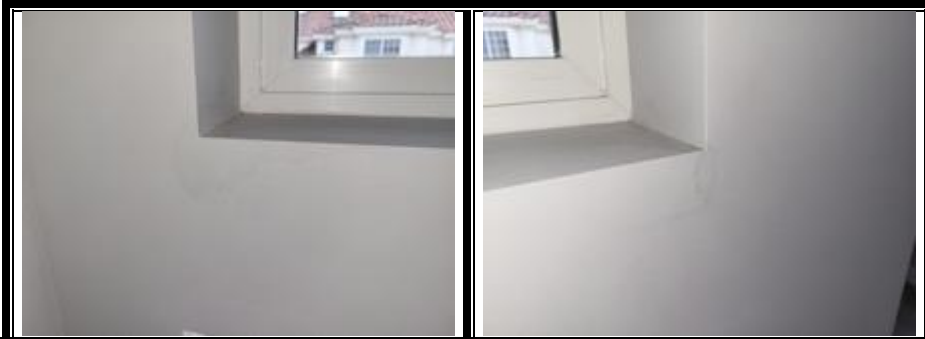
In the entry, there are stains on the upper east drywall below the high east windows. The stains are present on drywall framing of the windows.

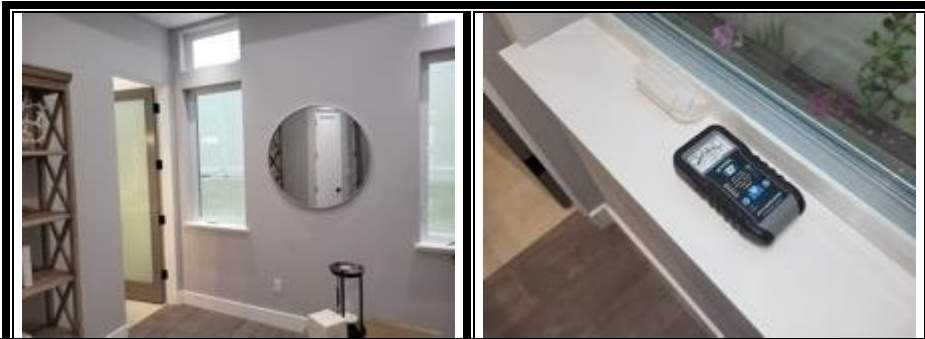
Concern #5: Office

Overview image of the west windows.

There is elevated moisture on the base of the SW window.

- The following areas of concern should be addressed:
 - Remove the base of the SW window frame.
 - Remove the west drywall below the SW window to investigate.
 - Upon removal, further investigate to determine if more removal is necessary due to damage/mold growth.
 - Place full containment if mold growth is found.

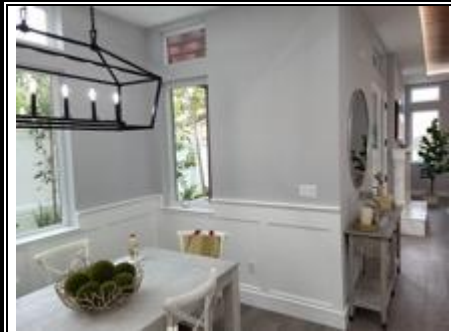
Concern #6: Dining Room

Overview image of the east window.

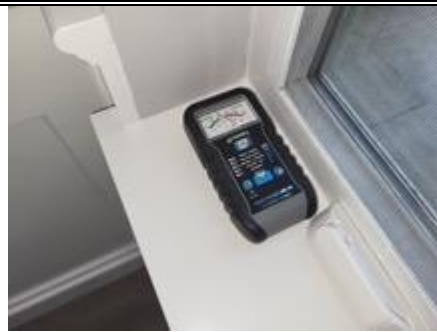
There is elevated moisture on the base of the east window.

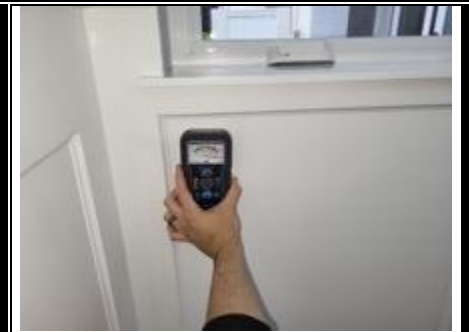
There is elevated moisture on the east wood panel wall under the east window.

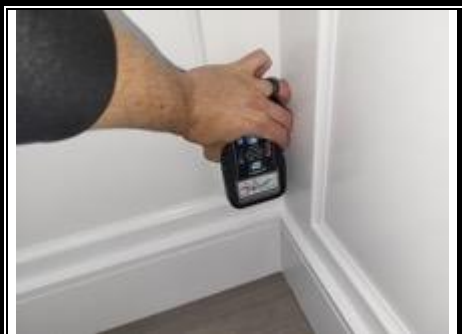
There is elevated moisture on the north wood panel wall in the NE corner.

- **Remove the north wood panel wall in the NE corner.**
 - **Upon removal, further investigate to determine if more removal is necessary due to damage/mold growth.**
