Your Inspection Report

527 Valley Dr
Crestline, CA 92325

INSPECTION DATE:
Tuesday, December 28, 2021

RE: Report No. 6893, v.2
527 Valley Dr
Crestline, CA
92325

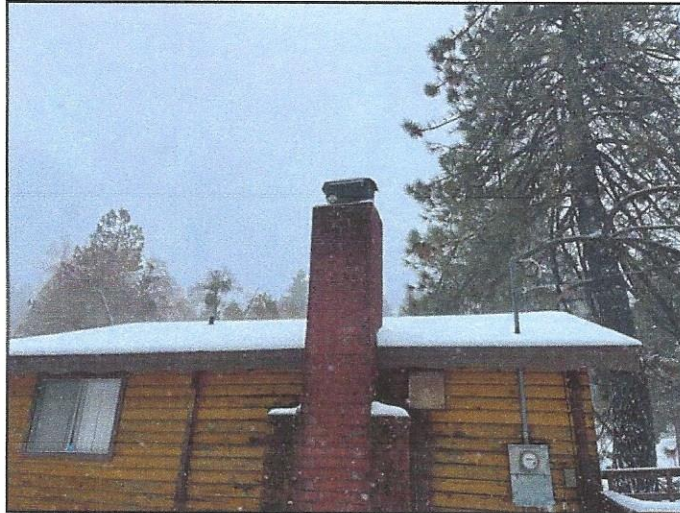
Roof inspection limited/prevented by:

- Snow

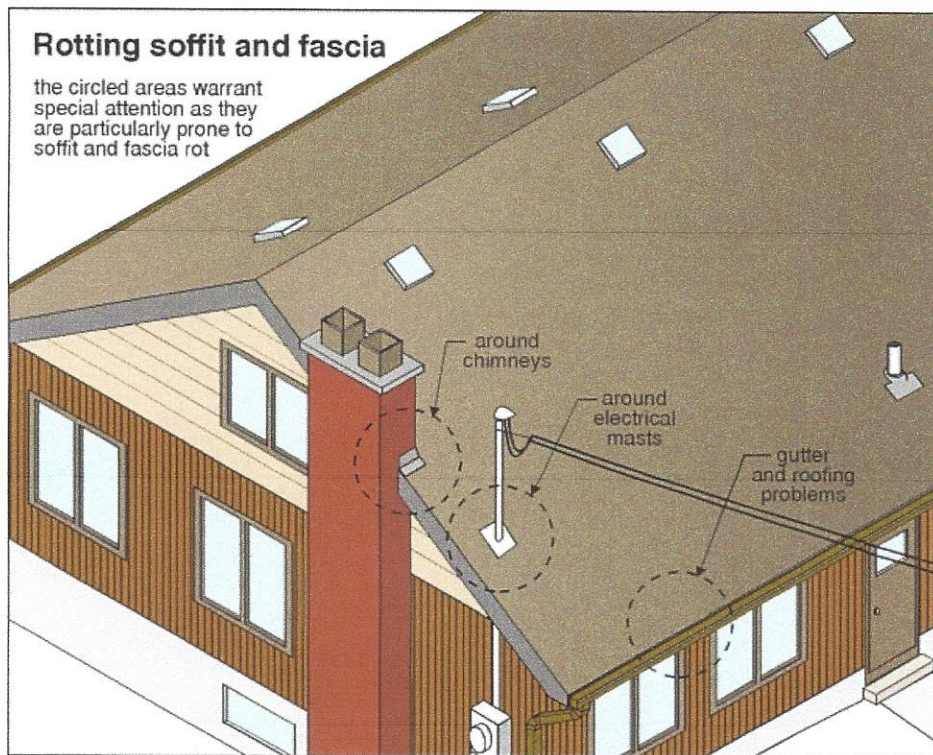
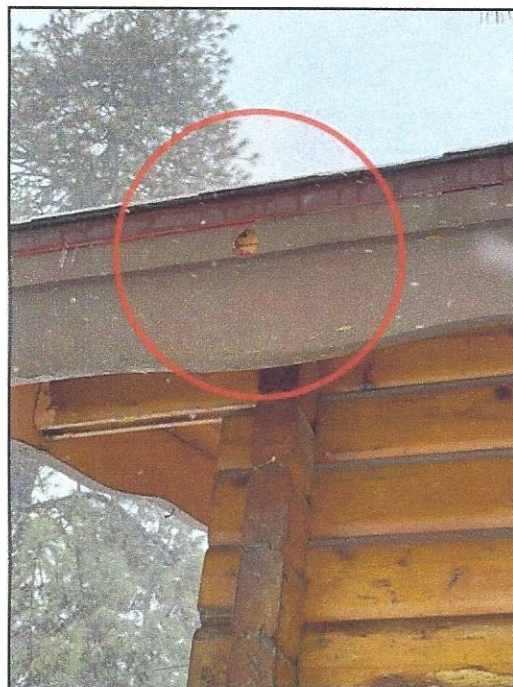
3. Condition: • [Damage](#)

Location: Right Side

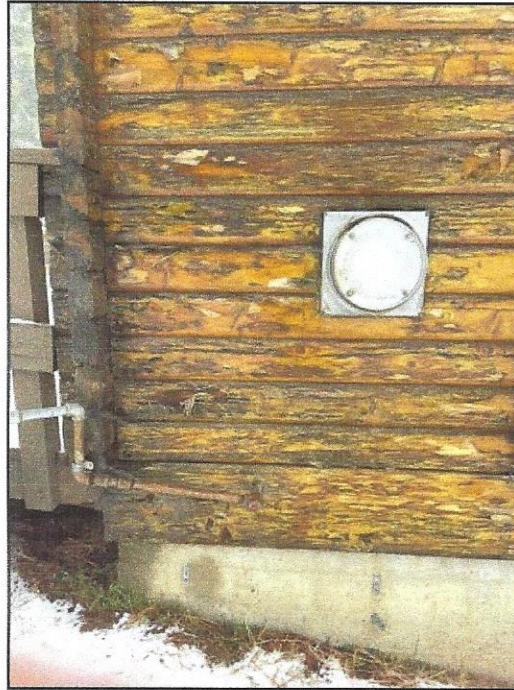
4. Condition: • Finish coat / sealant deteriorated

Location: Exterior Wall

Task: Repair

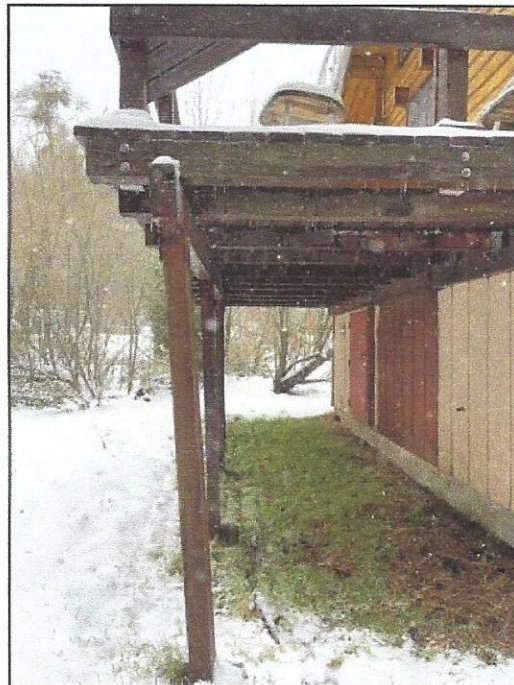
5. Condition: • [Leaning](#)

Location: Rear Exterior

Task: Repair

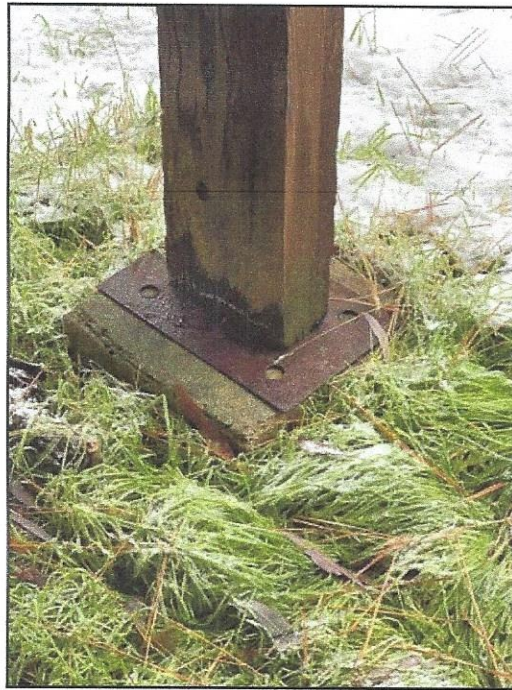
6. Condition: • Not anchored at base

Location: Rear Yard

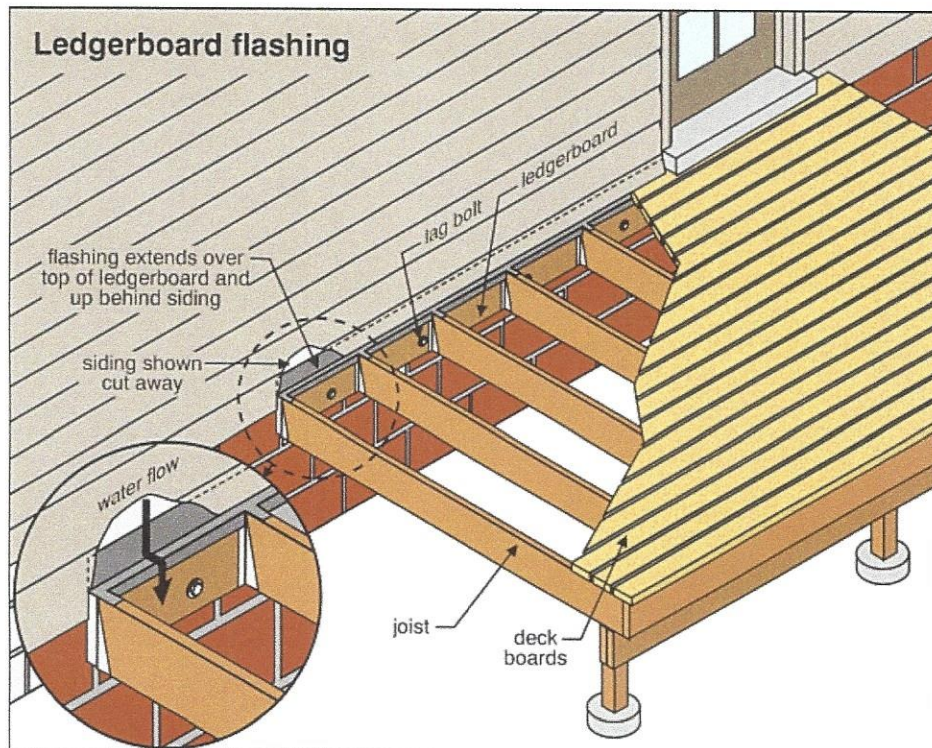
7. Condition: • [Ledgerboard problems](#)

Location: Exterior

Task: Improve

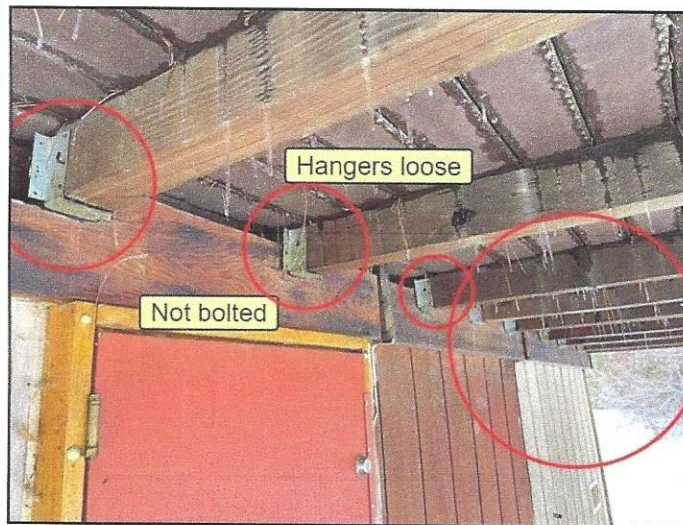
8. Condition: • [Loose](#)

Location: Front Porch

Task: Repair

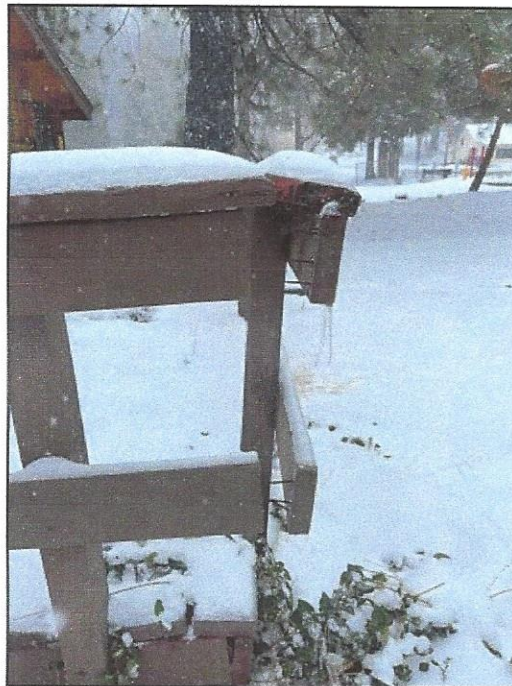
9. Condition: • [Spindles \(balusters\) climbable](#)

Task: Improve

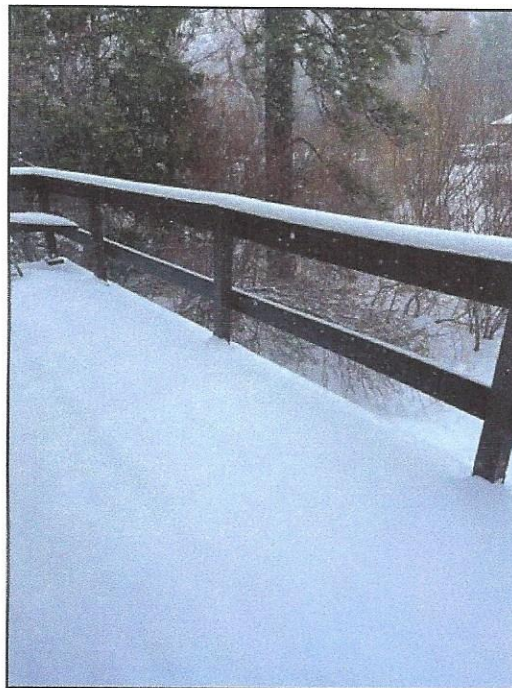
10. Condition: • [Improper slope or drainage](#)

Location: Various Yard

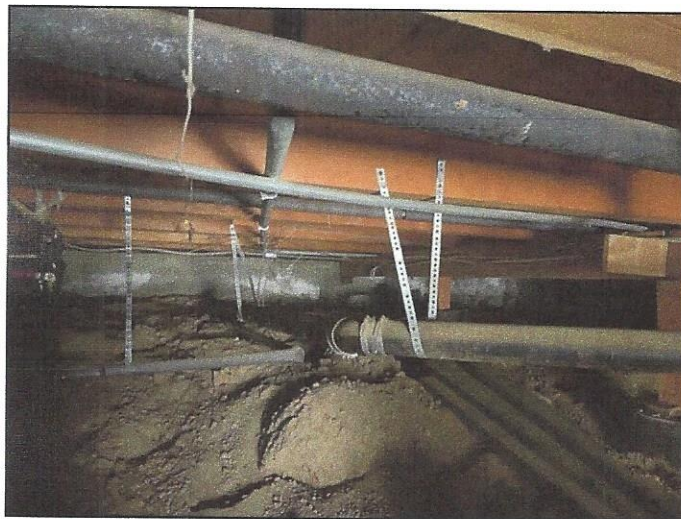
11. Condition: • Some efflorescence (salt deposit from water evaporation) found inside some areas of the foundation walls from moisture intrusion. Recommend water controls like roof gutters and down spouts to convey water min 6' from the foundation and planters that drain away from the foundation.

Location: Crawl Space

Task: Improve

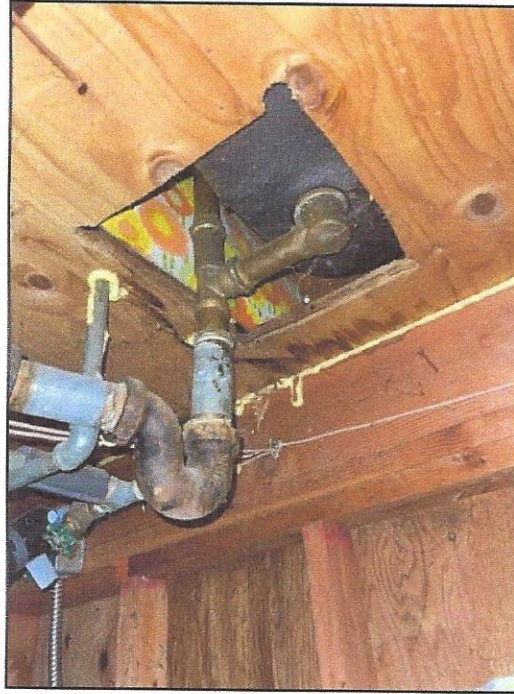
12. Condition: • Water stains

Location: Crawl Space Bathroom

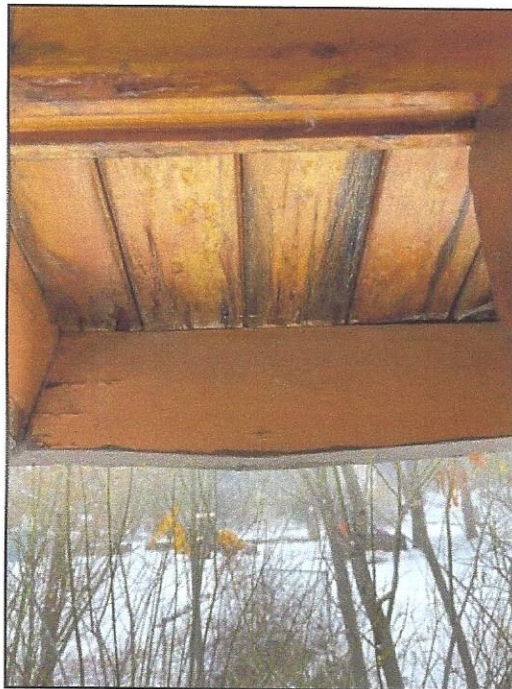
13. Condition: • [Water stains](#)

Location: Various

Task: Repair

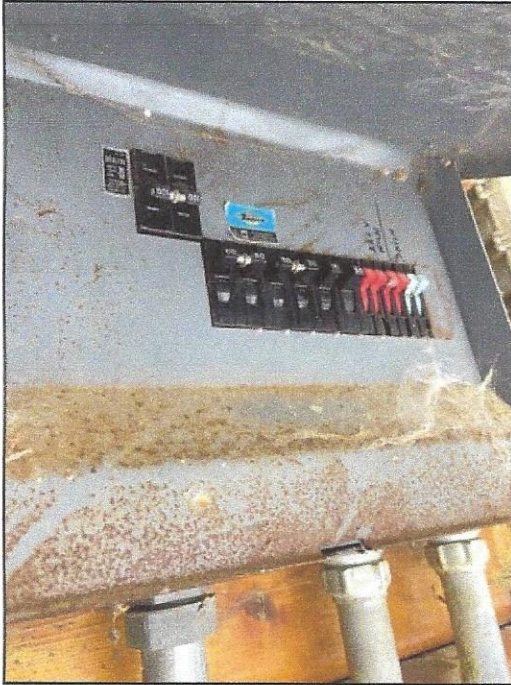
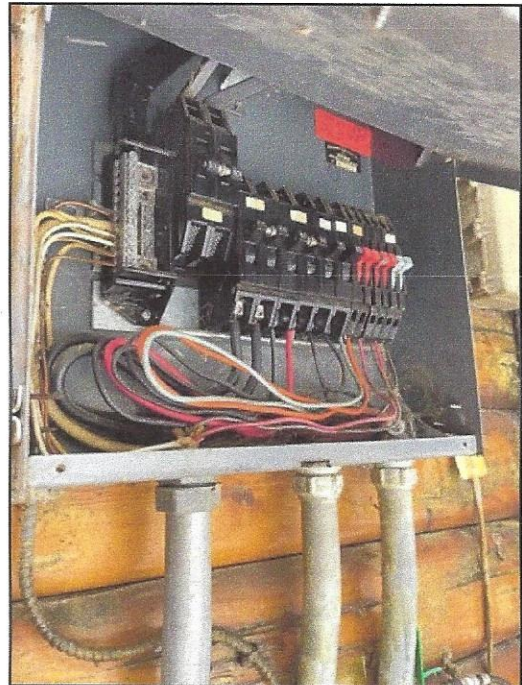
14. Condition: • [Zinsco panel may be defective.](#)

Zinsco circuit breakers are notorious for arcing and welding to the aluminum power bus.

Task: Further evaluation

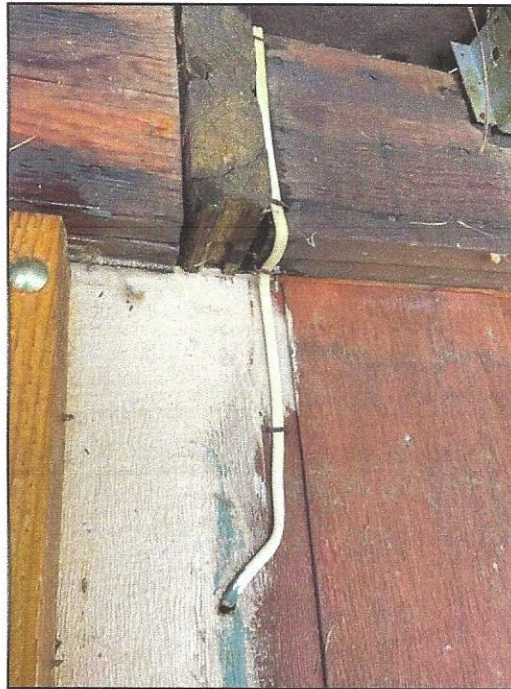
15. Condition: • [Exposed on walls or ceilings](#)

Location: Rear Exterior Wall

Task: Repair

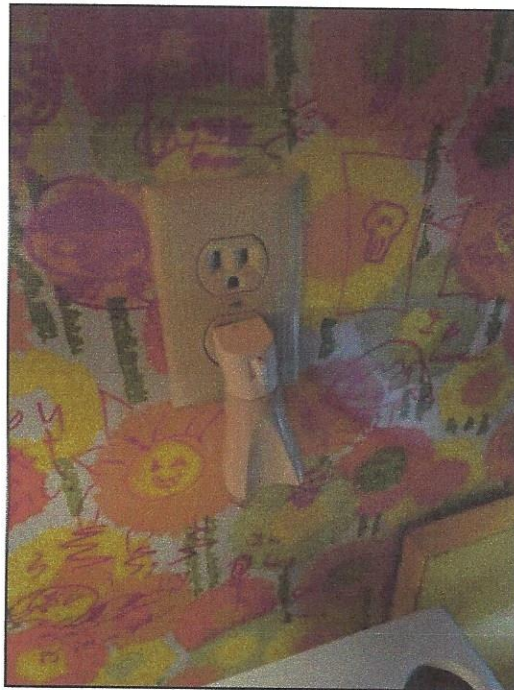
17. Condition: • GFCI/GFI needed (Ground Fault Circuit Interrupter)

Location: Bathroom

Task: Provide

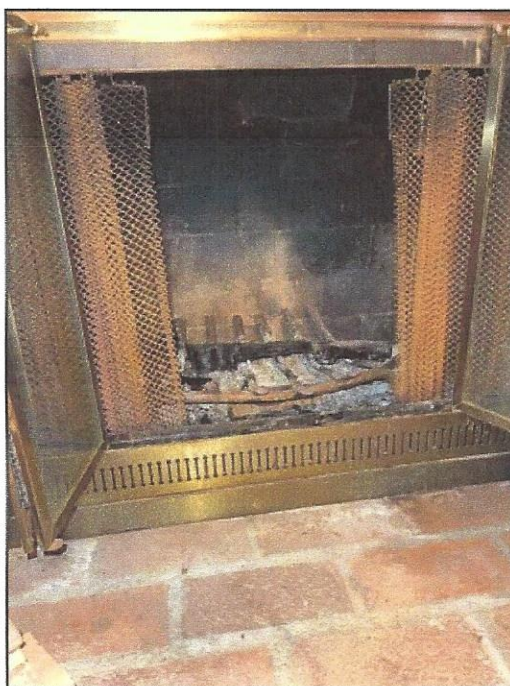
21. Condition: • [Inspect \(and/sweep if needed\) before using](#)

Location: Living Room

Task: Clean

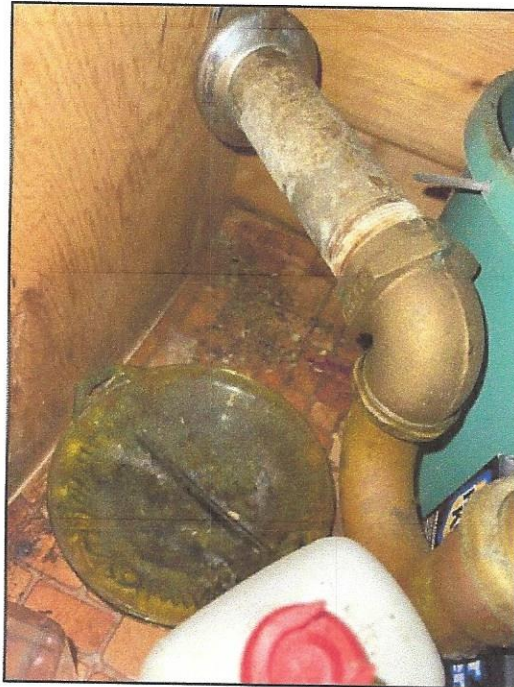
22. Condition: • May have had rodent activity

Location: Kitchen

Task: Further evaluation

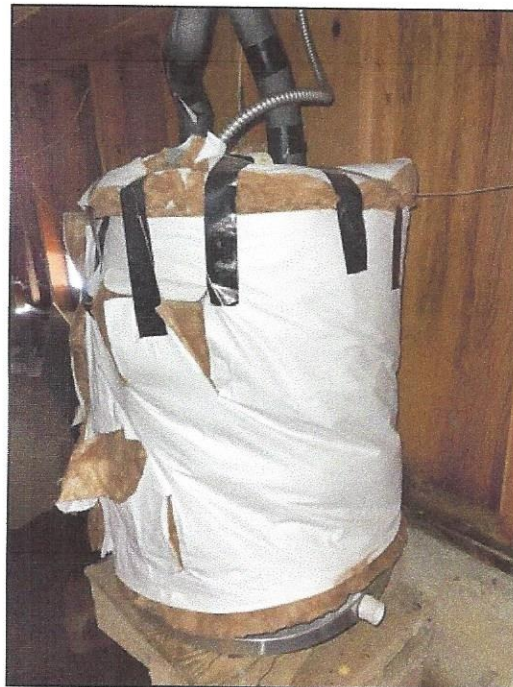
23. Condition: • Seismic Braces required

During past earthquakes, water heaters have moved or tipped over if they were not securely anchored to adjacent walls or floors. This movement has resulted in gas line or water line leaks, and electrical wiring damage. Gas line leaks and damaged electrical wiring pose health and fire hazards, and water line leaks can cause significant and costly property damage.

Two required, One placed 1/3 down from the top and one placed 4" above controls.

Location: Crawl Space

Task: Provide

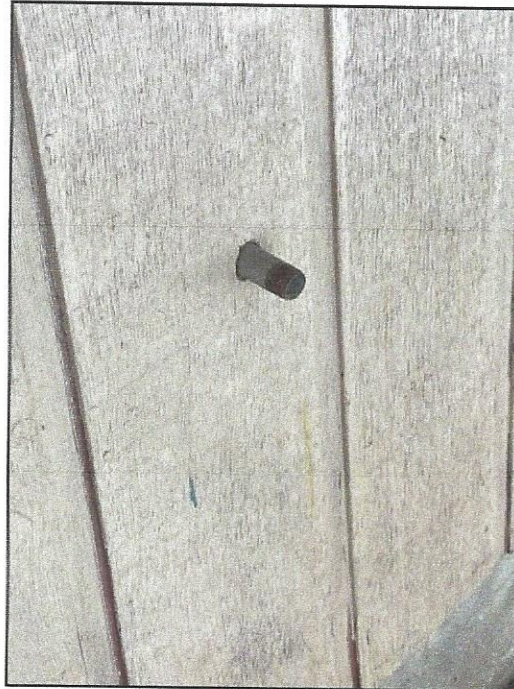
24. Condition: • [Discharge tube threaded](#)

Location: Exterior Wall

Task: Repair

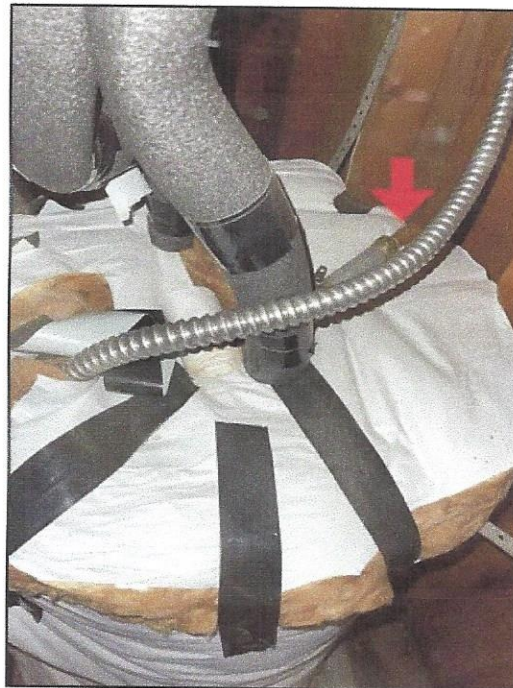
25. Condition: • Improper TPR drain material used. Material is to be the same as allowed for water distribution. (galvanized steel, hard-drawn copper) no flexible line.

Location: Crawl Space

Task: Replace

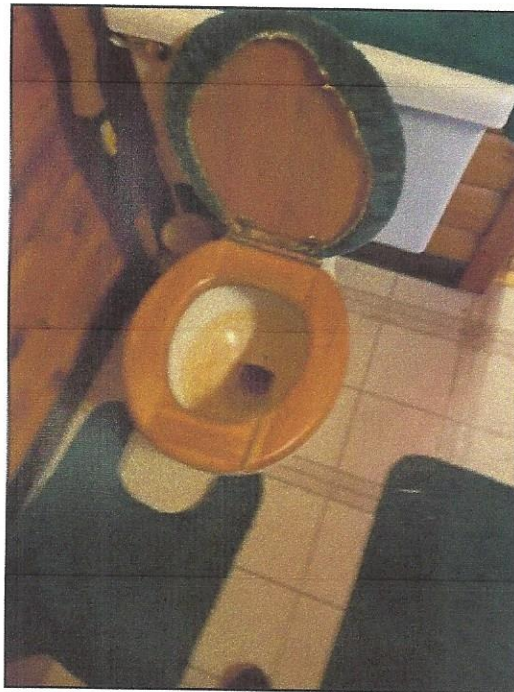
26. Condition: • Broken seat

Location: Bathroom

Task: Replace

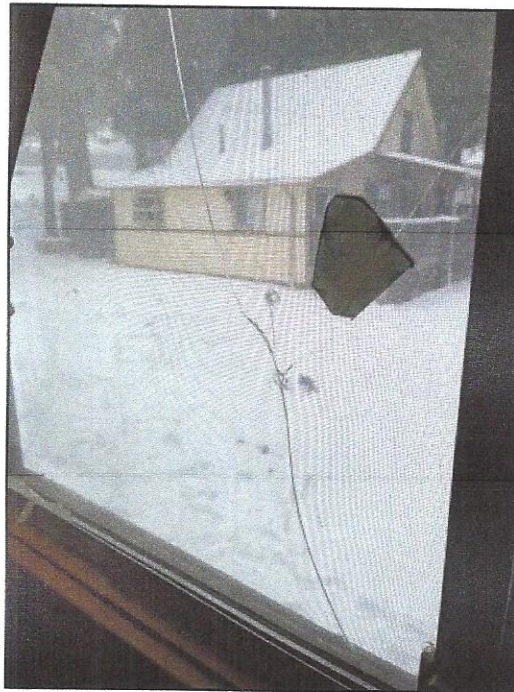
27. Condition: • [Broken](#)

Location: North Bedroom

Task: Replace

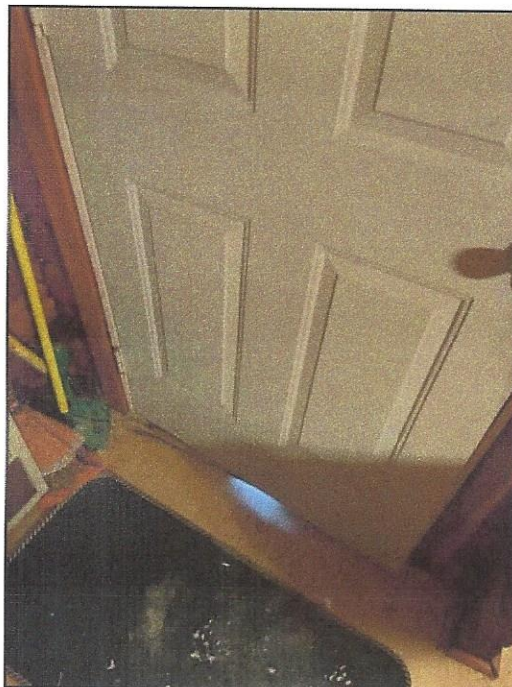
28. Condition: • [Damage](#)

Location: Front door

Task: Repair or replace
