# INSPECTION REPORT

For the Property at:  
**10675 PARAMOUNT ROAD**  
PHELAN, CA 92371

Prepared for: LILLIAN TIFFANY  
Inspection Date: Monday, June 23, 2025  
Prepared by: Scott Junk

RE: Report No. 7813  
10675 Paramount Road  
Phelan, CA  
92371

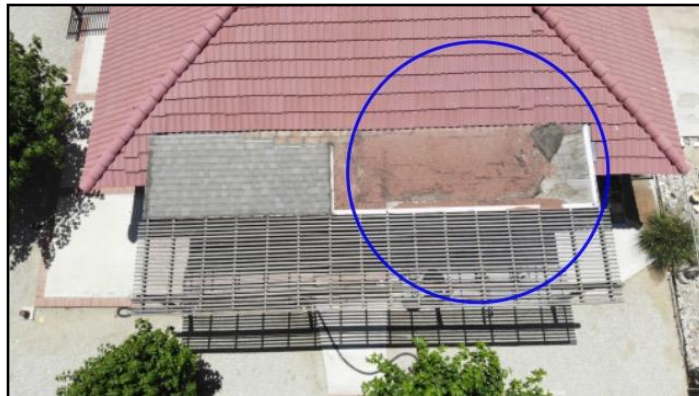
1.

**1. Condition:** • Damage

Recommend repairing or replacing the damaged roofing to prevent further damage and deterioration of the roofing structure. The roofing in this area appears to be experiencing deterioration and needs to be replaced, to prevent further deterioration.

**Implication(s):** Chance of water damage to structure, finishes and contents

**Task:** Repair or Replace

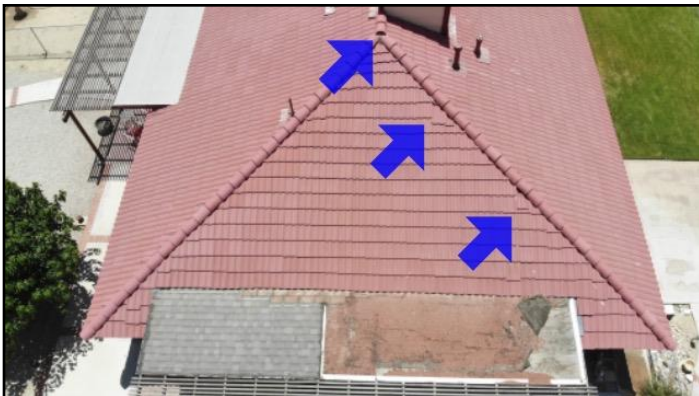
2.

**2. Condition:** • Missing, loose or broken pieces

Recommend repairing or replacing loose, broken, or missing roofing tiles to prevent wood rot, insect intrusion, future leaks and to provide increased integrity to the roofing system. There was no evidence or implications of roof leaks and water damage in the attic area or the ceilings at the time of the home inspection.

**Implication(s):** Chance of water damage to structure, finishes and contents | Damage or physical injury due to falling materials

**Task:** Repair

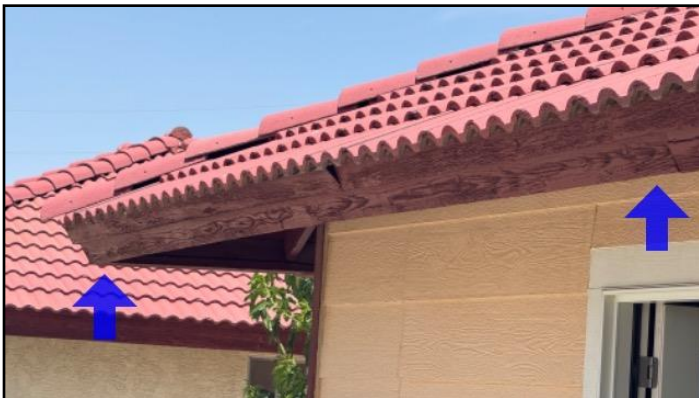
5.

**3. Condition:** • Soffit and Trim Rot or Insect Damage

Recommend further evaluation of the exterior trim, walls and fascia to determine the cause of the damage. The deterioration may be caused by insect damage or fungal rot.

**Location:** Various Areas of The Property

**Task:** Repair or Replace Request for Further Evaluation

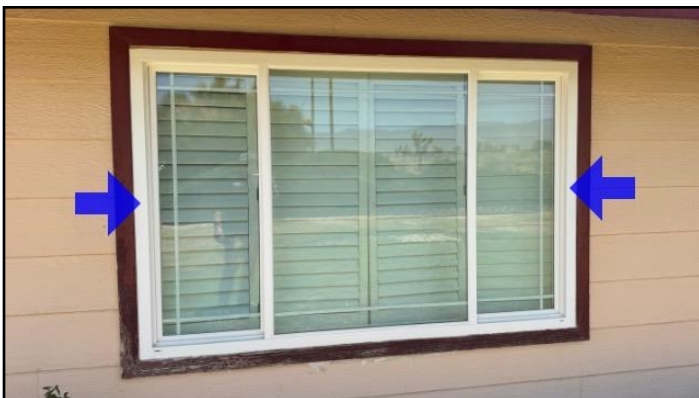
25.

### **5. Condition:** • Missing

Recommend installing screens on windows where they are missing or damaged to improve full functionality of the windows and improve the energy efficiency of the home.

**Implication(s):** Increased heating and cooling costs | Reduced comfort

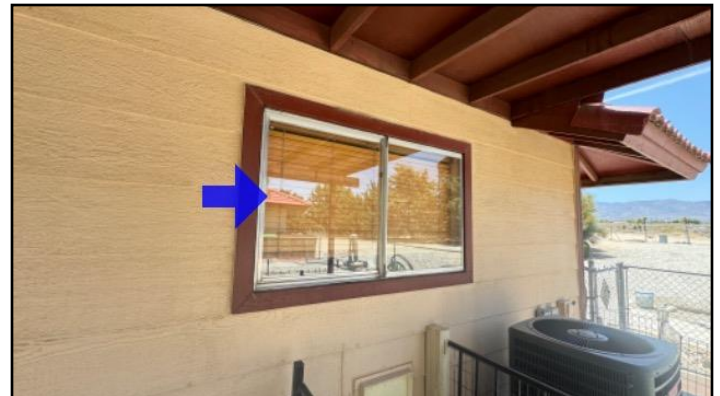
28.

## 6. Condition: • Damaged

Recommend replacing the damaged screen on the exterior of the property, to improve the energy efficiency of the home.

**Task:** Repair or Replace

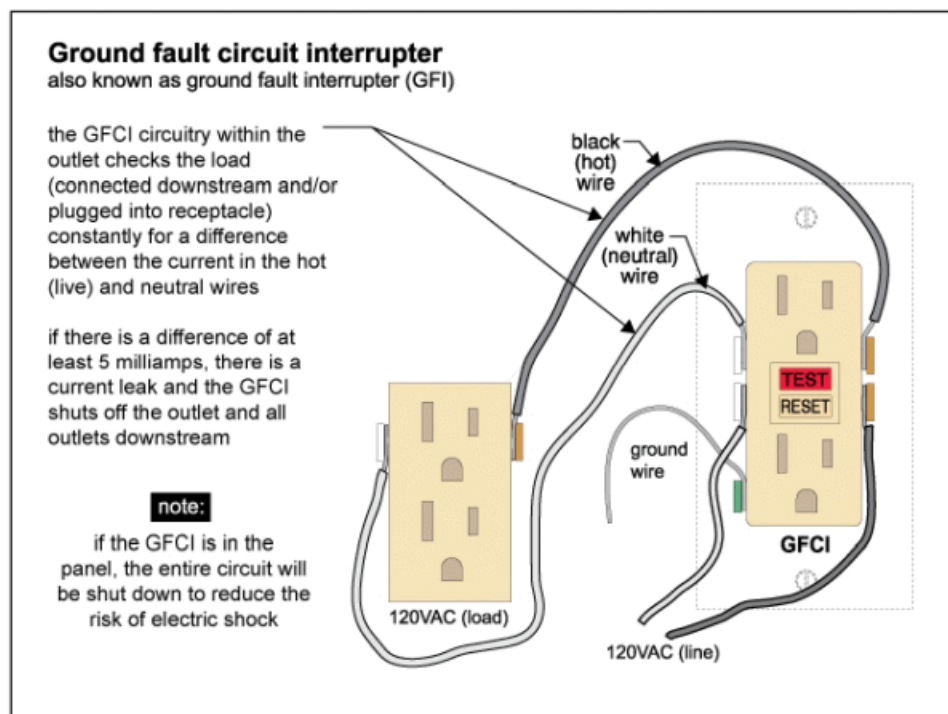
60.

**8. Condition:** • GFCI/GFI needed (Ground Fault Circuit Interrupter)

Recommend installing GFCI in garages, kitchen, bathrooms, exterior walls, and garbage disposal area under the sink. Unless the outlet is connected to a GFCI down stream. Master GFCI outlets should be labeled "Master GFCI", and all outlets connected should be labeled AFGCI or GFCI Protected. labeled the outlets that need a GFCI with a blue marker GFI.

**Location:** Bathroom in Laundry Area

**Task:** Install

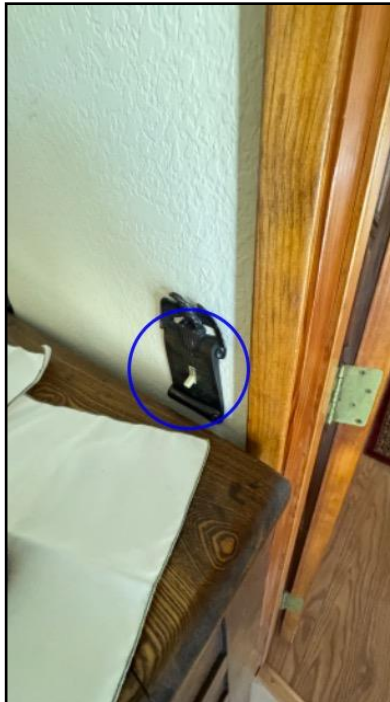
64.

**DISTRIBUTION SYSTEM \ Switches****9. Condition:** • Inoperable

Recommend correcting any inoperable light switch to restore the full function of the light switch and to improve the electrical system in this area of the home. This switch was fully inoperable at the time of the home inspection.

**Implication(s):** Inadequate lighting

**Location:** Living Room

**Task:** Repair Correct

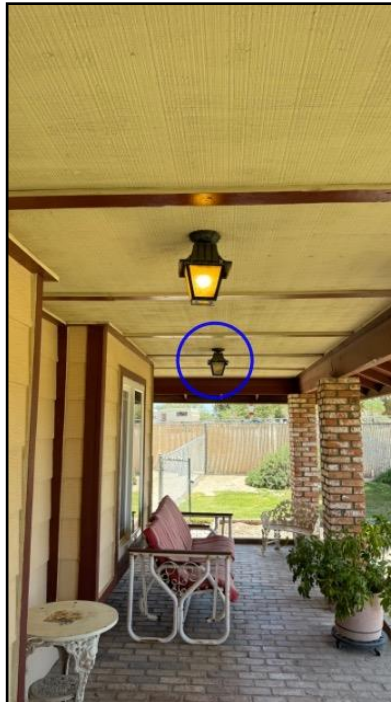
65.

### **10. Condition:** • Inoperative

Recommend repairing or replacing the inoperable light to restore the full operability of the electrical system. Most inoperable lights are due to burnt out bulbs, further evaluation may be necessary if changing the bulb and batteries does not fix issue.

**Implication(s):** Inadequate lighting

**Task:** Repair or Replace

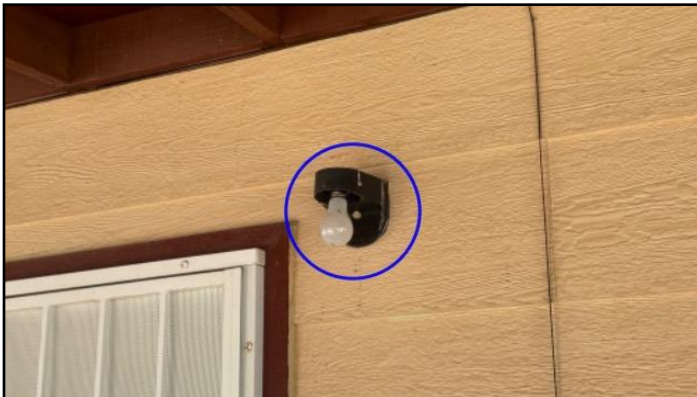
66.

## 11. Condition: • Missing Covers

Recommend installing fixture covers, to prevent disruption of the electrical system, in the event that a bulb would get broken. Light fixture cover are designed to improve the safety of the light fixture and the electrical system around the property.

**Location:** Various Areas of The Property

**Task:** Repair or Replace

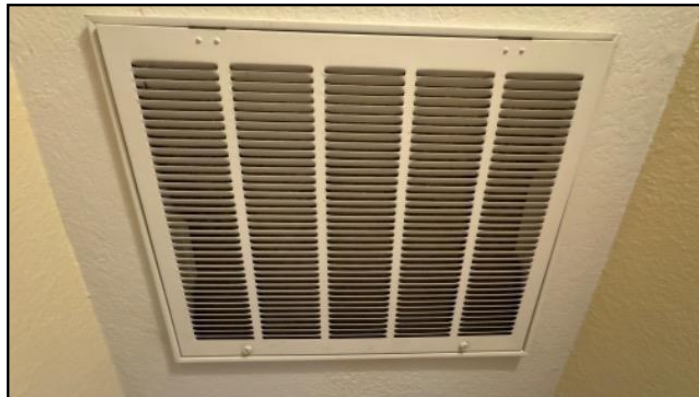
77.

**Location:** Ceiling Hall

**Task:** Replace

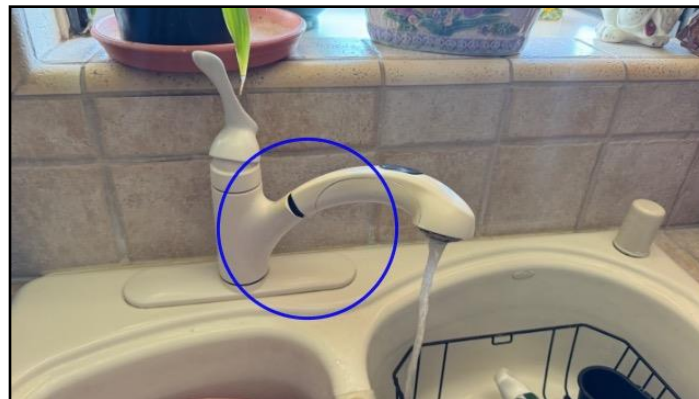
94.

**Location:** Kitchen

**Task:** Repair or Replace

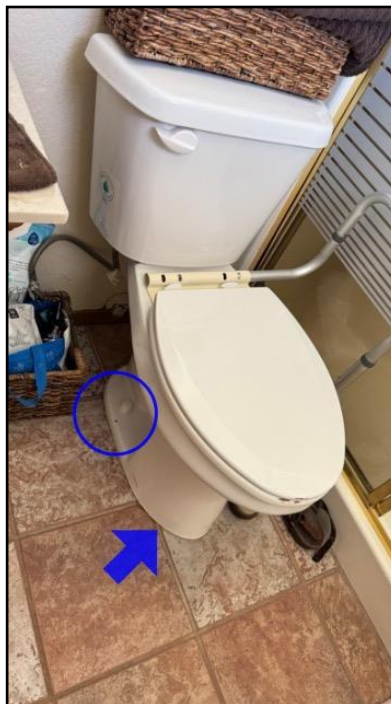
95.

## Loose toilet

**Task:** Repair Improve Seal

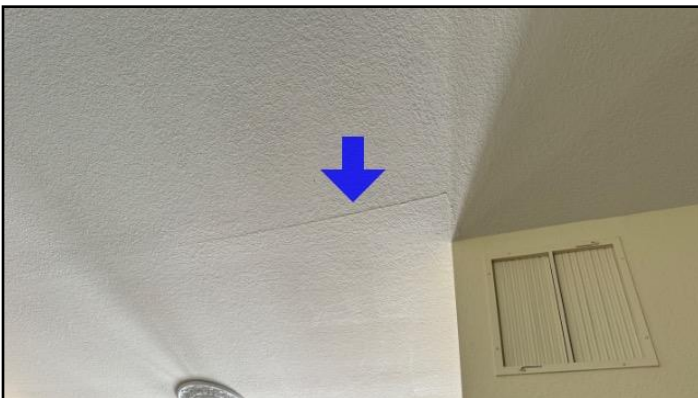
96.

**Location:** Ceiling Family Room

**Task:** Repair

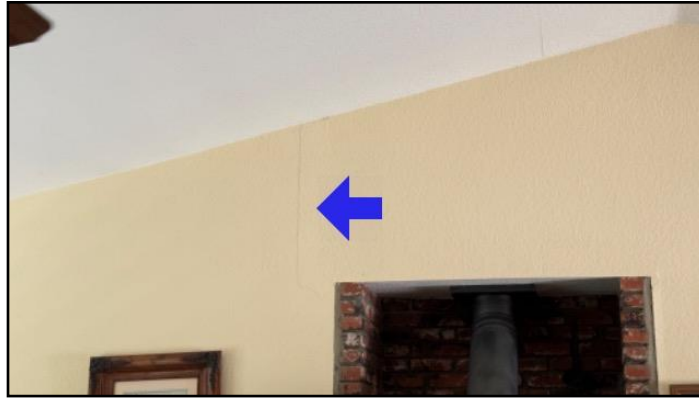
98.

**Location:** Living Room

**Task:** Repair Seal

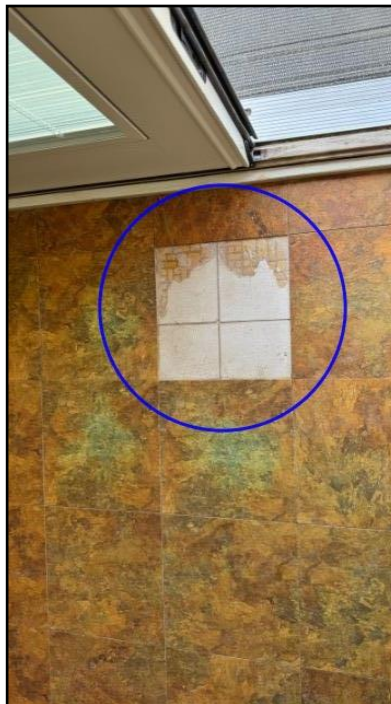
99.

**Location:** Bonus room

**Task:** Repair or Replace

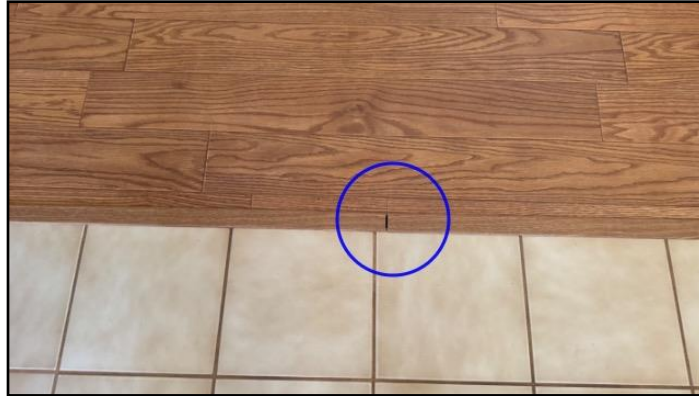
100.

**Location:** Various Areas of The Property

**Task:** Repair or Replace

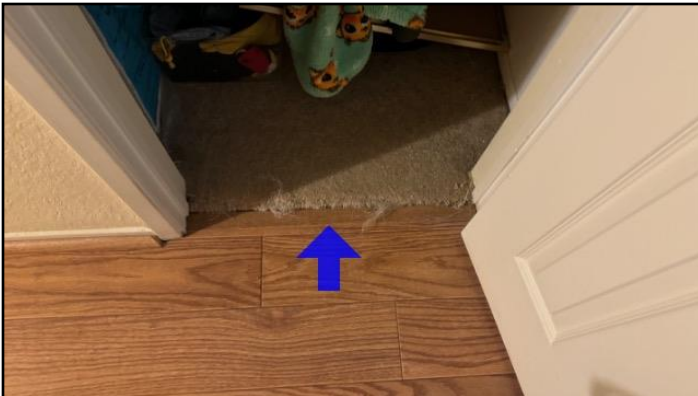
101.

**Location:** Various Areas of The Property

**Task:** Repair or Replace

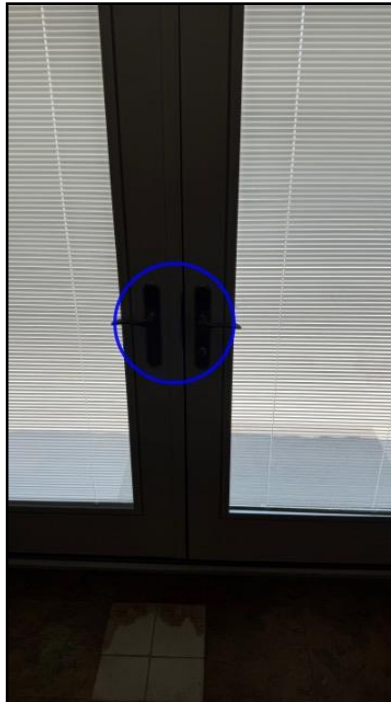
103.

**Location:** Bonus Room French Doors

**Task:** Repair or replace

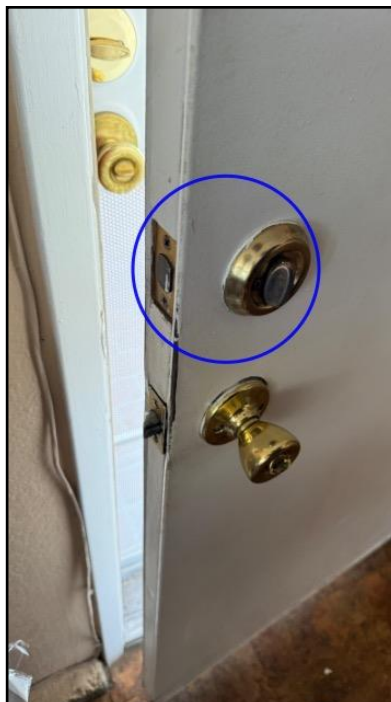
104.

**25. Condition:** • Difficult To Operate

**Location:** Front Entry

**Task:** Repair or Replace

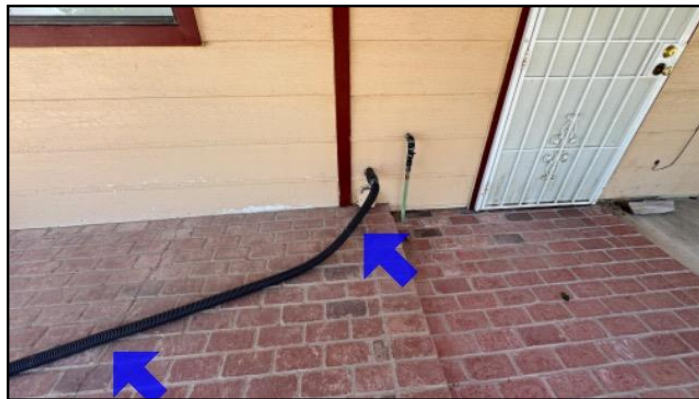
105.

**Location:** Left Side

**Task:** Replace with The Correct Type of Material Remove HIGH IMPORTANCE
