# WOOD DESTROYING PESTS AND ORGANISMS INSPECTION REPORT

| BUILDING NO.<br><b>5197</b> | STREET, CITY, STATE, ZIP<br><b>E. Hamilton Ave., Fresno CA 93727</b> | Date of Inspection<br><b>2/25/2026</b> | No. of Pages<br><b>8</b> |

| General Description:<br>Two story, framed, stucco sided residence, furnished and occupied, attached garage, comp shingle roof on a concrete slab. | Inspection Tag Posted:<br>Garage |

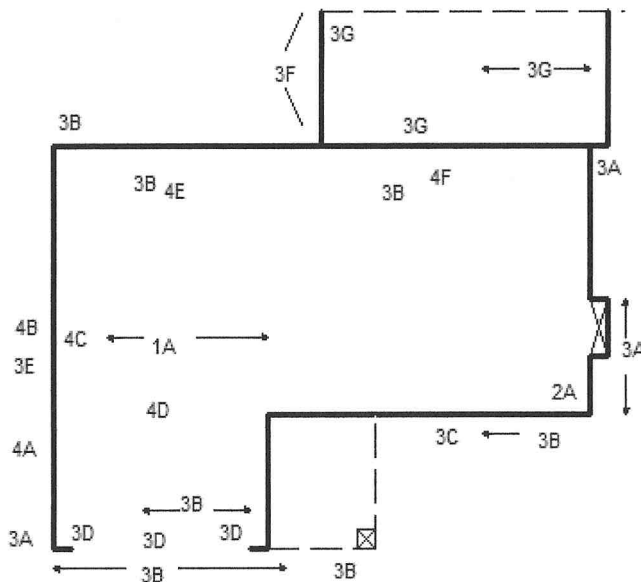
Evidence of subterranean termites noted at the head wall of garage as indicated on the diagram.

Evidence of drywood termites noted in the south wall of living room as indicated on the diagram.

Fungus infection and damage noted to the 2x8 barge rafters as indicated on the diagram. Condition appears to be due to exposure to the elements.

Fungus infection and damage noted to the 2x8 fascia boards as indicated on the diagram. Condition appears to be due to exposure to the elements.

Fungus infection and damage noted to the 2x8 window trim as indicated on the diagram. Condition appears to be due to exposure to the elements.

Fungus infection and damage noted to the main garage door jams as indicated on the diagram. Condition appears to be due to exposure to the elements.

Fungus infection and damage noted to the pedestrian garage door as indicated on the diagram. Condition appears to be due to exposure to the elements.

Fungus infection and damage noted to the 2x10 fascia board as indicated on the diagram. Condition appears to be due to exposure to the elements.

Fungus infection and damage noted to the patio roof sheathing as indicated on the diagram. Condition appears to be due to roof cover leakage.

Loose and/or missing stucco noted at areas as indicated on the diagram.

Water damage noted to the water heater closet door as indicated on the diagram. This condition appears to be due to exposure to the elements.

Water damage noted to the shhetrock in water heater closet as indicated on the diagram. This condition appears to be due to plumbing leak.

Water damage noted to the kitchen sink cabinet side wall as indicated on the diagram. This condition appears to be due to past leaks.

Drill through the concrete slab along the interior wall of the infestation and all concrete slabs abutting the exterior foundation and pressure treat the soil for the control measure of subterranean termites. Treat accessible tub voids and trench and treat along the exterior foundation. Mister Sprayman assumes no responsibility for damage to hidden pipes under concrete.

Vacate premises and seal the structure. Fumigate with a lethal gas overnight for the extermination of all drywood termite infestations. Remove seals and air out building ready for occupancy. Remove or cover accessible evidence of infestations. Mister Sprayman Pest Control will not be liable for damage to plants, paint, roofs, or TV antennae. The fumigation cannot be done in strong winds or rain, and will be rescheduled if there is inclement weather.

Remove and replace the damaged portions as needed.

Remove and replace the door.

Remove and replace the damaged fascia board.

Remove and replace the damaged roof sheathing as needed.

Owner/Agent to contact a licensed roofer to replace roof covering.

Patch stucco to a reasonable match.

Repair sheetrock as needed.

Owner/Agent to contact a licensed plumber to repair leak.

Repair as needed.
