June 24, 2021
17-2338-3

Subject: Second Updated Geotechnical and
Engineering Geology Investigation
Remedial Slope Repair and Proposed Swimming Pool
40 Avenida Corona
Rancho Palos Verdes, California

Update Geotechnical Report

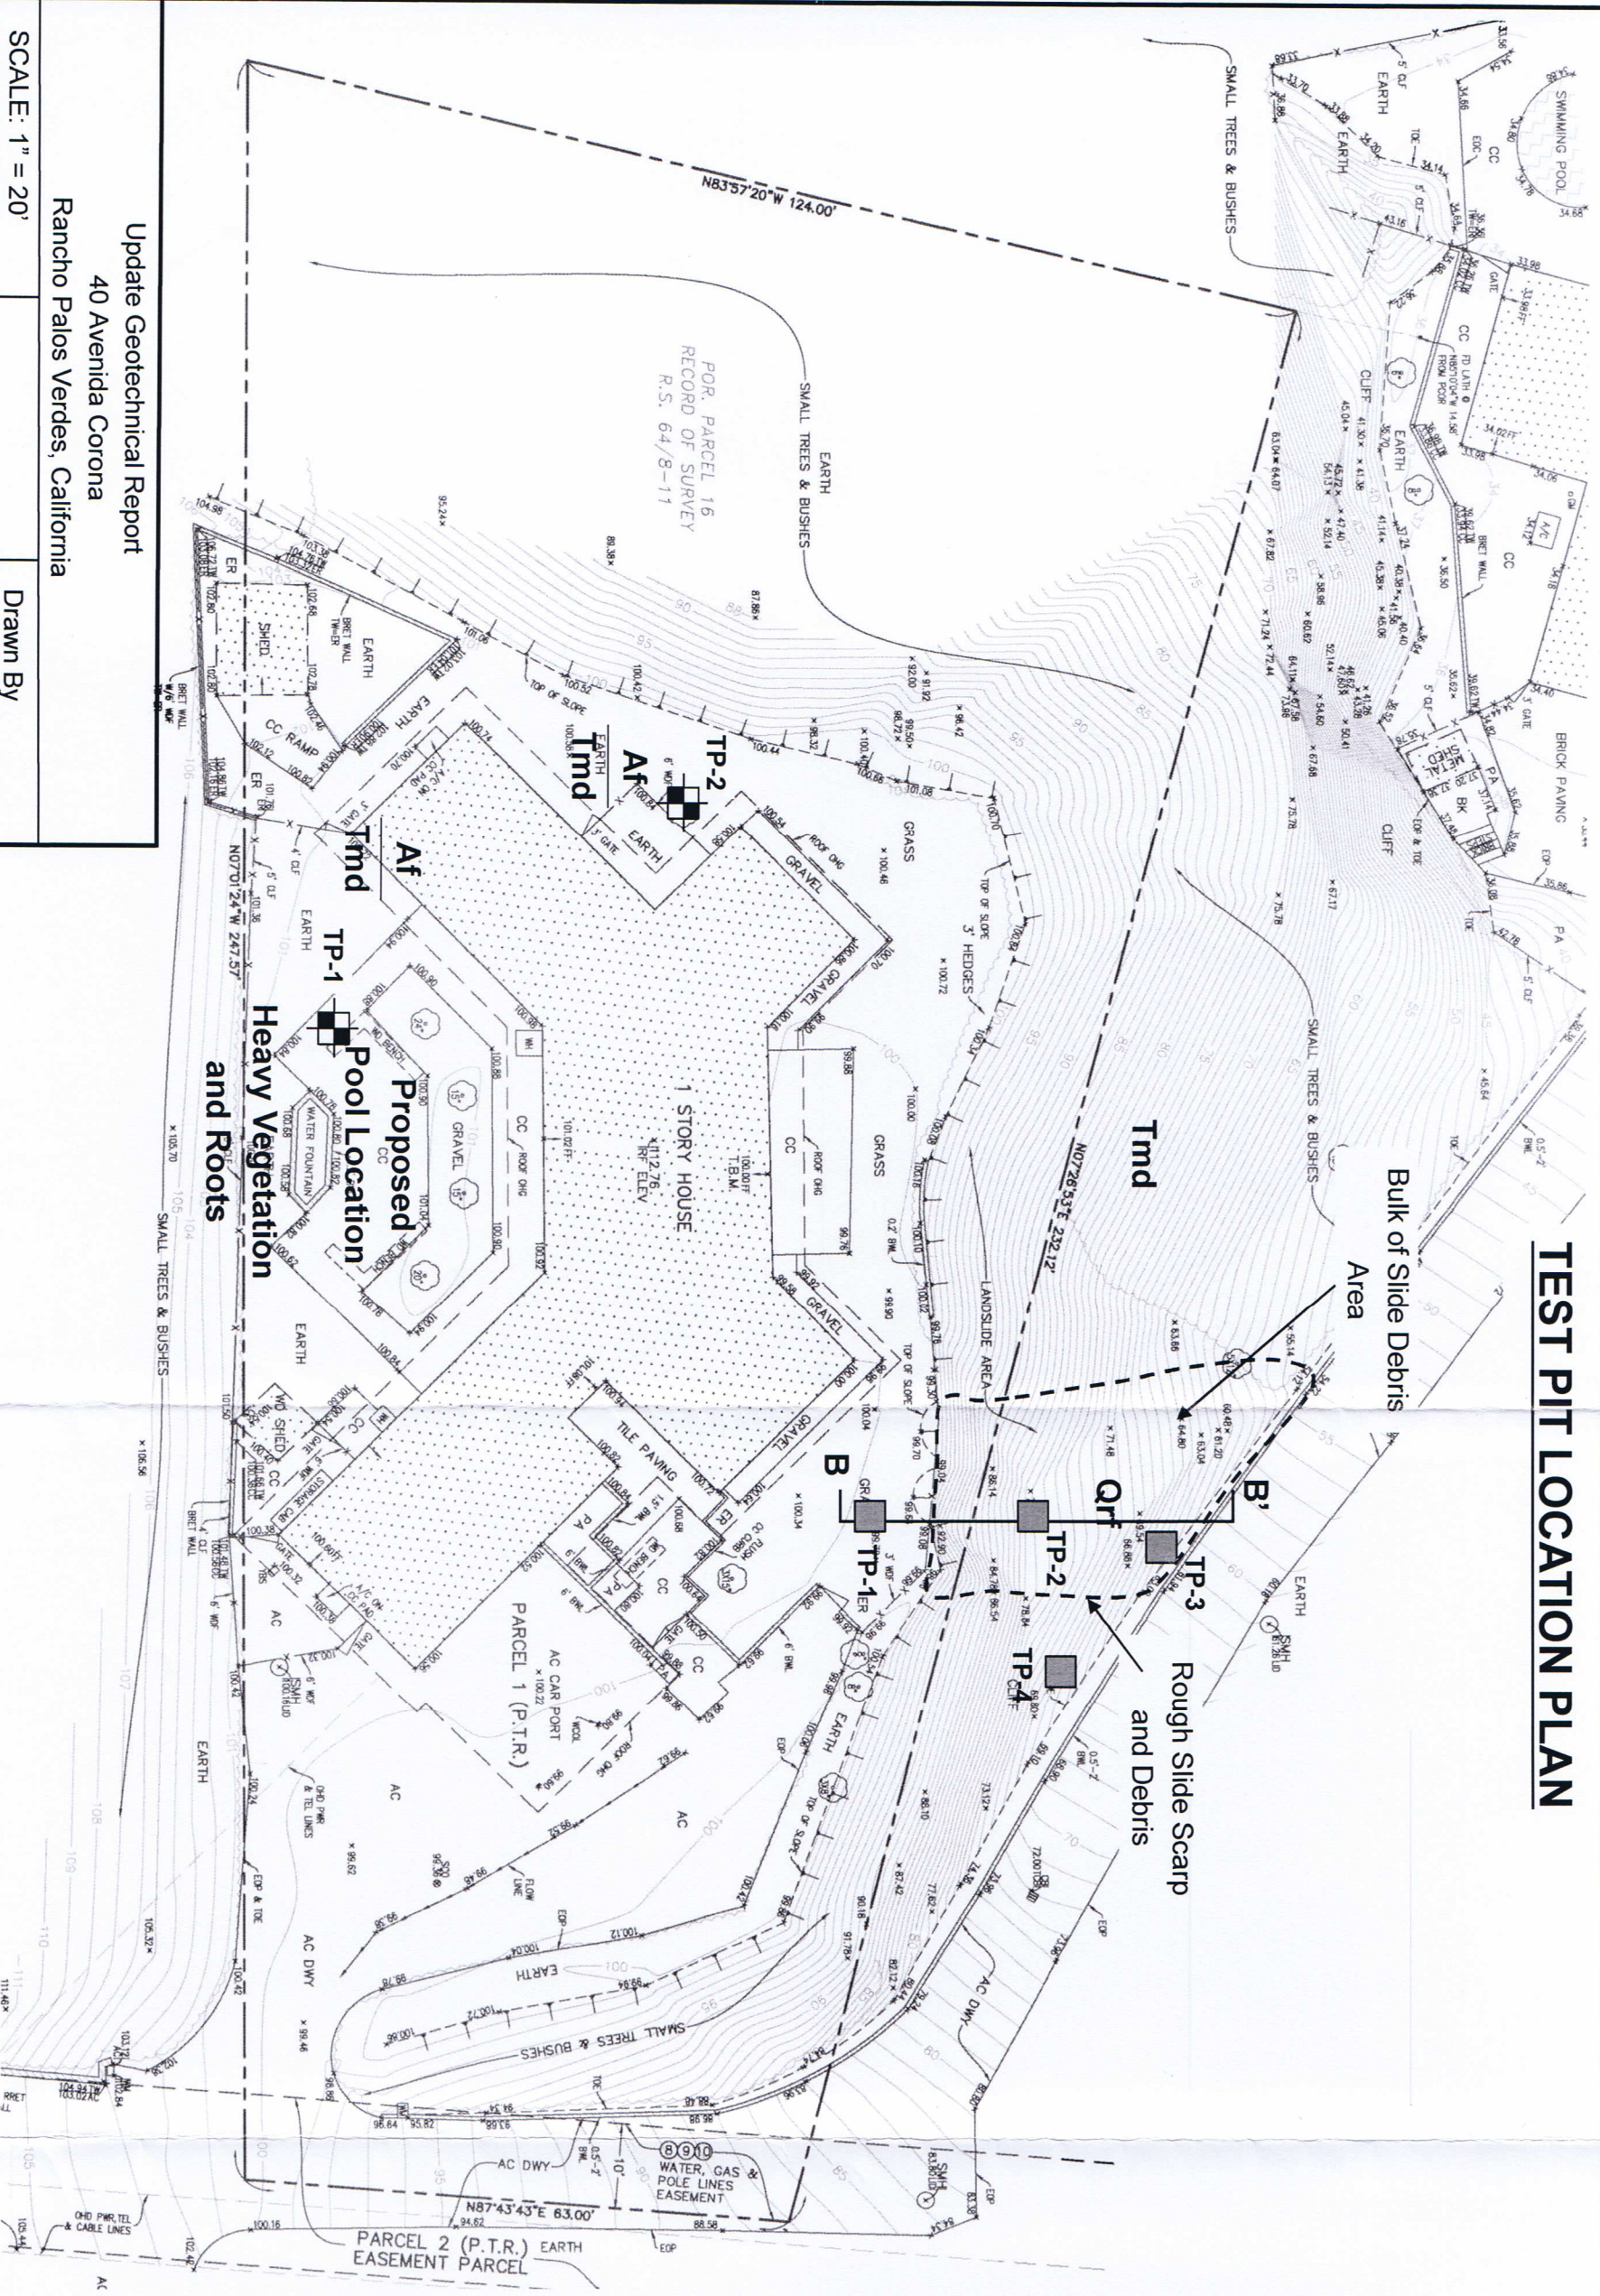
PLATE A-1

On May 12, 2021, this firm hand dug two (2) test pits which supplement the four as shown on Plate A-1. (enclosed). Test Pit TP-1 was excavated where this firm believed that from geotechnical and geological standpoints was the area best suited for pool placement (Plate A-1). Test Pit TP-2 was located to provide information regarding depth of fill on the existing pad. Both pits refused hand tools at about one and one-half to two-feet owing to the presence of hard diabasic bedrock within the Miocene-aged Altamira Shale Member of the Monterey Formation (see attached Logs of Test Pits). The rock, where observed, consists of brown to reddish brown diabase, which is an extruded igneous rock common to the lower Monterey Formation (of which the Altamira Shale is part). For reference, it is generally similar to basaltic rock.

In essence the pool site best suited for construction of a swimming pool is shown on Plate A-1. That is in the backyard of the residence away from the slope that has been subject to rockslides, near the east-facing slope and an existing planter, just south of the HAI Test Pit TP-1. Based on this and previous HAI investigations, bedrock adequate for foundation is about 1.5 to 3 feet below present ground surface.

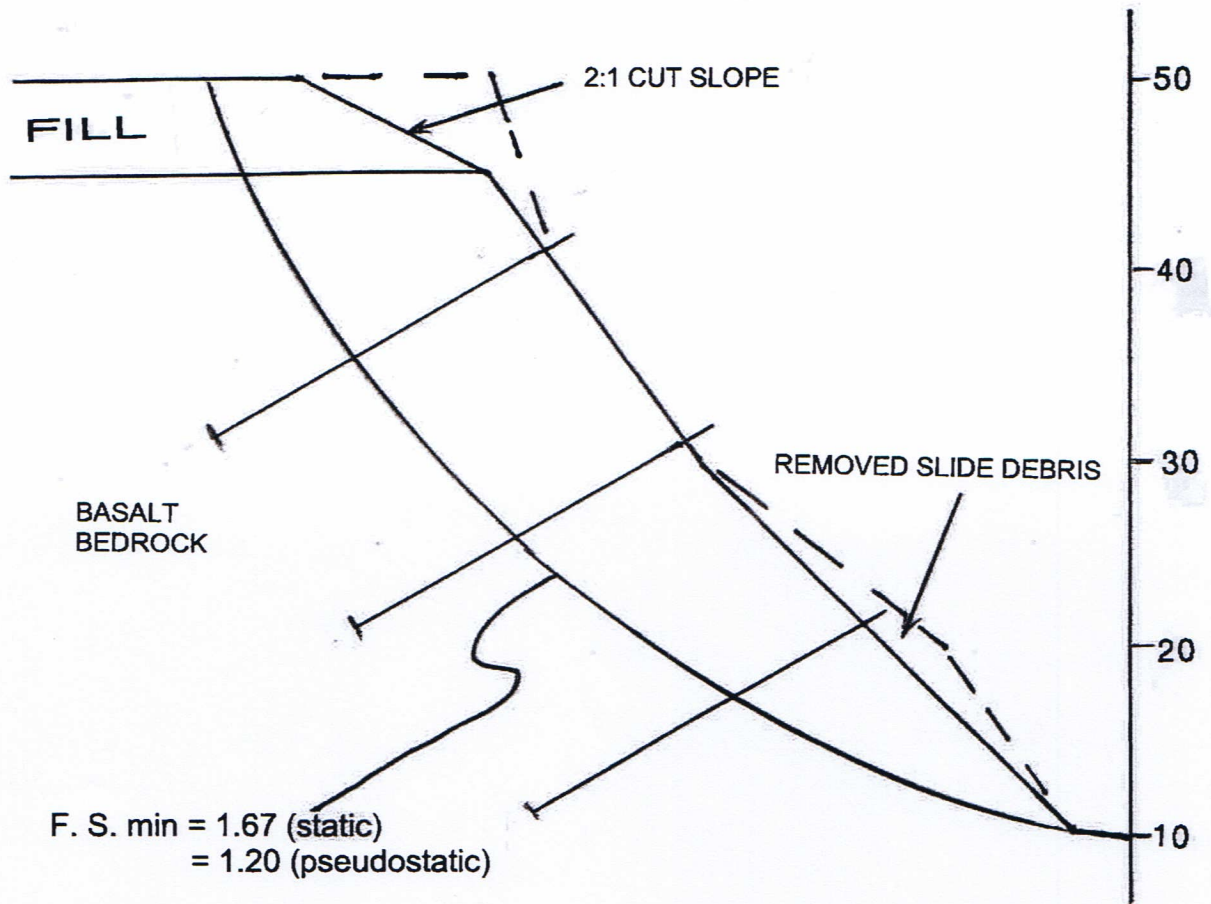
Plate A-3

The use of nails/tiebacks with chain link and gunite are still the recommended products tor stabilizing the bedrock surface remaining after the 1995 rock fall area. The possible arrangement of repairs, with and without a retaining wall at the toe, is shown on Plates A-3 and A-4. The use of the Tecco System for similar project has been approved for use by the City of Los Angeles.

The preliminary design is for bolts to be installed is 10 feet on center, angled 30 degrees from the horizontal, and 20 feet long. For design purposes, the following may be used for the basalt bedrock:
