Aldis Enterprises

Property Inspection Report

15 Dream Lane, Cohasset, CA 95973
Inspection prepared for: Chad Rothe
Date of Inspection: 1/6/2022 Time: 9AM
Age of Home: 1980(?) Size: 1,400 sqft
Weather: Cool

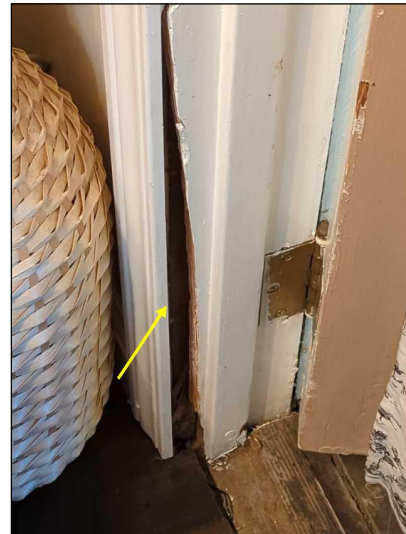
4. Interior Doors

- General maintenance/repairs needed.
- Damaged door jamb noted at left side bedroom.

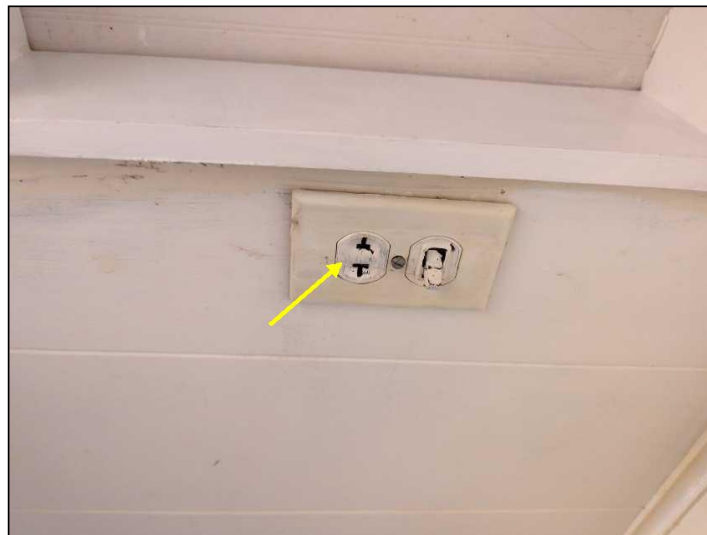
5. Electrical

- Accessible interior electrical tested good at inspection.
- Loose switch noted at left side bedroom.
- A couple old 2-wire outlets observed, indicating no equipment ground.
- Current safety standards call for bedroom and living area electrical circuits to be **AFCI** protected. Though not required for this home at the time of construction, it is worth considering this safety upgrade to the home electrical system, and may be required at such time of any major remodeling/addition work on the home involving these electrical circuits.

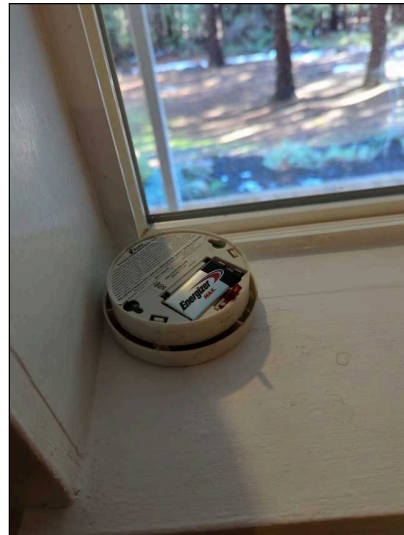
6. Smoke/CO Detectors

Interior Areas		
Page 6 Item: 6	Smoke/CO Detectors	<ul style="list-style-type: none"> • Detached/damaged alarm noted at left side bedroom, needs to be replaced. • Recommend adding carbon monoxide alarm at master bedroom near the door, and at hallway outside the left side bedroom.
Bathroom		
Page 10 Item: 3	GFCI Protection	<ul style="list-style-type: none"> • No GFCI protection detected at guest bath. Recommend adding GFCI protection as needed for safety, work should be done by a licensed electrical contractor.
Page 11 Item: 11	Toilets	<ul style="list-style-type: none"> • Toilets were loose at floor, should be remounted with new hardware and gasket/seal. Subfloor at guest bath should be evaluated for damage and repaired as needed before reinstalling the toilet.
Kitchen		
Page 13 Item: 10	GFCI Protection	<ul style="list-style-type: none"> • No GFCI protection detected at counter outlet next to range. Recommend adding GFCI protection as needed for safety, work should be done by a licensed electrical contractor.

- Testing of all smoke and carbon monoxide alarms should be done at final walk-through to ensure all are functional prior to moving in. Alarms should then be tested monthly and replaced every 10 years or as needed.
- **Detached/damaged alarm noted at left side bedroom, needs to be replaced.**
- **Recommend adding carbon monoxide alarm at master bedroom near the door, and at hallway outside the left side bedroom.**

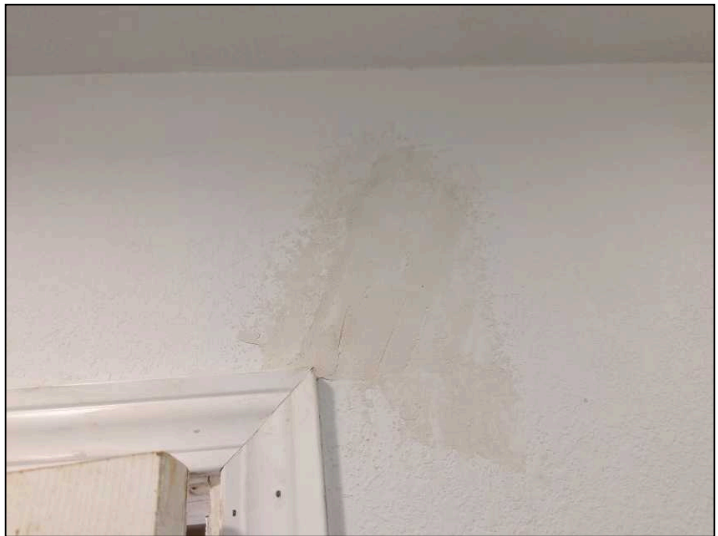
8. Wall Condition

- Appeared satisfactory, minor imperfections only.
- Evidence of possible leaking observed at left side bedroom.

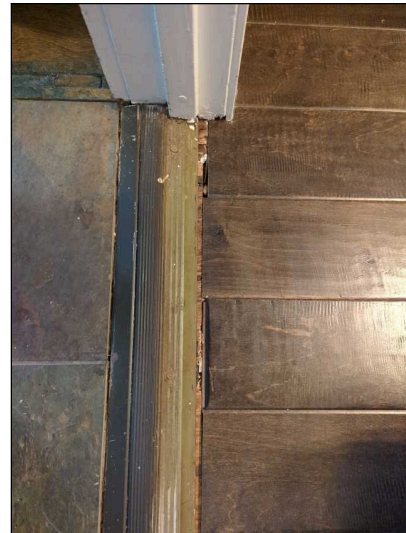
11. Floor Condition

- Appeared satisfactory for age and wear, some minor imperfections noted.
- Floors were sloped in areas, not level. This is not an uncommon condition for older/modified homes, and determining cause and cure of this condition is beyond the scope of a general home inspection. Consider having this condition further evaluated by a qualified licensed contractor. See also Foundation section of report.

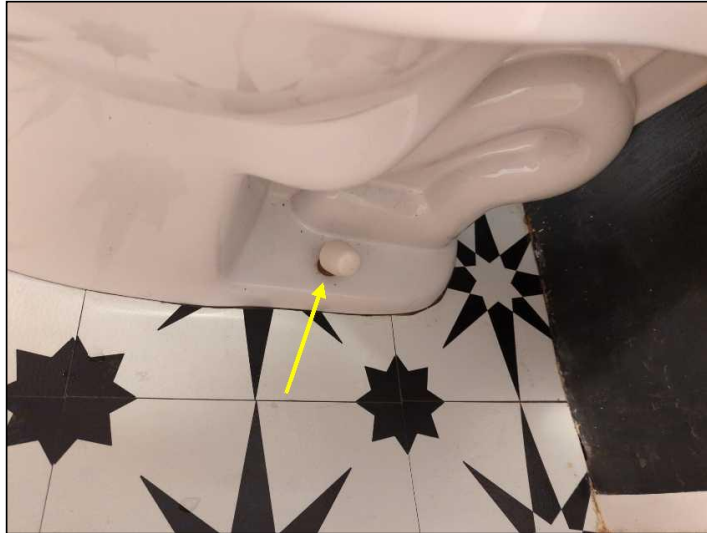
11. Toilets

- Appeared satisfactory for age and wear.
- Functional when tested.
- Toilets were loose at floor, should be remounted with new hardware and gasket/seal. Subfloor at guest bath should be evaluated for damage and repaired as needed before reinstalling the toilet.

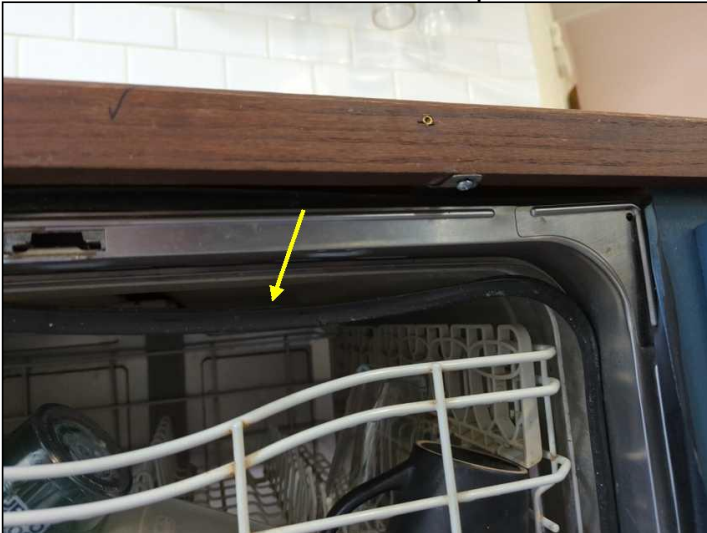
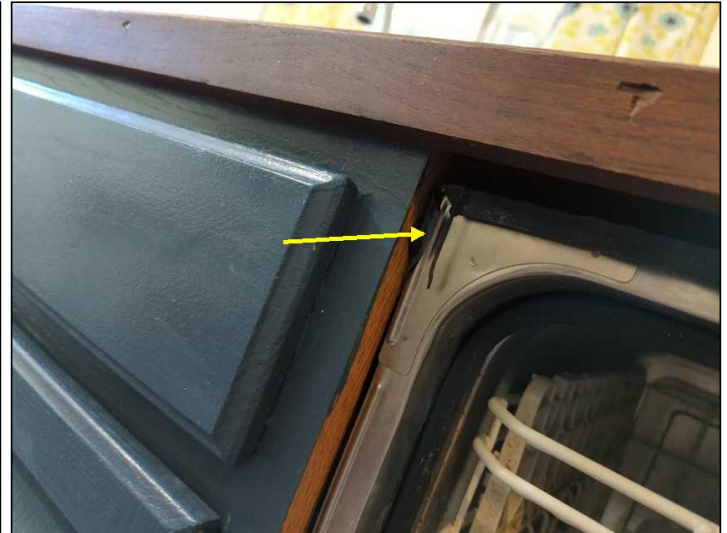
2. Dishwasher

- Appeared satisfactory for age and wear, some deterioration noted at the door gasket.
- Dishwasher was not installed square in cabinet.

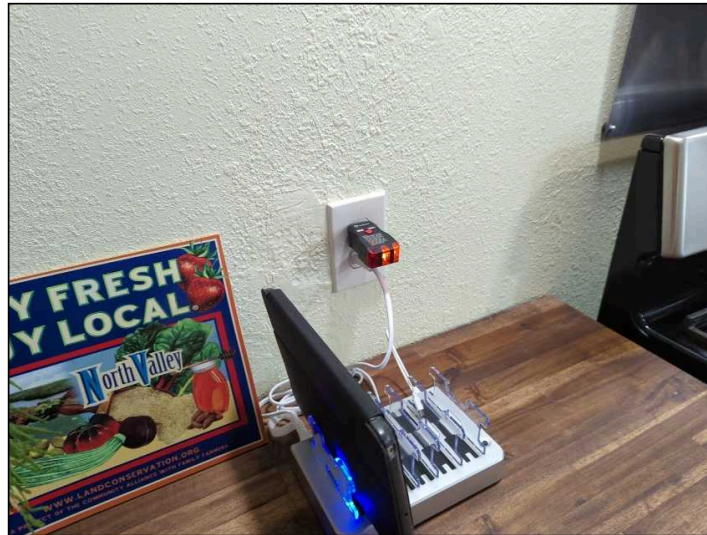
10. GFCI Protection

- GFCI protection in place and operational at 2 of the 3 counter outlets in kitchen inspection.
- **No GFCI protection detected at counter outlet next to range. Recommend adding GFCI protection as needed for safety, work should be done by a licensed electrical contractor.**

Failed GFCI trip test.

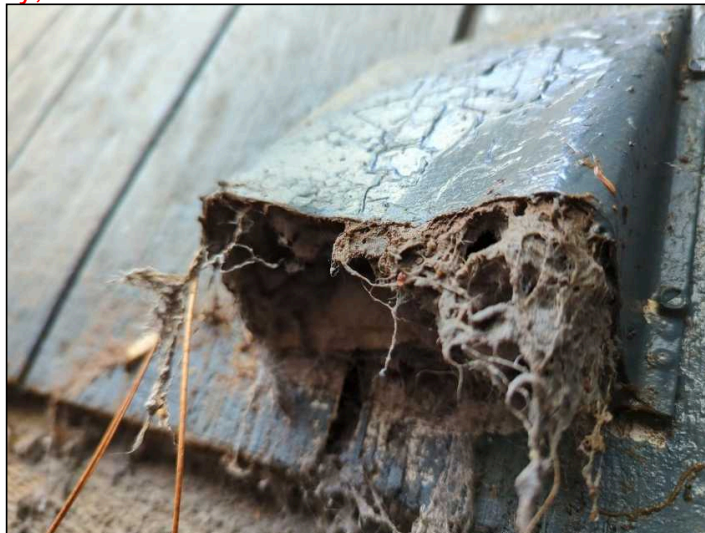
1. Dryer Vent Pipe/Hood

- Dryer vent pipes and hoods should be cleaned periodically to prevent excessive lint buildup and potential fire hazard.
- **Dryer vent hood was dirty, should be cleaned as needed.**

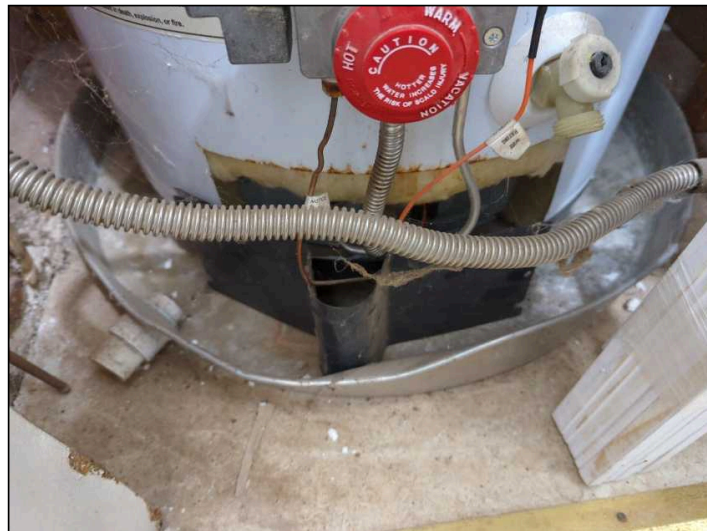
- Appeared satisfactory for age and wear, outer cover was off.
- Functional at inspection.

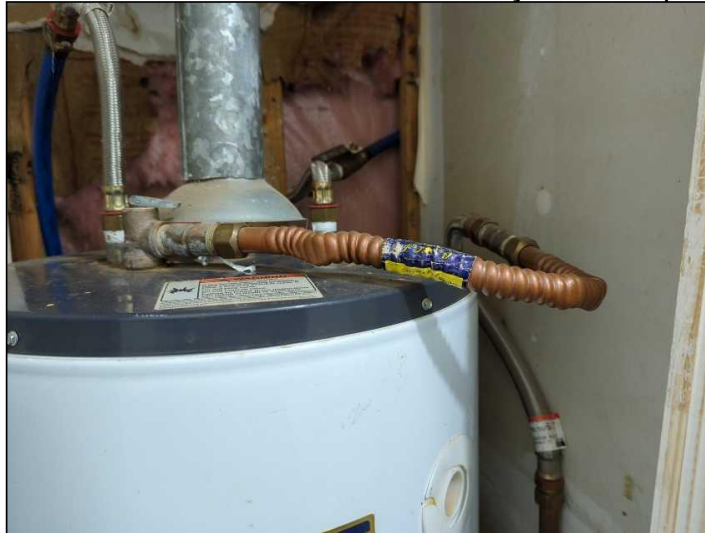
- **IPR valve** drain line improperly slopes uphill slightly, must only drain downhill, also is not professionally plumbed. Recommend correction as needed by licensed plumbing contractor.

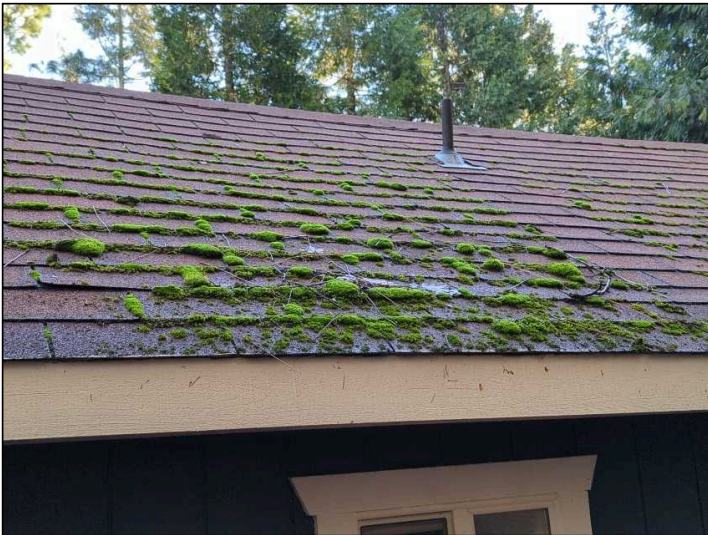
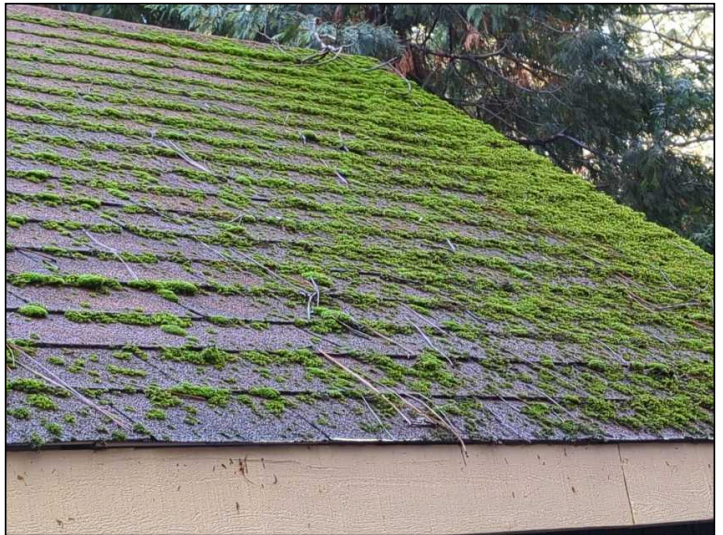
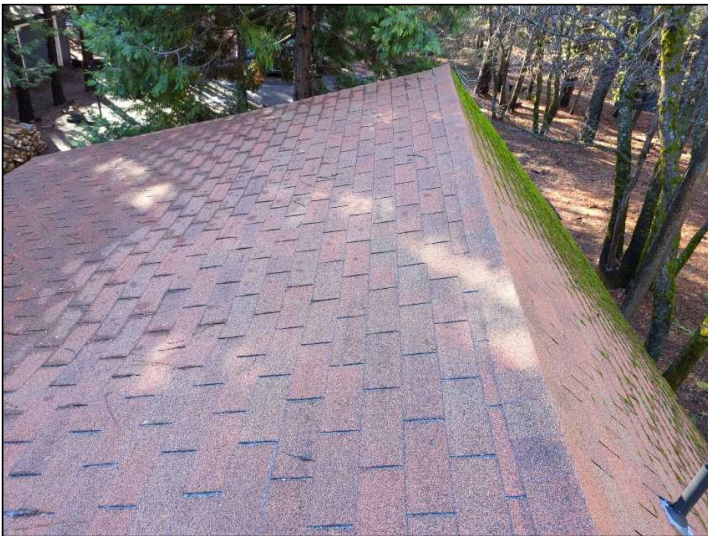
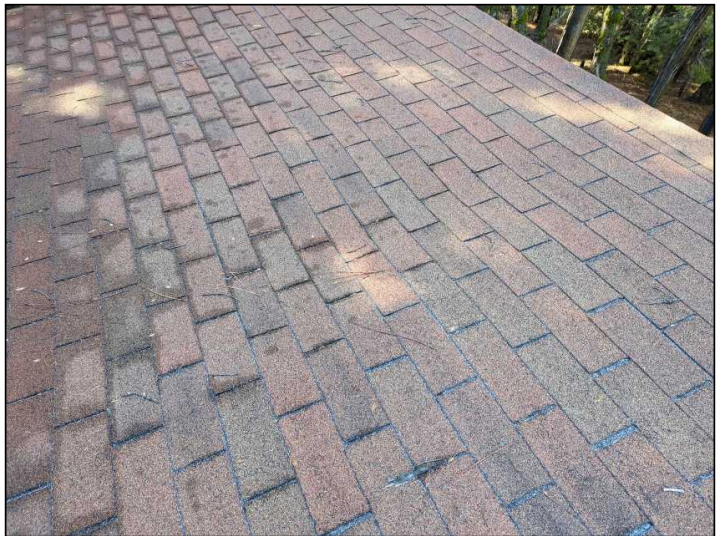
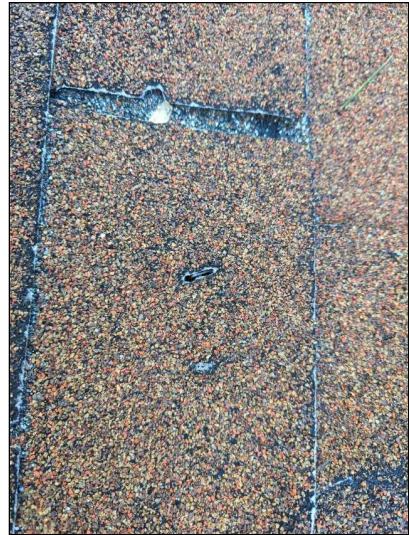
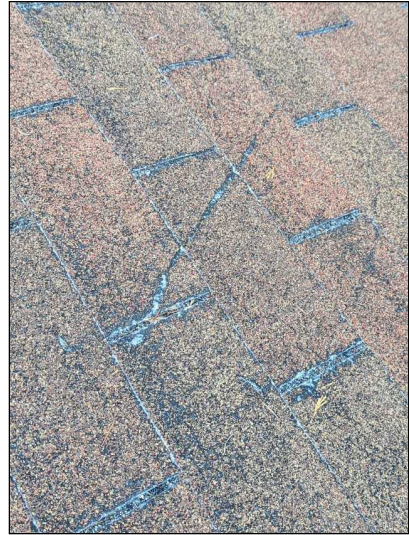
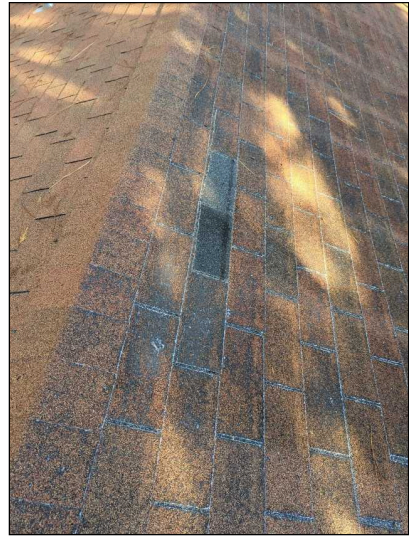
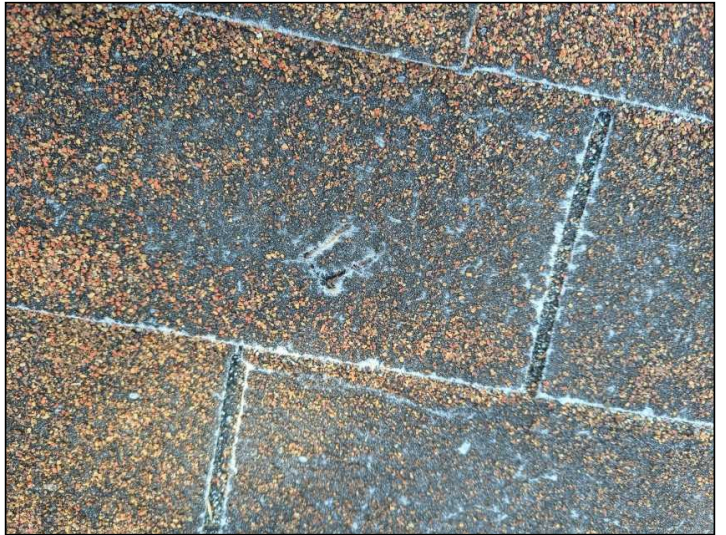
1. Roof Condition

- General maintenance needed.
- Heavy organic growth observed on roofing materials in areas.
- The rear flat roof section should be rolled, build-up roofing, or otherwise appropriate roofing other than asphalt shingles, which are designed for pitched roofs only.
- Worn/damaged shingles observed.
- Evidence of past repairs observed. Consult seller.
- Consult seller for exact age of roof in known.
- **Based on the age/overall condition of the roof, it is recommended having the roof fully evaluated with corrections as needed by a licensed roofing contractor, and having the remaining useful life determined, which may be limited.**

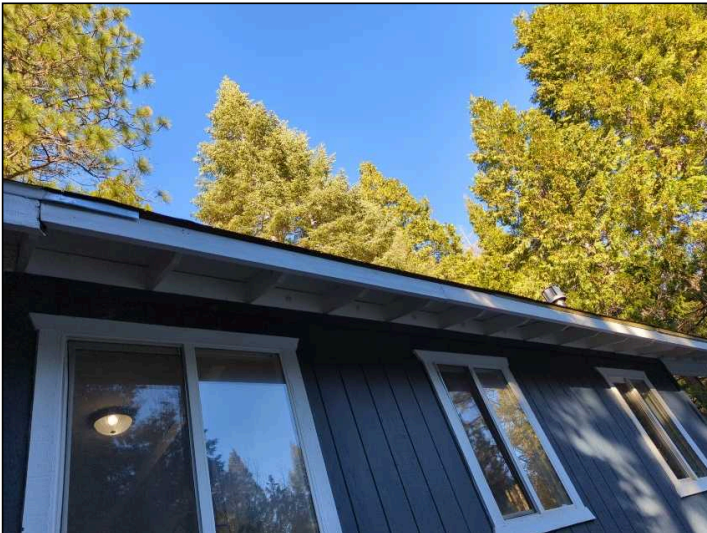
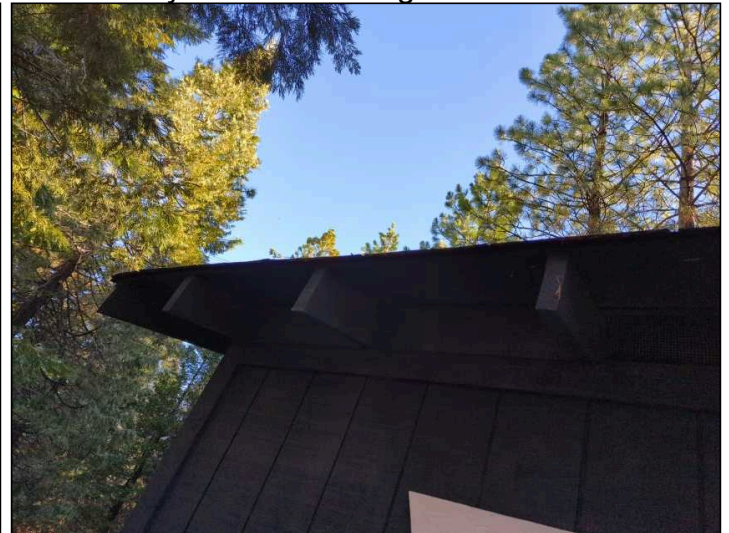
2. Flashing

- Missing sections of edge flashing noted.
- Recommend further evaluation and corrections as needed by licensed roofing contractor.

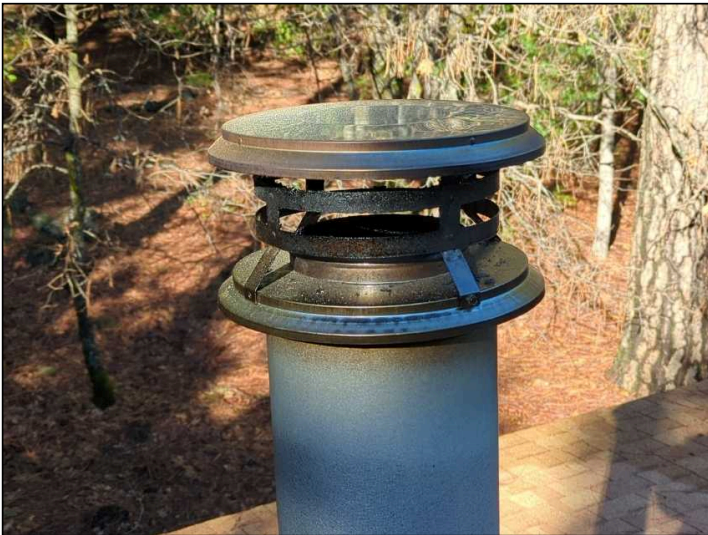
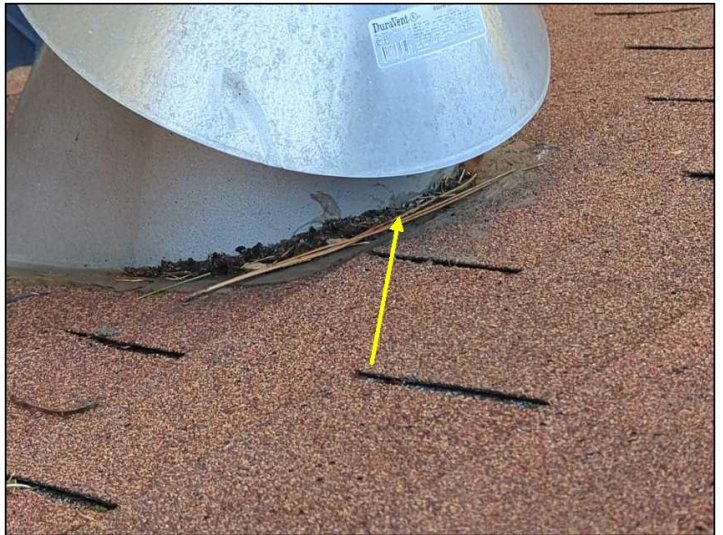
3. Chimney

- Appeared satisfactory for age and wear.
- Stove pipe and cap appear to be due for cleaning, which should be done annually.
- Stove pipe cap should have a spark arrestor screen.
- Flashing at chimney needs to be cleaned for proper drainage.

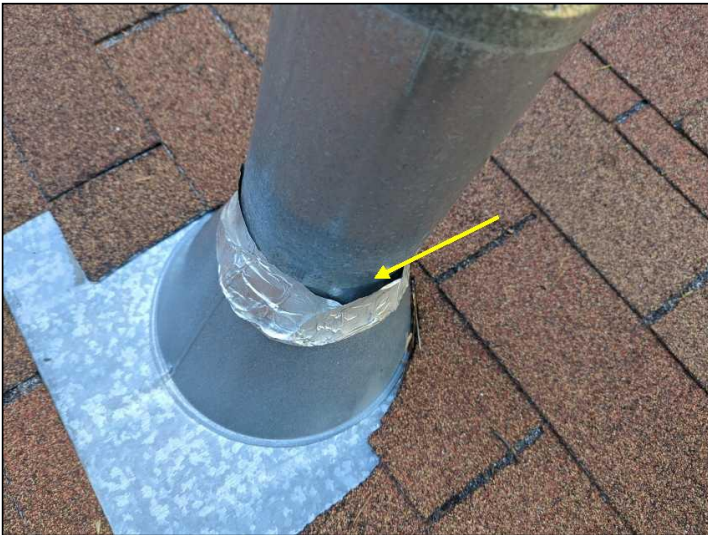
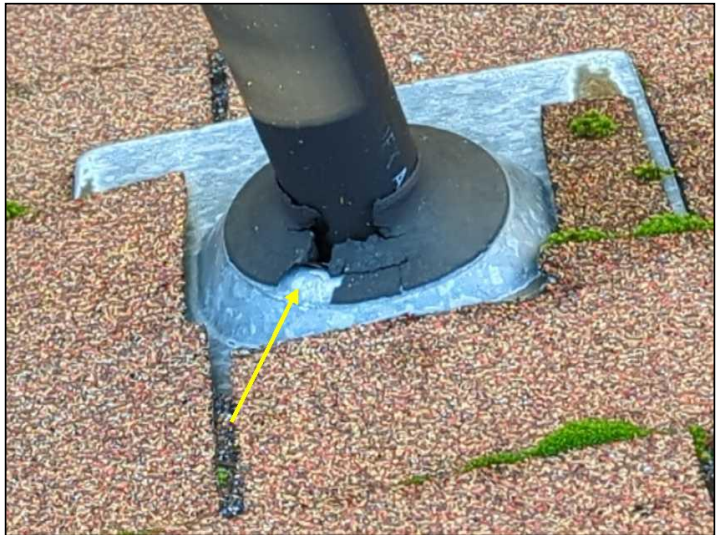
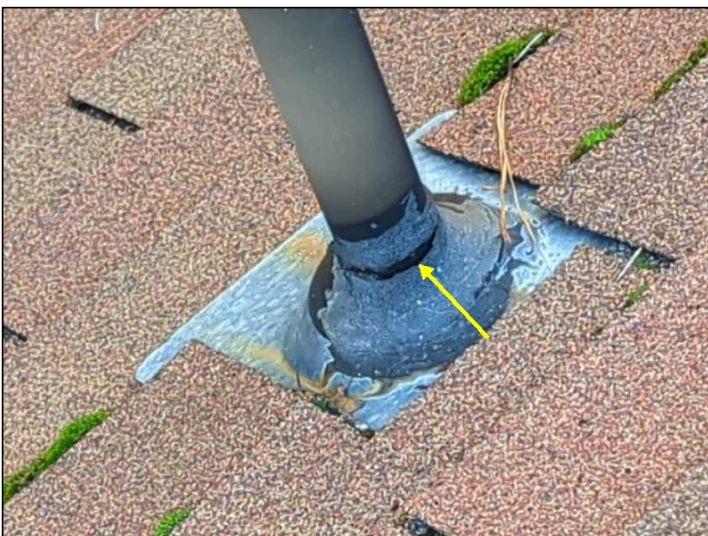
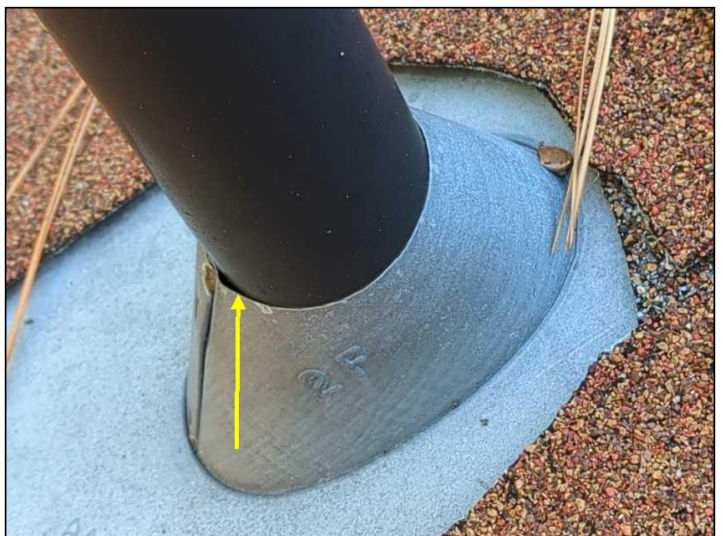
4. Vent Caps/Stacks

- Recommend further evaluation and corrections as needed by a roofing contractor.
- Vent stacks need to be sealed properly as needed to prevent leaking, several had gaps where water is getting in.

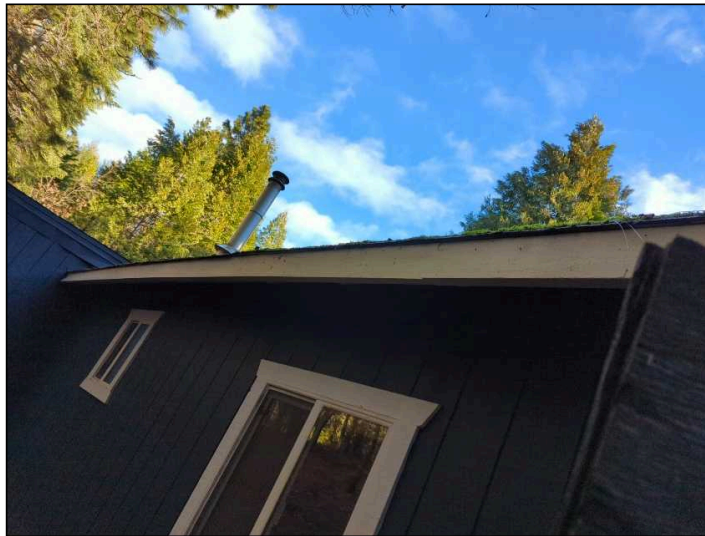
5. Gutters/Downspouts

- Missing gutters and downspouts noted, recommend installing to help with perimeter drainage and erosion control.

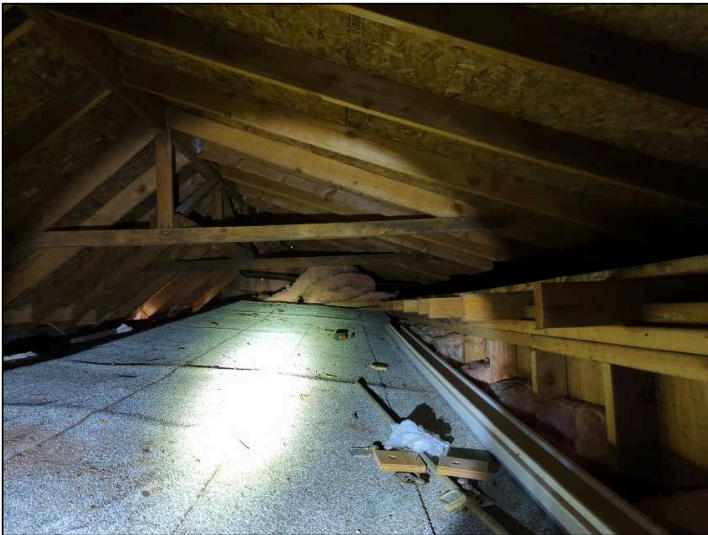
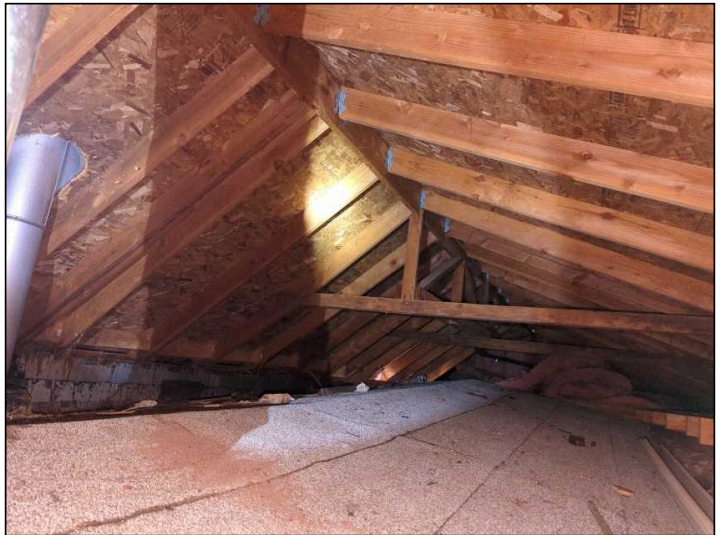
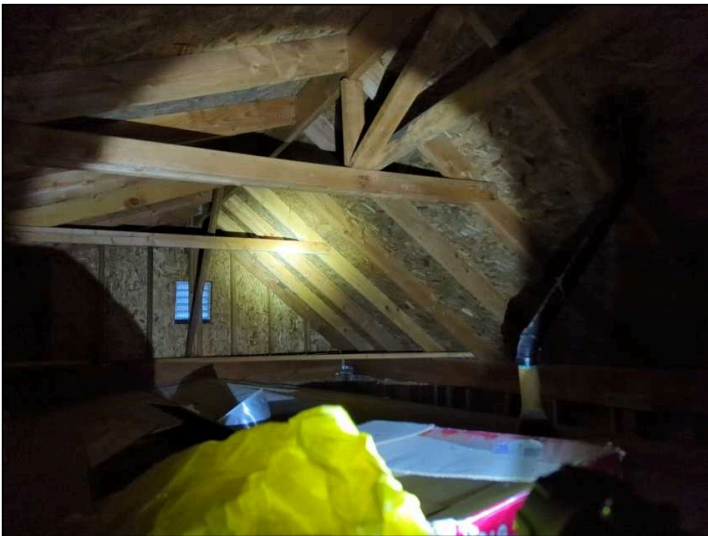
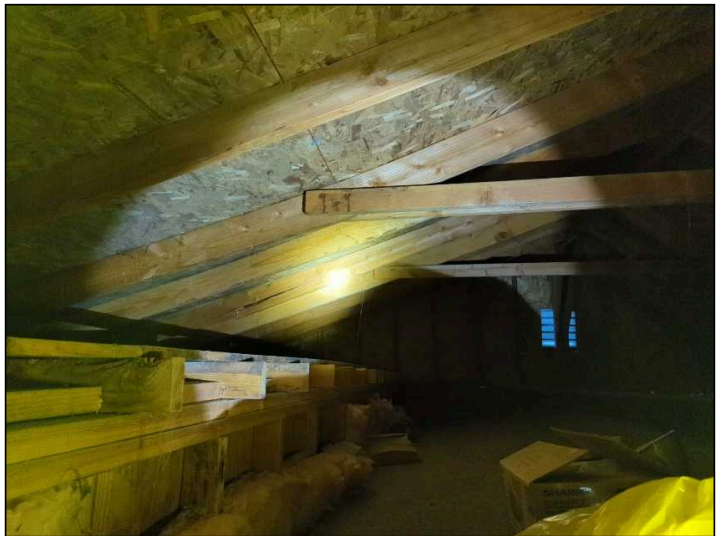
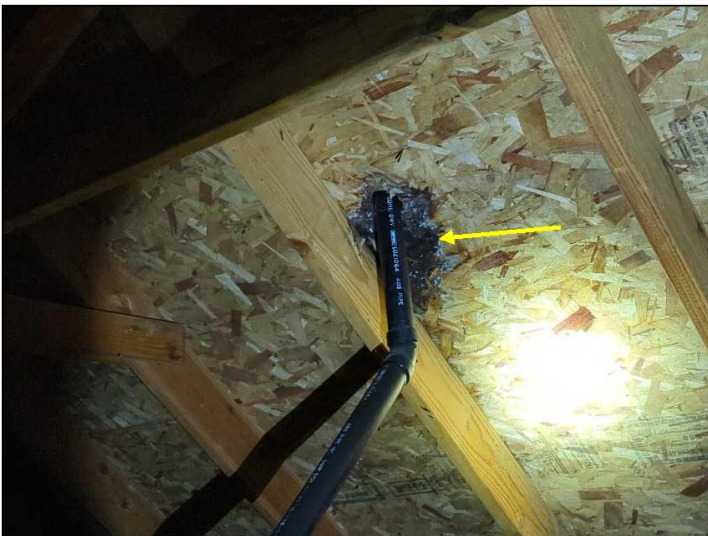
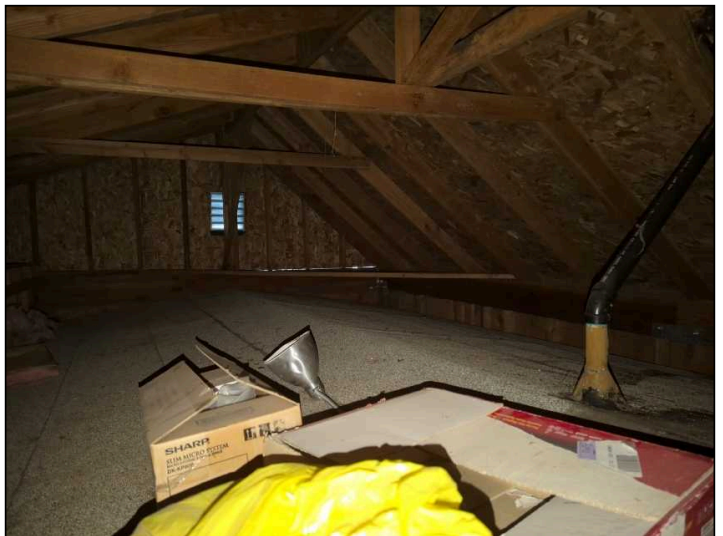
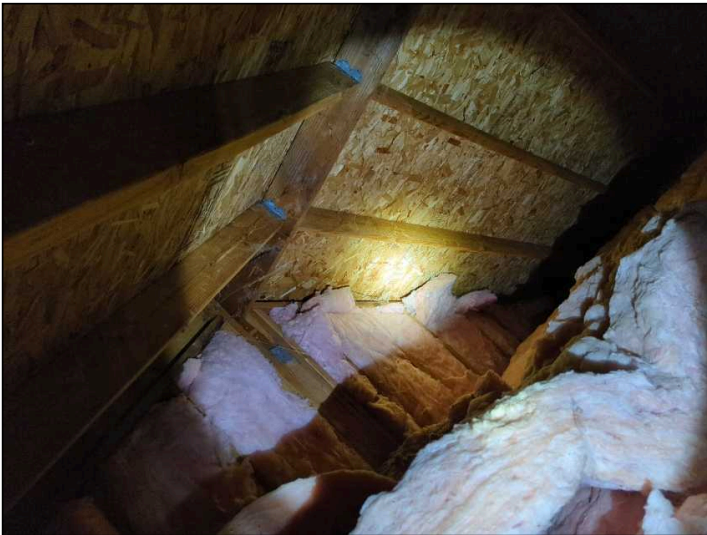
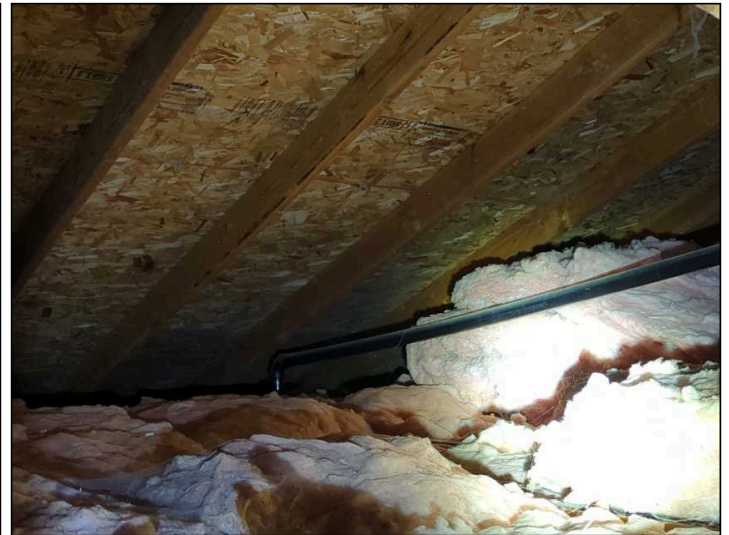
- Appeared satisfactory for age and wear, no major defects observed.
 - Stick framing noted, not engineered trusses.
 - Moisture stains observed at framing at areas around the leaking roof vent stacks.
 - Modifications to original structure observed, older roof still in place, new roof built around.
- Determining adequacy is beyond the scope of a general home inspection. Consult seller for more information.

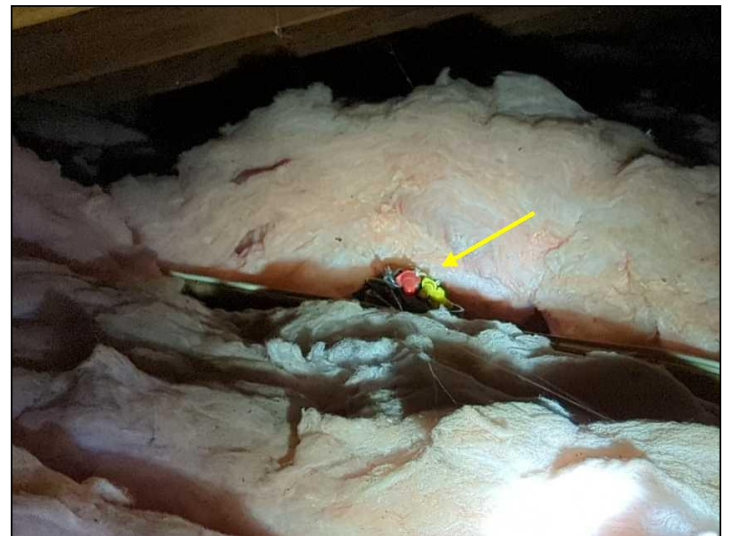
- Attic service light did not operate when tested.
- Recommend further evaluation and corrections as needed by a licensed electrician.
- **Open junction box observed at right side of home attic space, and the attic light switch was missing to cover plate, potential exposed electrical hazard.**

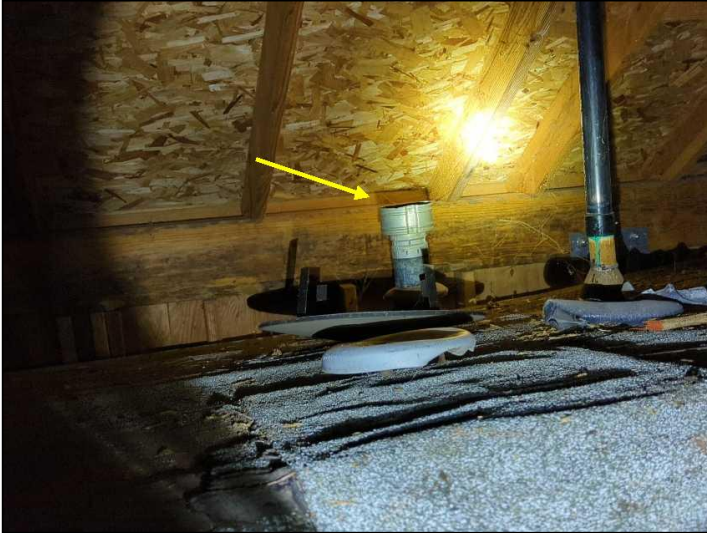
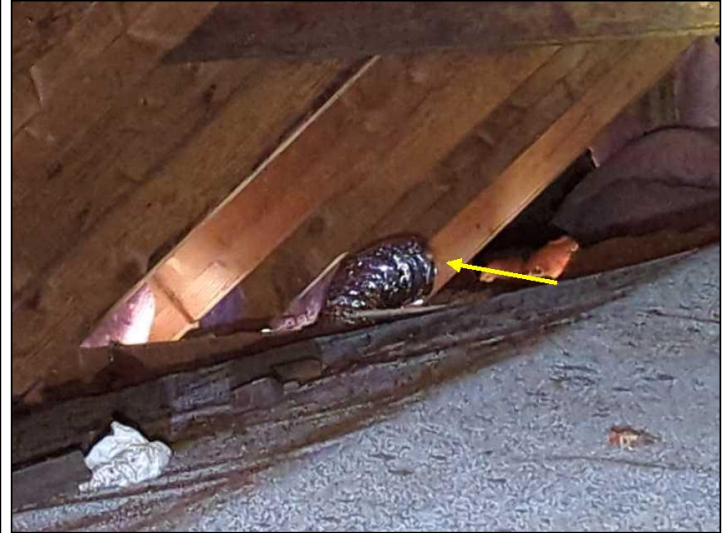
- Exhaust vents appear to terminate directly into attic space, should terminate to exterior, roof, or at gable/soffit vents.

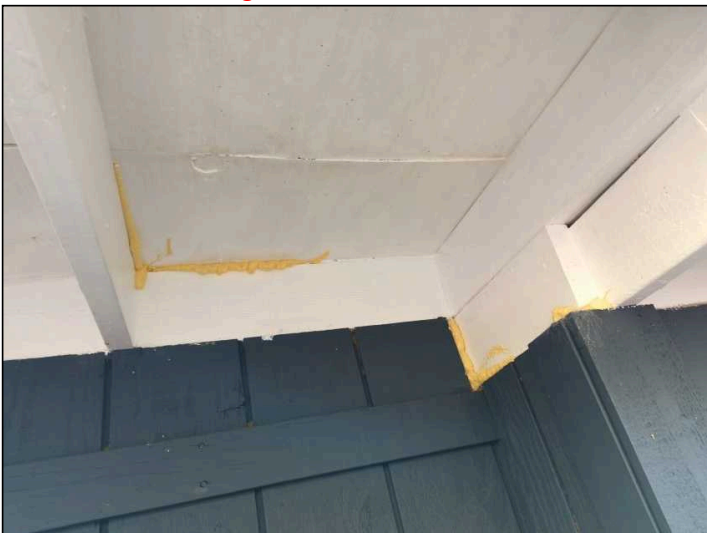
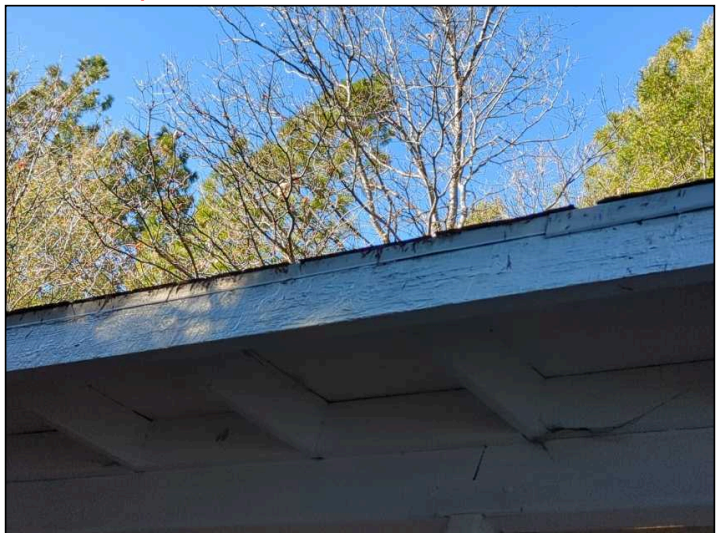
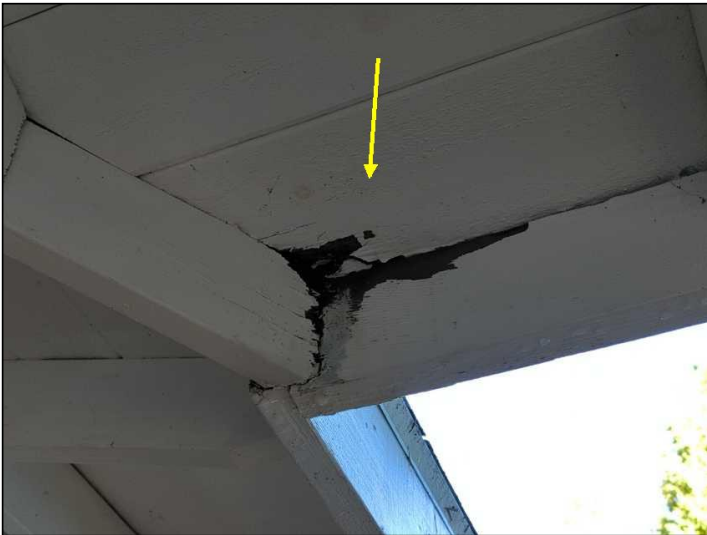
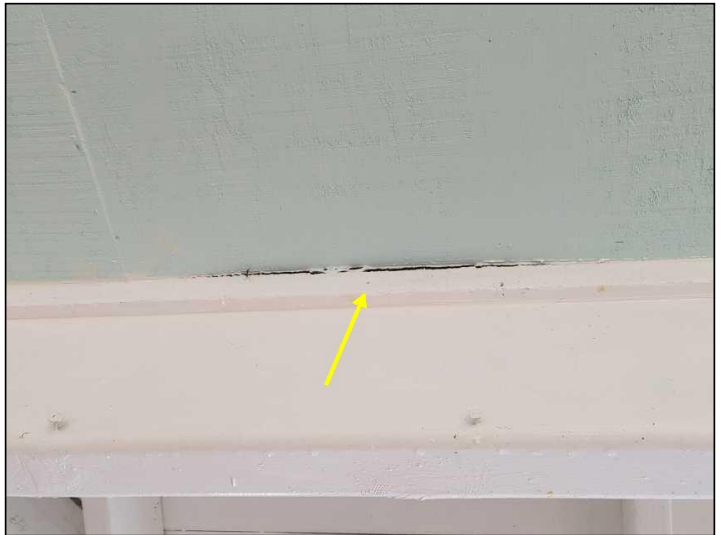
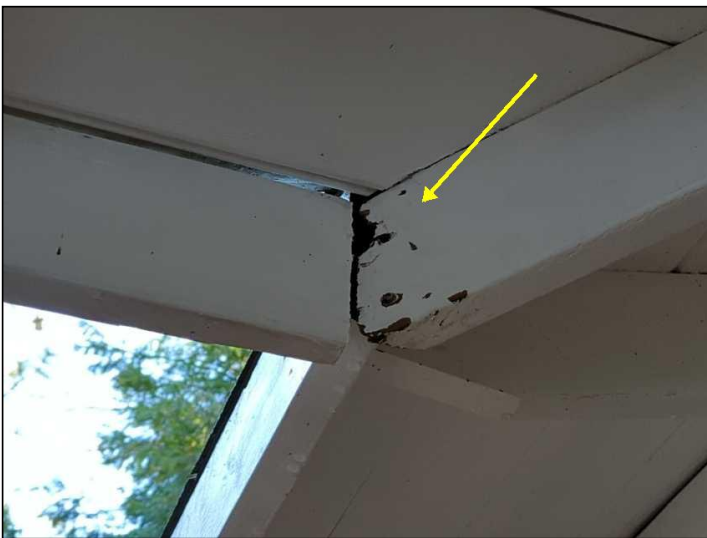
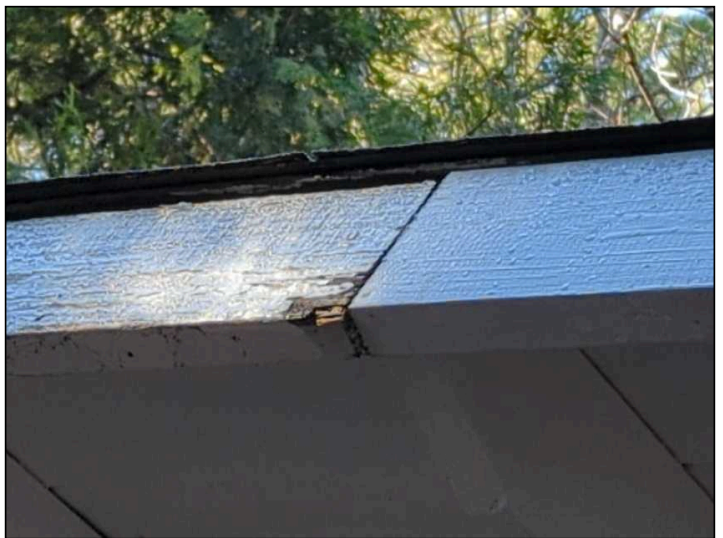
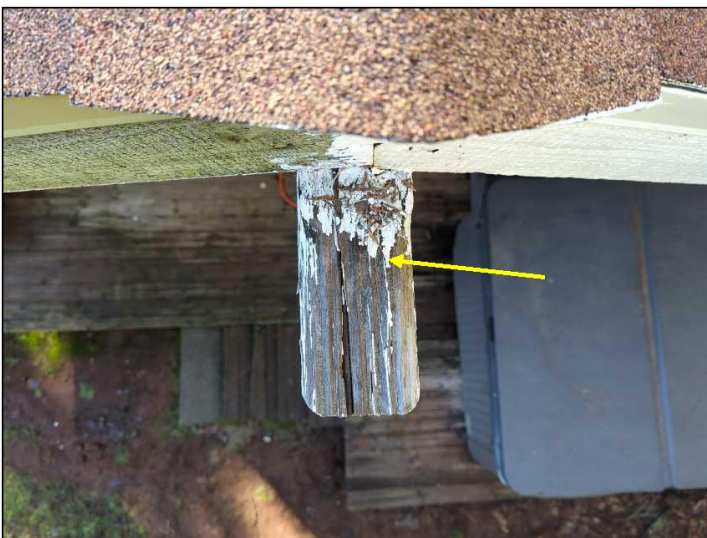
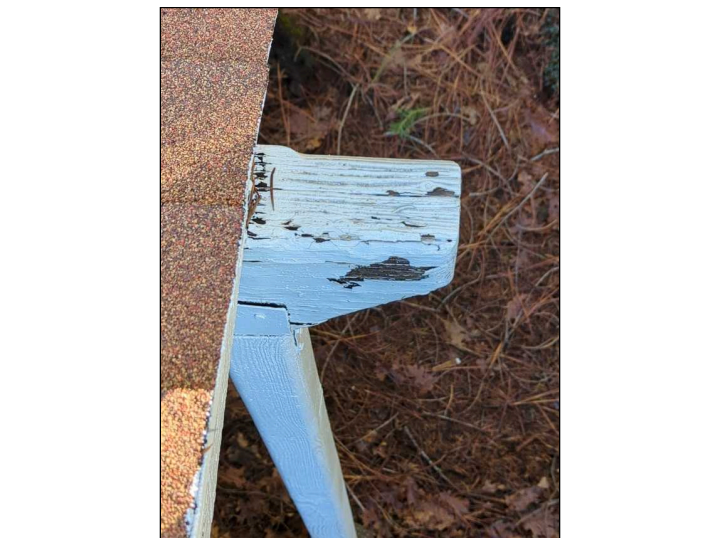
4. Eaves/Fascia

Page 32 Item: 4	Eaves/Fascia	<ul style="list-style-type: none"> • Moisture damage observed at sections of eaves, and at exposed beams.
Grounds		
Page 36 Item: 4	Electrical	<ul style="list-style-type: none"> • Improper/unprofessional wiring practices observed at well equipment area, missing outlet cover plate noted at shop/garage structure.

- Appeared satisfactory for age and wear.
- Evidence of past repairs/sealing noted. Consult seller for more information.
- Recommend further evaluation with corrections as needed by a licensed contractor/pest control.
- **Moisture damage observed at sections of eaves, and at exposed beams.**

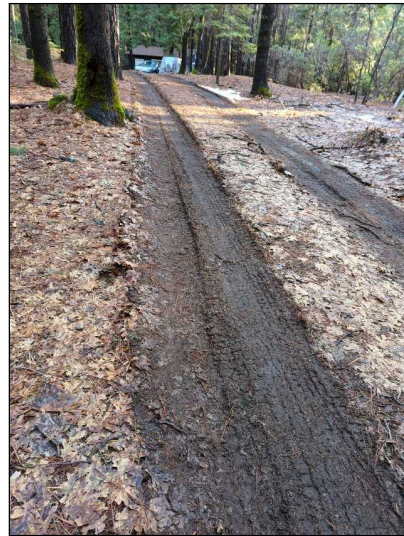
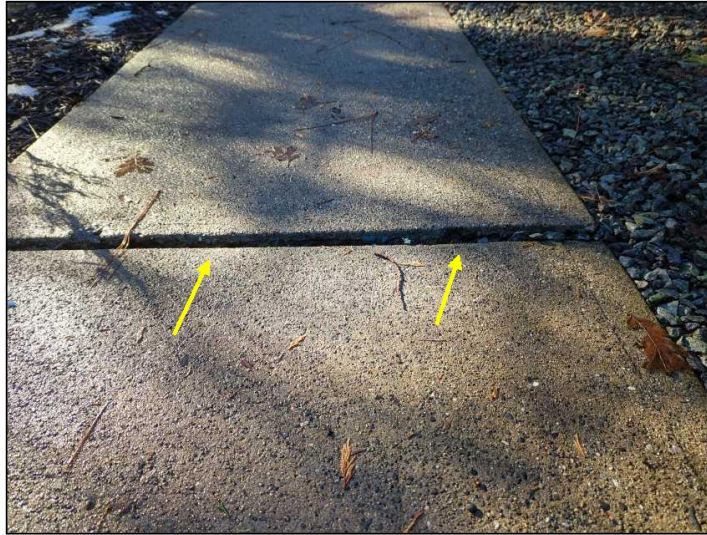
1. Driveway/Walkway Condition

- Appeared satisfactory for age and wear.
- Recommend adding rock/gravel at driveway as needed.
- A section of the front walkway is lifting at the joint, should be monitored and improved as needed to prevent potential trip/fall hazard.

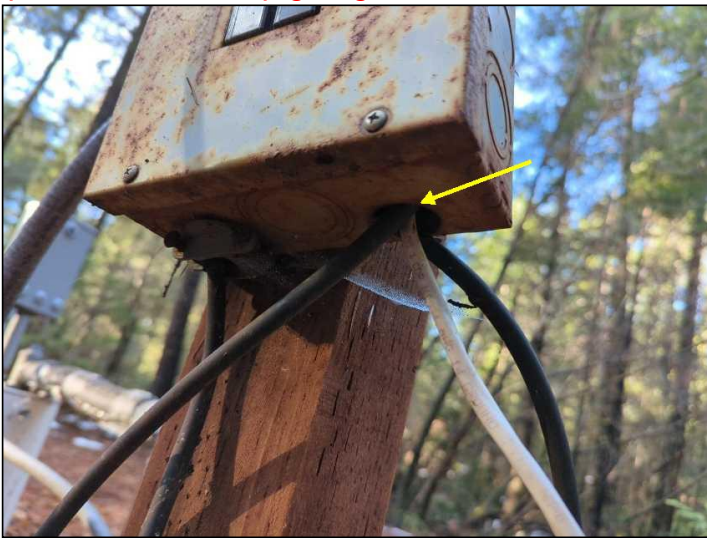
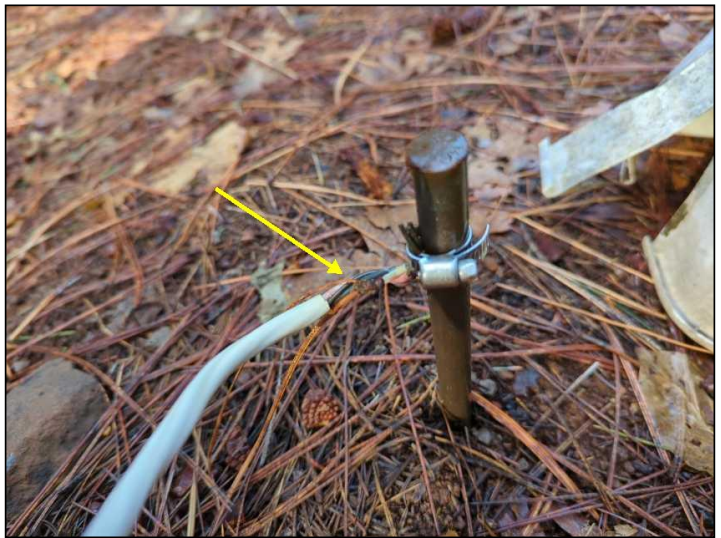
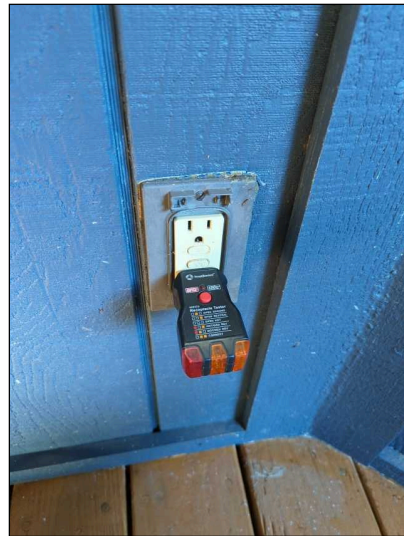
- Outlet at front porch area tested for no power. Had power in, but no power out.
- Some abandoned electrical observed by small storage shed. Consult seller.
- Recommend further evaluation of grounds and shop/garage electrical with corrections as needed by a licensed electrical contractor.
- **Improper/unprofessional wiring practices observed at well equipment area, missing outlet cover plate noted at shop/garage structure.**

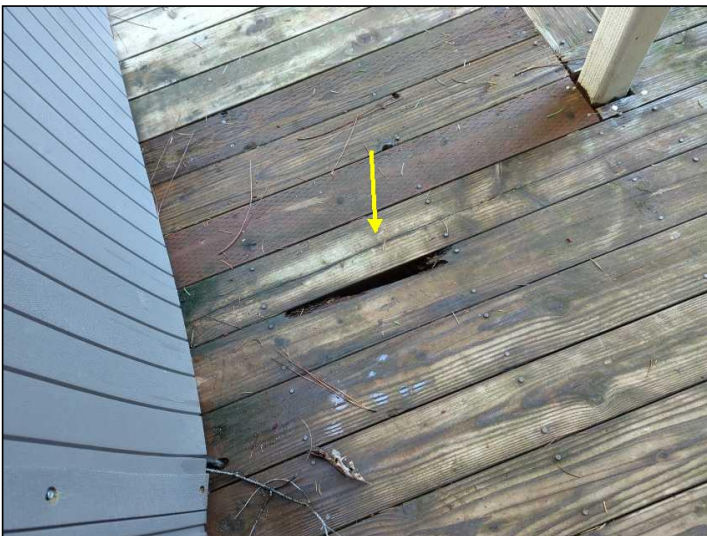
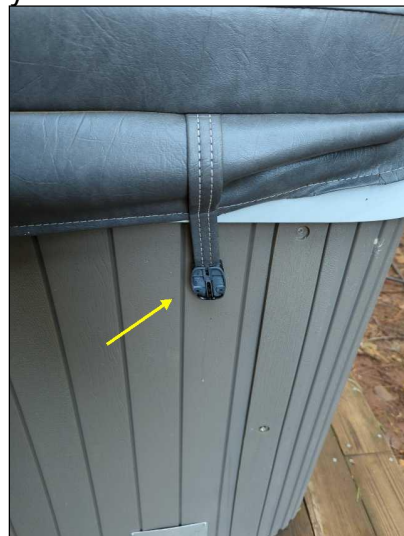
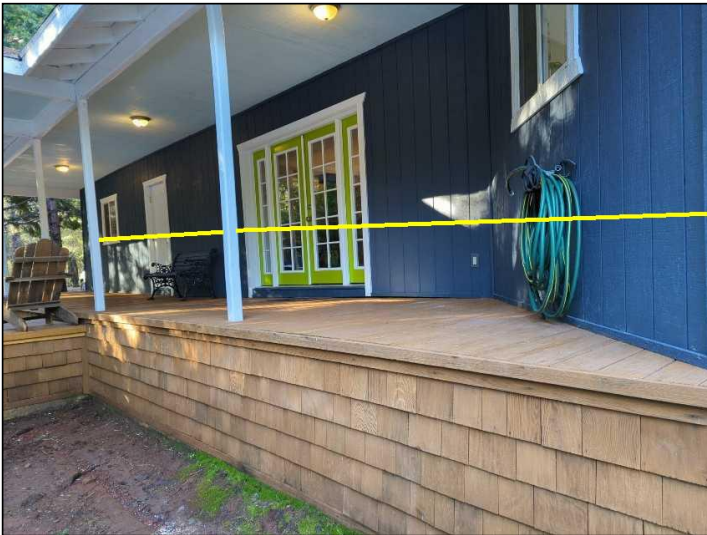
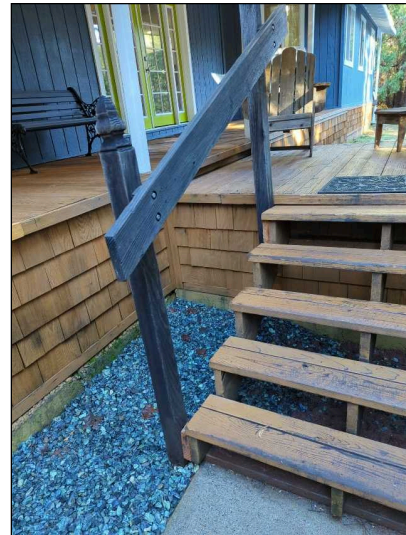
- Some general maintenance/repairs needed.
- Recommend having the steps at front deck improved as needed.
- Recommend having hand and guard rails installed.
- Recommend further evaluation and corrections as needed by licensed contractor.
