Aldis Enterprises

Property Inspection Report

15 Dream Lane, Cohasset, CA 95973
Inspection prepared for: Chad Rothe
Date of Inspection: 1/6/2022 Time: 9AM
Age of Home: 1980(?) Size: 1,400 sqft
Weather: Cool

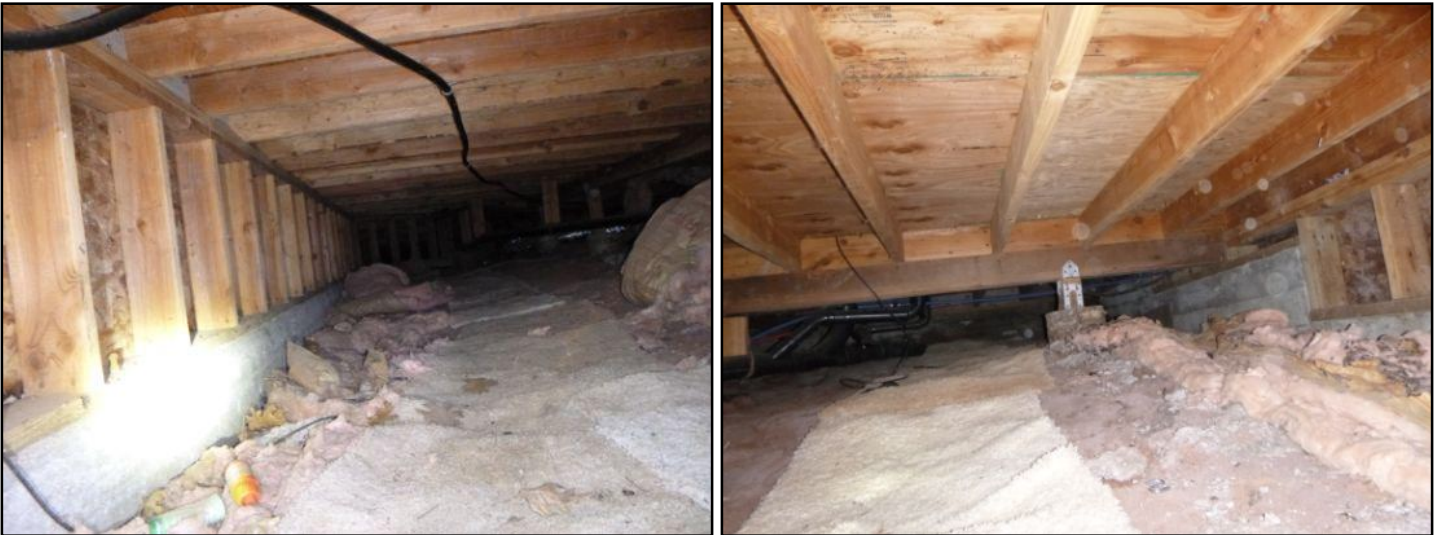
1. Foundation Structure

- Moisture stains observed at wood members in areas.
- Wood posts observed in contact with soil.
- Modifications to home observed, determining adequacy is beyond the scope of a general home inspection. Part of the home appears to be a trailer/Mobile home. Consult seller.
- Evidence of possible pest intrusion observed.
- The foundation perimeter is anchored at the concrete support walls where visible. Determining adequacy of foundation anchoring is beyond the scope of a general home inspection.
- Some old wood piles noted under the home at left side. These should be removed as to not attract pests.
- As this is a limited scope inspection, it is recommended to have further evaluation of the home foundation system by a licensed contractor.
- Recommend further evaluation and corrections as needed by licensed contractor/pest control.
