Inspection Report

Address: 354 S Court St Baywood-Los Osos, CA 93402

05/27/2024

Inspector: Taylor Vreeken, CCI

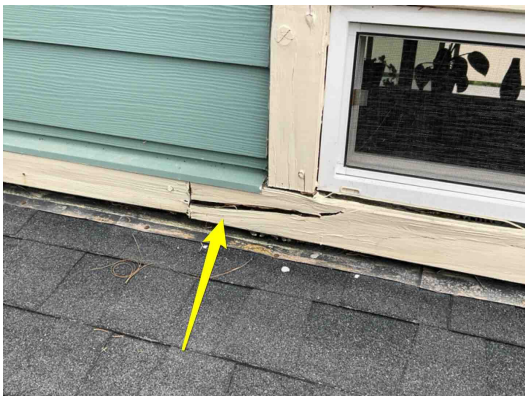
E&C s-30: Some moisture and/or bug type damage & deterioration found at exterior areas such as eaves, fascia and/or trim. Refer to the termite report for locations and extent.

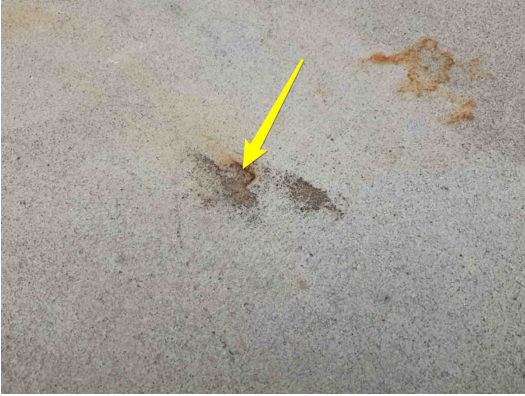
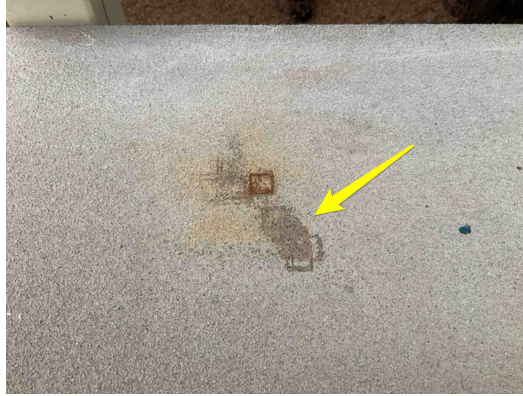
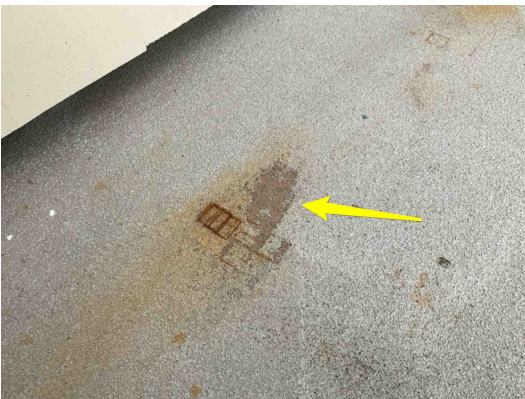
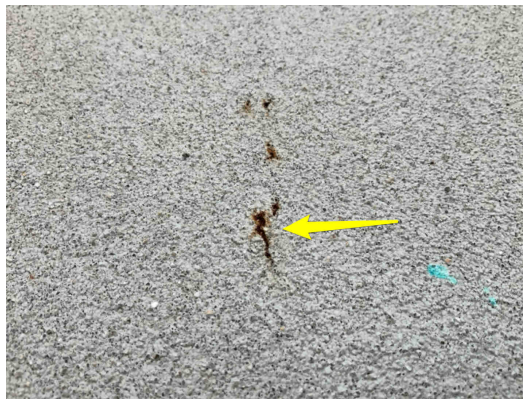
E&C s-39: Areas of minor deterioration found at the waterproof deck coating at the UPSTAIRS DECK OFF THE LIVING ROOM. Maintenance or repairs needed. Recommend further review and/or repairs by a certified or licensed waterproof deck coating professional familiar with minimum requirements.

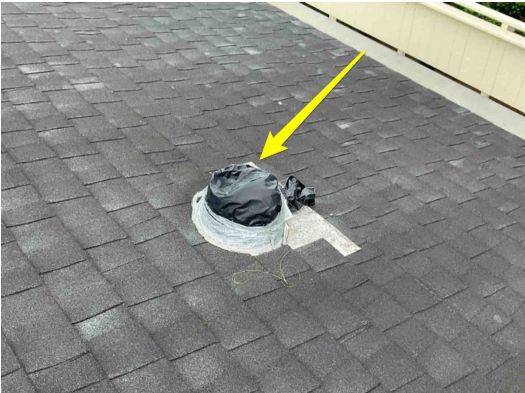
E&C s-52: Improper repair of the former kitchen cooktop exhaust termination on the roof. Recommend further evaluation and Installation of a screened "T" cap per minimum codes and standards.

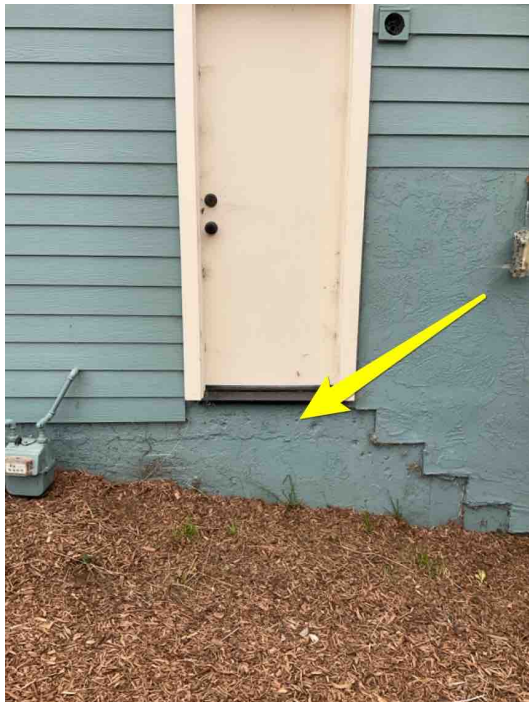
E&C s-137: Disclosure: Missing a proper three foot door landing off exterior door: GARAGE EXTERIOR PEDESTRIAN DOOR

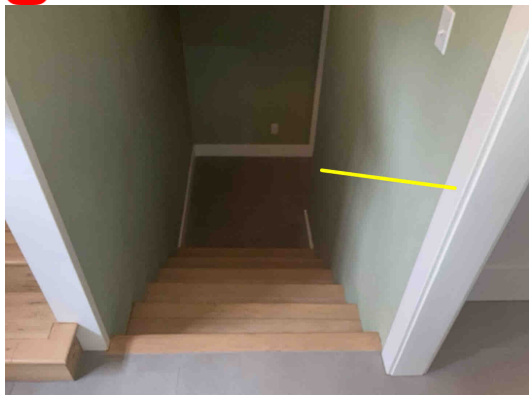
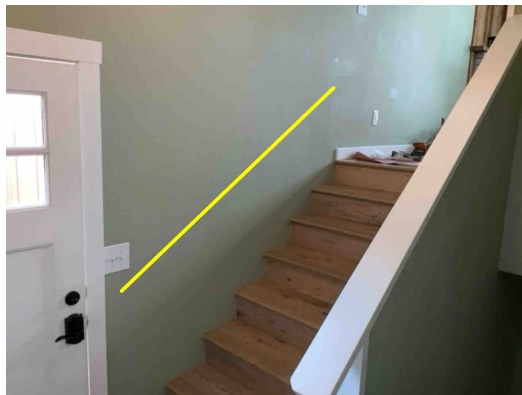
SC s-157: Missing the interior stairway railings. Repairs warranted.

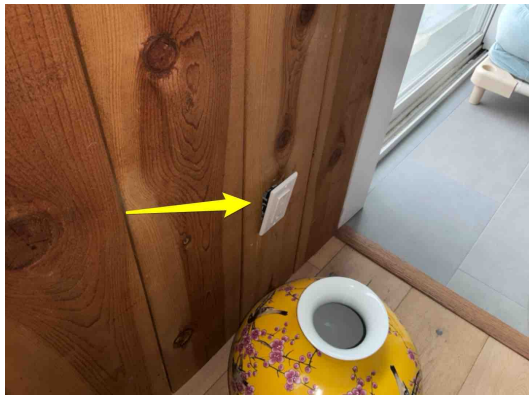
SC s-181: Electrical outlet found loose in wall. Corrections warranted for safety: LIVING ROOM NEAR FIREPLACE

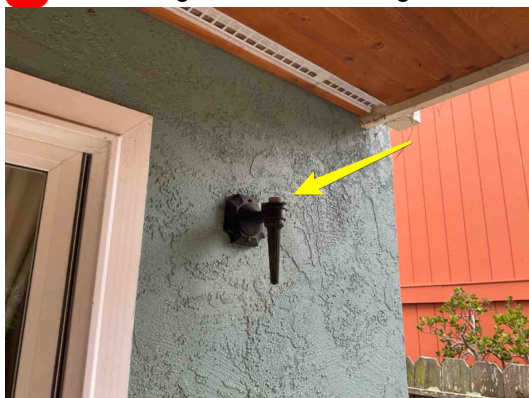
E&C s-185: Light fixture is damaged: EXTERIOR LIGHT NORTHWEST CORNER

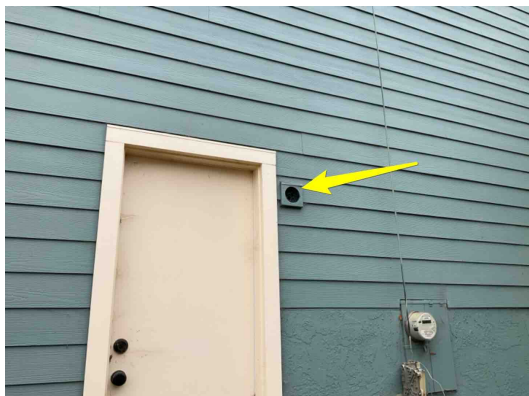
SC s-186: Light fixture is missing, exposed wiring. Recommend repair or replacement: OFF GARAGE EXTERIOR PEDESTRIAN DOOR EAST SIDE

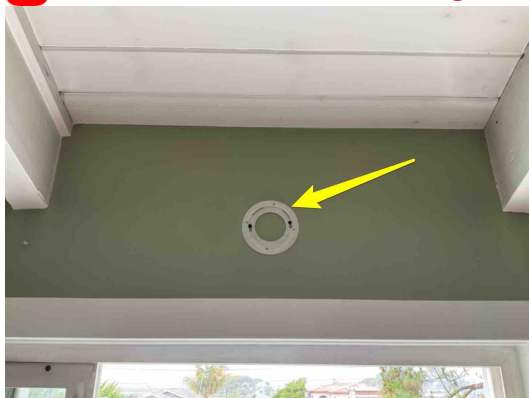
SC s-191: Smoke detector missing at required location: **UPSTAIRS AND MIDDLE LEVEL HALLWAY**

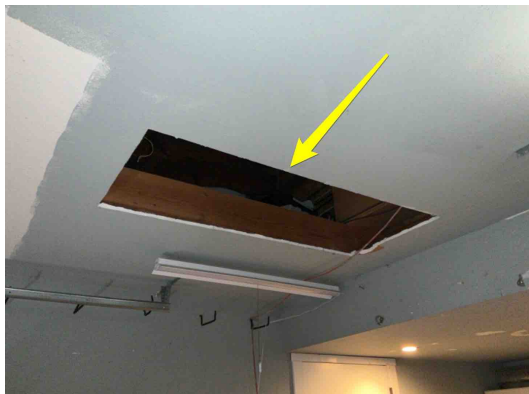
SC s-200: The attic access in the garage does not meet minimum garage fire wall requirements. Upgrades are recommended.

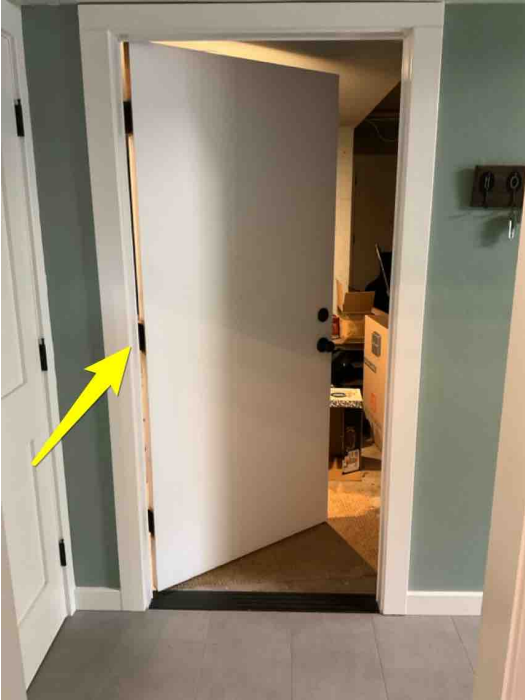
SC s-202: Self-closer is non-operational at garage fire rated door to the living space.

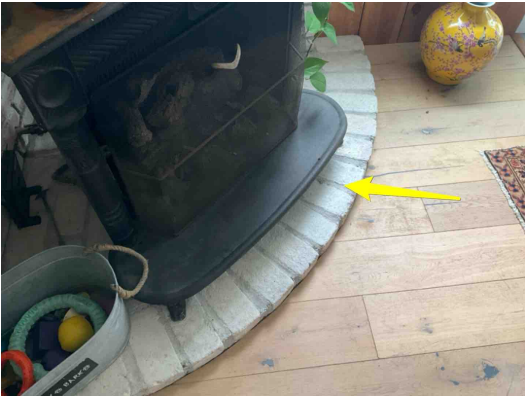
s-211: The living room fireplace appears to have been improperly altered and does not conform to minimum installation standards. Too many individual defects to list. Recommend further evaluation by a qualified/ licensed fireplace- chimney professional familiar with minimum codes and clearance requirements.

Undersized hearth extension over combustible materials

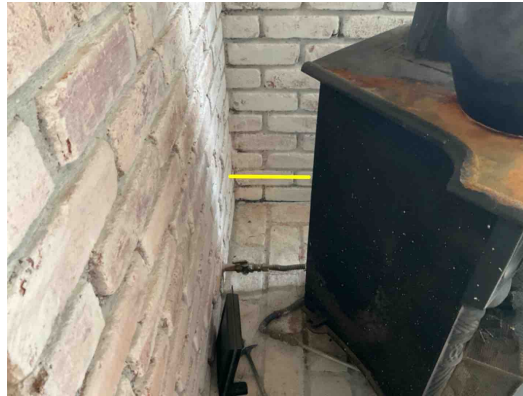
Inadequate clearance to the wall

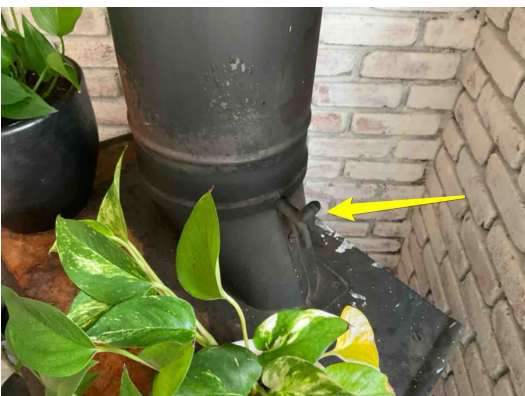
Functional damper on a fuel burning appliance

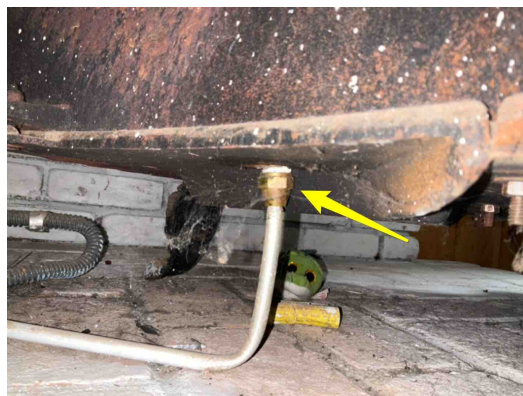
Missing a fuel regulator for a custom fuel burning appliance

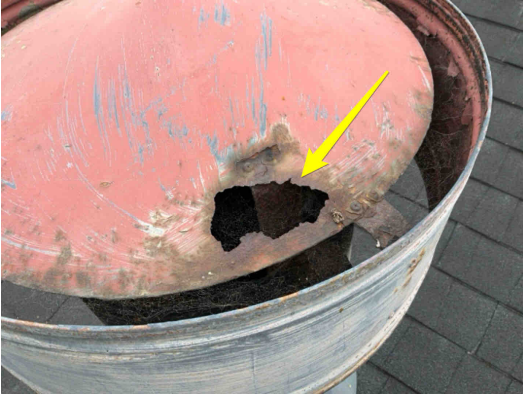
E&C s-213: The spark screen and cap found rusted, deteriorated and/or damaged atop the LIVING ROOM fireplace chimney. Recommend replacement for fire safety. Contact a qualified professional.

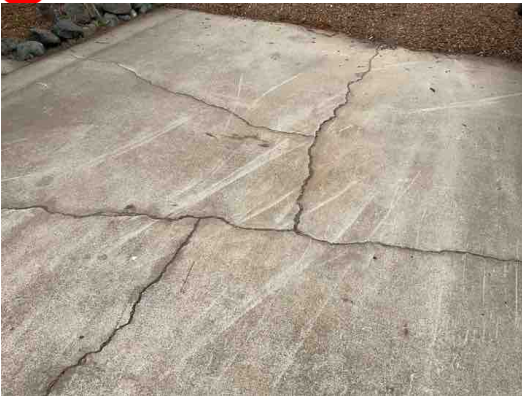
E&C 12: Some moderate and heavy cracks found in areas of the driveway.

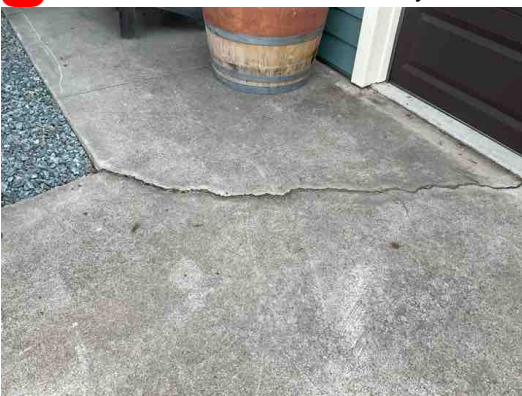
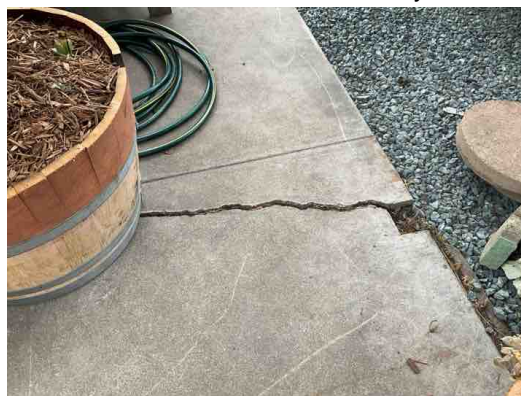
E&C 16: Some moderate and heavy cracks found at areas of the concrete walkways.

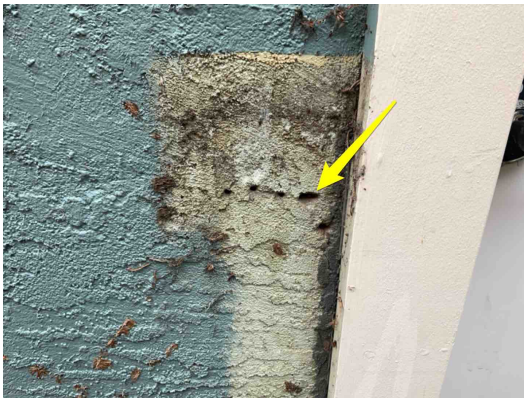
MR 27: Recommend sealing holes in exterior walls to prevent water intrusion around areas such as unused open holes, exterior light fixtures, around exterior electrical boxes, and where utility pipes and/or wires pass through the exterior walls. Have a qualified painter or licensed professional evaluate the entire exterior and seal where needed.

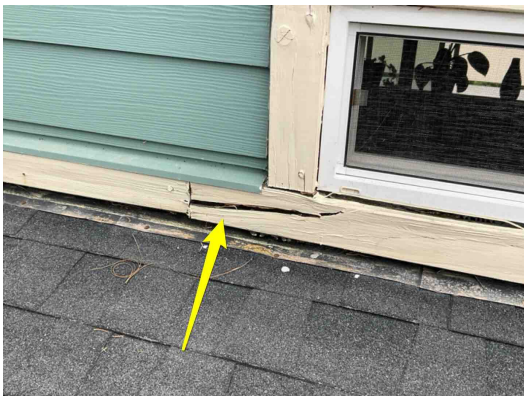
E&C 30: Some moisture and/or bug type damage & deterioration found at exterior areas such as eaves, fascia and/or trim. Refer to the termite report for locations and extent.

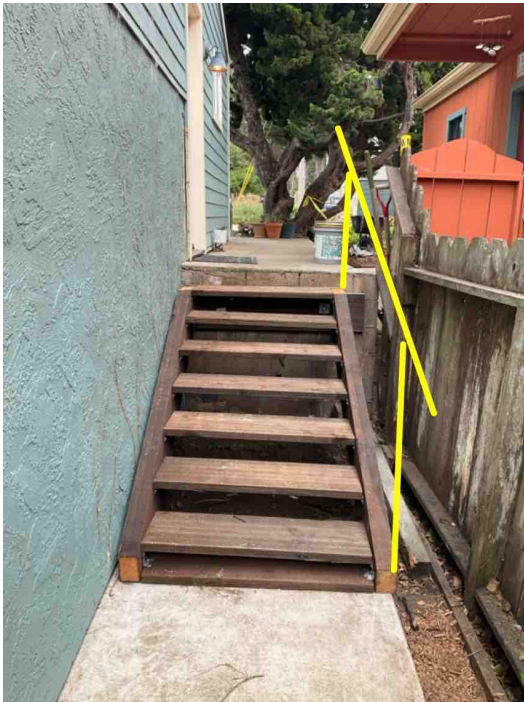
SC 37: Missing the proper and required guardrails and graspable handrail at the exterior stairway: OFF THE ENTRY PATIO. A Guardrail and graspable handrail is required on all exterior stairs where the potential fall from the stairway it's greater than 30 inches.

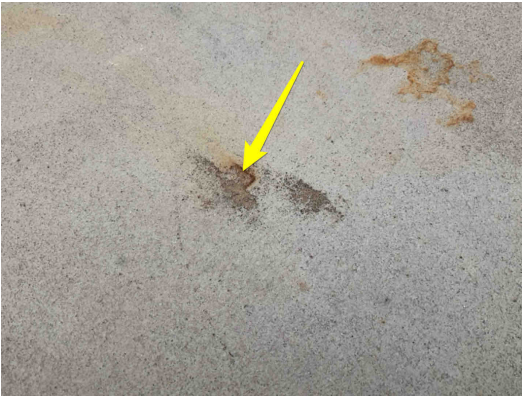
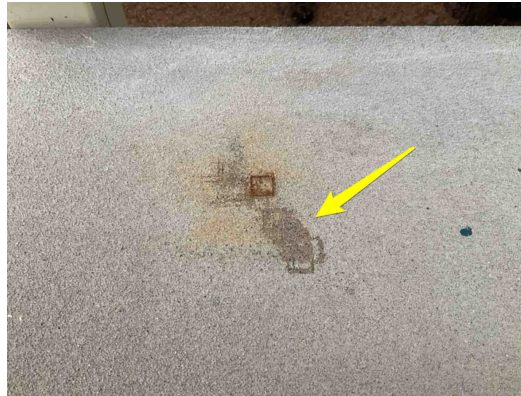
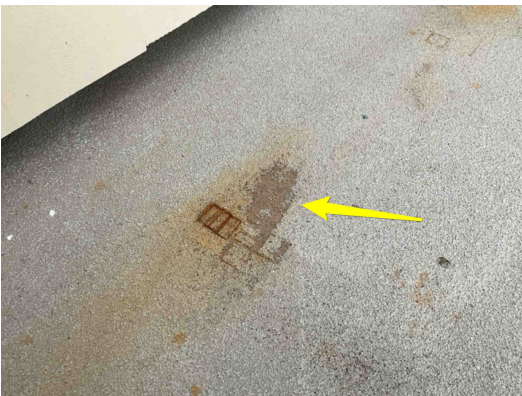
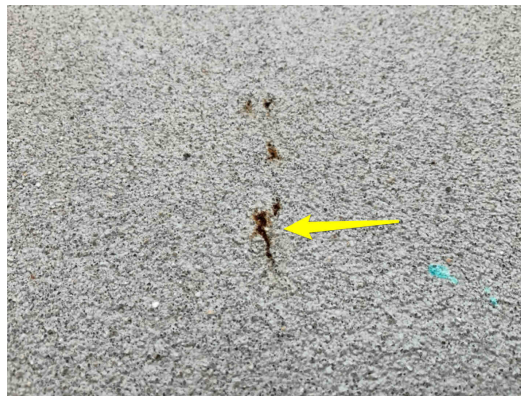
E&C 39: Areas of minor deterioration found at the waterproof deck coating at the UPSTAIRS DECK OFF THE LIVING ROOM. Maintenance or repairs needed. Recommend further review and/or repairs by a certified or licensed waterproof deck coating professional familiar with minimum requirements.

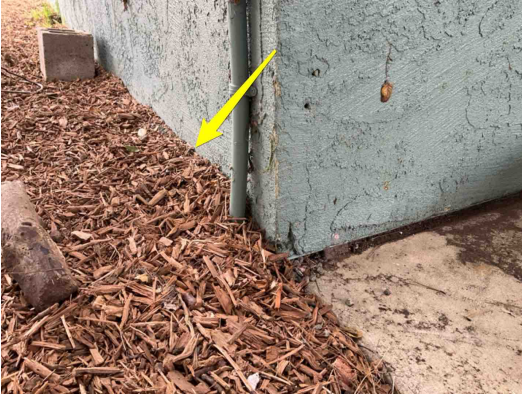
E&C MR 41: Soil level found high at areas of the perimeter along the foundation. (Recommend 6 inches from the bottom of the exterior siding to dirt, rock, mulch or wood chips).

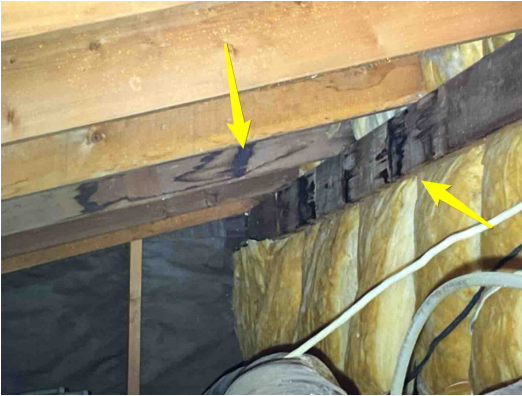
FI DS 62: Some moisture stains noted in areas throughout the attic. Refer to termite report for additional comments and/or recommendations.

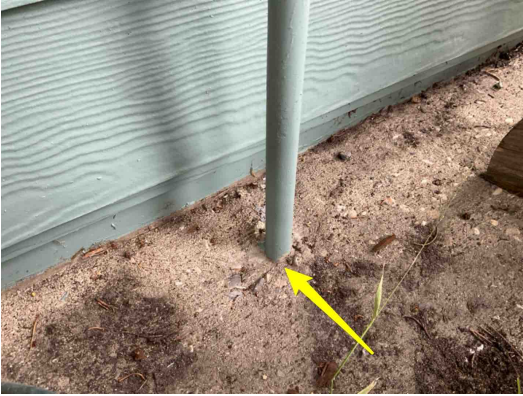
DS 65: Disclosure: Main water supply pipe found not protected or sleeved through concrete.

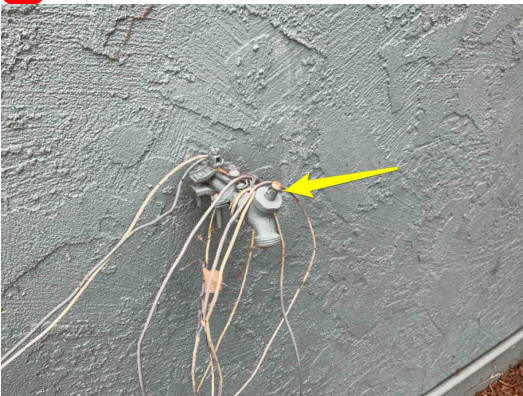
EAST SIDE

E&C 72: Broken or Missing handles at some exterior hose faucets

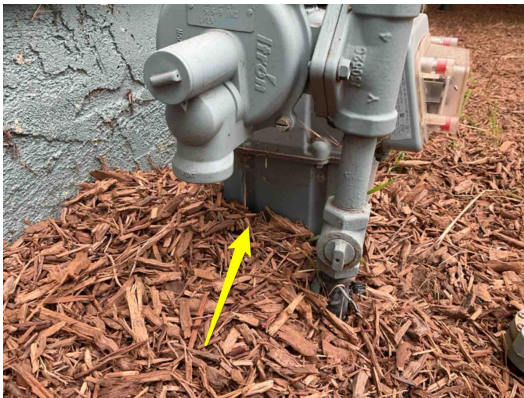
MR 80: Gas meter and/or shutoff valve in contact with ground or soil. Deterioration may occur. Maintenance, upgrades recommended.

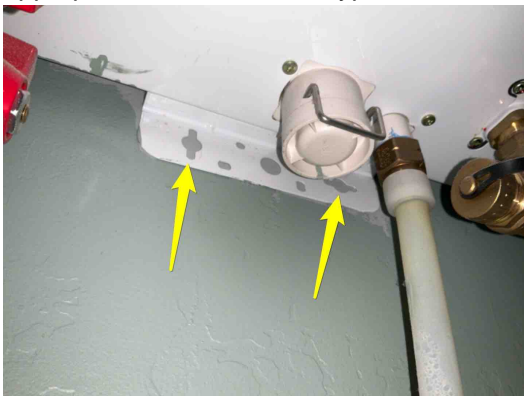
E&C 84: The TANKLESS water heater is NOT properly fastened to the wall at the BOTTOM STRAP with the appropriate number and/or type of fasteners. Refer to manufacture's installation requirements for proper fastening.

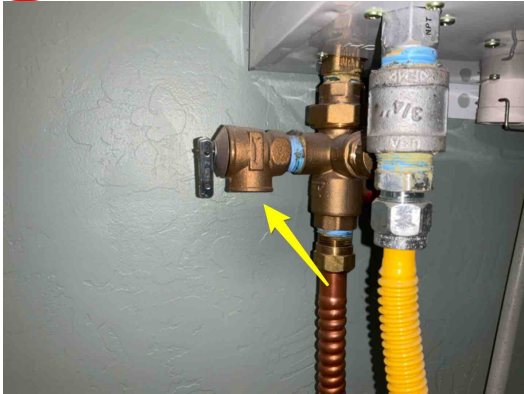
SC 85: Water heater TPR (pressure relief) pipe is missing / not installed.

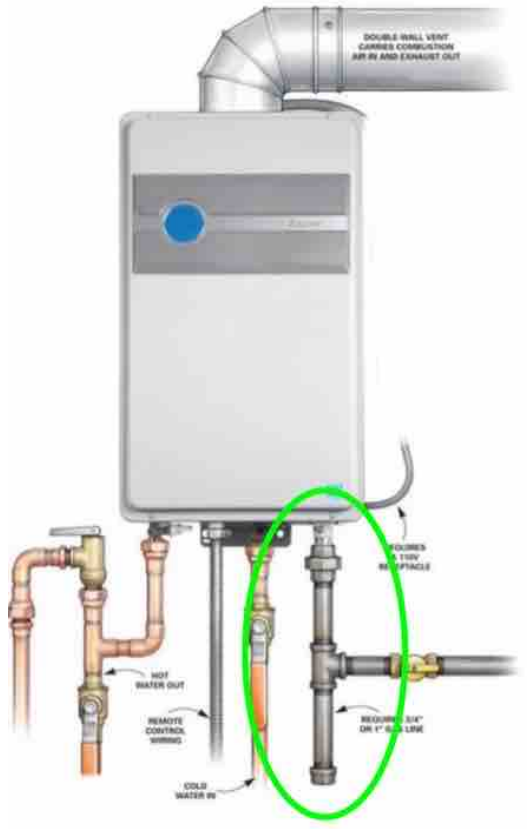
89: Recommend the installation of the missing sediment trap / drip leg at the gas TANKLESS WATER HEATER gas piping at flex connection by a certified or licensed plumbing professional familiar with minimum requirements.

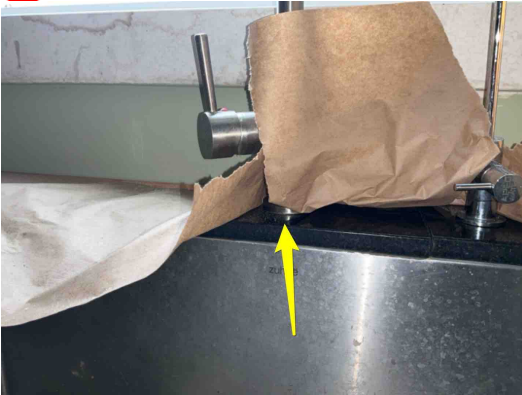
E&C 98: Kitchen sink faucet found loose at sink or counter connection. Maintenance or repairs Recommended.

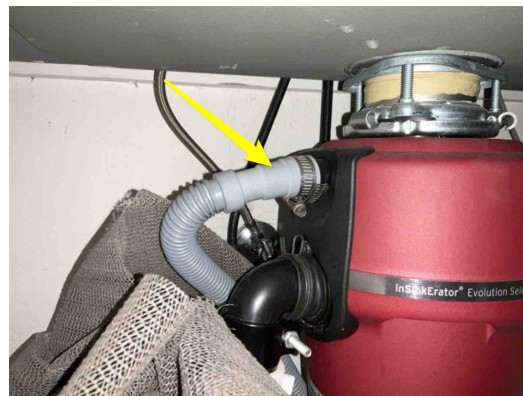
E&C 101: Improper installation of the dishwasher drain hose. Missing the Air Gap Device at the dishwasher drain per minimum codes and standards (California does not allow for high-loop methods or direct waste connections). {CPC 801.2}

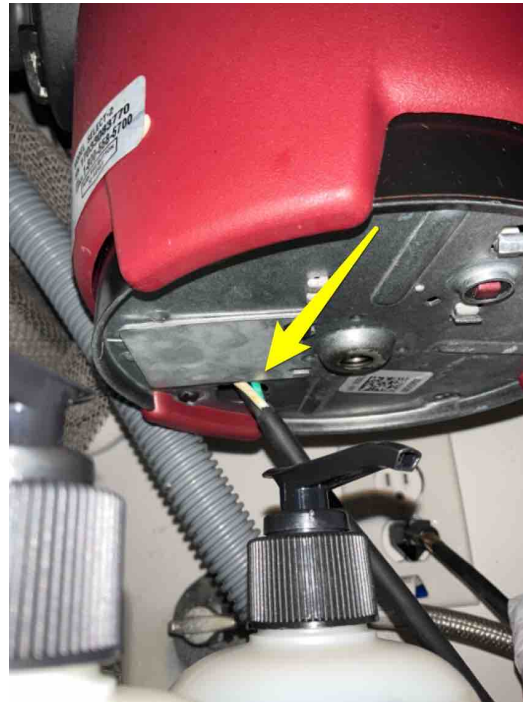
SC 108: Missing a proper electrical wire-bushing clamp at bottom of kitchen sink disposal.

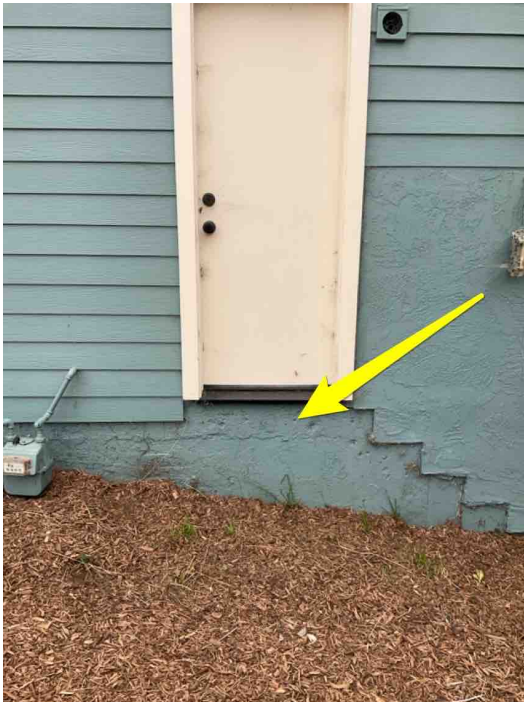
E&C 137: Disclosure: Missing a proper three foot door landing off exterior door: GARAGE EXTERIOR PEDESTRIAN DOOR

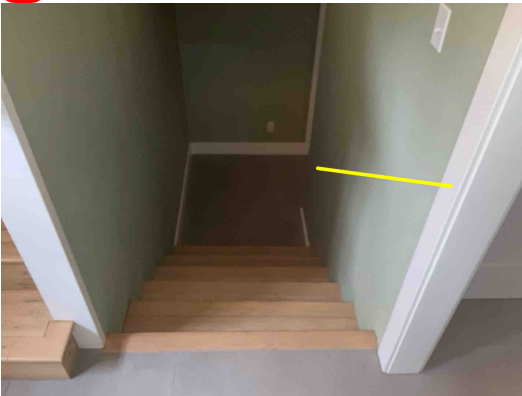
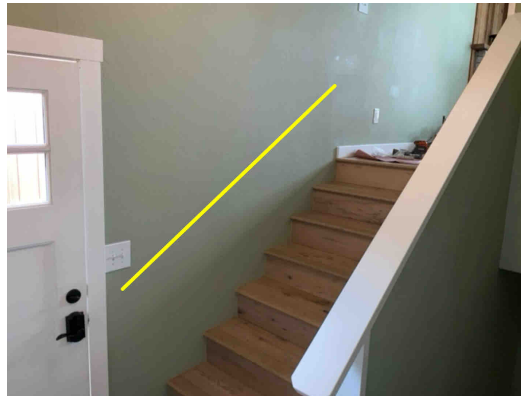
SC 157: Missing the interior stairway railings. Repairs warranted.

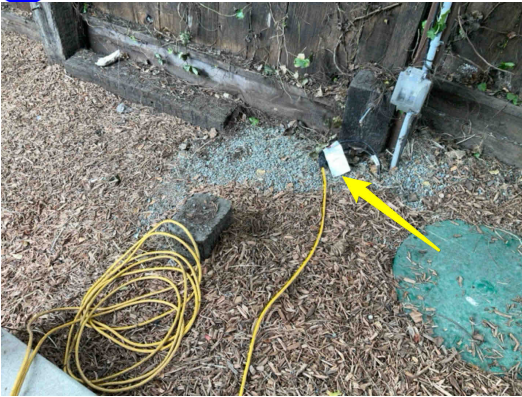
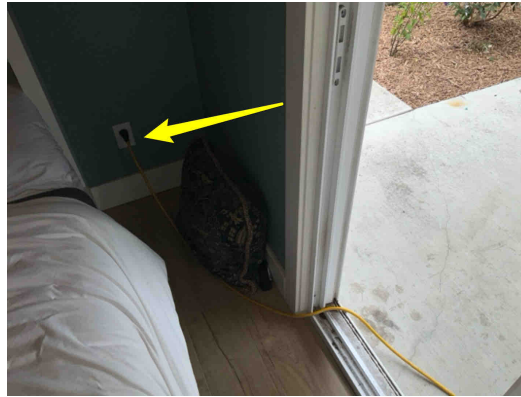
SU 179: Extension cord improperly used as permanent electrical wiring: SEWER EJECTION PUMP

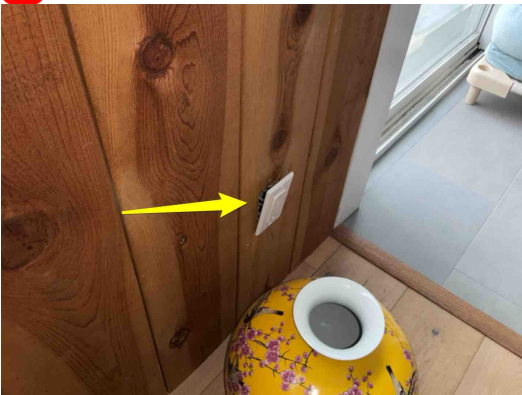
SC 181: Electrical outlet found loose in wall. Corrections warranted for safety: LIVING ROOM NEAR FIREPLACE

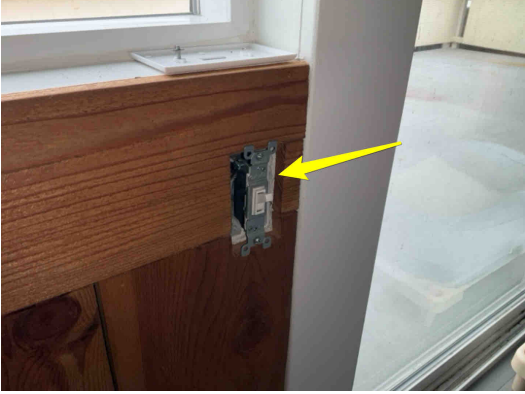
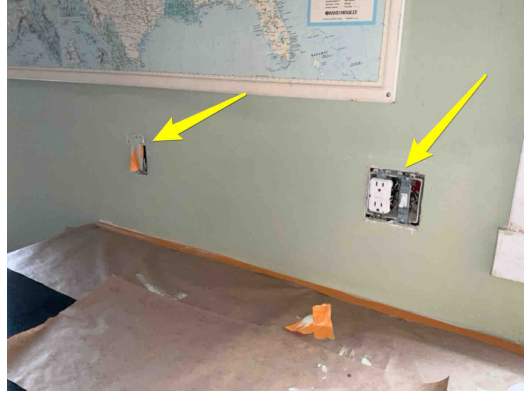
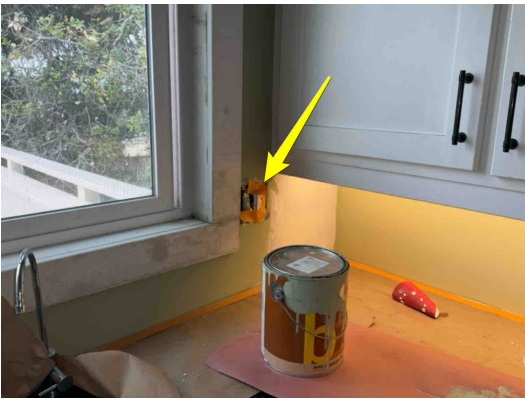
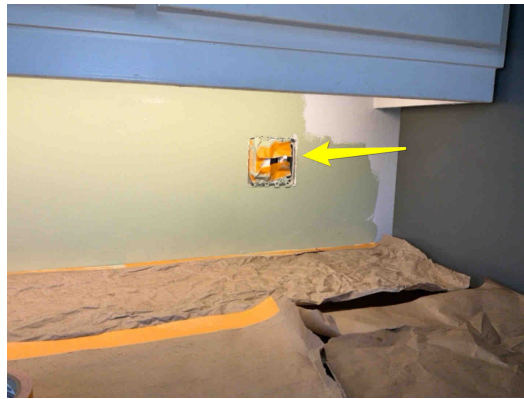
SC 182: Missing electrical cover plates at areas of the interior as the house appears to be under construction or in the process of being painted.

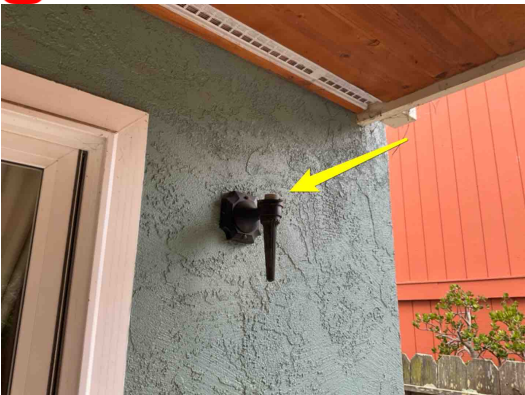
E&C 185: Light fixture is damaged: EXTERIOR LIGHT NORTHWEST CORNER

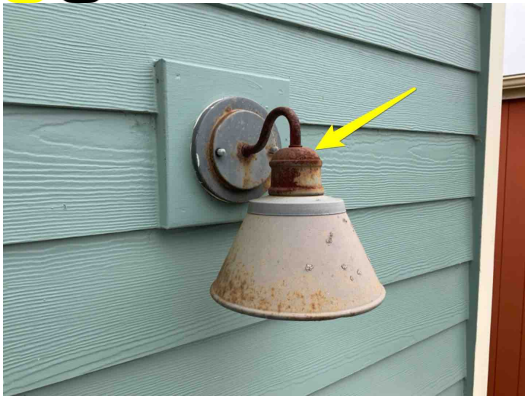
MR DS 187: Disclosure: Some exterior light fixtures found corroded.

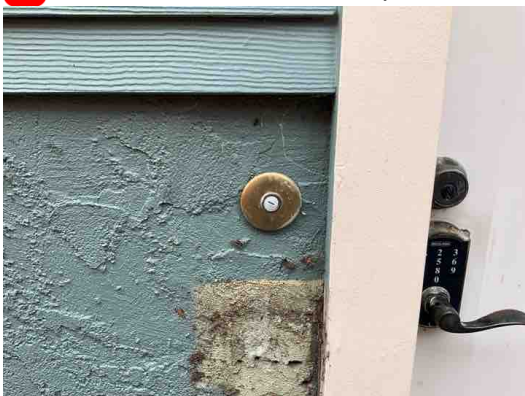
E&C 190: The doorbell did not operate.

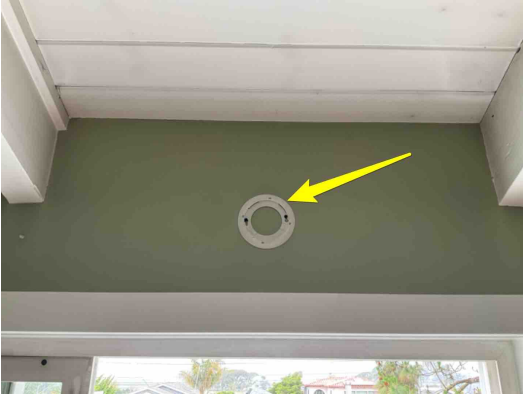
SC 191: Smoke detector missing at required location: **UPSTAIRS AND MIDDLE LEVEL HALLWAY**

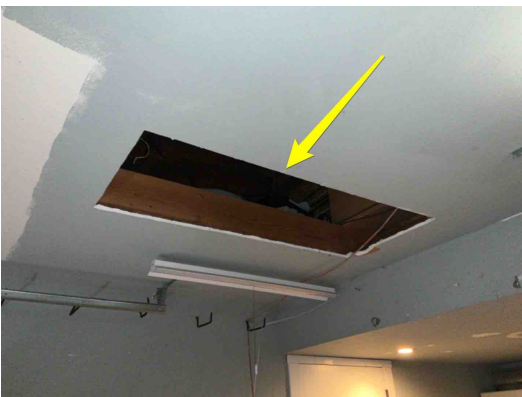
SC 200: The attic access in the garage does not meet minimum garage fire wall requirements. Upgrades are recommended.

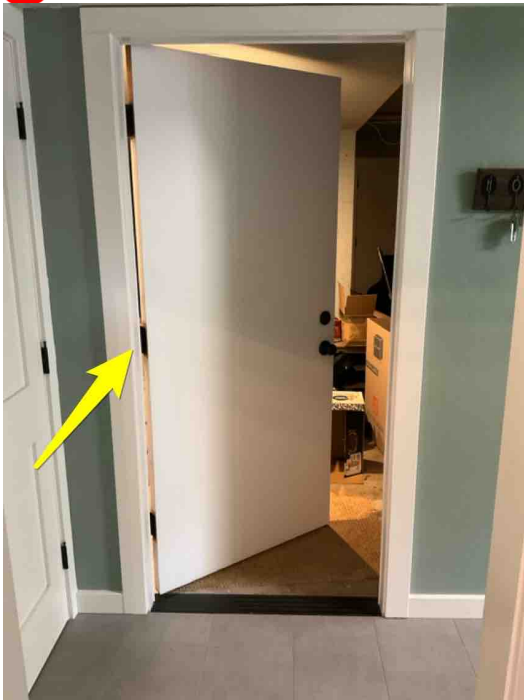
SC 202: Self-closer is non-operational at garage fire rated door to the living space.

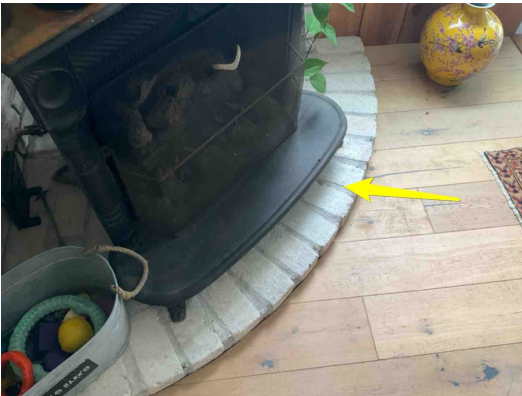
211: The living room fireplace appears to have been improperly altered and does not conform to minimum installation standards. Too many individual defects to list. Recommend further evaluation by a qualified/ licensed fireplace- chimney professional familiar with minimum codes and clearance requirements.

Undersized hearth extension over combustible materials

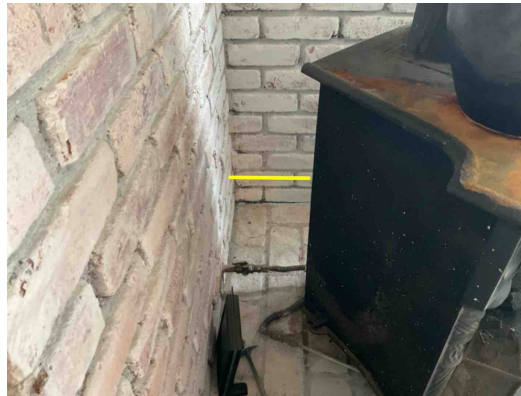
Inadequate clearance to the wall

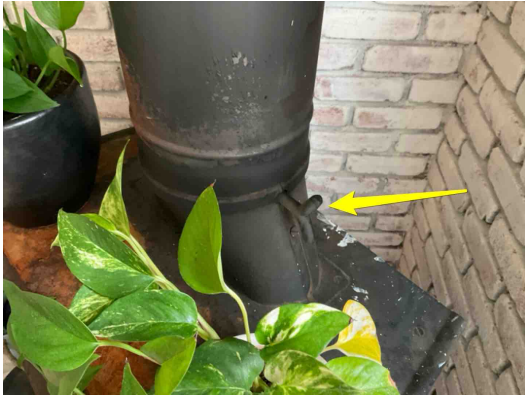
Functional damper on a fuel burning appliance

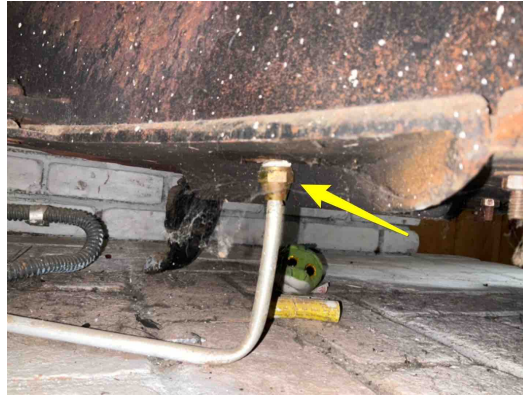
Missing a fuel regulator for a custom fuel burning appliance

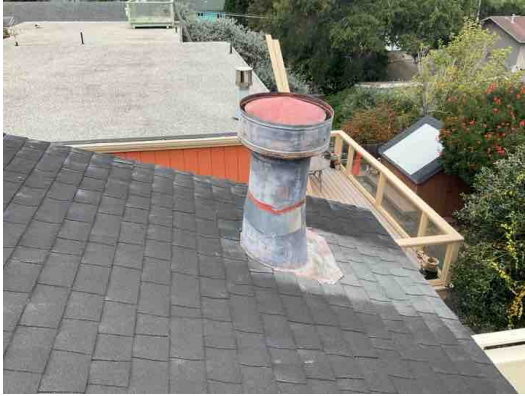
E&C 212: The LIVING ROOM fireplace metal chimney pipe terminates too low above the roof per standards. (Does not meet the minimum 3-2-10 rule). This can negatively affect the drafting of the fireplace and can lead to back-venting of smoke into the living space when a fire is burning. Upgrades and/or repairs warranted. Contact a qualified fireplace and chimney repair professional.

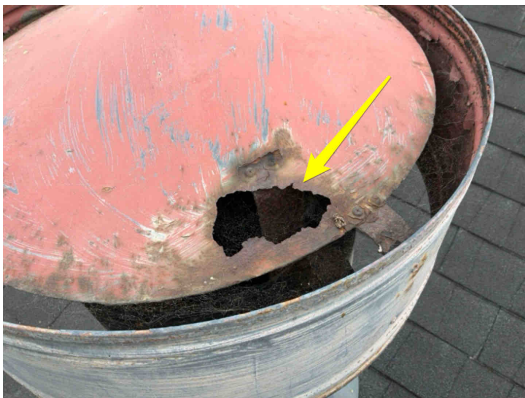
E&C 213: The spark screen and cap found rusted, deteriorated and/or damaged atop the LIVING ROOM fireplace chimney. Recommend replacement for fire safety. Contact a qualified professional.
