# ***Superior Property Inspections***

## **Property Inspection Report**

4224 Falcon, Long Beach, CA 90807

Inspection prepared for: Horning Family Trust

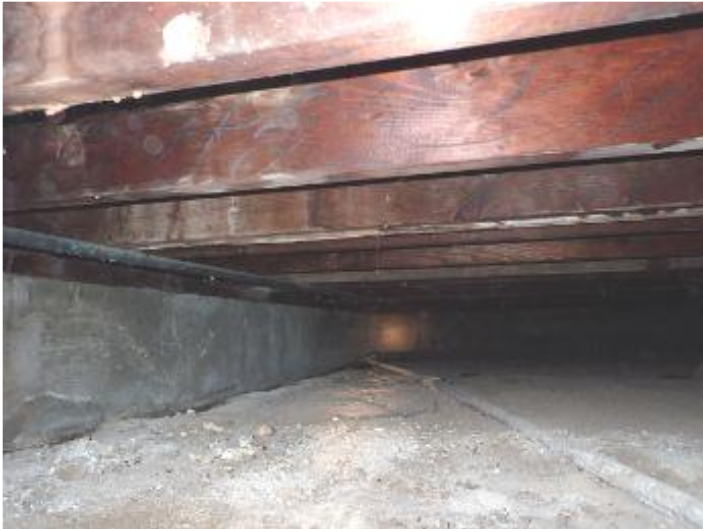
- The general condition of the concrete perimeter foundation appears serviceable.
- There are common cracks visible in random areas of the foundation. Most small cracks and poured concrete walls less than 3/16 of an inch usually indicate normal shrinkage and settlement. These cracks can be sealed with injected cement or epoxy to prevent water penetration. It is recommended to monitor the cracks for moisture intrusion or further movement.

The general condition of the concrete perimeter foundation appears serviceable.

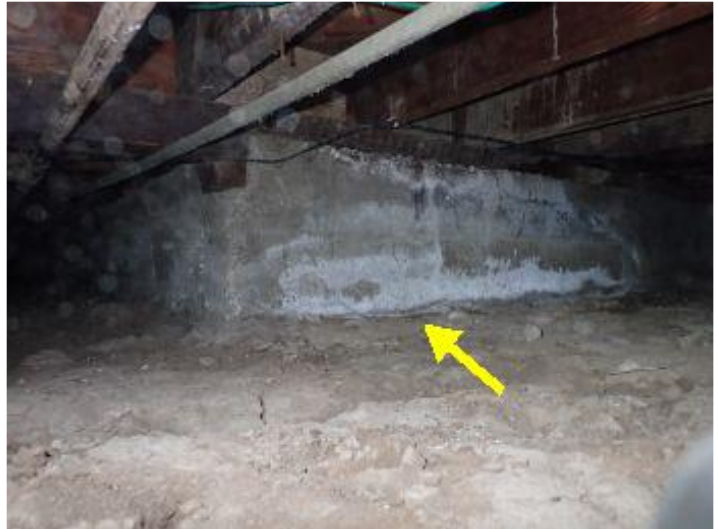
FYI: There are areas of efflorescence observed. This is a mineral deposit left behind from exterior water infiltration or standing water from plumbing leaks, etc.

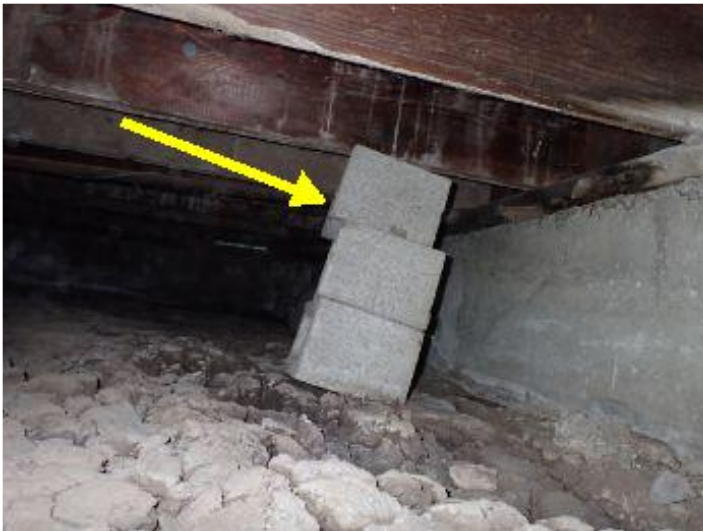
\*There appears to be a couple of non-professional supports installed. Loose concrete blocks in specific areas are not a concern. This may have been installed to minimize flexing floors, etc., but is not a concern.

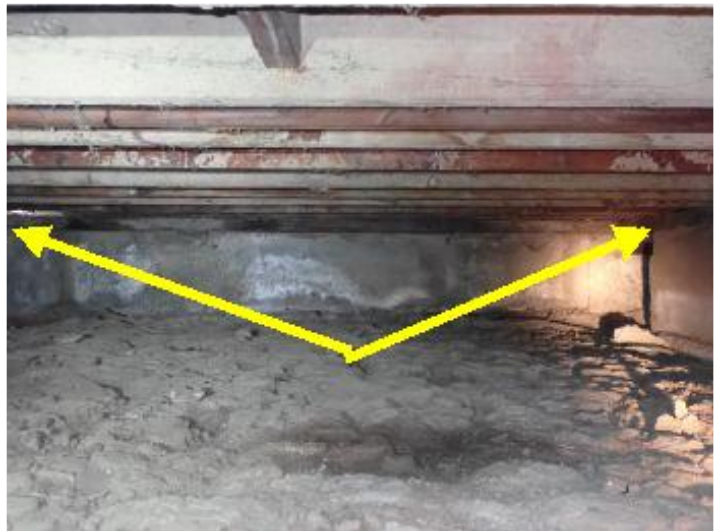
This simply highlights that the construction appears serviceable and this building has a clear span instead of numerous posts. When building a "clear span", the floor joist will be larger than 2 x 6s. Also note they are all level showing no shifting up or down despite seismic activity.

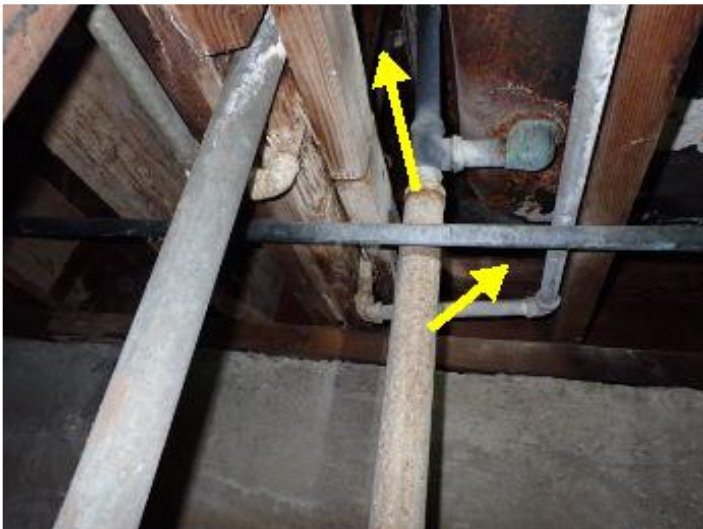
There were no active leaks or damaged framing at the time of the inspection under the bathtub. It is recommended to install screen material under the tub at the plumbing to prevent pests from entering the wall cavity.

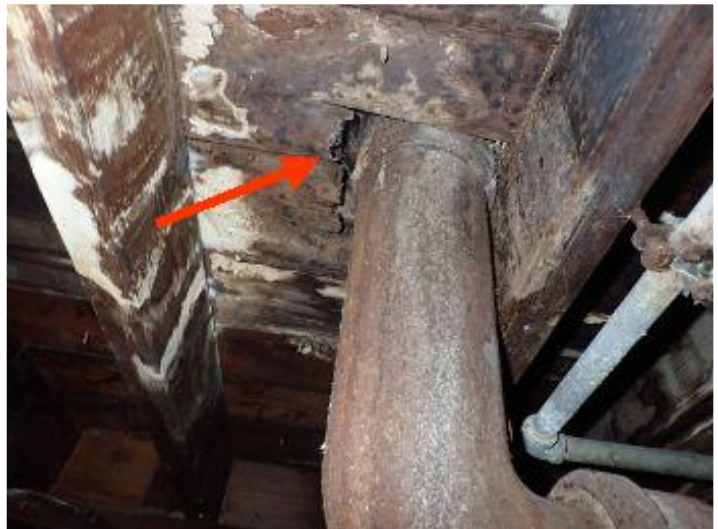
**\*\*Wood rot, moisture damage observed at the Front bathroom toilet.**

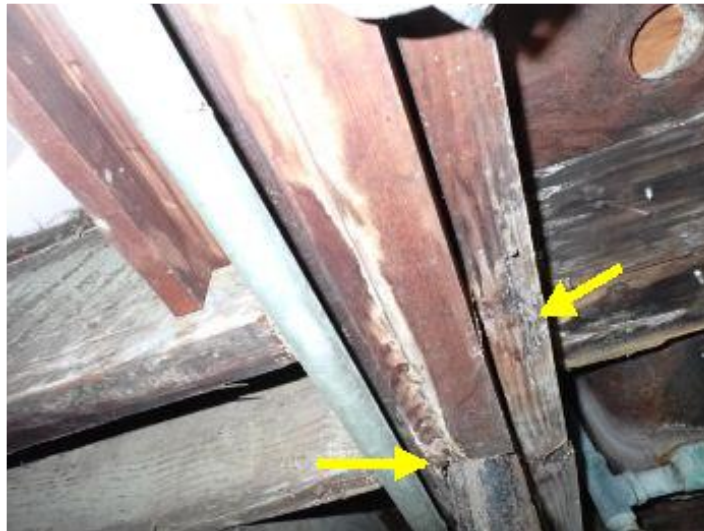
This simply shows past, old evidence of subterranean termites. There was no significant damage to the floor joist by the crawlspace entrance in the closet.

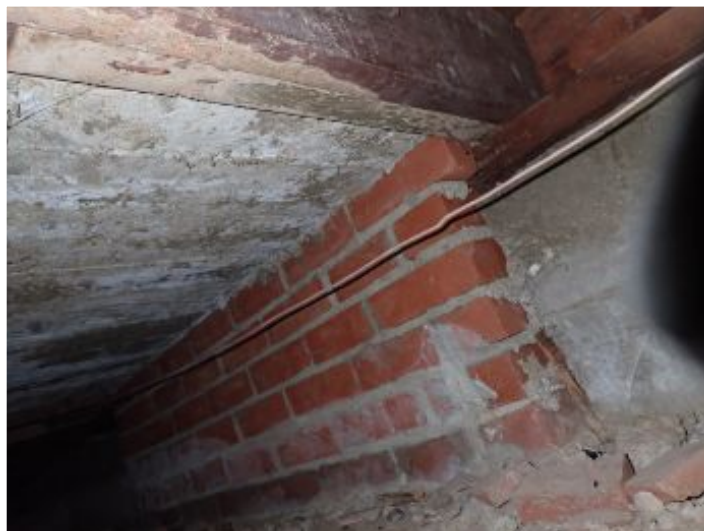
The visible Foundation under the chimney appears serviceable when viewed from the crawlspace. There were no signs of deteriorated mortar or displaced bricks.

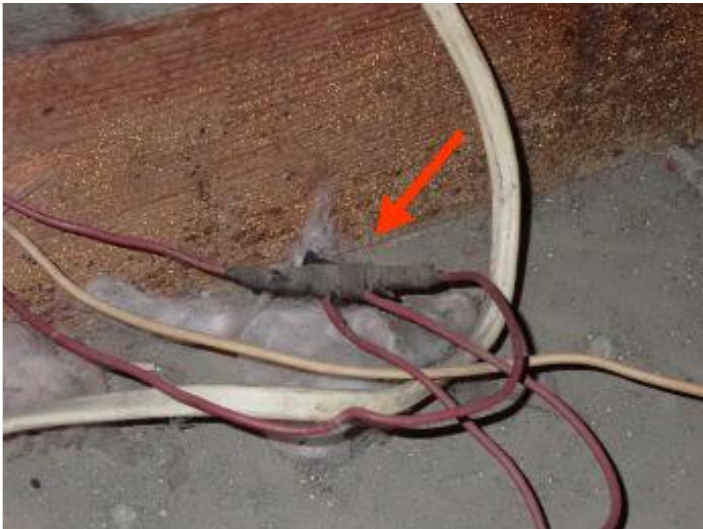
\*Exposed wire splices were visible in the attic.

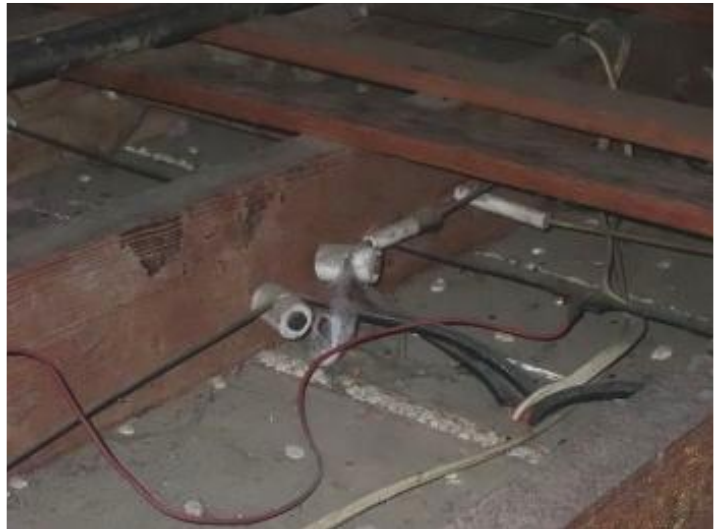
Live knob and tube wiring present.

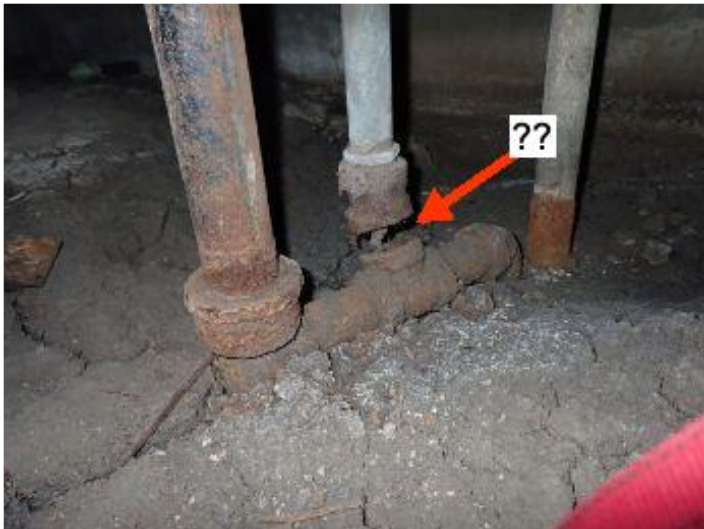
\*\*There is a disconnected plumbing line creating an active leak in a drain below the bathroom.

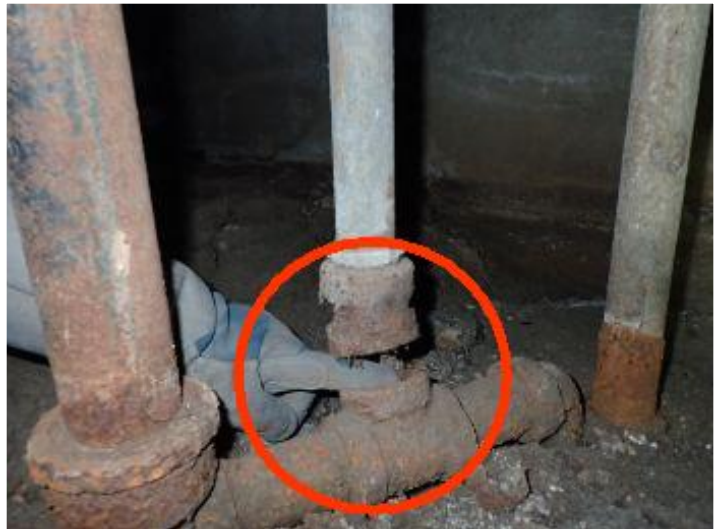
As the inspector is pointing to the damaged fitting, the pipe is actually disconnected, and any blockage of the drains will overflow into the crawlspace.

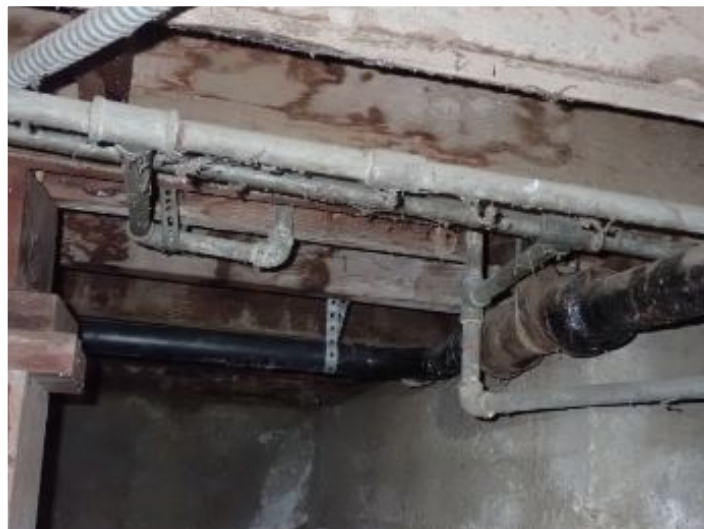
No major concerns with the plumbing beneath the kitchen when viewed from the crawlspace.

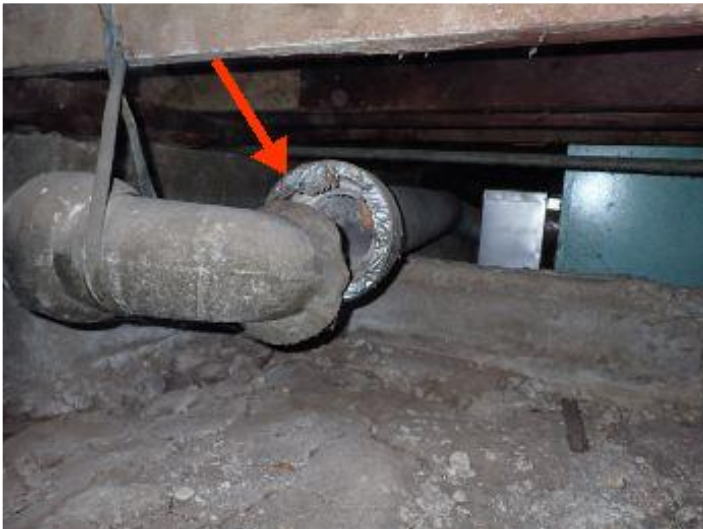
**\*\* it is currently not safe to operate the floor heater. The exhaust vent is disconnected in the crawlspace, and this would allow exhaust gases to enter the living space.**

- It is recommended that a licensed HVAC contractor further evaluate and service the unit to determine what repairs are necessary and/or recommended.

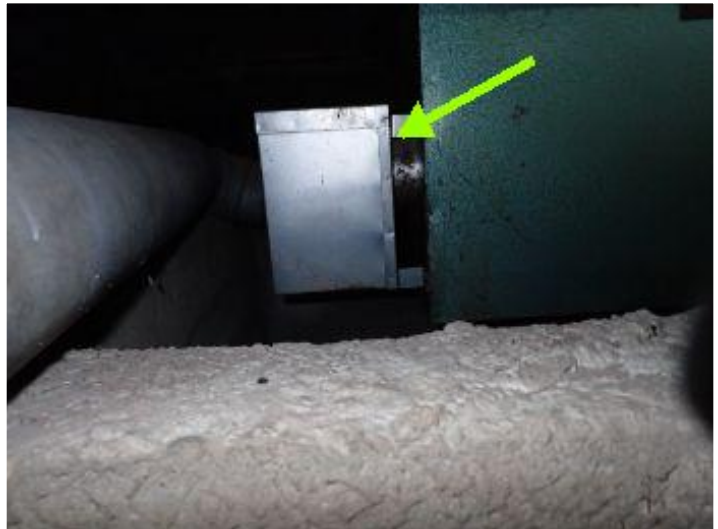
FYI: When viewing the floor heater from the crawlspace, there was no damage to the exhaust chamber.

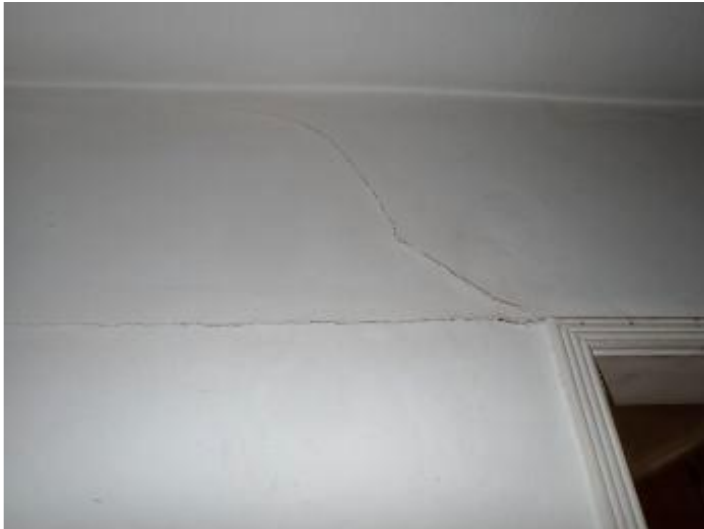
- The general condition of the interior walls appear serviceable except as noted.
- There are some common cracks visible that do not appear to be a structural concern. After further evaluation of the attic/roof and foundation, the interior wall cracks simply reflect past seismic activity and are not from structural failure.

This shows a crack that was a concern to the client. This is the door frame between the kitchen and dining room.

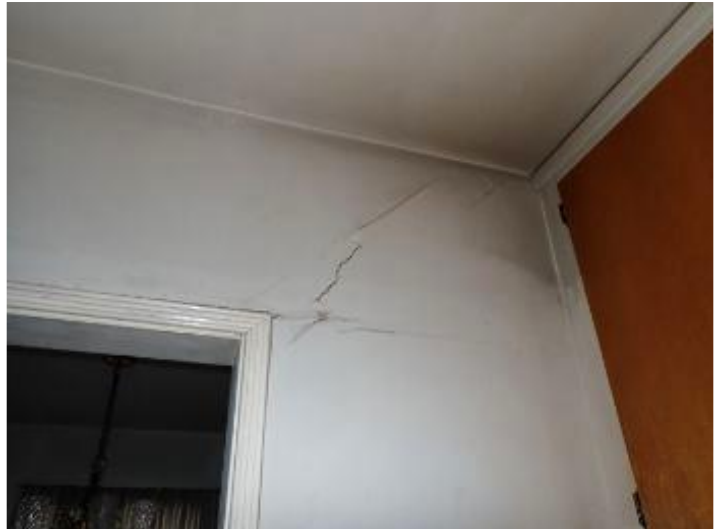
This is the same door frame from the kitchen side, showing the identical direction of small cracks.

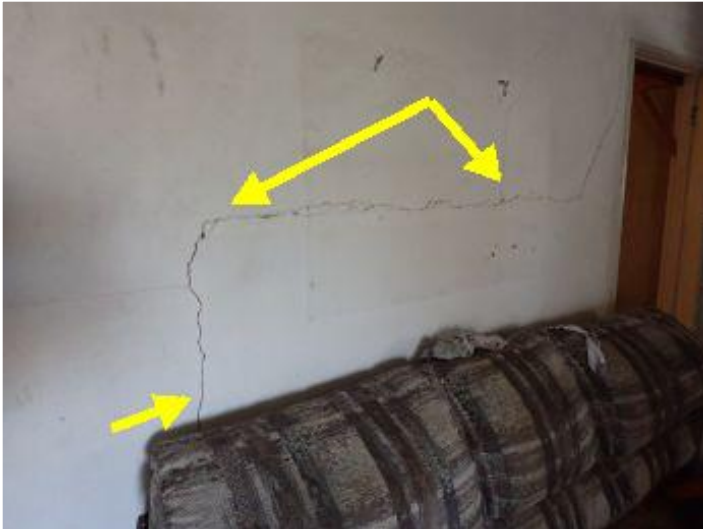
This is the living room where the original fireplace was sealed. The framing of the original mantle is readily visible as when the fireplace was covered, the wood was not dried and cured like the old original 1942 house. And in the atomic object like a house cannot make a straight line and so the crack is simply following the replaced framing.

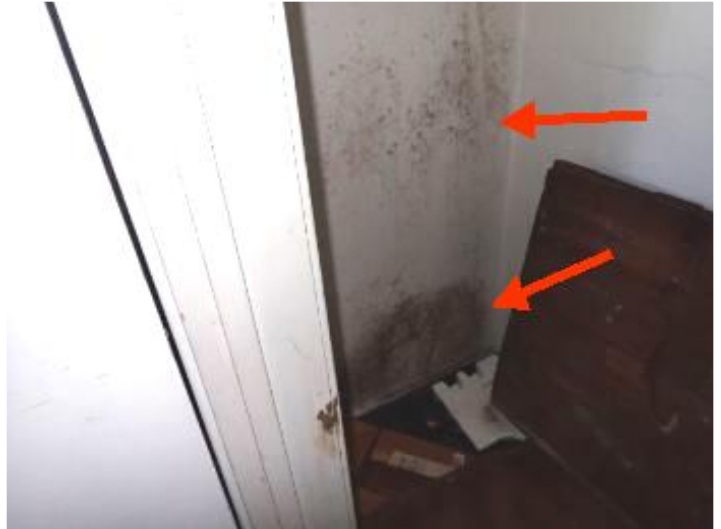
- FYI: The House has been vacated, and the plumbing has not been used for a period of time. There was no wet soil under the house at the time of the inspection. Interior closets can also develop mildew from self introduced moisture on wet golf shoes with grass, sweaty tennis shoes, or wet rain coats hung in the closet, etc. There were no supply line plumbing leaks in this area. There is a damaged drain line under the bathroom that is adjacent to this closet and past moisture concerns would have allowed this mildew growth.

\*\*Mildew/mold-like substance and moisture stains are present inside the closet with the crawlspace entrance directly behind the bathroom.

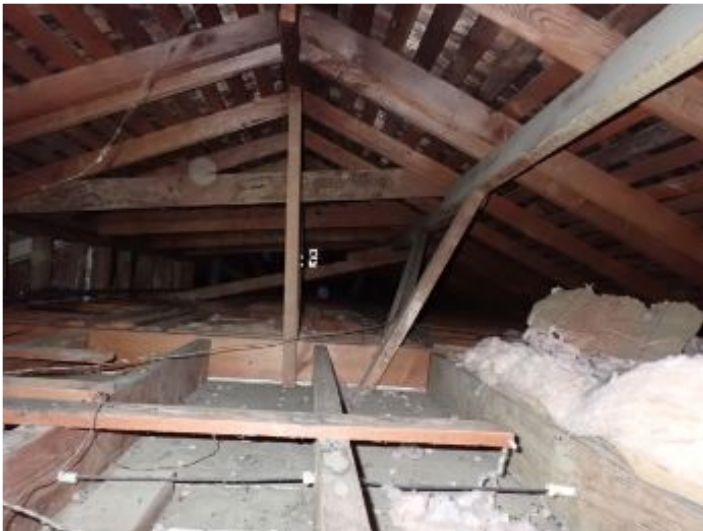
The general construction and framing in the attic appears serviceable. Notice all the individual skip shaving boards are hugging the roof rafters. No significant movement or separation is visible.

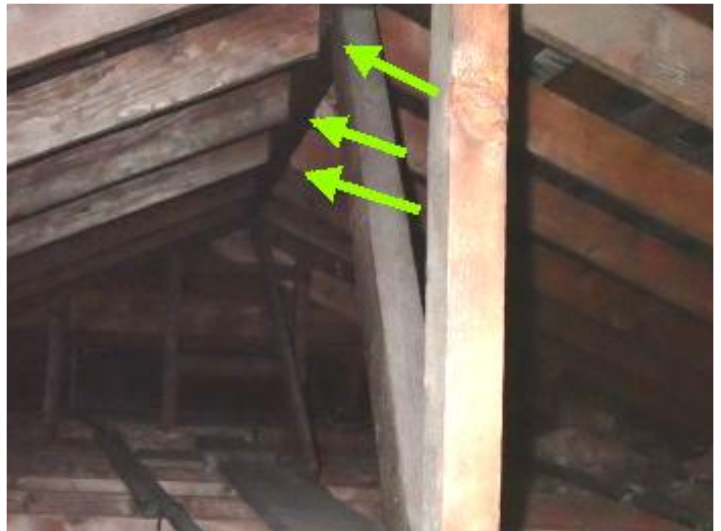
The roof will swing more than the foundation footing that is bolted. This attempts to show that none of the roof rafters are separating from the center Ridge

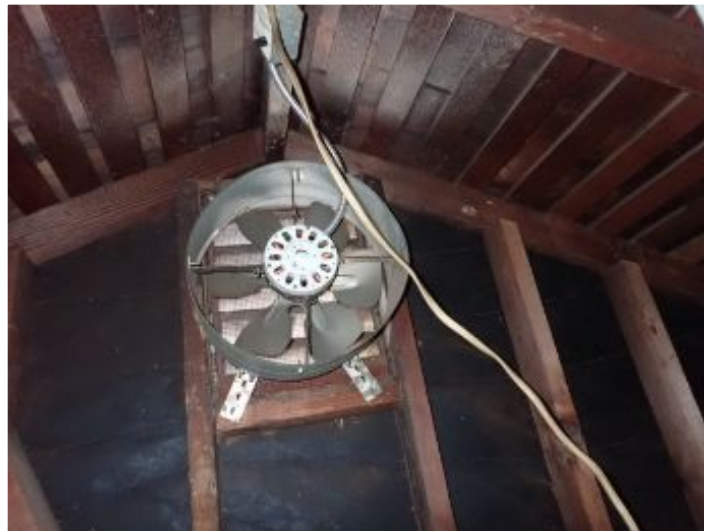
There is a powered attic fan that has been installed.

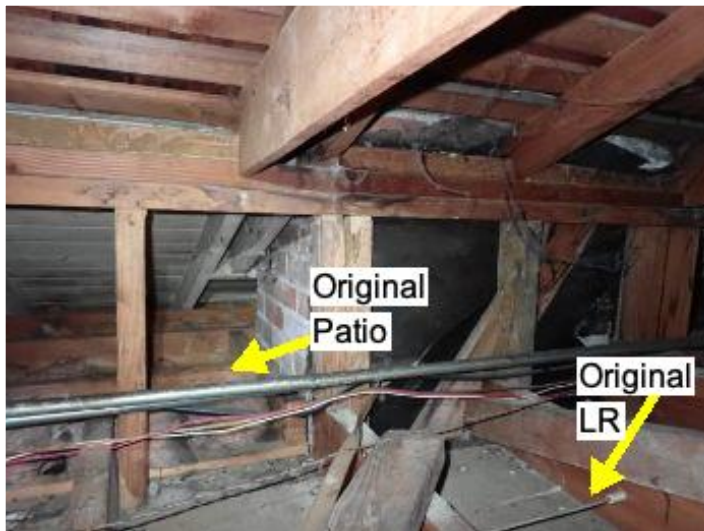
The original chimney was outside the family room that is in the foreground. The continuation of the roof that has a different color was now an enclosed patio. This also alludes to the living room cracks where the fireplace opening was sealed in another picture in this report.

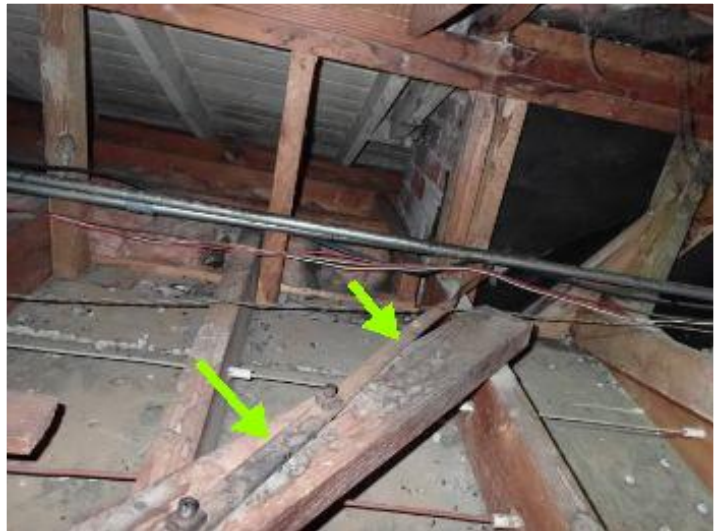
The current brick chimney is flush against the wall without gaps. This also shows there was original seismic bracing bolted to the chimney.

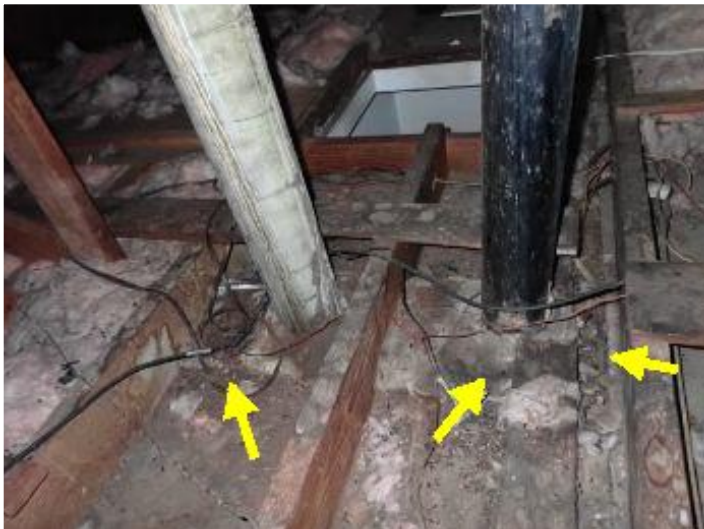
After 80 years and multiple roofs, there are minor stains in the attic, but no damage to the plaster ceiling by the heater and main plumbing vent pipe. Significant plumbing leaks will cause the wood to swell and also create cracks and this is not the condition in this location that could've made cracks anywhere near the living room.

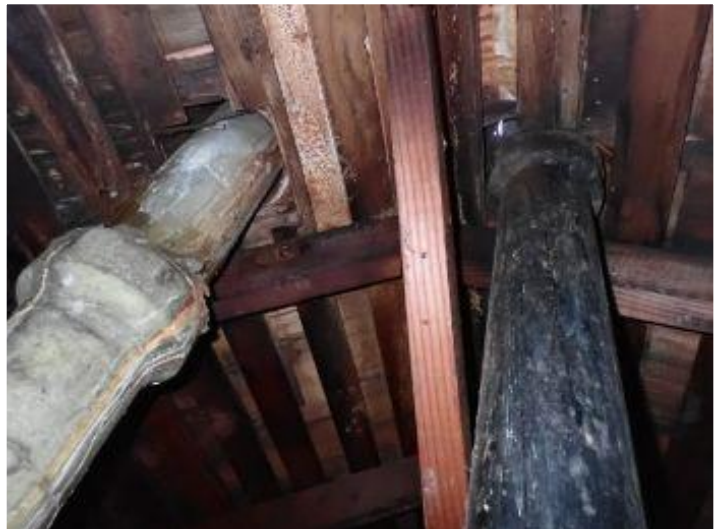
Continuing at the same vent pipes that show moisture stains at the roof line. Normal maintenance of roof mastic around vents is to prevent leaks and moisture stains are visible from past leaks and possibly some current.

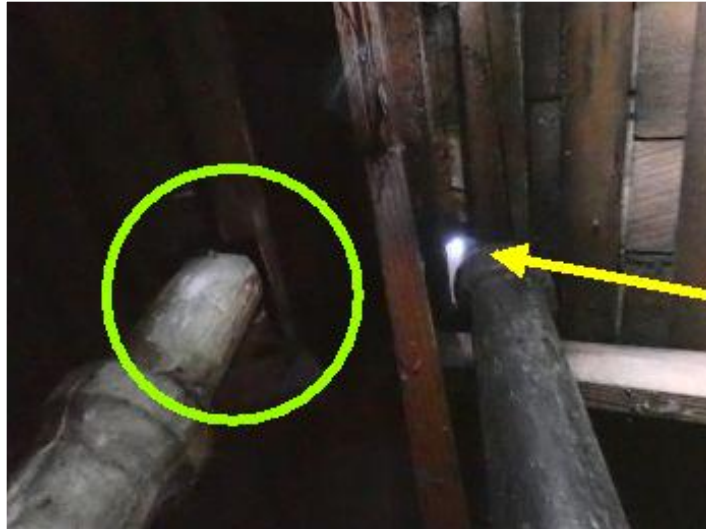
This photo taken without the flash camera shows a little bit of ambient light denoting that this one vent needs to be resealed at the roof. Not a cause of cracks in the kitchen or living room wall as this is above the bathroom.
