**Address:** 26 Oceanaire Dr, Rancho Palos Verdes

**Date of Inspection:** 11-14-24

## Main Sewer Line Inspection Report

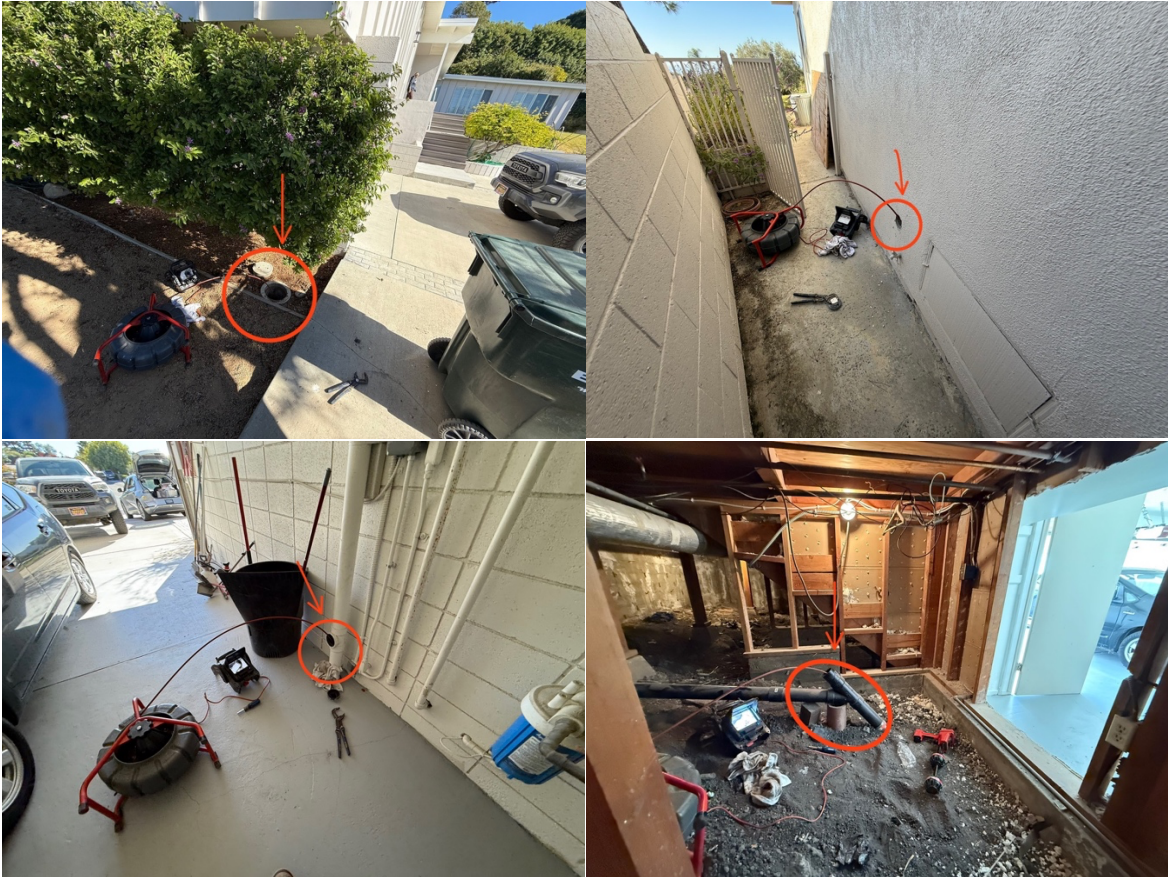
**Location of cleanouts used for inspection.**

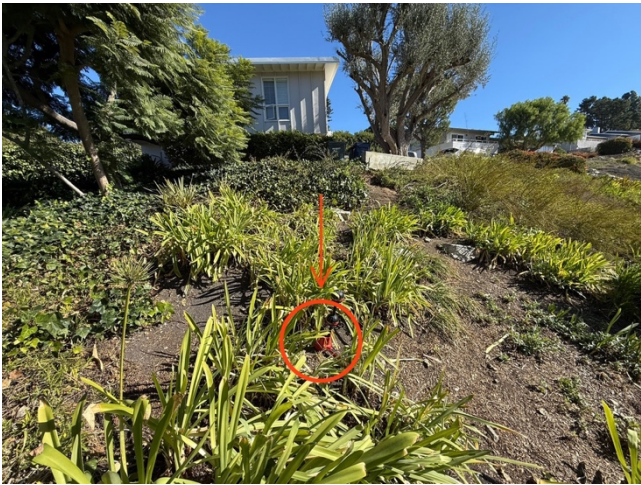
**Path of Main Sewer Line on Property:** The main sewer line is made of a plastic material pipe from the cleanout as it travels down the front yard/planter area. The pipe then transitions into a clay material pipe where the sewer line is currently blocked.

**Types of Materials used in sewer line:** Clay is a good material for sewer lines as it does not rust or corrode over time. There is no limit to how long clay can potentially last but can be damaged by earthquakes or roots or even bad installation. There are areas of root intrusion within this clay main sewer line that will need to be cleared by hydrojet. Roots intruding into a clay system are common and can normally be maintained with regular sewer line cleanings. If neglected, roots can cause blockages in the pipe as well as potential damage.

**Furthest camera was pushed due to block in sewer line.**

**Areas Needing Attention:** The root intrusion in the clay pipe should be removed by hydrojet at this time. Hydro-jetting is high powered pressured water that will cut the roots and push them out towards the city sewer. This will allow us to view and inspect the covered sections of clay pipe and evaluate the condition of the pipe once the roots are removed.
