Inspection Report

Property Address:
560 S. 12th St.
Grover Beach CA 93433

6/13/2025

Harper Homes: Home Inspection Services

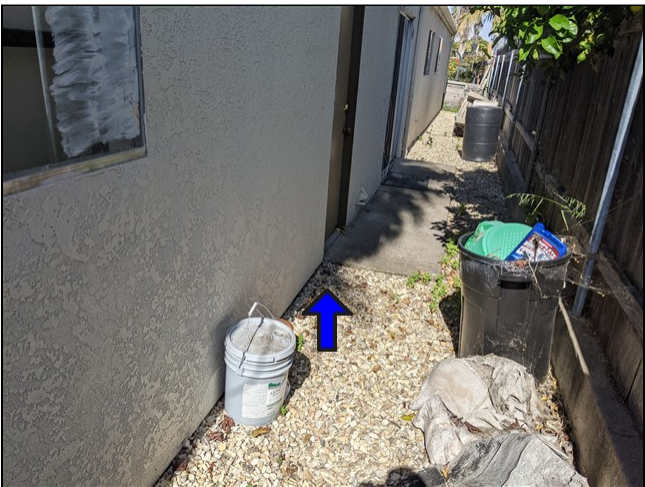
1.0 Item 1(Picture)

Soil or landscape materials are pushed up against the stucco siding at various areas around the home. Landscape maintenance is needed to remove material from holding moisture at the siding while maintaining functional drainage away from the foundation.

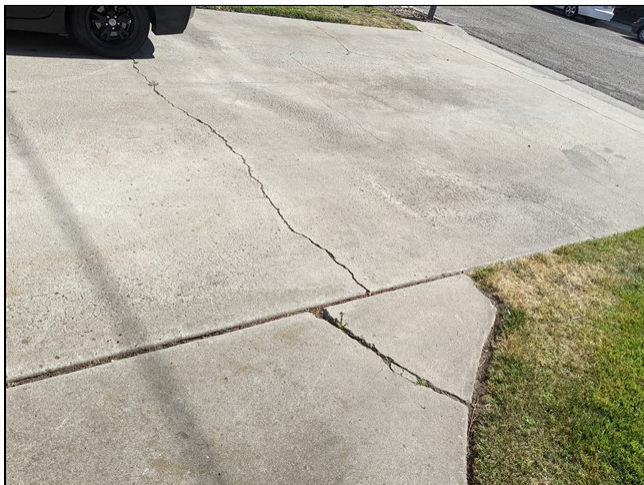
1.2 Item 1(Picture)

Concrete cracks were noted on the walkways, likely due to tree roots or expansive soil. Walkway cracking is not affecting the structure. Any walkway height variance over 3/4" should be altered or repaired to prevent a possible trip hazard.

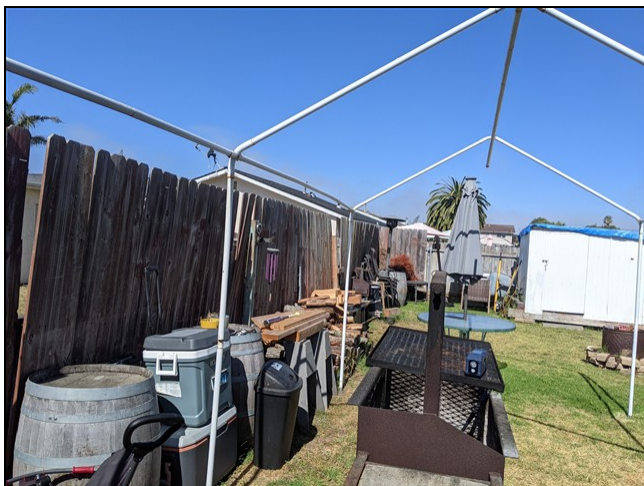
1.3 Item 1(Picture)

Several fence posts are loose or broken and fence boards are damaged or unattached. Recommend repairing or replacing fence as needed.

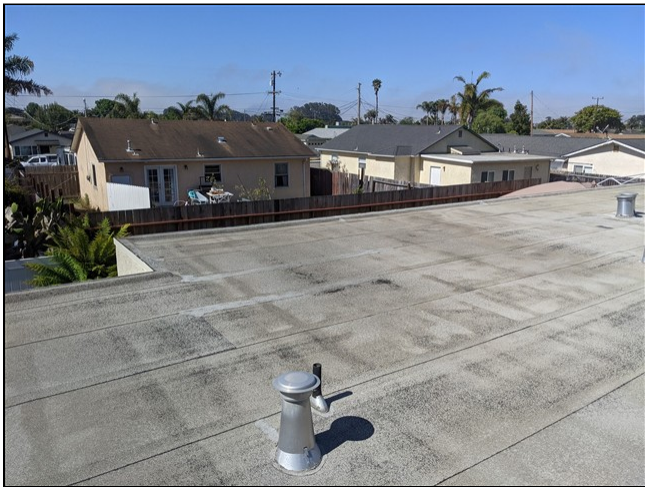
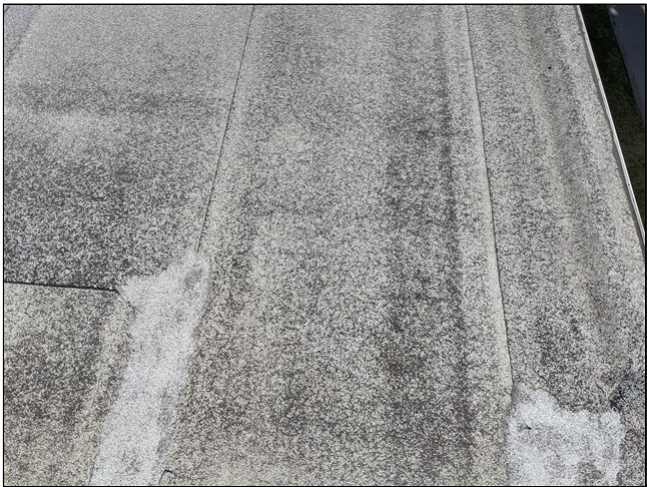
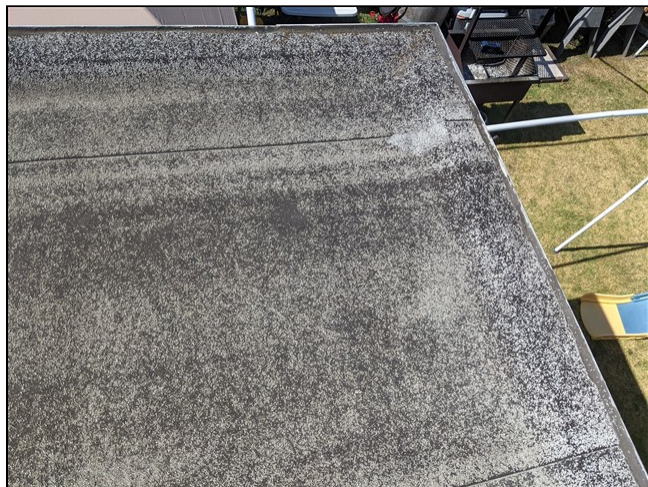
Areas of the roofing material are weathered and showing signs of age. No signs of active leaks were noted in the interior.

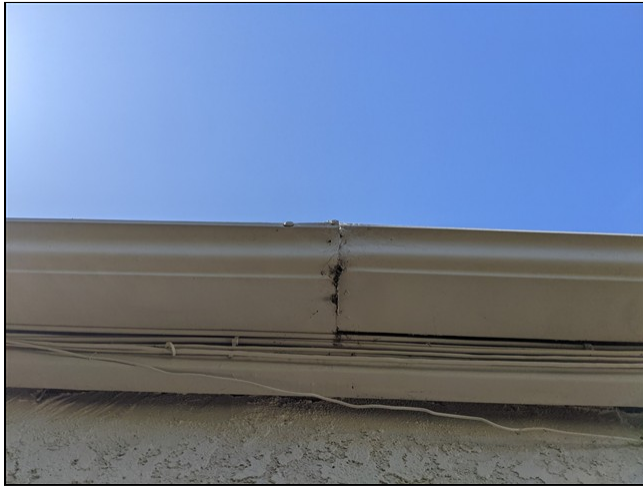
2.3 Item 1(Picture)

The gutters contain debris in areas and need cleaned and an annual maintenance schedule established to allow intended drainage of roof runoff water away from the home.

Downspout extension needed at various locations to channel rain water away from the foundation and help promote functional drainage.

Gutter seams show signs of leaking. Recommend cleaning and sealing the seams with gutter sealant to prevent continued moisture exposure at the fascia.

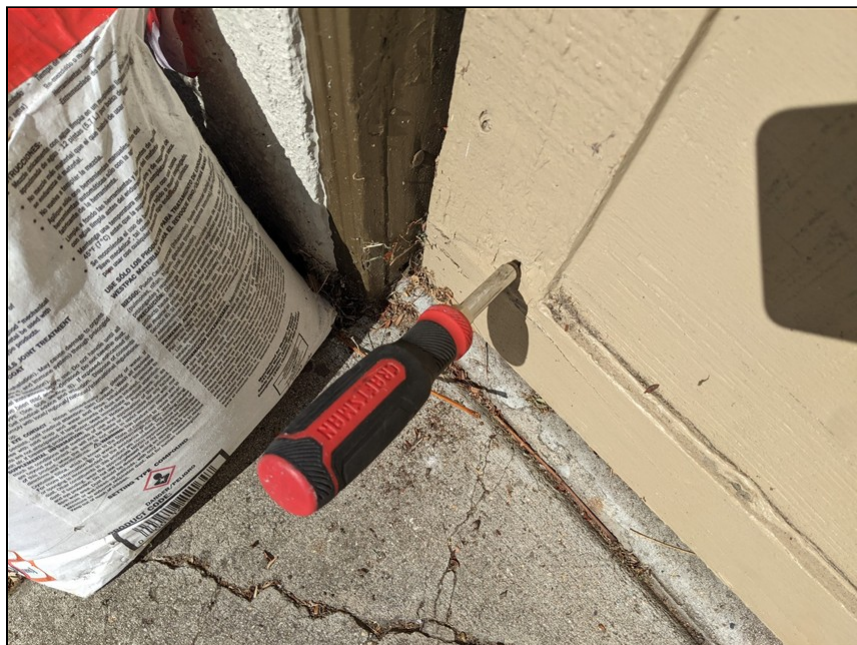
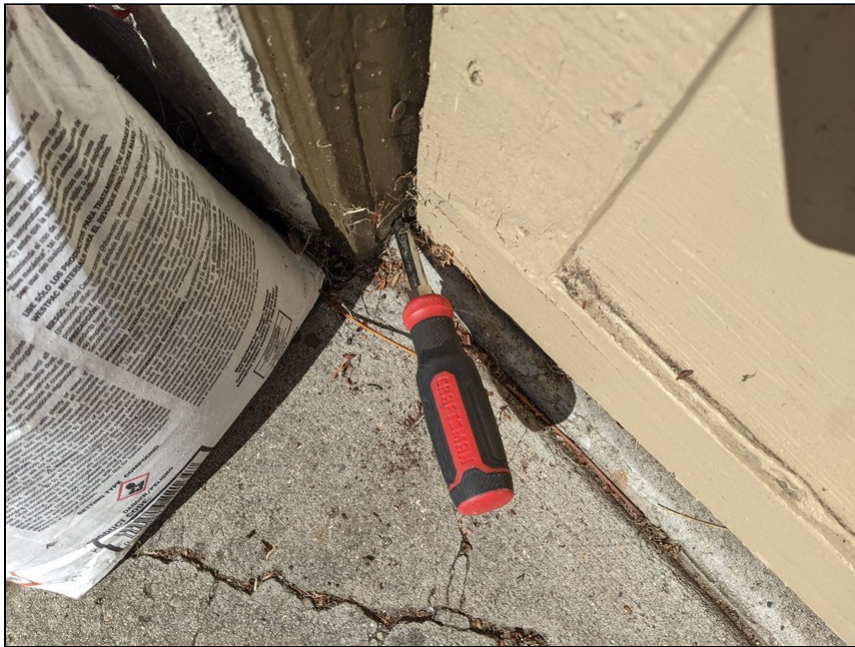
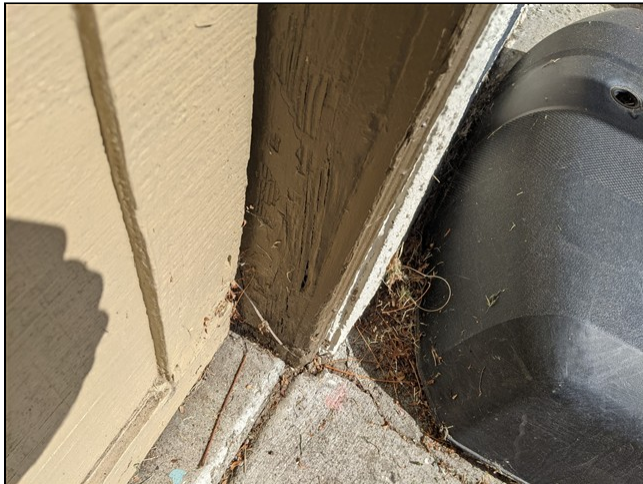
Slight stucco cracking noted at various areas around the building. This can be typical with stucco siding, and cracks should be sealed at the next paint maintenance interval to improve cosmetics and prevent further weather exposure.

Stucco extending into the soil, typical for the era of construction. Recommend drainage improved to limit the significance of this condition and limit the opportunity of run off water to wick up into the walls.

Moisture damage noted at the trim and garage doors. Recommend further evaluation by a structural pest control operator and make repairs as prescribed.

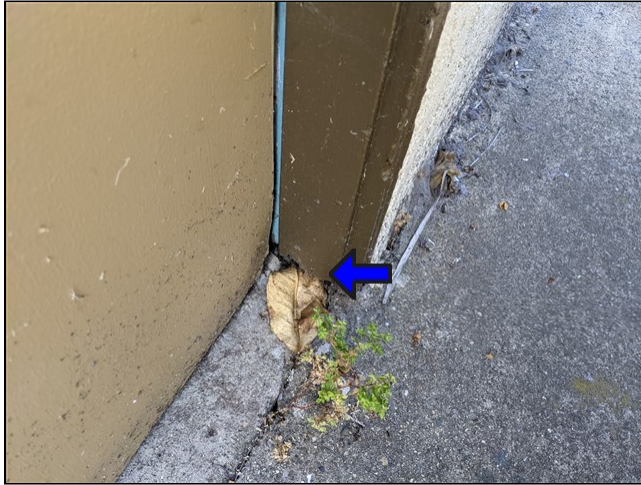
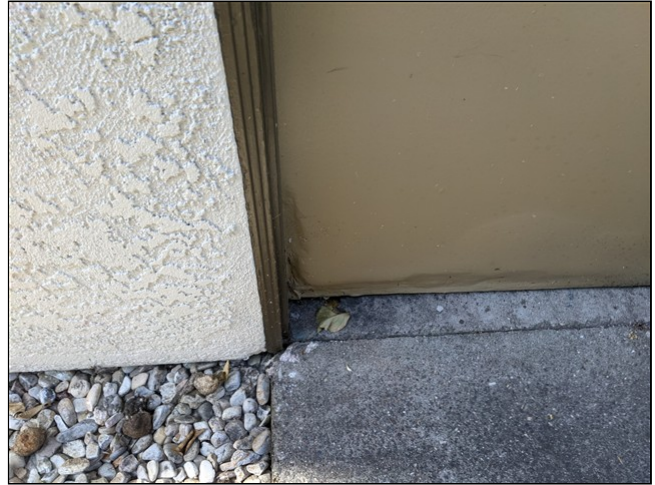
Moisture damage noted on the door at the right exterior door and jamb. Recommend further evaluation by a structural pest control operator and make repairs as prescribed.

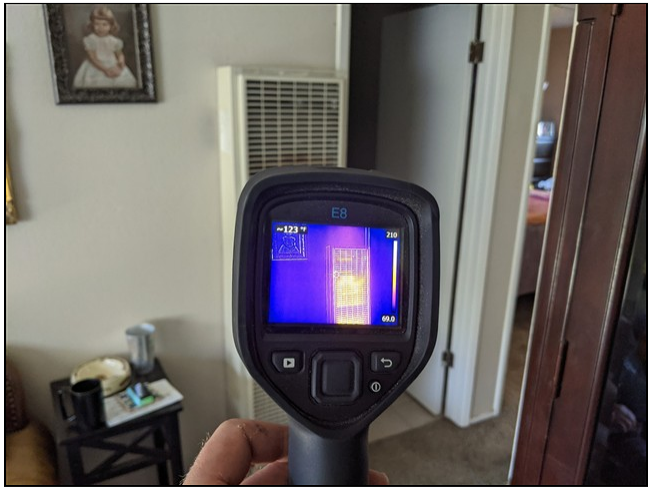
3.0 Item 1(Picture)

The wall heater in the front unit appears to be in working condition, but is over 30 years old and at or near the end of it's serviceable life. Recommend service performed by a qualified HVAC contractor to help conserve the remaining life of the unit and have replaced as necessary.

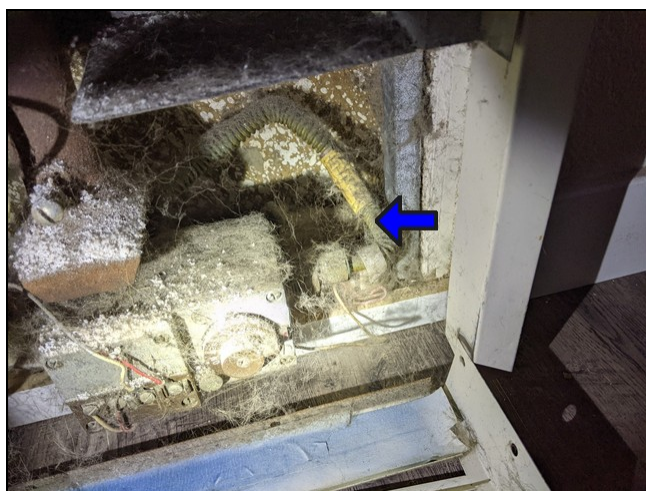
4.3 Item 2(Picture)

An older-style brass flexible gas connector was observed at the wall heater in the rear unit. These connectors are considered outdated and may be prone to failure over time. Replacement with an approved, modern connector by a qualified plumbing or HVAC contractor is recommended for improved safety.

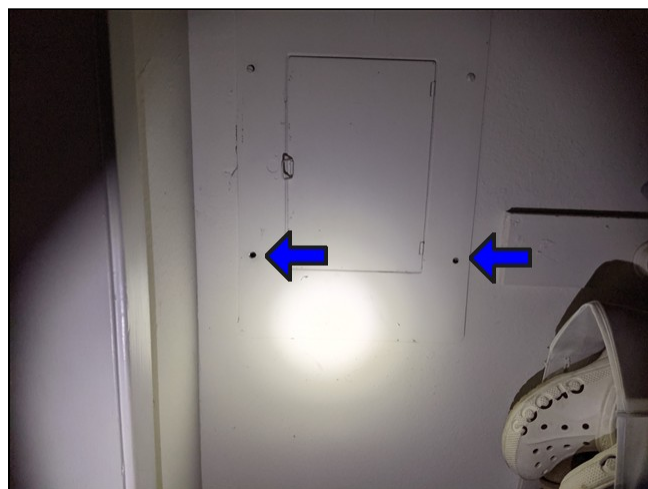
5.1 Item 1(Picture)

Zinsco brand electrical panel noted for the sub panels. This brand of panel has been known to fail prematurely or not trip properly, creating an unsafe condition. No signs of failure were noted at the time of inspection. Recommend further evaluation, as needed, by a qualified licensed electrician.

Rear unit sub panel front cover screws have pointed ends and are improper. Recommend proper non-pointed fasteners utilized to prevent damage to the wires and a possible unsafe condition.

Front cover screw missing at the rear unit sub panel panel and needs to be installed to prevent a possible unsafe condition.

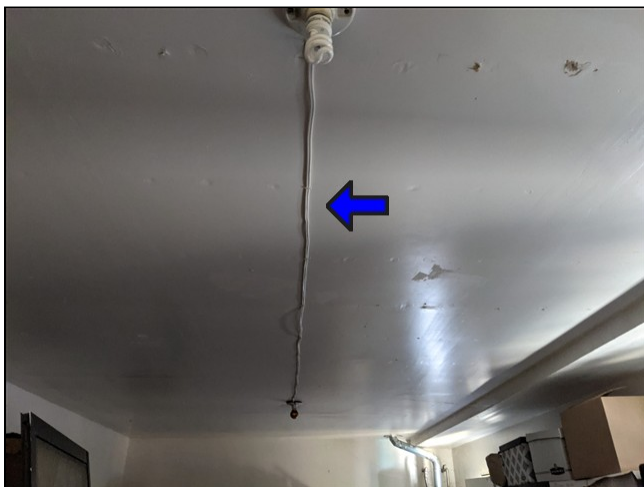
5.3 Item 1(Picture)

Wiring installed improperly and exposed where damage could occur, noted at the right garage. Recommend the wiring be installed inside conduit or behind walls.

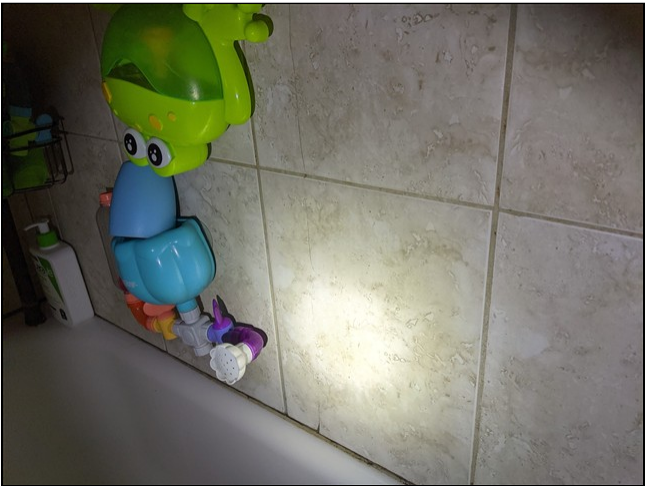
6.0.A Item 1(Picture)

Cracked tile noted at the shower surround. Tile remains attached to the mortar beds and in need of proper sealing to prevent further moisture exposure behind the tile. Repair or replacement can be made as needed.

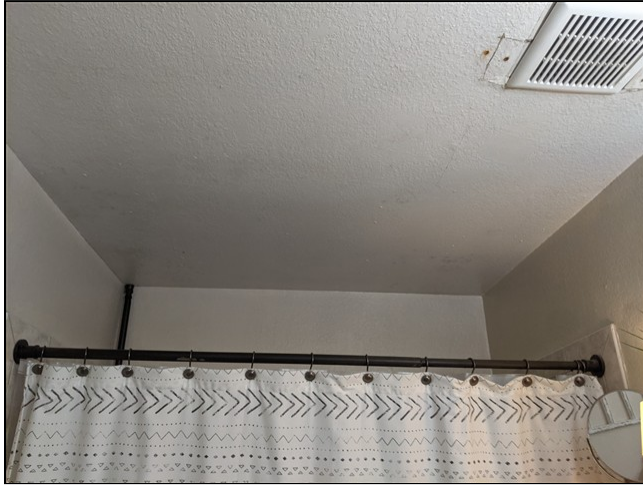
6.5.A Item 1(Picture)

Mildew collection around the wall material above the shower. Recommend proper sterilization/cleaning of the wall materials.

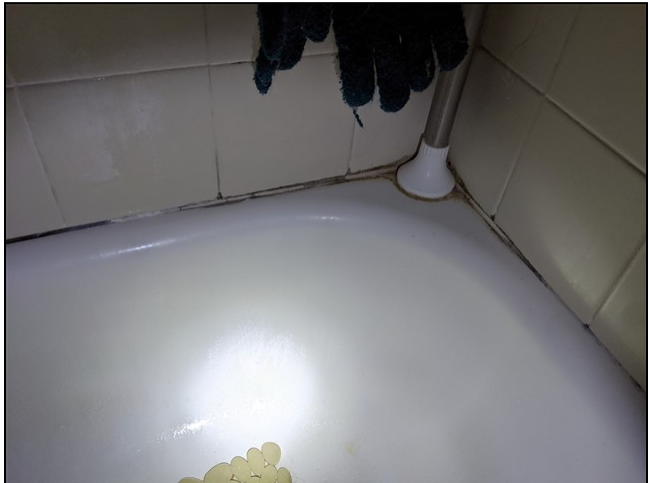
6.6.B Item 1(Picture)

MAINTENANCE NEEDED
Grout needs improved at the tub/shower surround. Recommend color matched grout caulk for these areas.

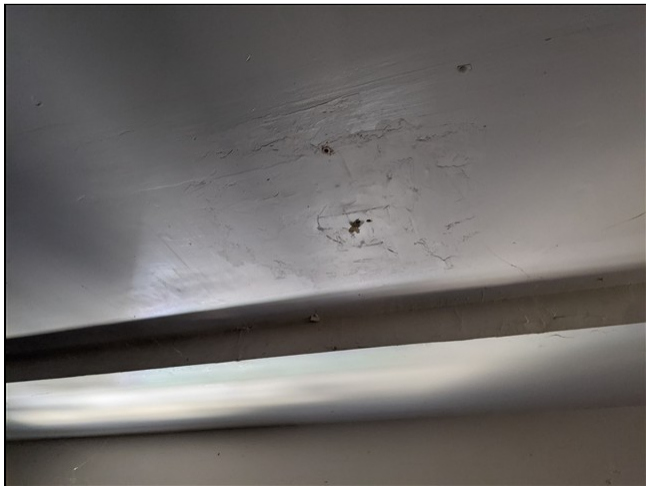
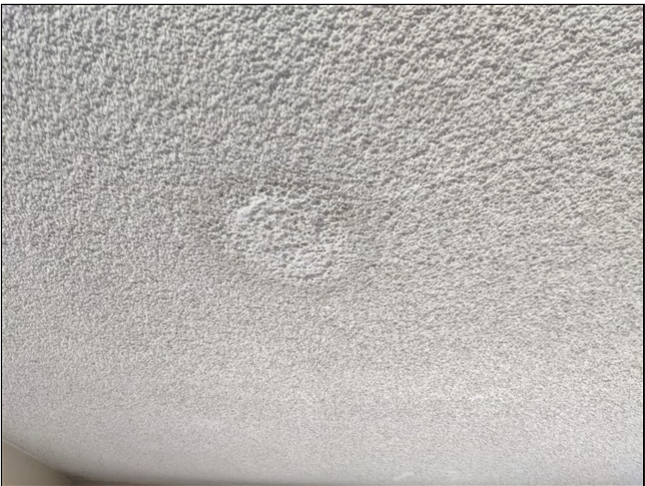
(2) FURTHER EVALUATION
Evidence of previous repairs were noted on the ceiling in the right garage and the front unit. Recommend referring to the sellers disclosures for more information on previous repairs made at these locations.

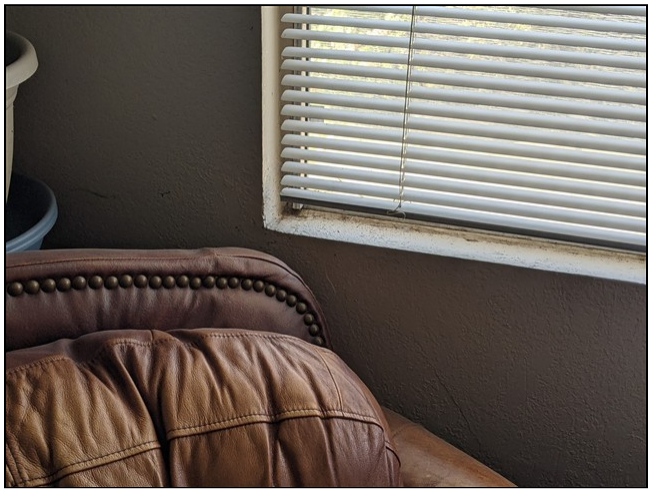
7.3 Item 1(Picture)

Signs of moisture noted around the interior of the windows at the sill areas. This can be typical when metal single pane windows "sweat" at the interior due to temperature fluctuation. Recommend cosmetic repairs made as needed.
